## Body and Fittings

Last updated 02-Jan-2012

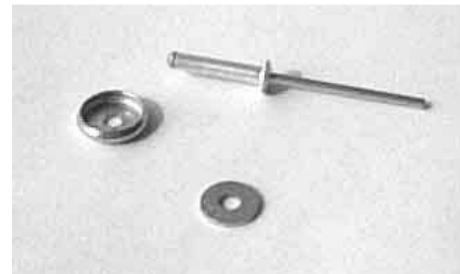
Fitting kits are available containing the full complement of pop-rivets with cup-shaped washers attached and six studs and nuts, sometimes washers too sometimes not, as shown in this picture.
