## Clutch Slave

## Clutch Linkage Wear

## Clutch Change

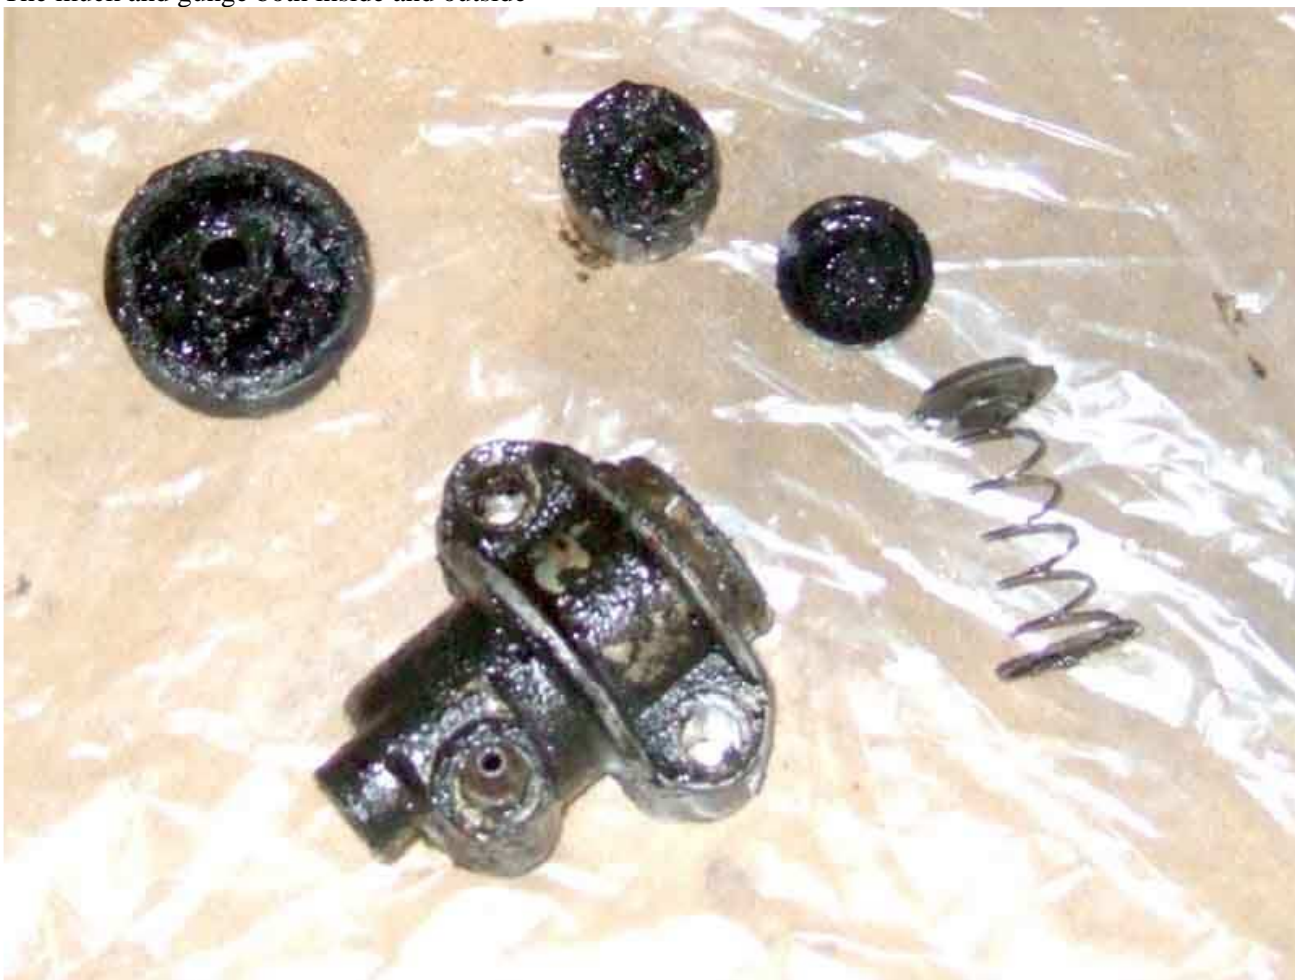
The muck and gunge both inside and outside

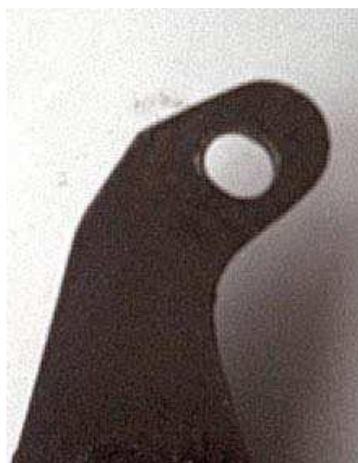
The clutch pedal very ovalled, ...

... and the master push-rod significantly so. Both had also cut into the clevis pin, recucing travel still further.

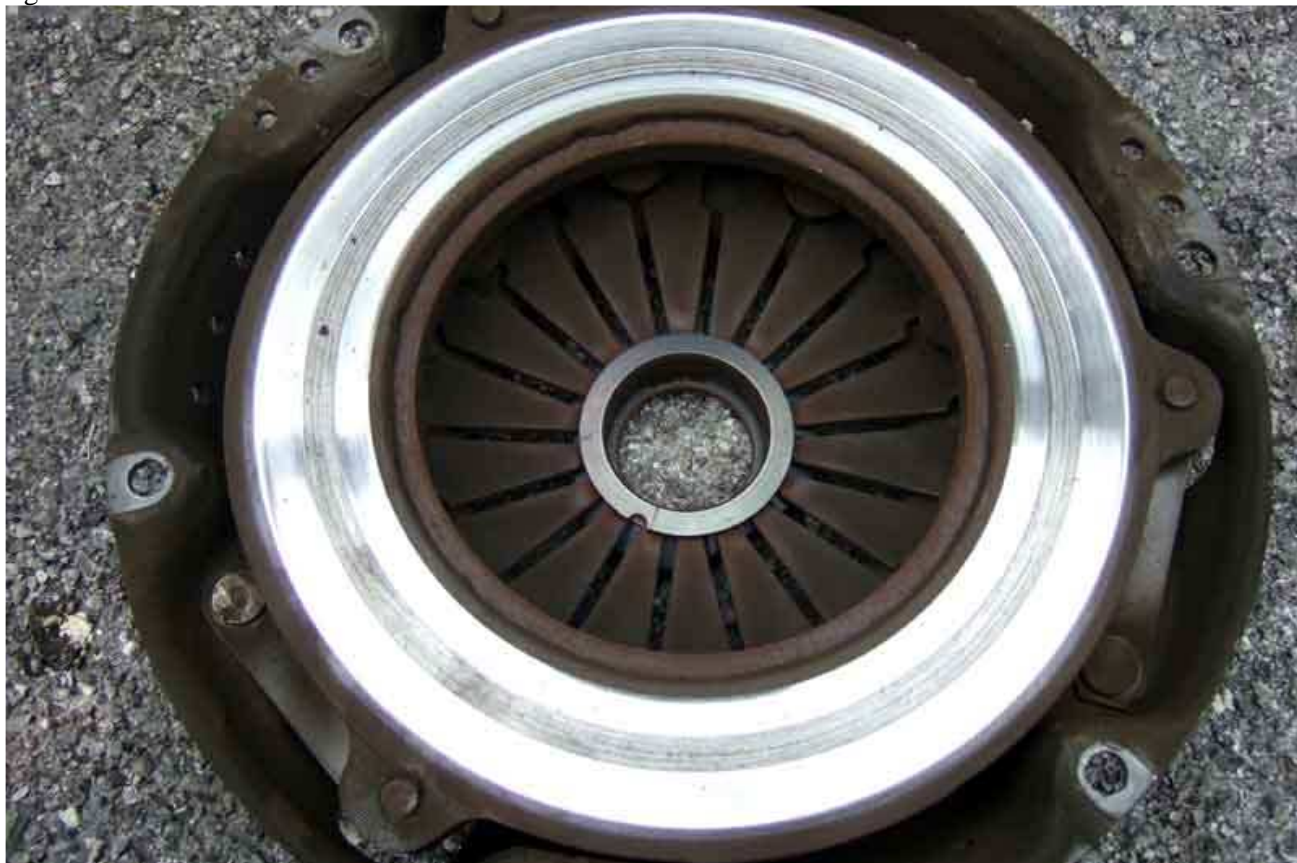
Very badly scored friction surface on the cover-plate, a deep groove from the friction plate rivets as well as significant wear across the full width of the friction surface.

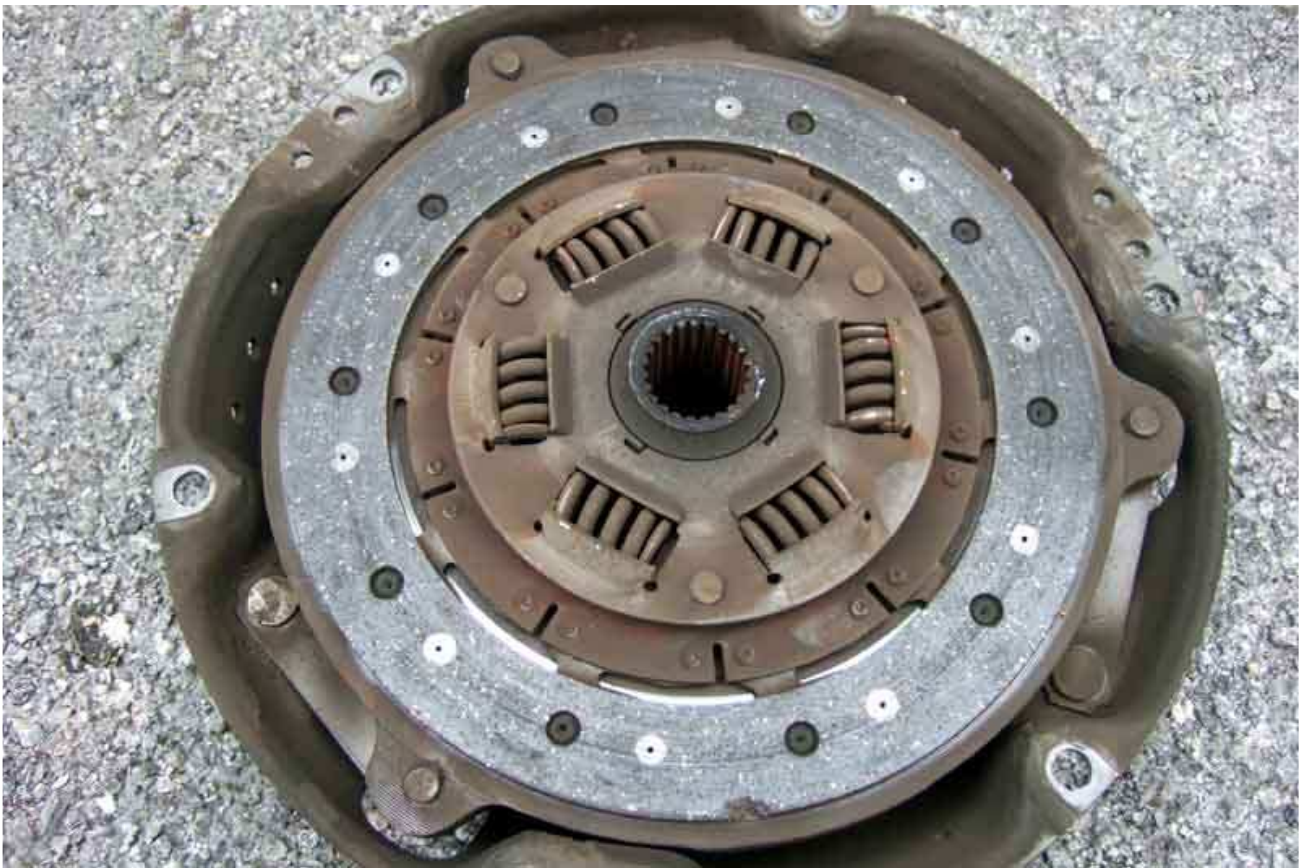
Friction-plate down to the rivets, fortunately only on the cover-plate side

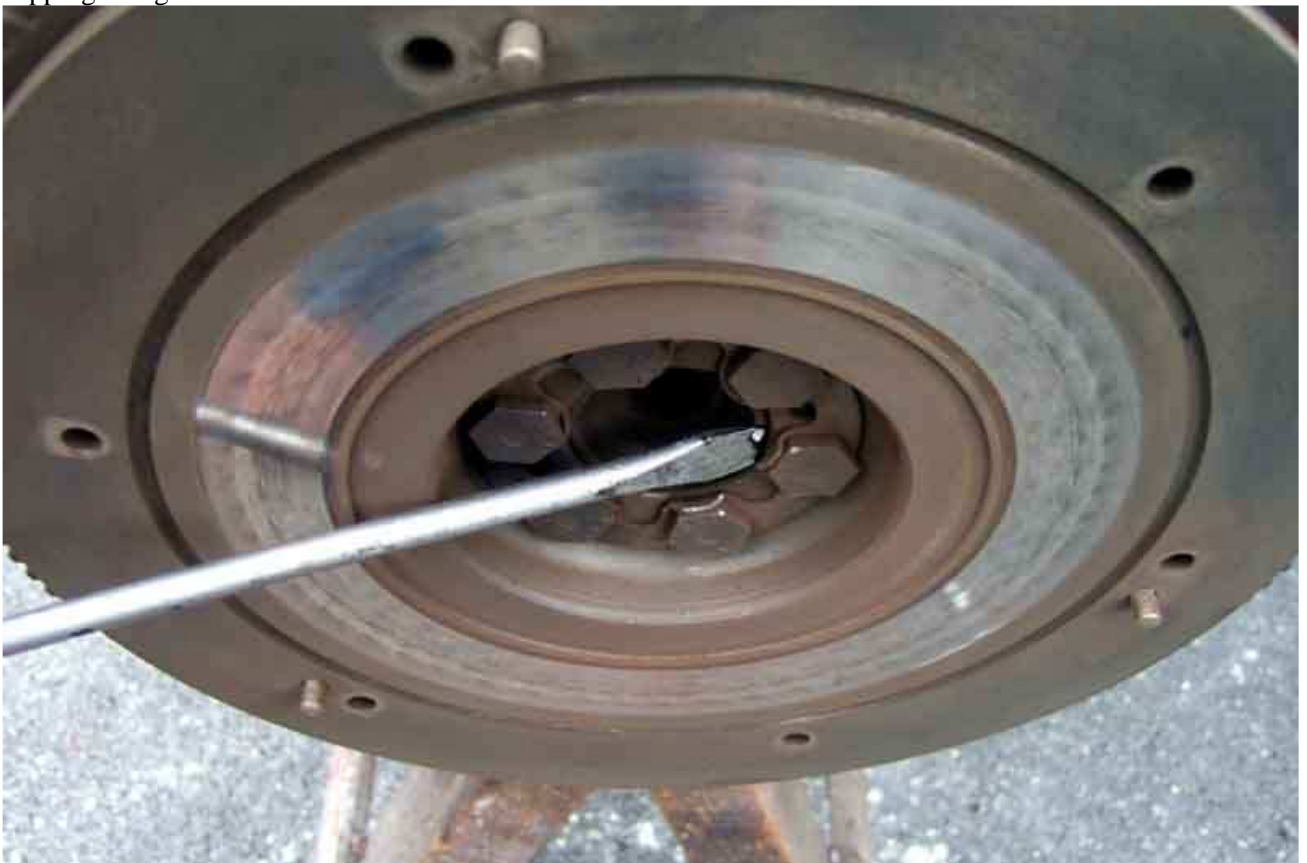
Flywheel fortunately sound. Only a very slight depression across the full width, what looks like a groove from rivets is actually only a polish mark as can be seen by the reflection of the screwdriver. No blueing from the slipping or sign of oil from the crank seal.

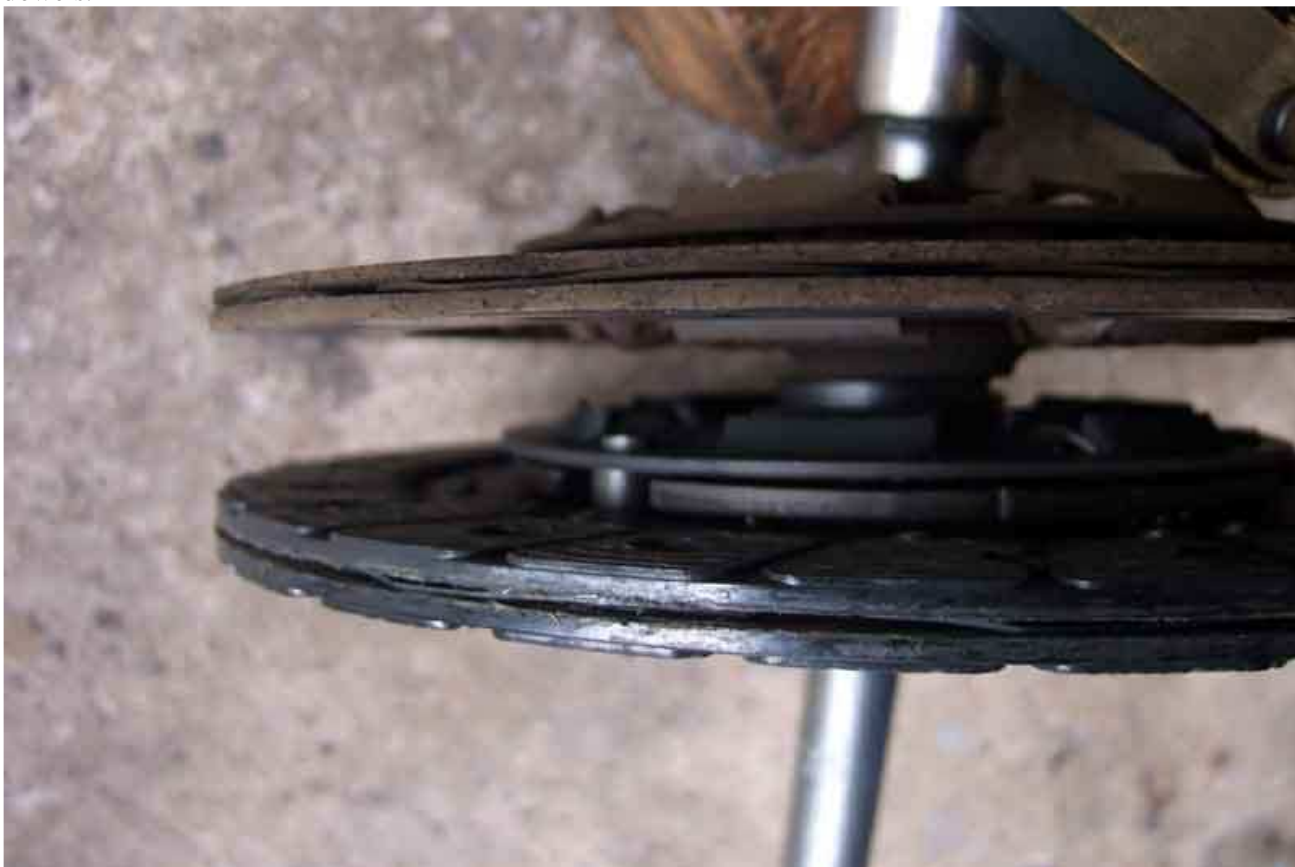
Old and new friction plates - the old has the pads completely worn away both sides plus about half the base

material on the cover-plate side. Quite a difference in thickness between old and new, together with the wear on the cover plate it's not surprising it was slipping and the springs wouldn't push the cover-plate off the dowels.

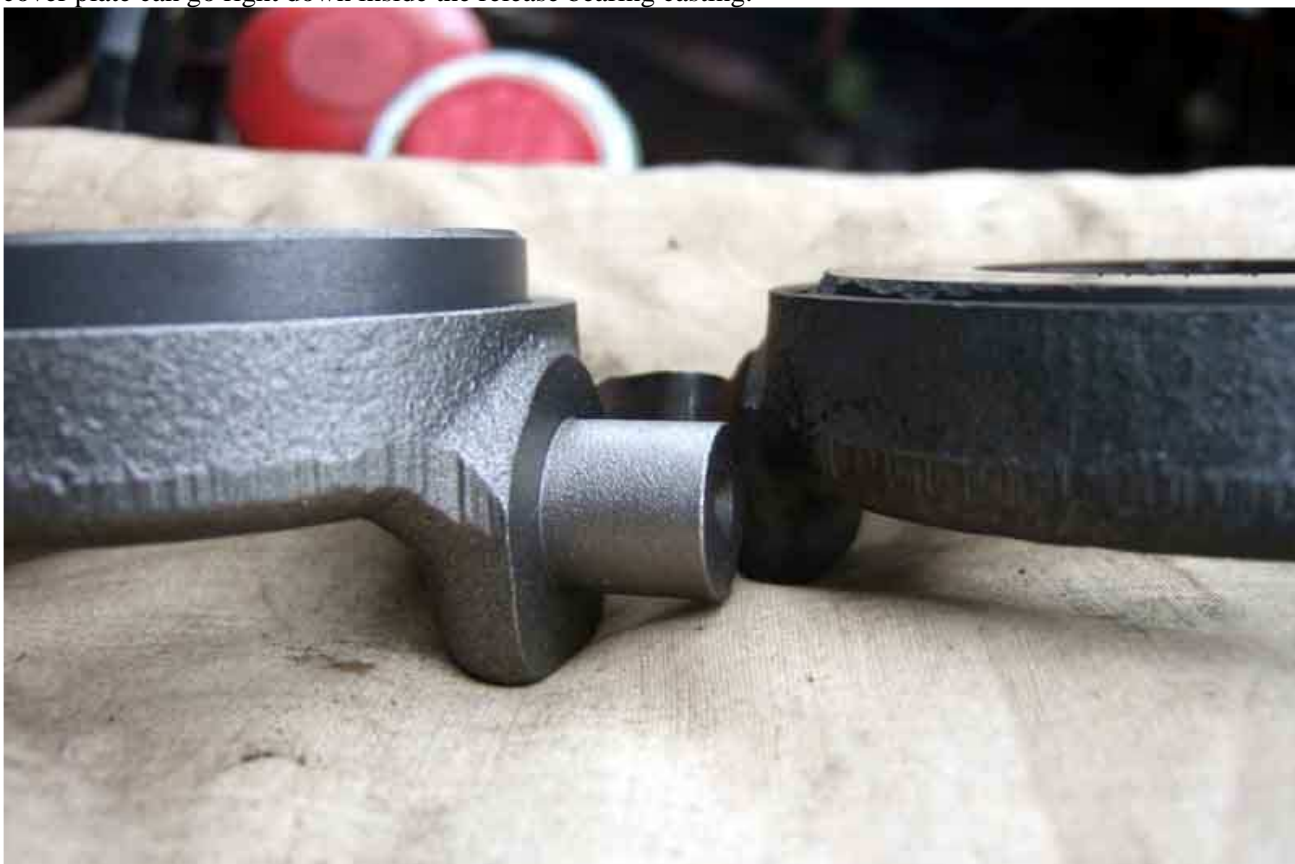
New and old release bearings - plenty of meat left on the old, perhaps only 1/3rd worn, as the boss on the cover plate can go right down inside the release bearing casting.

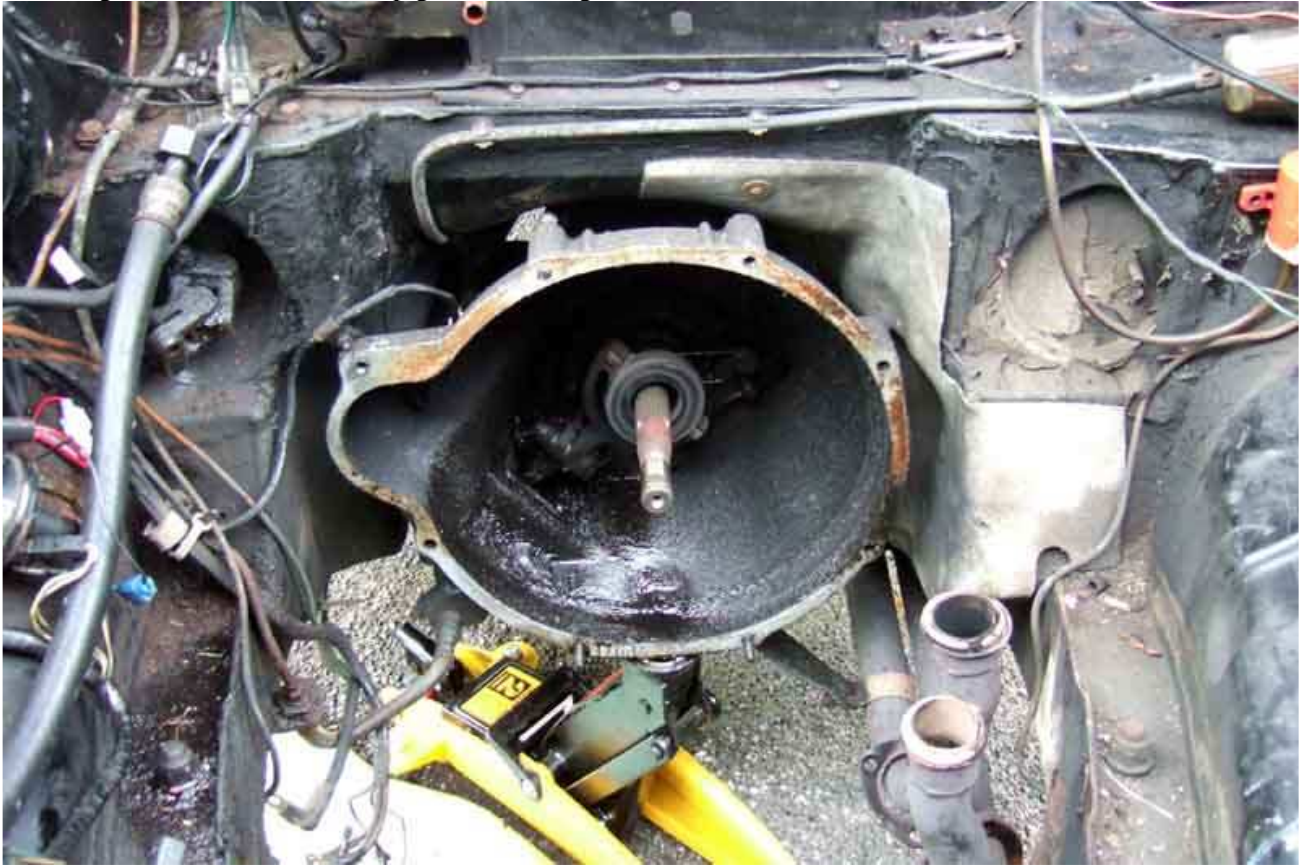
... and engine out (wish it were as easy as that). Gunky oil in the bell-housing, around the release arm rather than straight down from the first-motion shaft and cleaner oil if it had been the oil seal. I would very strongly advise freeing-up the connection between the clutch hydraulic pipe and the end of the hose, and the locknut securing the hose to the bracket on the chassis rail while the engine is out even if you don't think you will be removing it later. It's an absolute pig when the engine is in.

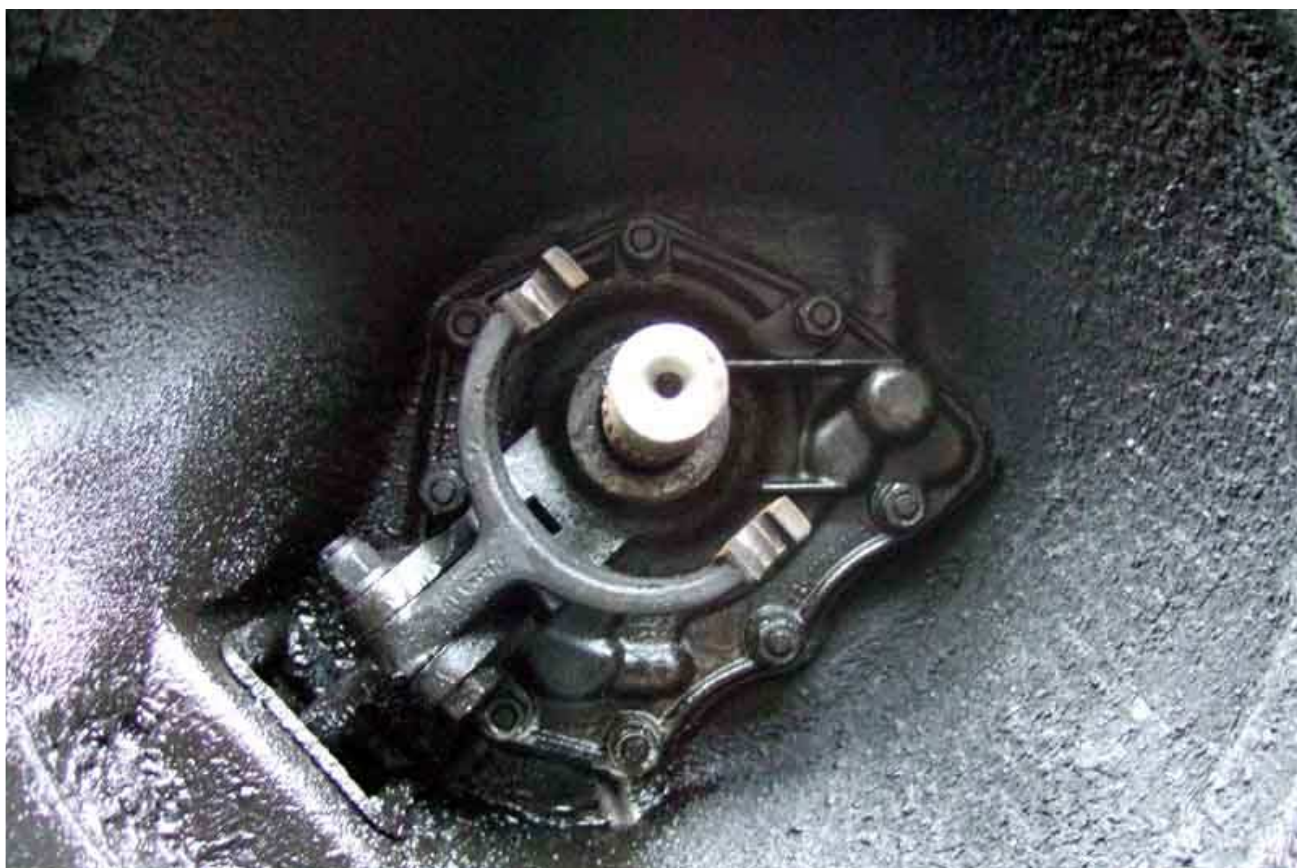
No visible seepage from the seal itself, so just checked the nuts on the seal plate for tightness. Check the release arm does not wobble on its pivot, but still moves freely. If the arm wobbles the release bearing can be off-set to the cover plate which causes premature failure.

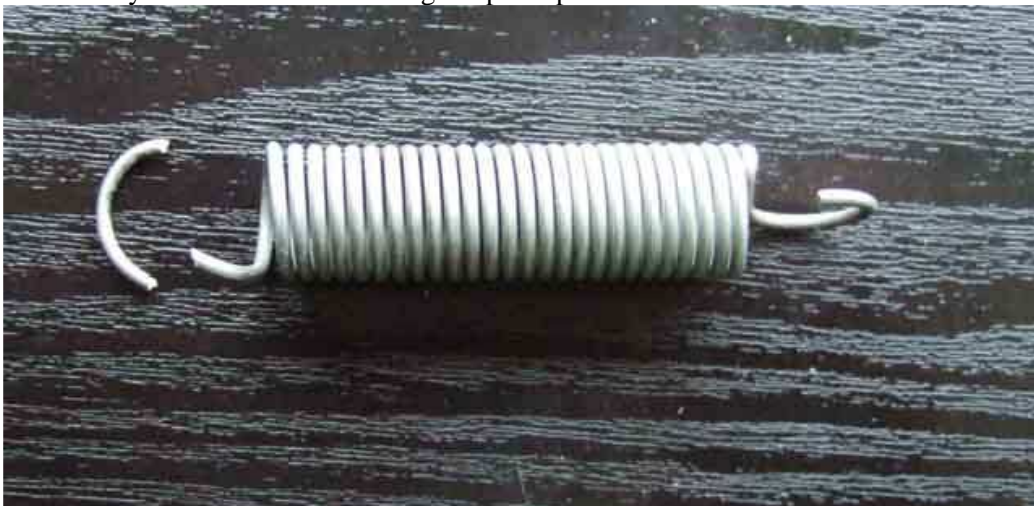
The fracture well away from the marks showing the pivot-point.

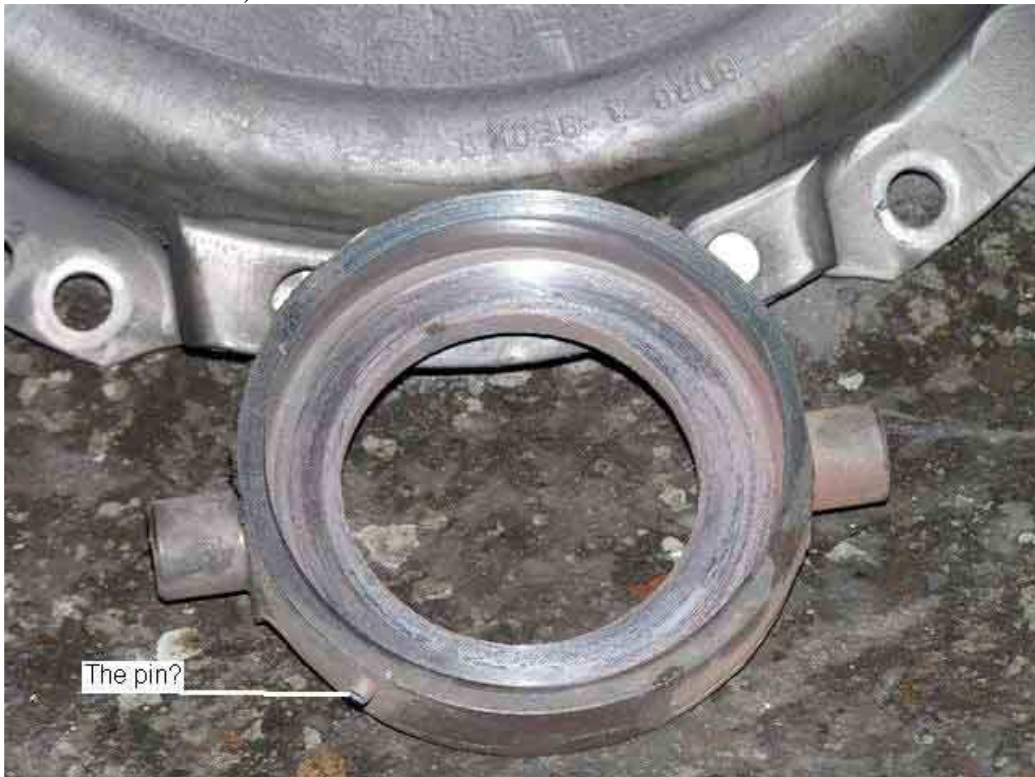
The 8000 mile release bearing. Not a trace of carbon left in it, or any pieces in the bell-housing, just a fine dust spread all round the inside. Note the roll-pin on the bottom left-hand side, is this the pin that causes the problem? (Photo: David Bolton)

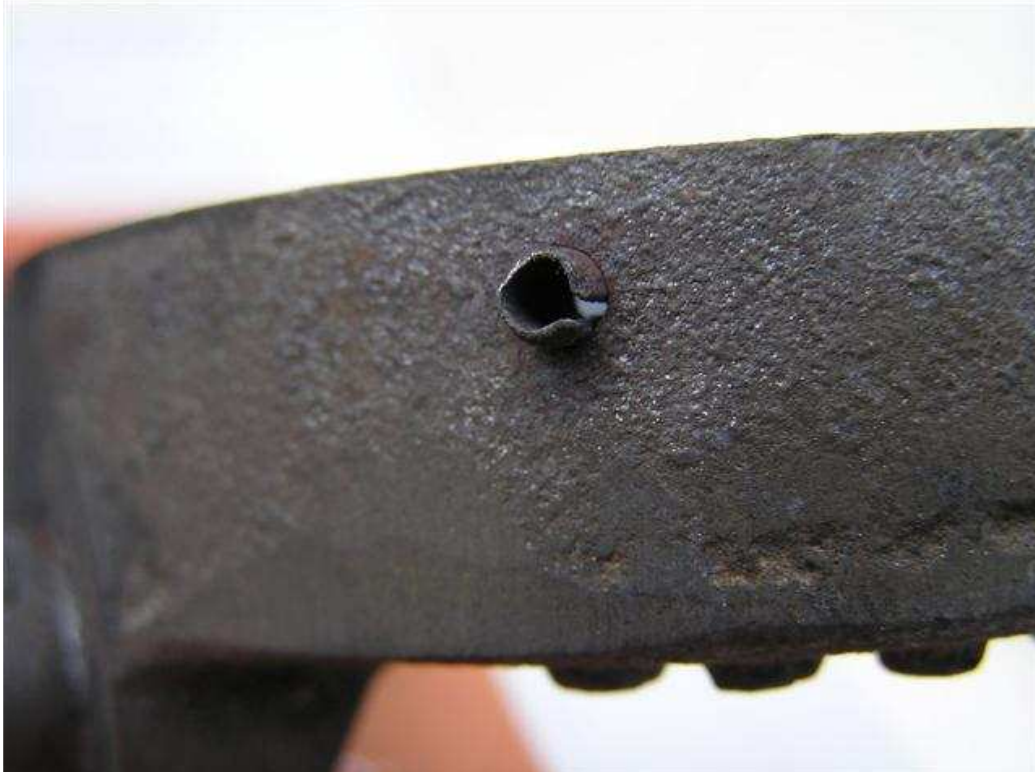
Two more pictures of the roll-pin in the old bearing. Is it supposed to be sticking out like this or flush? (Photo: David Bolton)

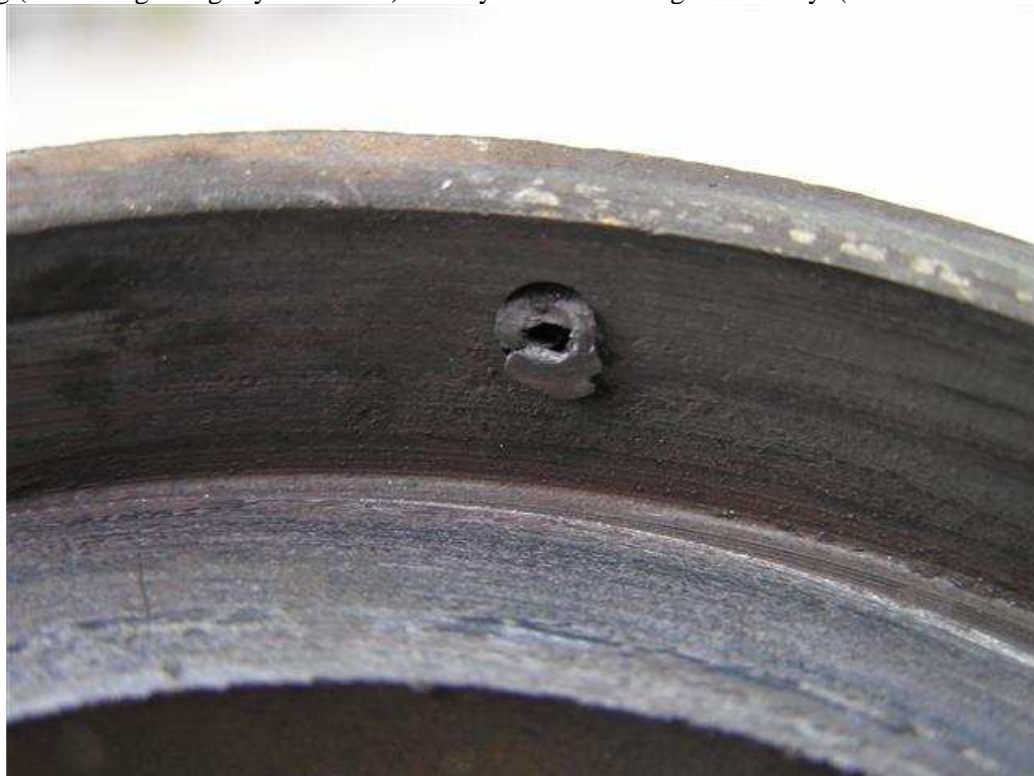
The inner end of the roll-pin. Part shows obvious signs of wear, but there is a recessed part that doesn't. It's not possible to determine whether the pin projected into a hole in the carbon ring and so has had quite a bit ground

off by the boss on the cover plate plus some broken away, or whether the pin only bears on the side of the carbon ring (so holding it slightly off-centre) so very little has been ground away. (Photo: David Bolton)

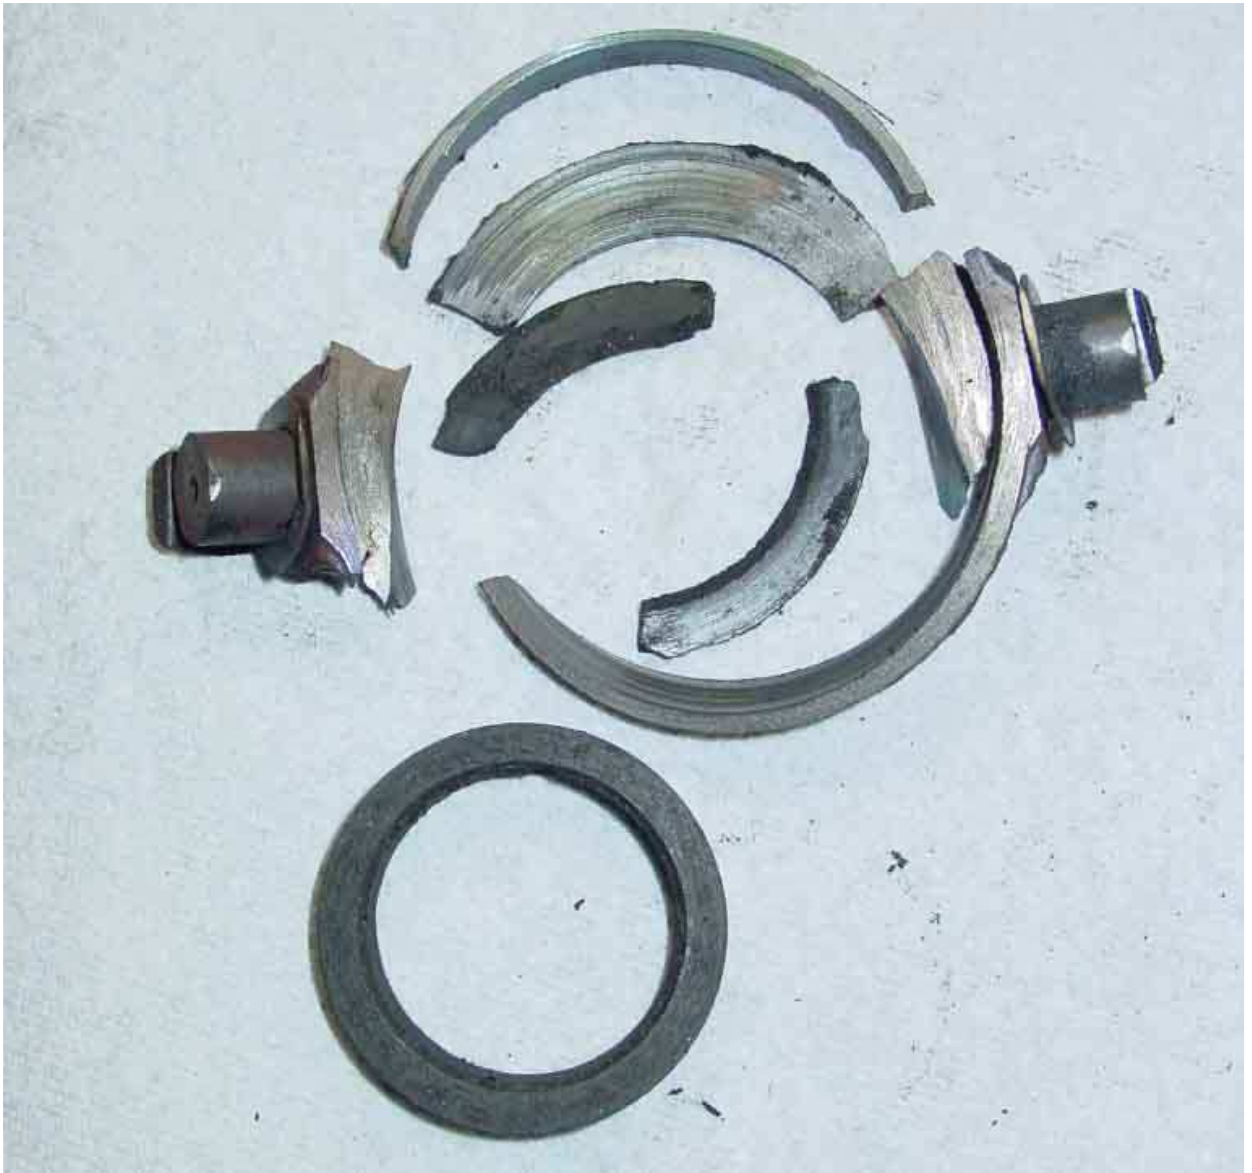
These four photos by Bob Muenchausen: Badly broken-up bearing but still a ring of carbon seems to be left. Probably once the boss on the cover plate had worn down the carbon to the top of the carrier there was a mismatch that meant it was bearing on the casting rather than the carbon ring, wearing that down instead, note the upper piece of the outer ring of casting is much thinner than the lower piece. Eventually it goes so thin it couldn't take the force of the clutch and it broke suddenly, further operations of the clutch pedal pushing the slave piston out of the end of the cylinder. This is very similar to what happened to the clutch on my roadster many years ago (mileage unknown), although on that the offset was worse and towards one of the pivots which snapped off leaving the rest of the bearing relatively undamaged.

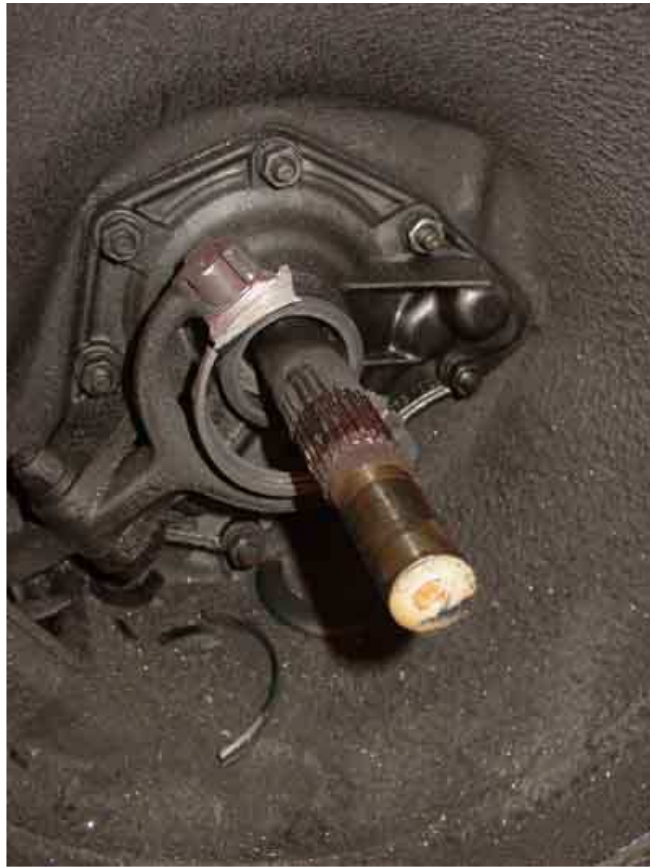
Inside of the bell-housing liberally coated with carbon.

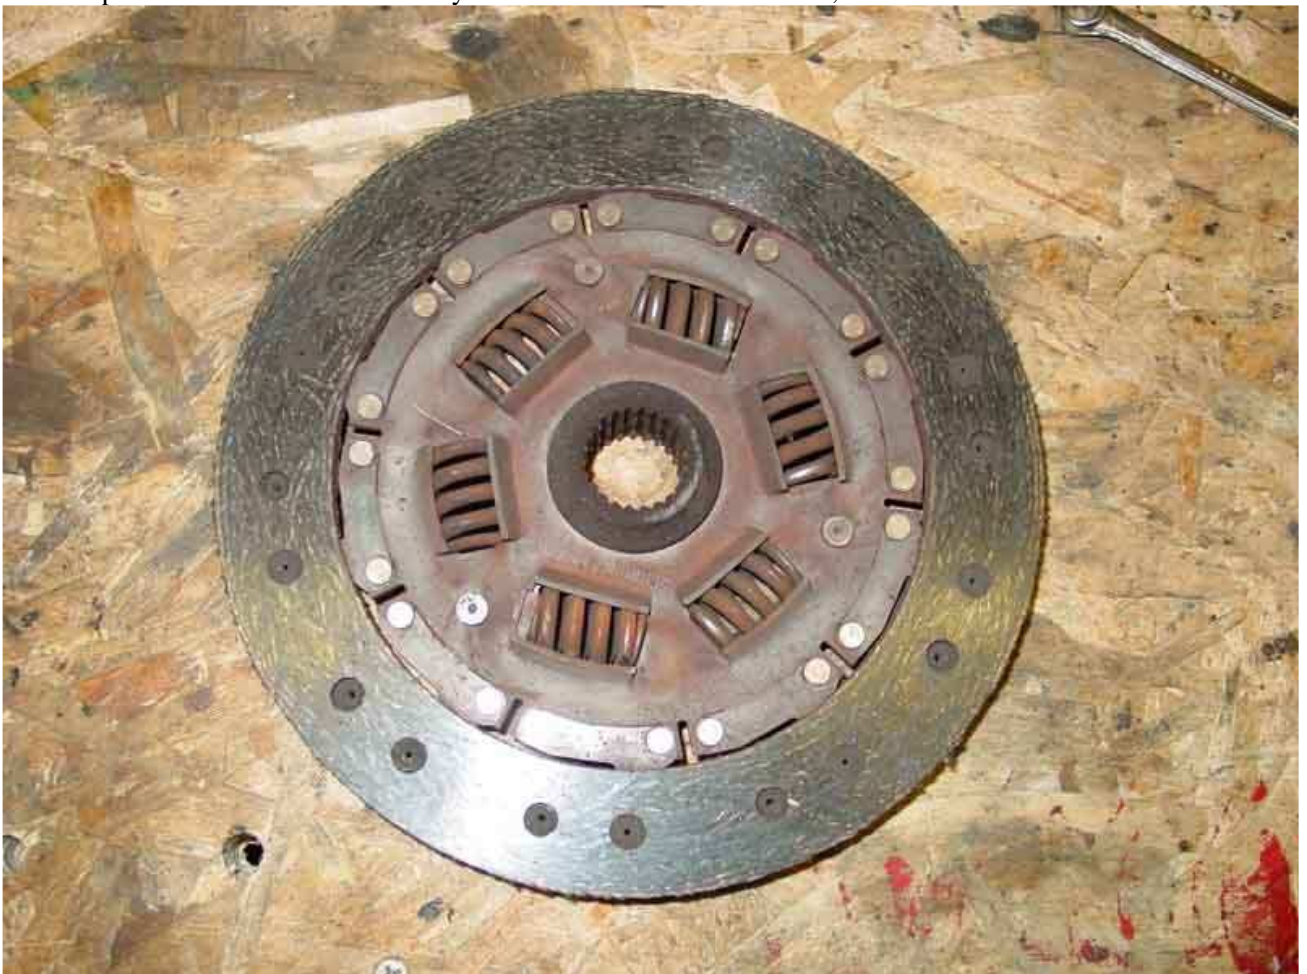
Friction plate with the lands worn away but still well clear of the rivets, not bad for 75k

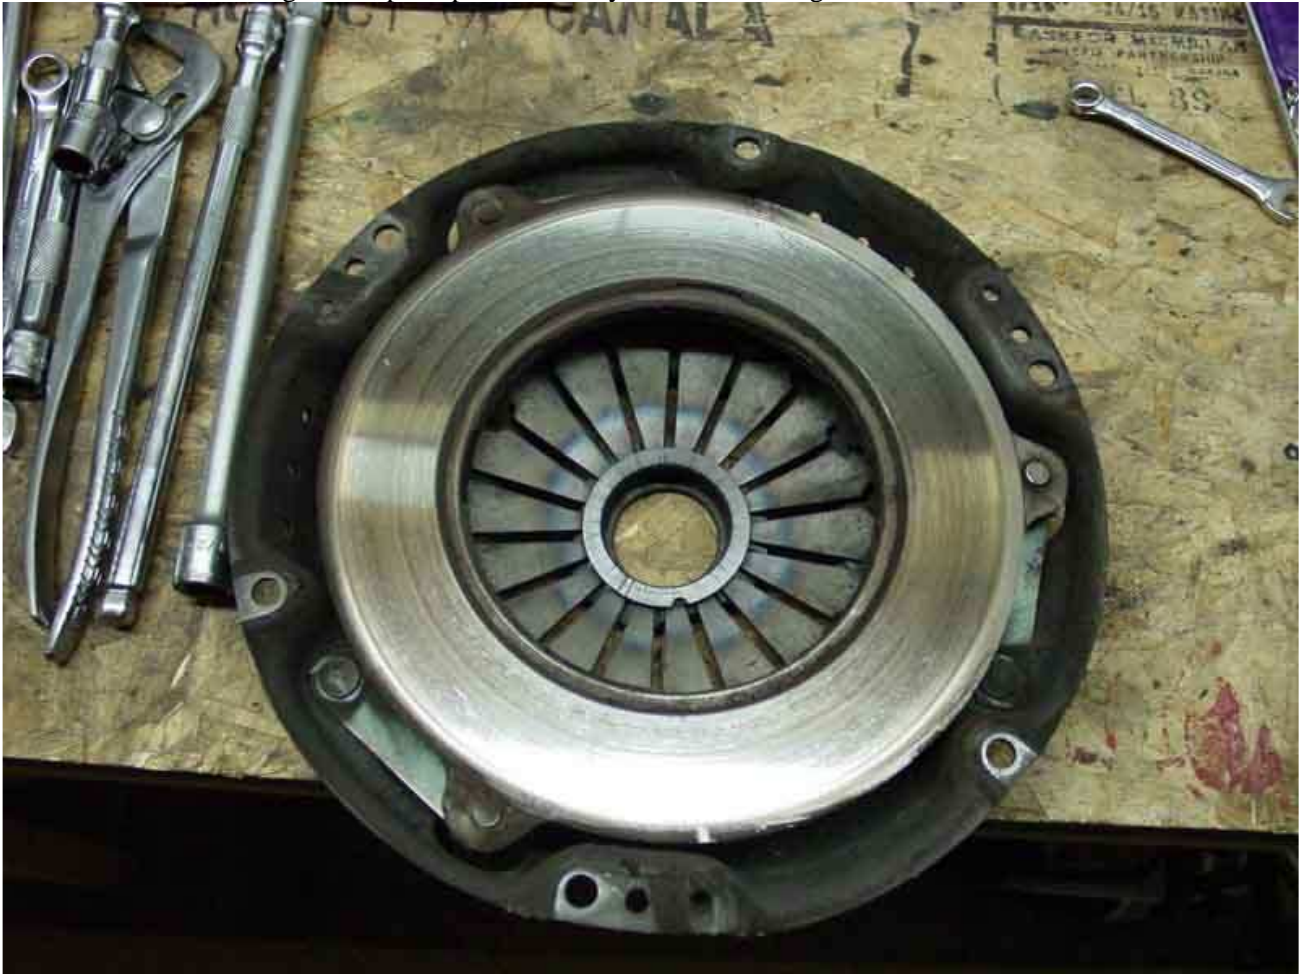
Deep wear groove in the cover-plate, although Bob reports that the flywheel itself was fine. I found much the same on the clutch change I did, perhaps deliberately dissimilar strength metals?
