## Ron Hopkinson Rear Anti-roll Bar

## Front Anti-roll Bar

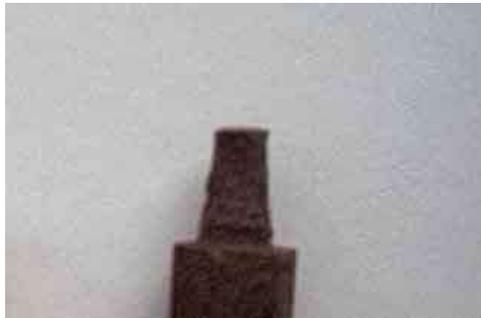
Corrosion weakening before breakage of the original drop-links

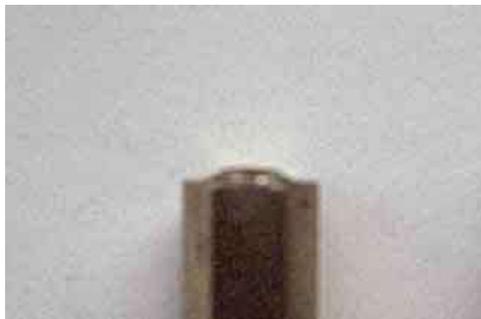
Snapping of the first replacement drop-links

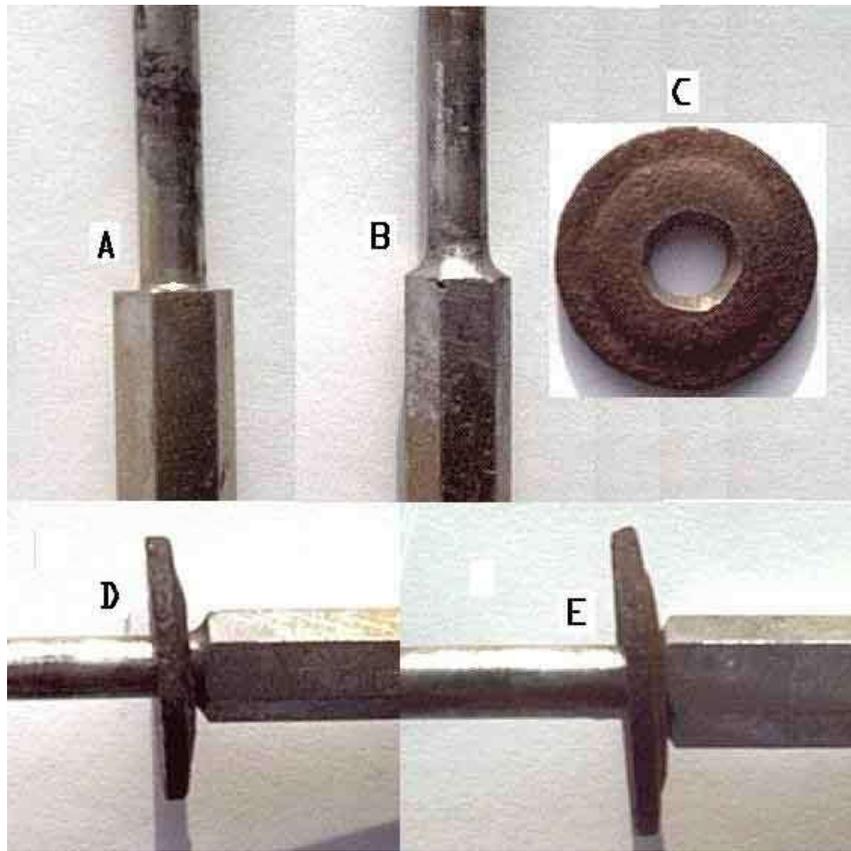
Second replacement drop-links:

- A - as received
- B - strengthened with weld
- C - Support washer chamfered to fit over strengthening
- D - unmodified washer
- E - modified washer

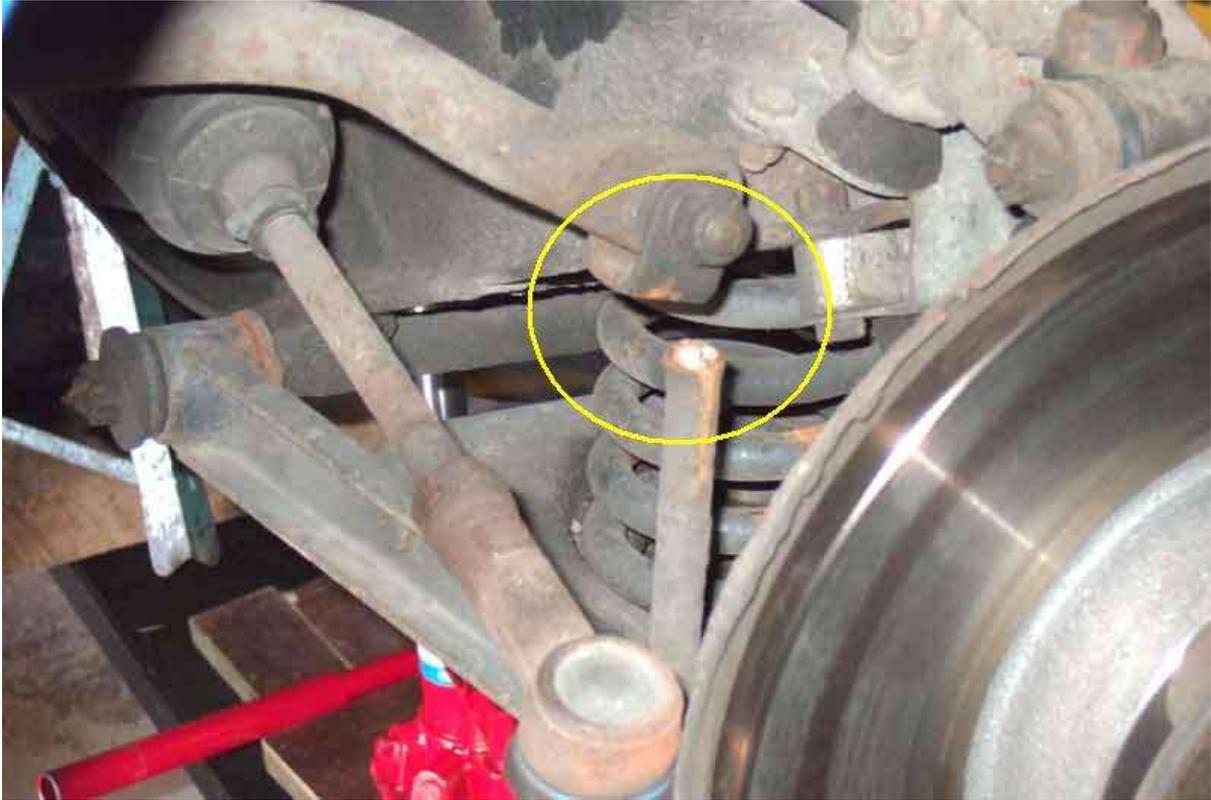
First break of the original in May 2016. Welded, it broke again in June, so was replaced with a new one.

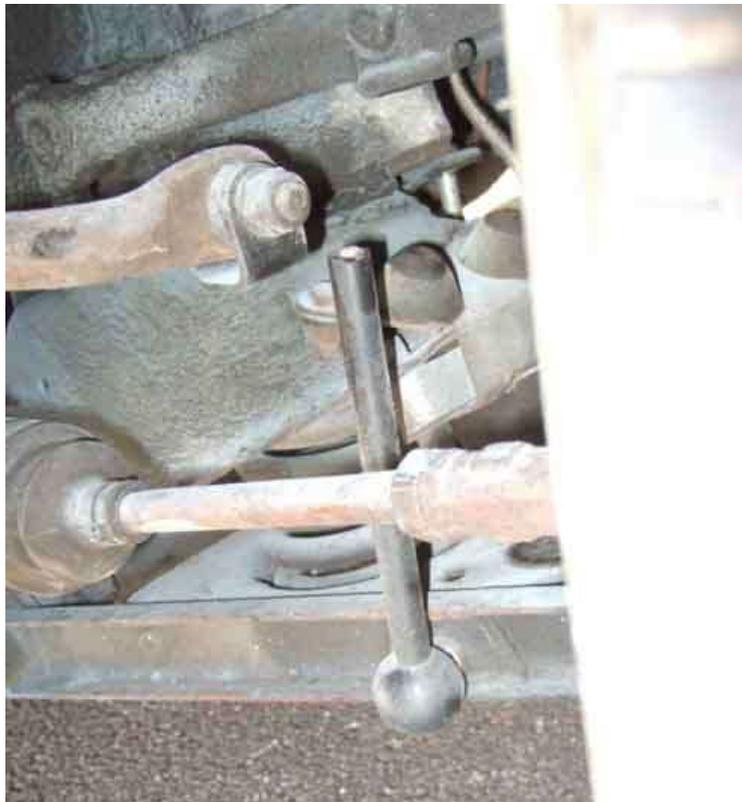
Replacement broken in the same way, after just four months.

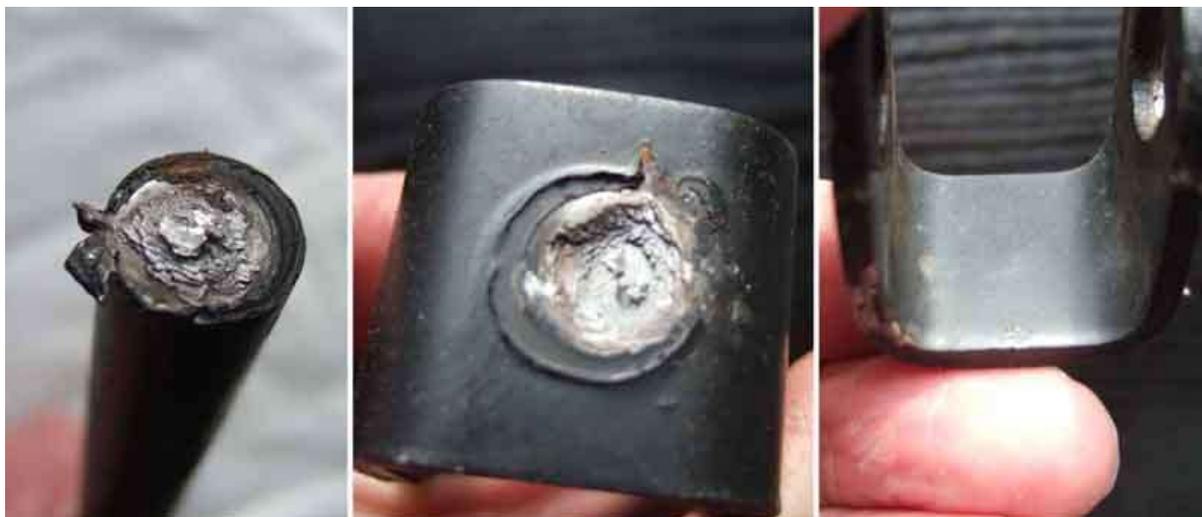
What seems to be a minimal weld, probably just a spot-weld i.e. the two components held together while a high (not high enough) current is passed through the joint

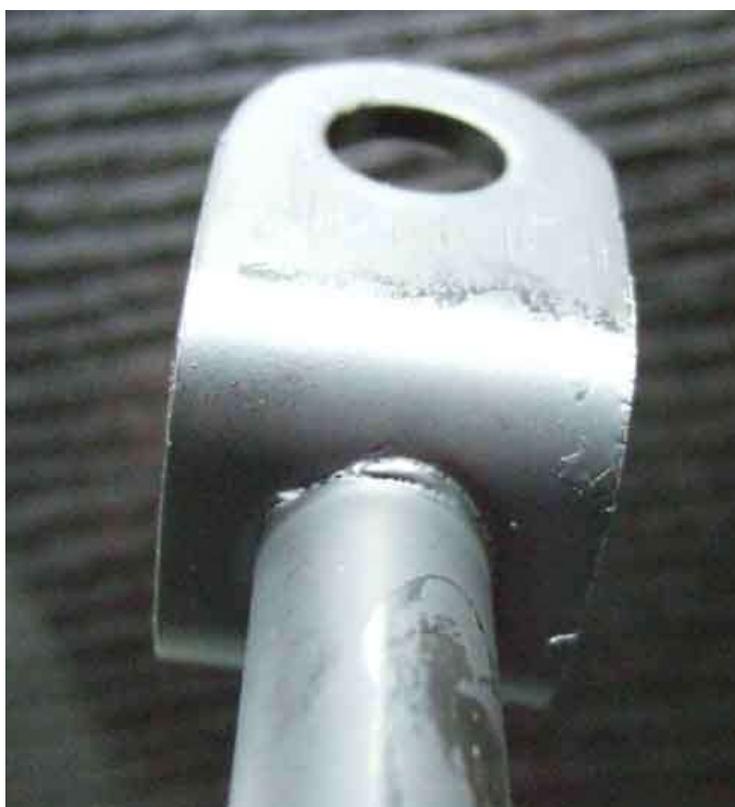
FOC replacement looks just the same, so I'll get it reinforced. OK, the breakages are probably down to the traffic calming 'pillows' we have to suffer round here, but I have no choice but to drive over at least one of them, and a significant detour to avoid another four.

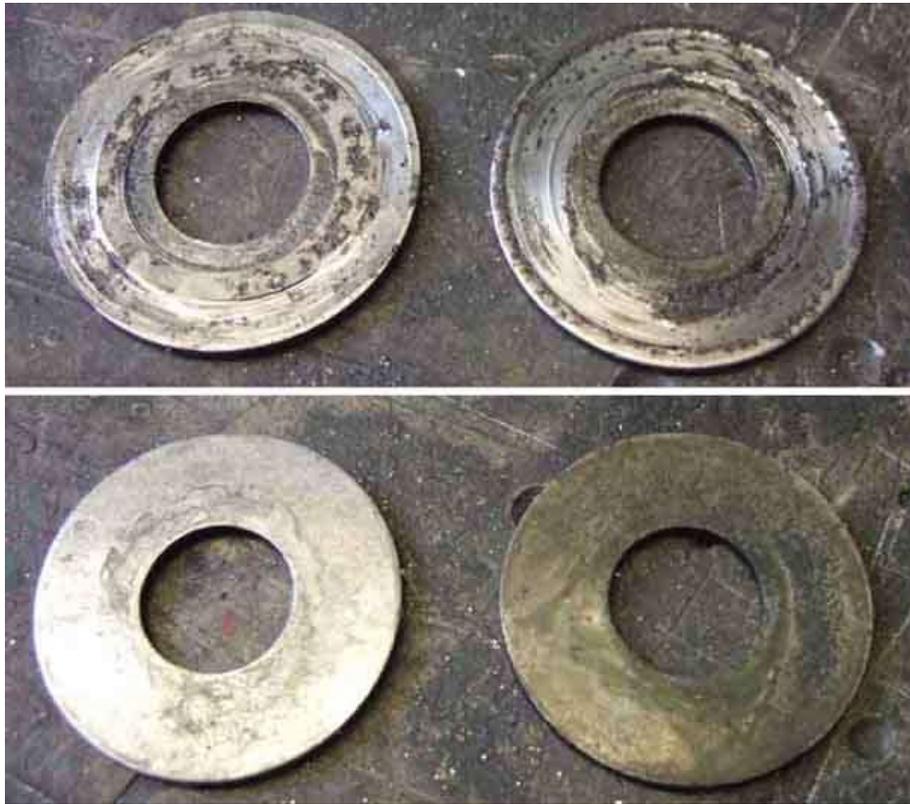
Bee's thrust washers. Clearly grooved on the faces that had been against the bush, but the backs unmarked.

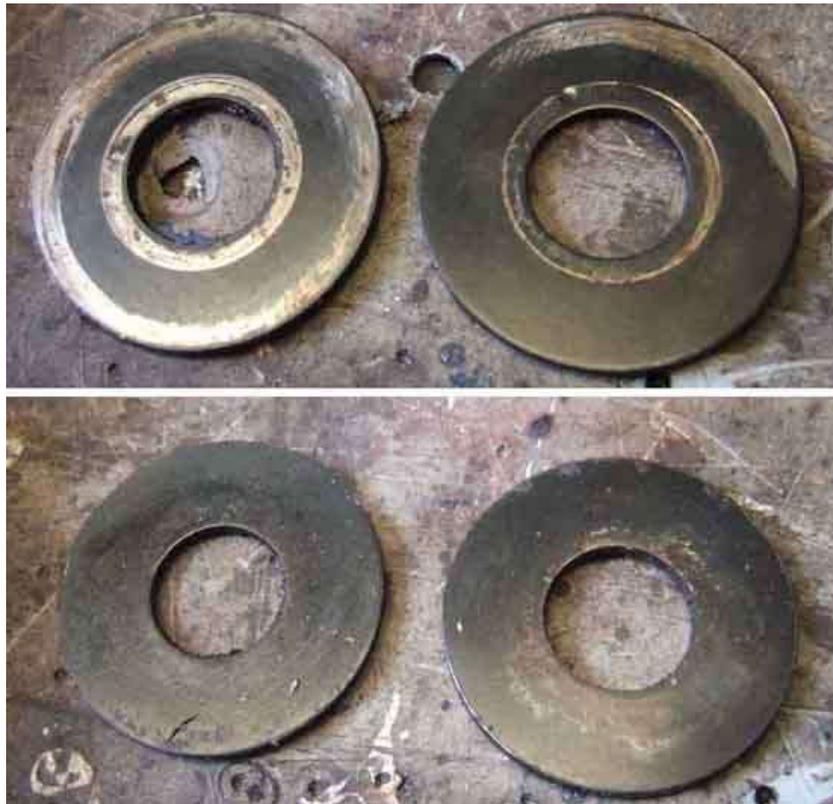
Vee's thrust washers. Definite wear marks, but not so deep, as evidenced from the lesser audible clonk.

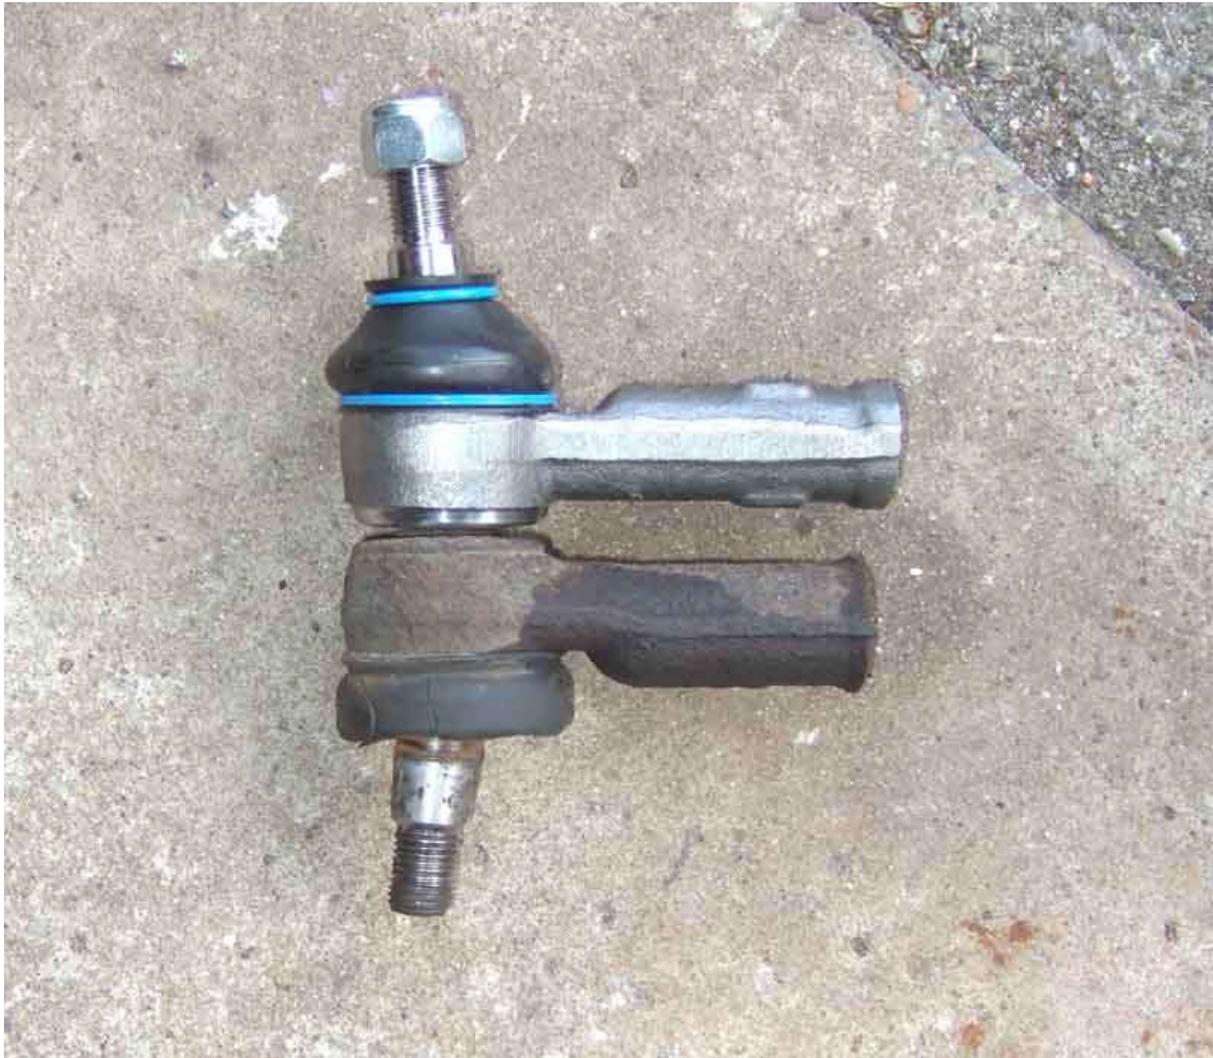
Bee's old and new track-rod ends of different lengths:

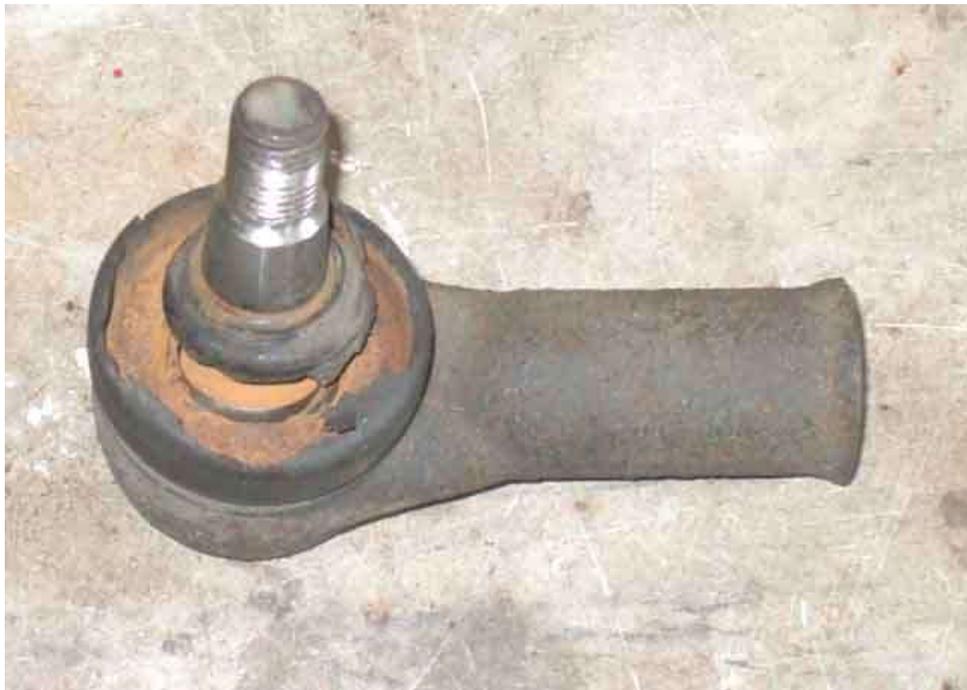
Badly worn unit:

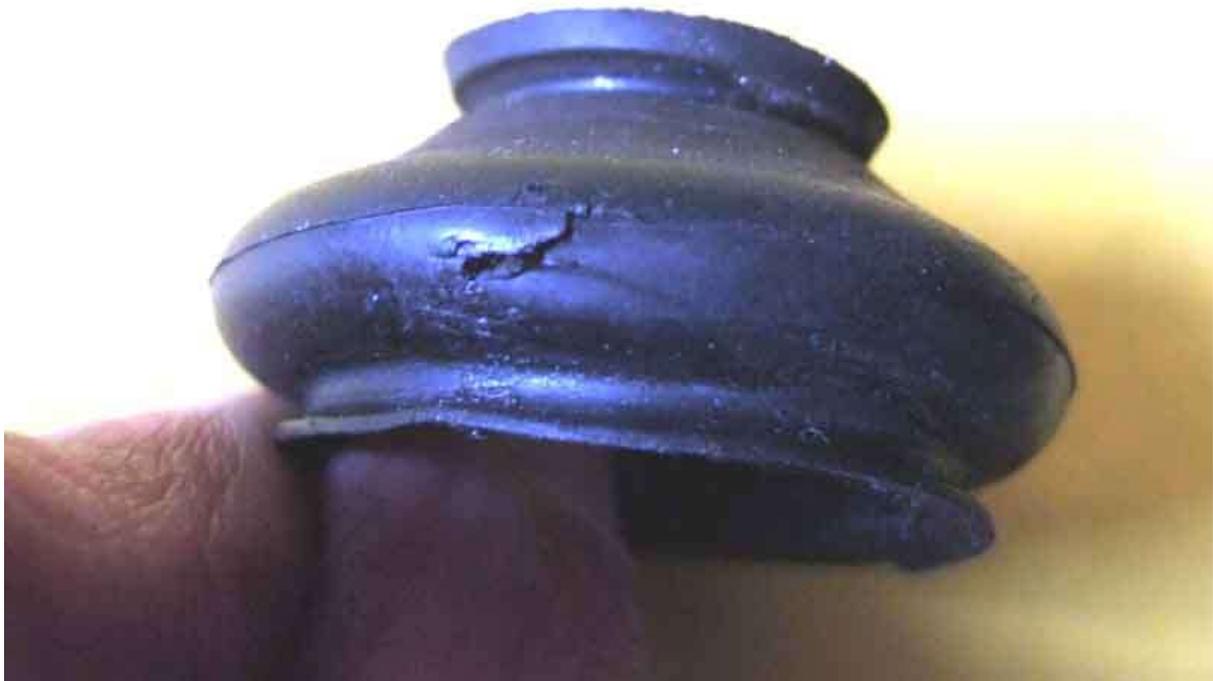
During the annual service I discovered the near-side dust cover damaged, along with its larger retaining spring. On removal it seems to have been punched through from an impact with something as otherwise the rubber is still very supple and shiny i.e. not perished. Fitted in 2010, 18k miles by 2019 so surprising the body is so rusty as the vast majority of those miles have been dry and definitely no salt:

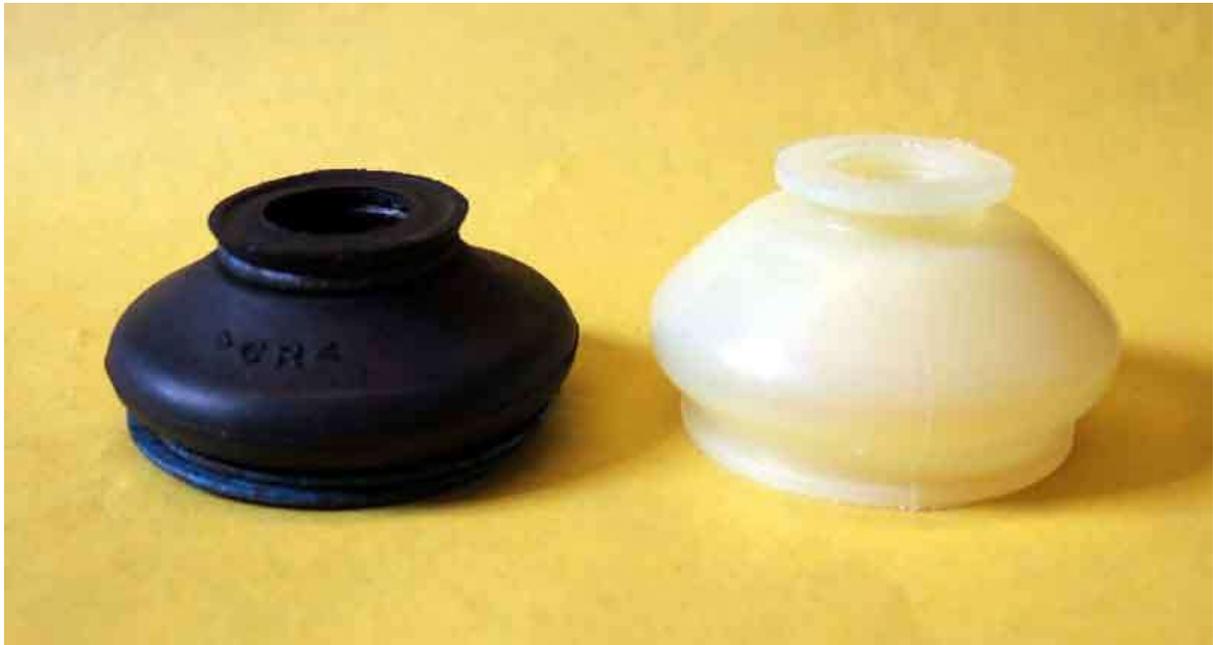
The existing ones are 12-31-17 (small hole - large hole - height) but the closest replacements I could get are 12-31-22. So taller, but correct for the pin and the socket. If they are too tall then when compressed from fitting they could cause the large end to pop off the socket letting dirt in. These are [polyurethane from Bulgaria](#), he sells loads of different types and I was looking for silicone rubber but they were either way too big or not available:

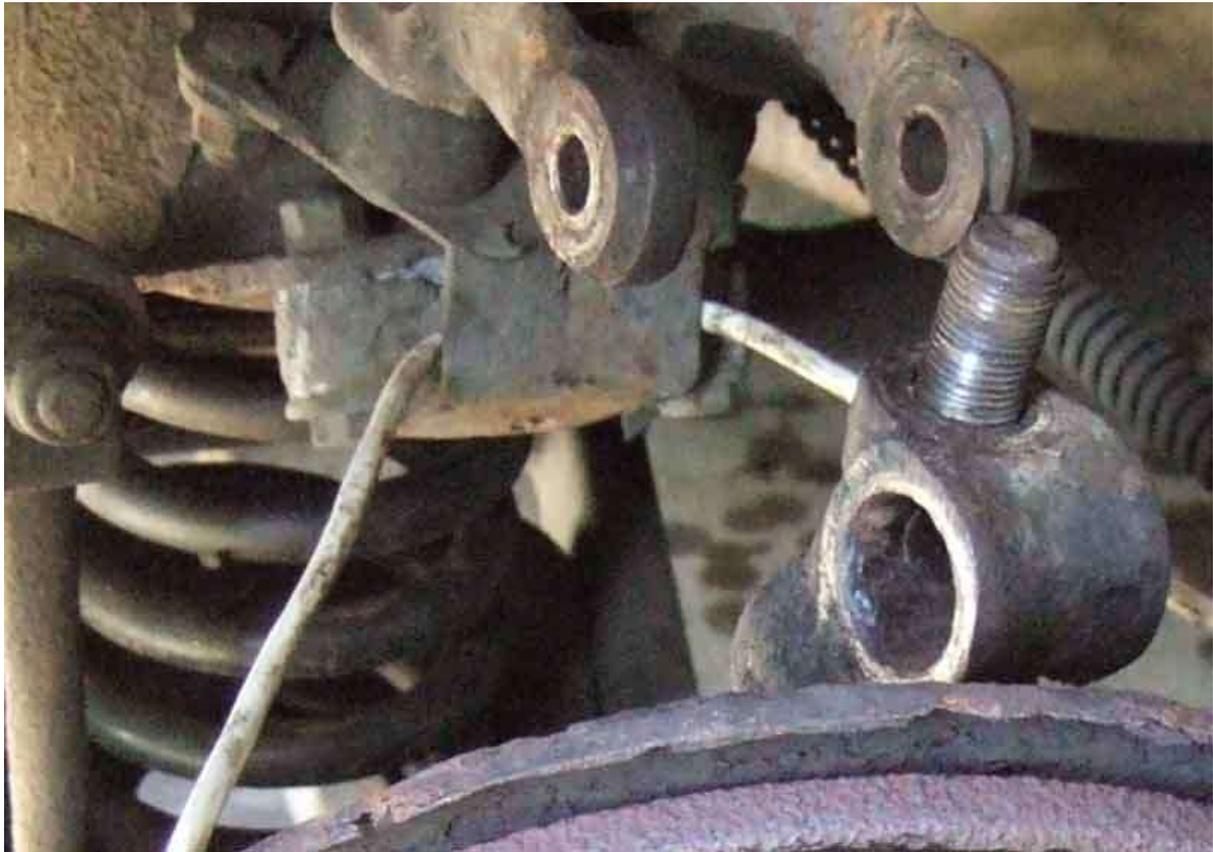
Bump rubber missing of the bottom of its bracket, spotted when working on the king-pin

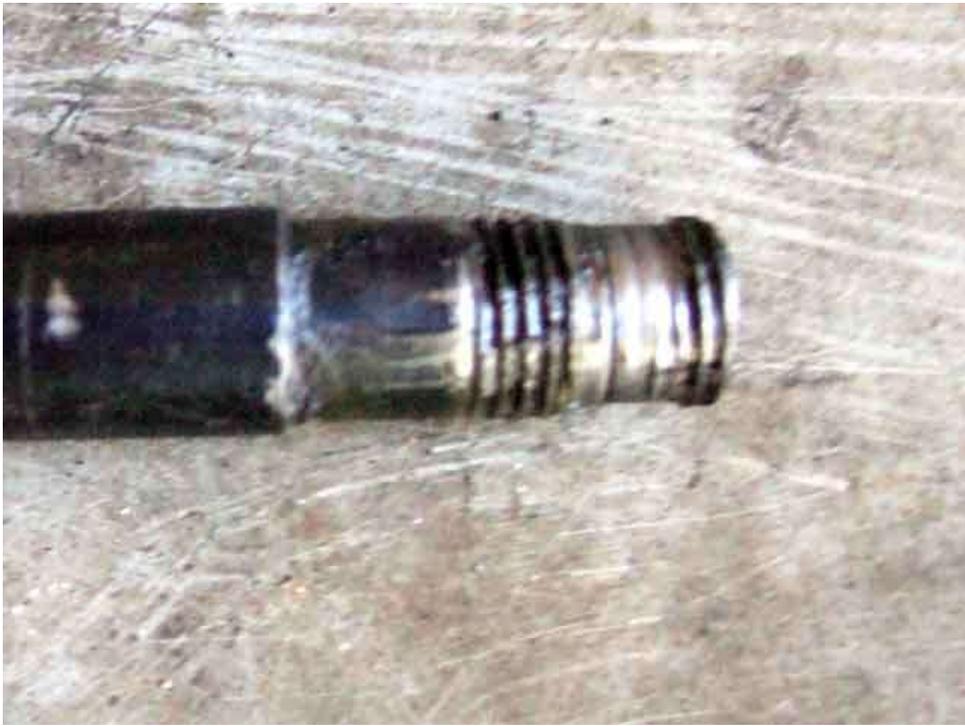
Just as well as the pin I'd replaced a few years earlier (which also came out just fine) stripped its thread when re-tightening the nut!

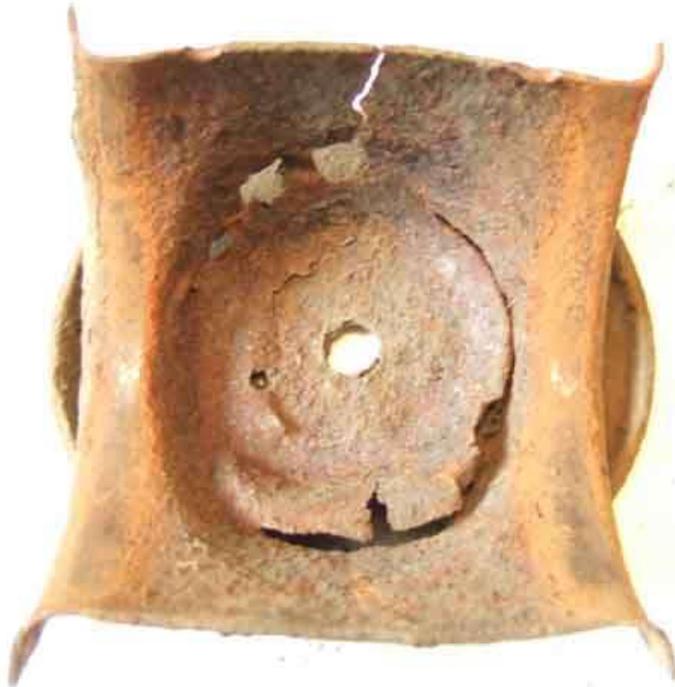
Heavily corroded ...

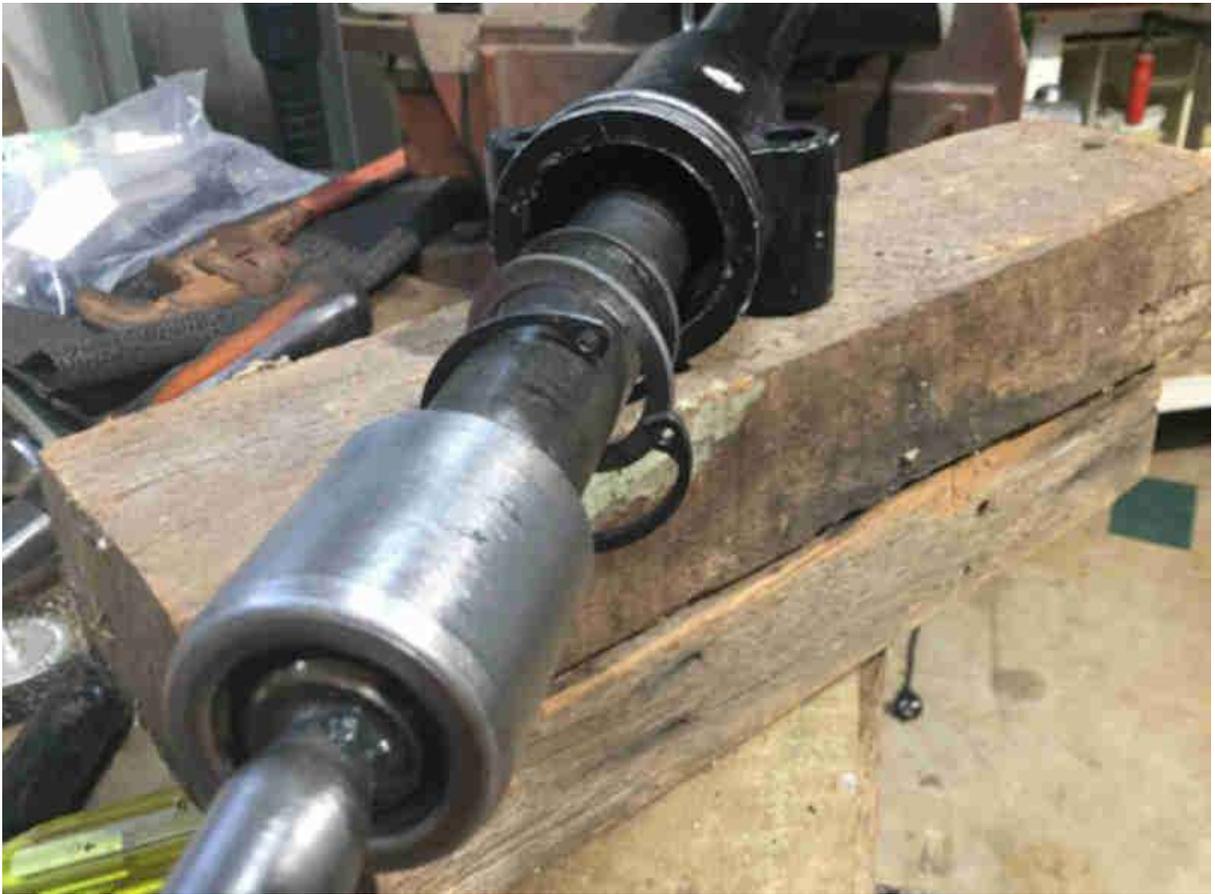
The reason for dismantling the joint was that there was no bush at the passenger side of the rack tube to support the rack shaft, and it flapped about all over the place! Starting inside the rack tube and working outwards there was a washer that wedged against a narrowing taper in the tube, then a gap, then a step in the tube against which a larger washer sat, then a groove against that with a circlip. So it looks like there should have been a bush of some kind between the two washers to support the rack shaft, but there wasn't. This was a replacement rack with the adjuster screw and locknut for the damper, [as above](#): (JPHall)

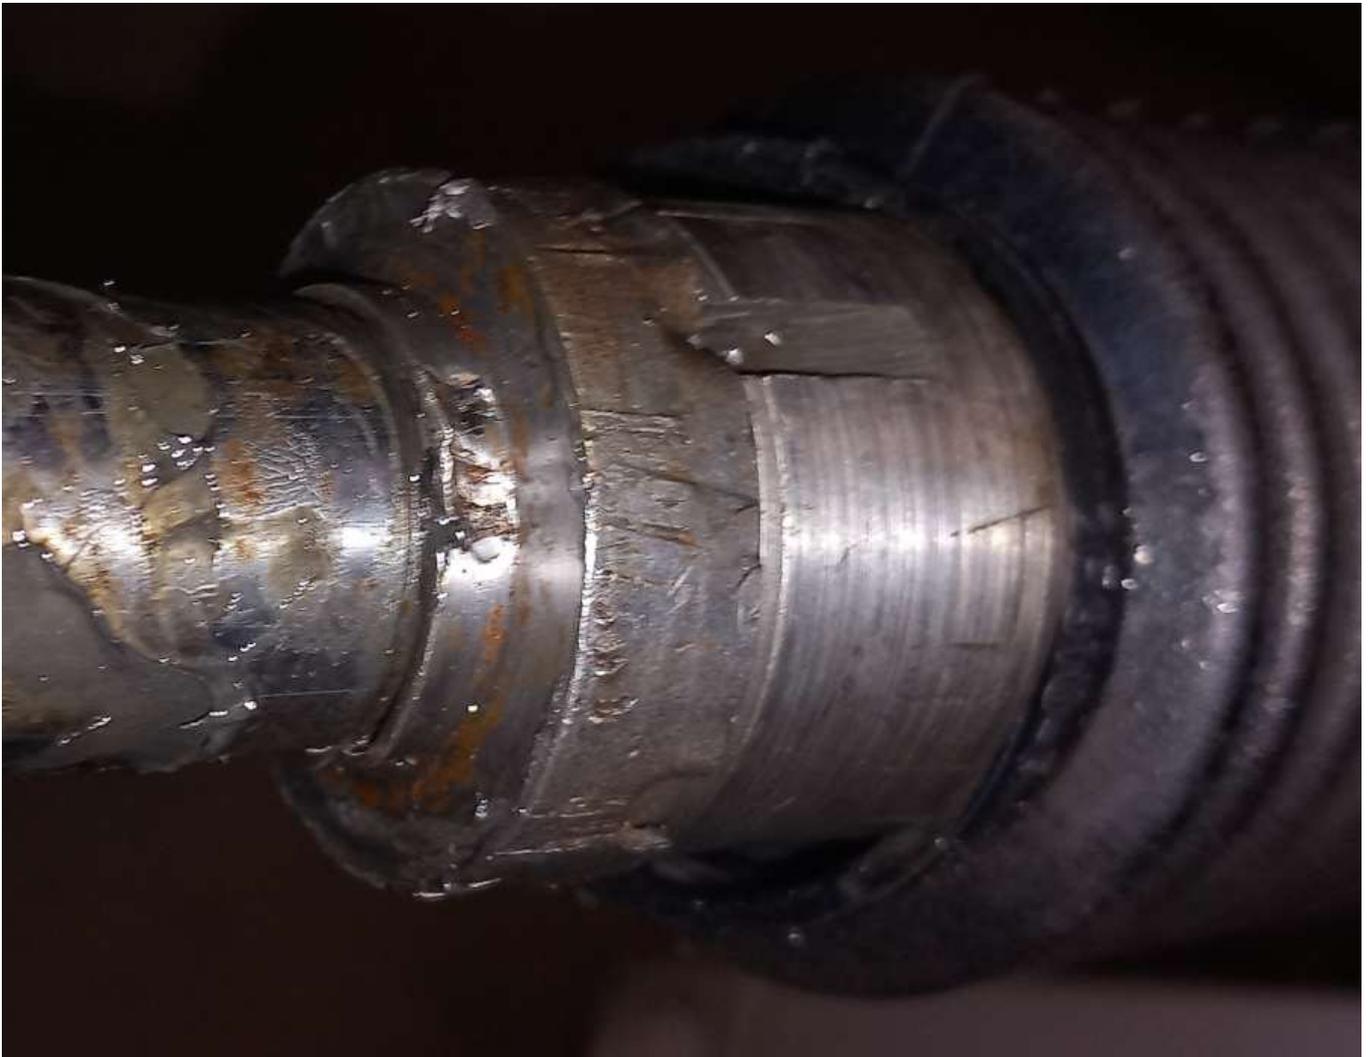
... and to the bearing cup. Well chewed so re-used which is not surprising as they are NLA:

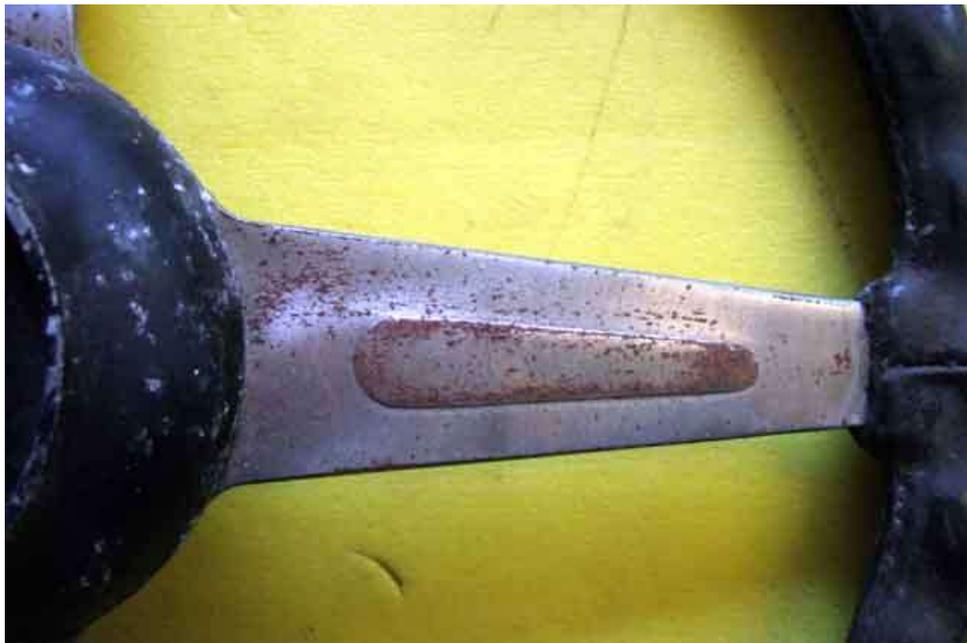
... and rust on the back

Hub needs repainting. Rubbing with wire wool dipped in cellulose thinners got all the old paint off and left a smooth surface. Hammerite special metals primer as the first coat, then two coats of Hammerite smoothrite satin black.

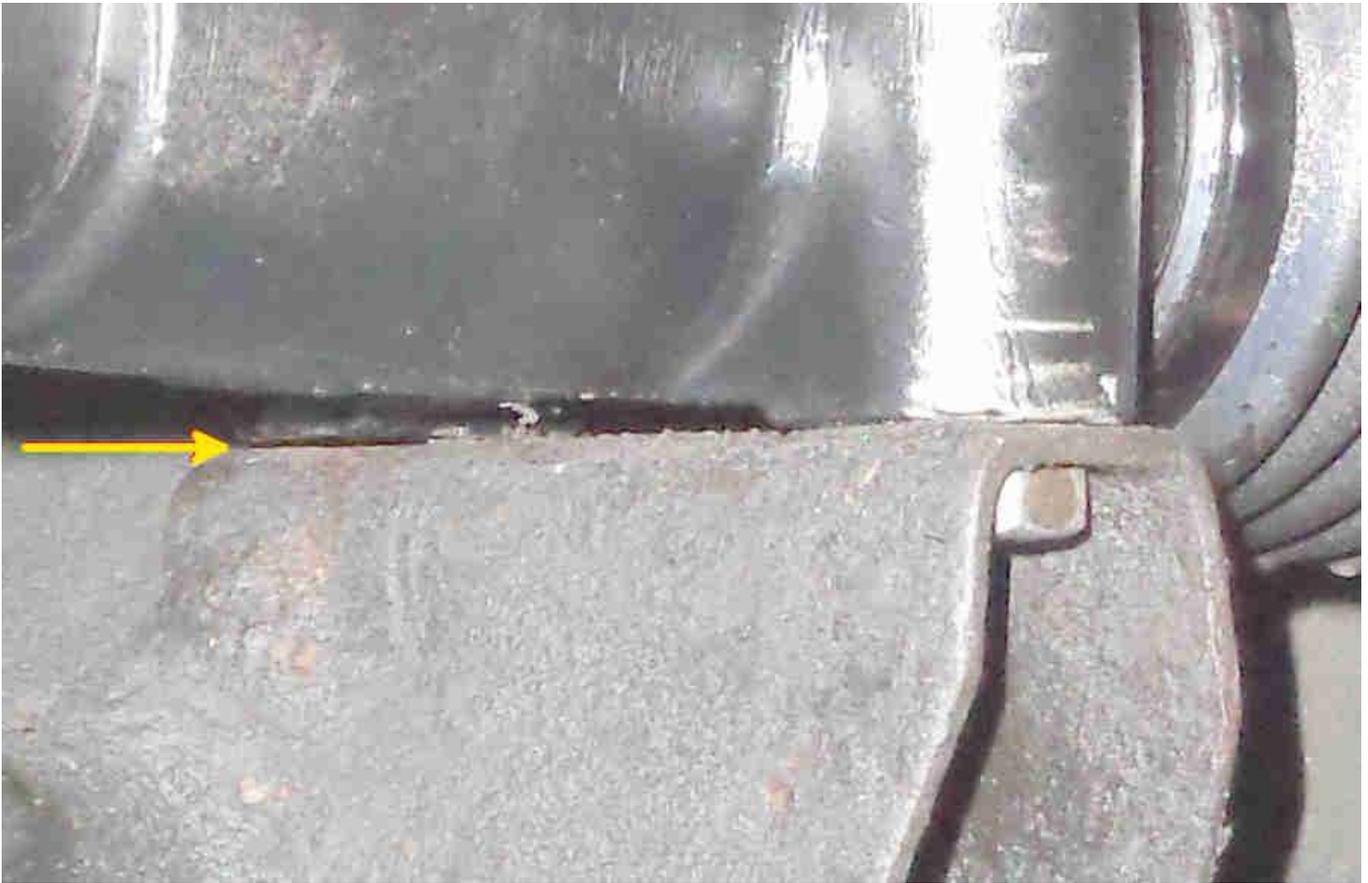
There is enough movement in the lower column bracket to correct the horizontal but not enough in either of the column brackets to correct the vertical so the upper mounting points on the new rack will have to be shimmed. As well as all that the four rack mounting points need to sit square to the cross-member brackets and with the new rack (at least, I didn't have cause to check the old rack) the upper end of the near-side has a 12 thou gap to the bracket with the other three bolts nipped up:
