Vitesse/Mazda 5-speed gearbox

After the [trials and tribulations of a rebuild then more problems just three years](#) later I investigate a Mazda 5-speed conversion by Vitesse Global Ltd.

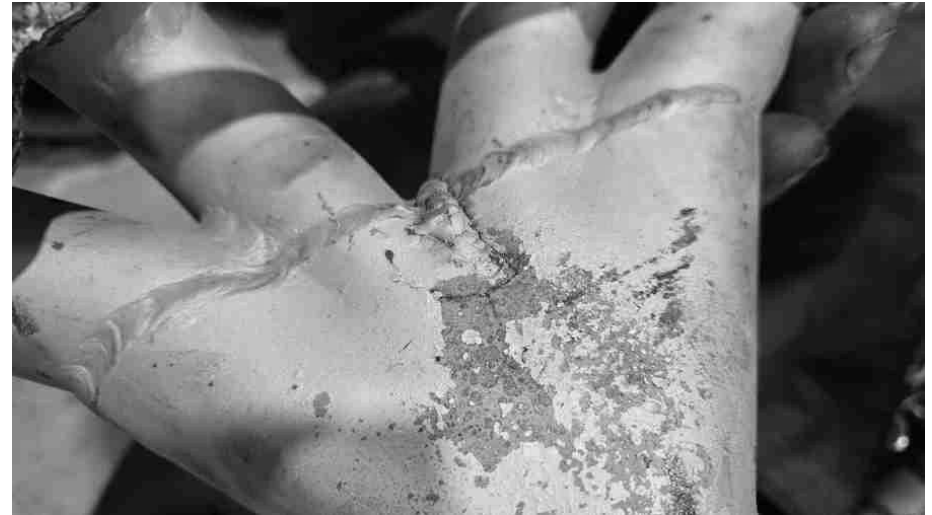
More gloom when I get an email with photos showing both inlet manifolds cracked between the front and rear pairs, and oil pooling on top of the inlet manifold gasket. They offered to take the manifolds to a local TIG welder but couldn't give me an idea of price or timescales, and as they hadn't been blowing I declined - maybe a foolish decision:

They also offered to replace the gasket for about £80 without delaying the job. Ordinarily I would have accepted that but I know the front offside thread is weak and won't fully torque up, and I didn't want more issues to come to light with taking the manifold off, so declined that as well. I've done both jobs myself in the past so can do them again, and will helicoil the head thread first, maybe over winter.

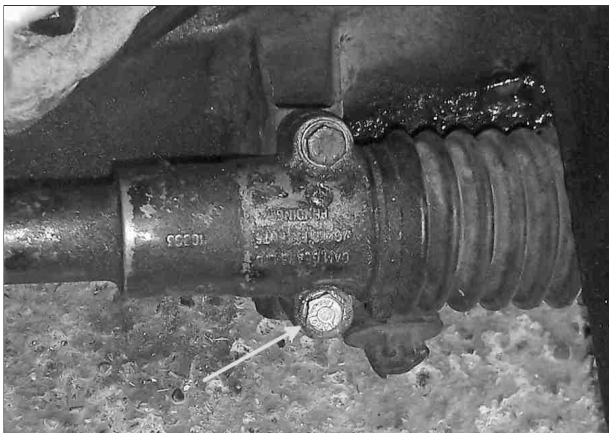
Also noticed that the front rack mounting bolts had been fitted upside down (the rack has to come off to remove the engine as the exhaust manifold that side fouls it), the bolts should be fitted from the bottom as there is a section of weld inside the bracket to hold the bolt held while the nut is tightened from above so you only need one spanner/socket. They had also changed the front bolts, and fitted Nylocs underneath, with lock-washers which is odd.

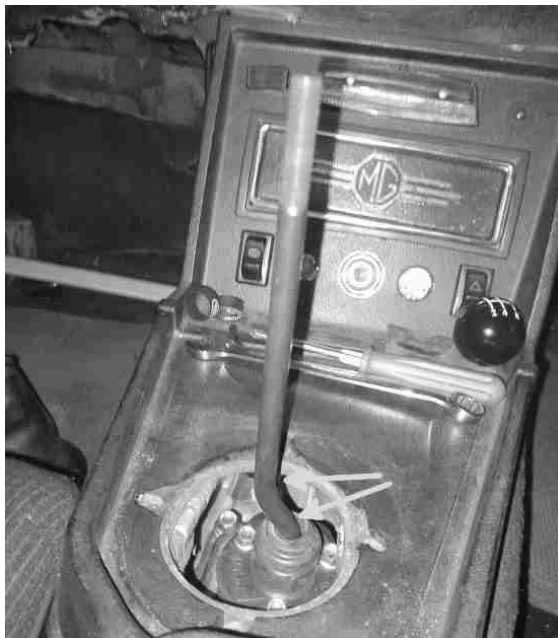
Then looking round inside I could see the edge of the leather gear lever gaiter sticking out from under the chrome trim ring. Took the ring off (noticing they had the short screw at the side instead of the front and it hadn't picked up the threads) and realised they had unstapled the leather gaiter from the rubber gaiter. I had previously reversed and restapled it to prevent the rubber gaiter from pulling on the lever which was opening the gearbox switch and turning OD off, the V8 having OD in 4th gear only it only closes when the lever is pulled down into 4th as well as across. It's operation is marginal compared to the 4-cylinder where you only have to pull the lever across to the 3/4 plane to close the switch, and after 230k miles the mechanism was probably as worn as everything else. I restapled it back as it would have been originally and refitted the ring with the screws in the right places. With the gaiter off I can see the gearbox through the hole in the console tunnel and the socket for the lever seems noticeably offset towards the driver ... but in fact it is the console hole that is offset towards the left. The MGB gearbox remote housing is offset towards the left, Bee's being almost central to the hole. Vee's originally was a small amount towards the driver. This gearbox and the socket for the lever is central to the car and the lever needs a double bend to the left to centralise it in the hole:

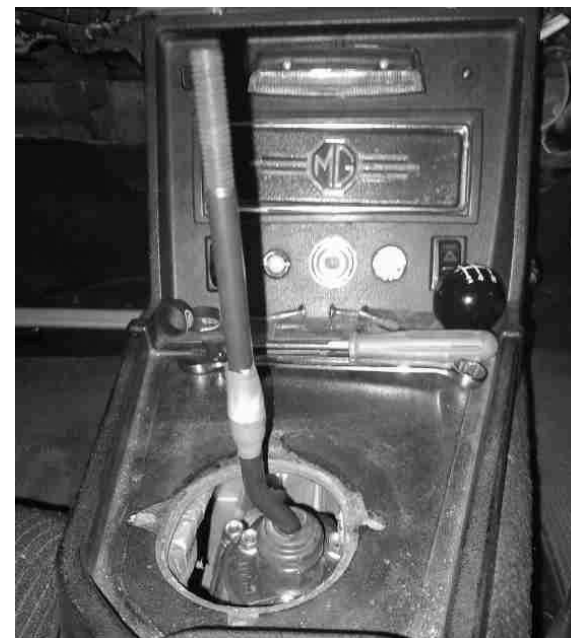
Subsequently I realise that the lever is noticeably thinner than the original at 0.375" as opposed to 0.447", so whereas before the top of the rubber gaiter was a snug fit to the lever there is a gap to the new one, and the noise is probably coming up through that gap ... and so is the draught I can feel! Pondering options I consider wrapping tape round to build it up with a bit of heat-shrink to stop it unravelling, then hit on the idea of a short length of hose. I have off-cuts of 1/4" and 5/16" but it needs 3/8" which I don't have, and that would only butt up against the top of the gaiter so may leave gaps or move around in different gears. Or successive layers of heat-shrink to build the thickness up to about .447" and fit inside the top of the gaiter like the original shaft - but I don't have any big enough. So I opt for layers of insulating tape and keep wrapping them round - the top of the rubber gaiter is less than half the height of the leather outer - until I can feel the resistance of the rubber gaiter going over them in trial fits. No heat-shrink for an outer layer to resist the tape unravelling, but as it's inside the neck of the rubber gaiter that should keep it in place. If not I'll get a piece of suitably-sized heat-shrink. Note the length of the thread:

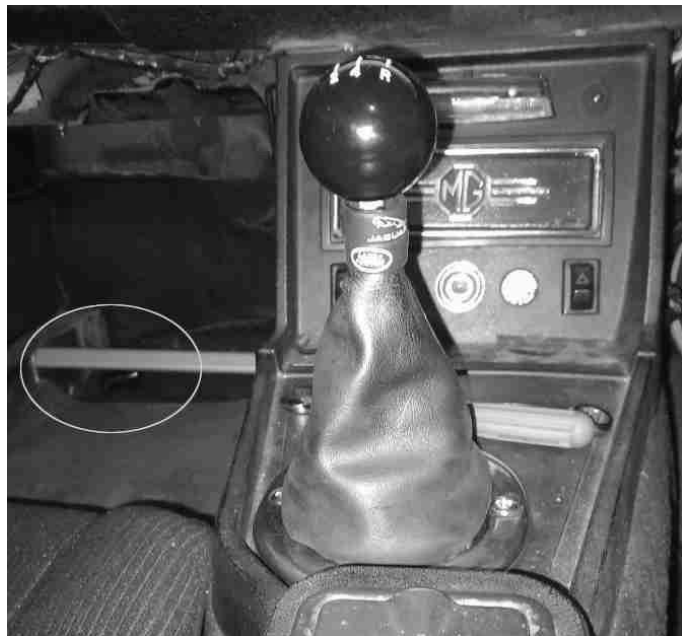
And the answer is that it has stopped both the noise and the draught, which I'm pleased about. After a 37-mile jolly on a sunny morning that involved inadvertently getting tangled up in Redditch suburbs which at least gave me the 'opportunity' to use the gearbox much more than it otherwise would have done, and once in gear either it is now the same as the old box or I'm getting

Remove the die, drop the gaiters over and push the neck of the rubber one down over the tape, pop my JLR finger-ring protectors on, then the lock-nut to the bottom of the threads, then the knob which goes all the way down to meet the lock-nut, which I tighten up to the underside of the knob. The threads are now completely covered by the knob and any remaining bare shaft is covered by the finger-ring protectors - much better aesthetically, it remains to be seen what it has done to the noise and draught:

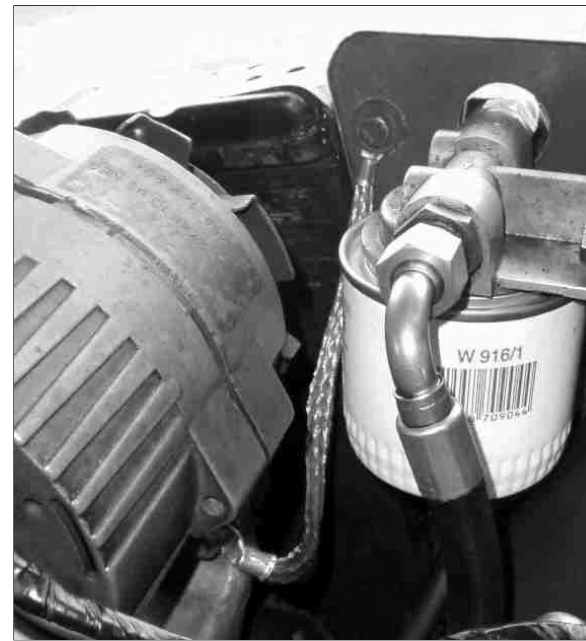
Another possibility is between alternator and radiator mounting bolts running past the other side of the oil filter, or the other side of the engine from the lifting bracket bolt, but I'm wondering if the relatively flimsy panel spot-welded to the inner wing is less than ideal as an earthing point. From a lifting bracket bolt to an expansion tank mounting bolt was briefly considered but the tank would no longer lie flat against that inner wing. From a lifting bracket bolt to a near-side wing mounting bolt, under the flange, is yet another, with a longer bolt and second nut (like the support bracket for the bonnet release cable) as the existing nuts are welded. Very little engine movement here as it would be right beside the steady bar, but the bolts are nicely painted and a new one would need painting to match. Which leaves underneath.

In the end, given that the diaphragm panel has got to be more robust that the clutch hose bracket, and it's much easier to get at, I opt for plan C i.e. between alternator and radiator mounting bolts which is by the oil filter but not in the way of its removal. In less than an hour it's on and there is now only 0.1v difference between engine and body so well worth it. A bit of a mystery as to why - when they recommend one for DIY installation of the gearbox - Vitesse don't fit one as part of the installation you are paying them for when they have a 2-post lift, but there we are.
