Bonnet and Boot/Hatch

Bonnet/Hood

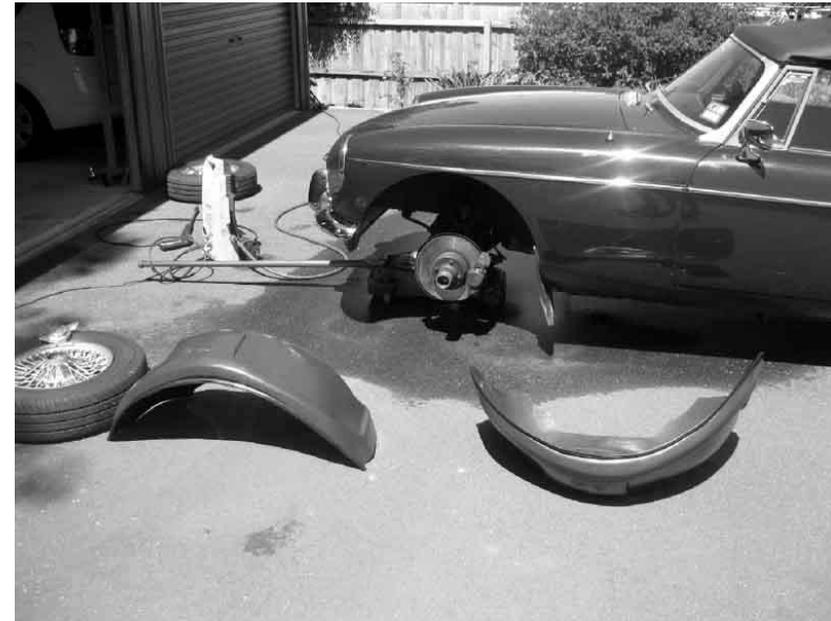
OK, so I got a bit paranoid about rust up in the mudguards, and other areas where mud could accumulate. So I invested in these thingys, Moss calls them "front wheel liner sets". Lets just call them wheel arches.

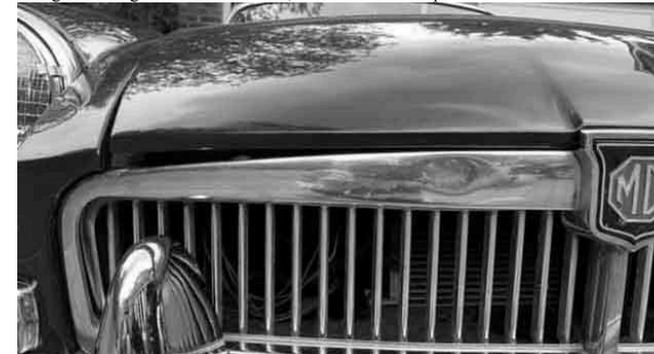
Pete Curtis - recessed grille changed to chrome slatted, no bonnet trim strip:

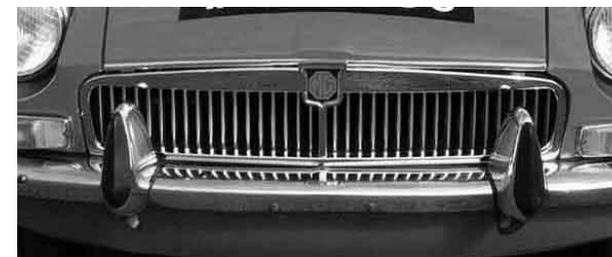
Two more with the same mod and the same poor alignment, this one with the trim strip: *(This and the remaining photos from [MG Experience](#))*

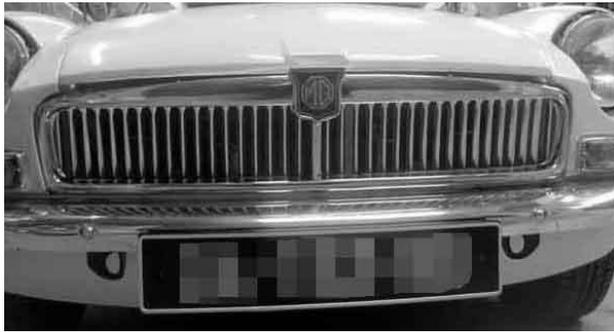
This without:

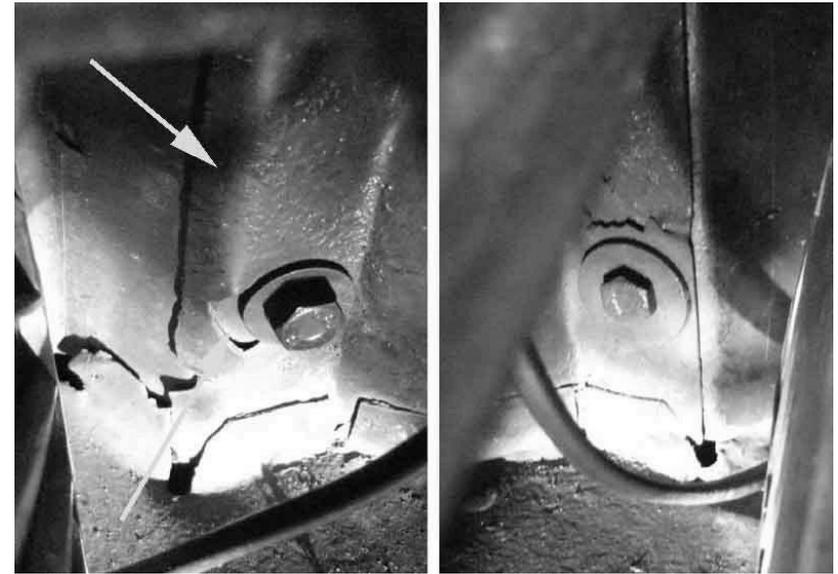
When preparing Bee for her repaint in 1991 I noticed that the grille was only slightly recessed from the wing on the nearside whereas it was significantly recessed on the offside but only at the bottom. The grille seemed to be aligned with the apron and bonnet, so it must be the wing. I can't push the whole wing back as that would compromise the door shut lines, but maybe I could push the lower part of the wing beside the grille back. I removed the bolt from the inner wing to the wing, and could push it back quite easily, but that put the holes way out of line. So I cut the hole for inner wing to outer wing bolt into a slot (lower arrow) on the offside, so the lower part of the outer wing can be pushed back to align with the grille like the nearside. The leading edge of the inner wing has been dressed back to lie against the outer wing (upper arrow). Compare with the nearside:

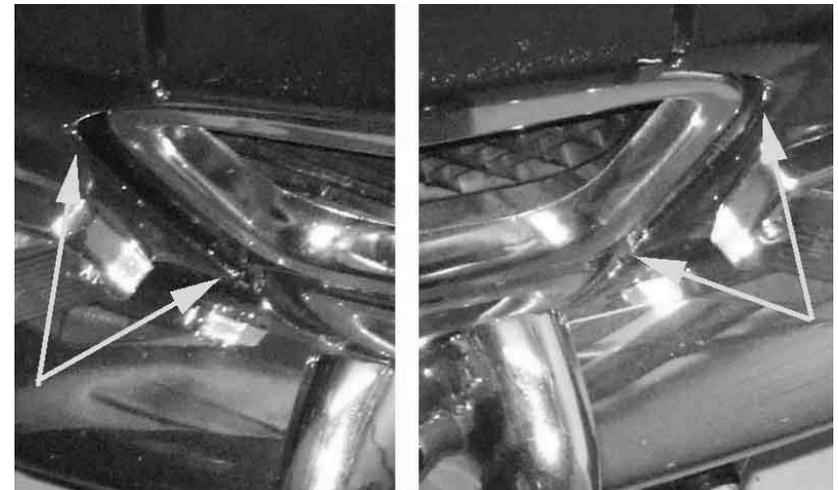
The offside wing is still a bit forwards of the bonnet and the grille, but at least the grille is recessed by the same amount top to bottom both sides. Before this the lower part of the grille on the offside was recessed by a good inch:

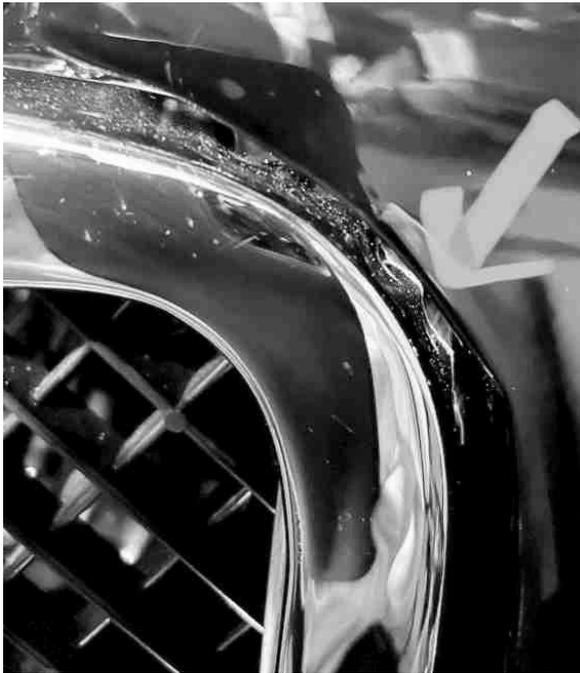
August 2022: Complaints on the MGOC forum of replacement grilles being too wide for the gap between the wings. The problem seems to be the 'U'-channel that forms the grill surround has not been fully formed and the outer flange sticks out sideways fouling the wings, instead of pointing straight back. The flange sticks out at an angle instead of pointing straight back. Ventilation pipe crimps were used here to force the flange to 'lie down' at the corners: (John Keane)

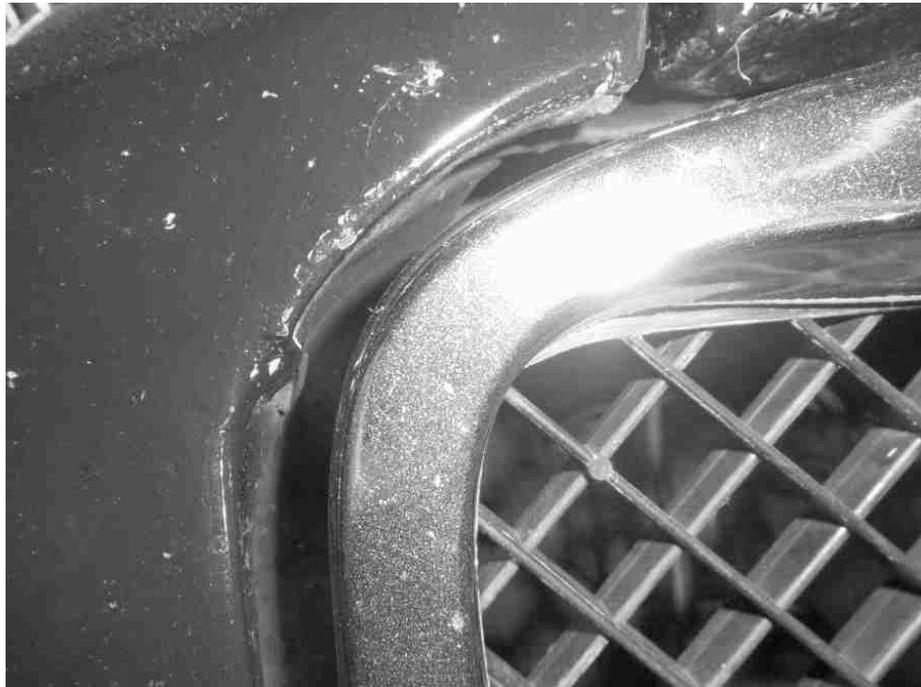
Bee's has the 'U' fully-formed with the flange at right-angles to the front face and parallel with the sides of the aperture giving a clearance to the wing, even at the top corners. This also shows the honeycomb with the raised diagonals going from upper left to lower right:
