[5-Speed Conversion](#) [Overdrive](#)

Vitesse/Mazda 5-speed gearbox

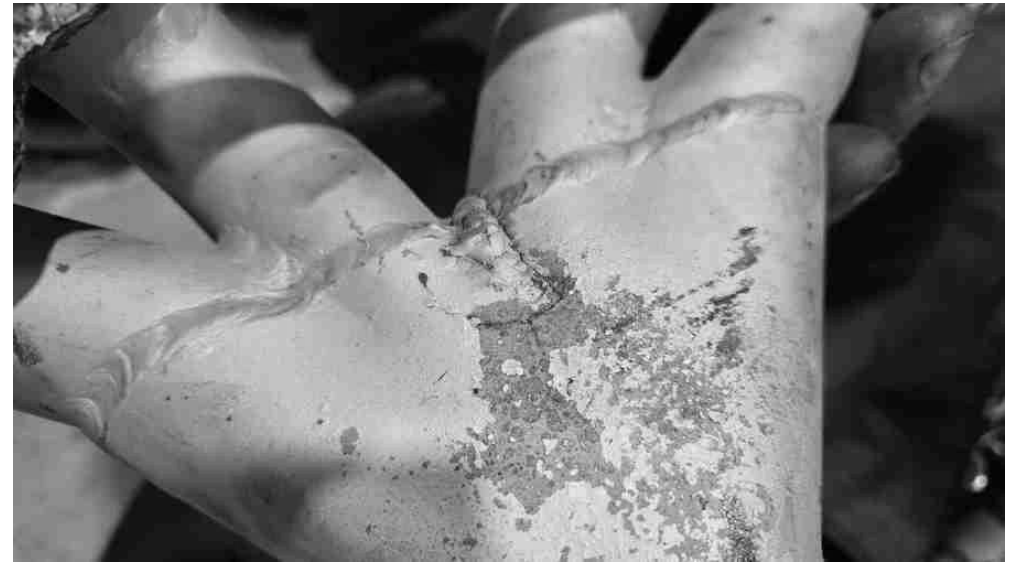
More gloom when I get an email with photos showing both inlet manifolds cracked between the front and rear pairs, and oil pooling on top of the inlet manifold gasket. They offered to take the manifolds to a local TIG welder but couldn't give me an idea of price or timescales, and as they hadn't been blowing I declined - maybe a foolish decision:

They also offered to replace the gasket for about £80 without delaying the job. Ordinarily I would have accepted that but I know the front offside thread is weak and won't fully torque up, and I didn't want more issues to come to light with taking the manifold off, so declined that as well. I've done both jobs myself in the past so can do them again, and will helicoil the head thread first, maybe over winter.

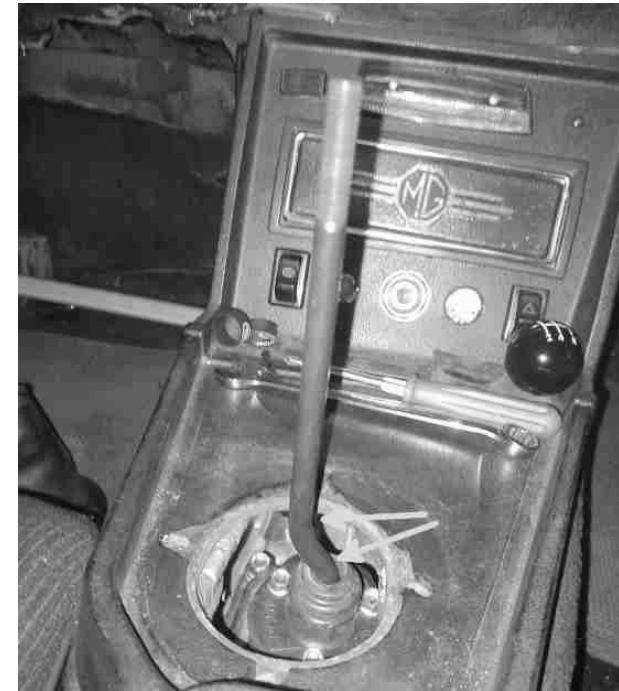
Then looking round inside I could see the edge of the leather gear lever gaiter sticking out from under the chrome trim ring. Took the ring off (noticing they had the short screw at the side instead of the front and it hadn't picked up the threads) and realised they had unstapled the leather gaiter from the rubber gaiter. I had previously reversed and restapled it to prevent the rubber gaiter from pulling on the lever which was opening the gearbox switch and turning OD off, the V8 having OD in 4th gear only it only closes when the lever is pulled down into 4th as well as across. It's operation is marginal compared to the 4-cylinder where you only have to pull the lever across to the 3/4 plane to close the switch, and after 230k miles the mechanism was probably as worn as everything else. I restapled it back as it would have been originally and refitted the ring with the screws in the right places. With the gaiter off I can see the gearbox through the hole in the tunnel is noticeably offset towards the driver - but actually it is the hole that is offset towards the passenger if you line it up with the arm-rest cubby, the gearbox itself is central. Bee is almost central to the hole. Vee originally was a small amount towards the driver presumably from the original remote housing. But the Mazda gearbox socket is central to the car so the lever has a very definite double-bend to come up through the middle of the gaiter:

The gear-knob had to come off for that, it has a 9/16" lock-nut underneath. I had already done that because since a visit to the Land Rover factory some years ago where they gave me rubber 'sleeves' with Jaguar and Land Rover logos to cover my engagement and wedding rings, and I had put them on the lever afterwards as a keep-sake. I noticed they were missing when I picked up the car, but found them in a poly bag (one of several) with the old gear lever bits and pieces. My gear knob is missing though which was an original for which I had to pay quite a bit to replace an after-market one. This gear knob seemed higher than I remembered and measuring from the console up to a spirit-level on the knob on both Bee and Vee it is 1cm higher. I did screw it down as far as it would go before tightening the lock-nut, but there are plenty of unused threads (3/8" UNC) on the lever (clearly visible from the driving seat and to the touch), it took 10 turns to 'bottom' on the lever so I'll cut about 1/2" off.

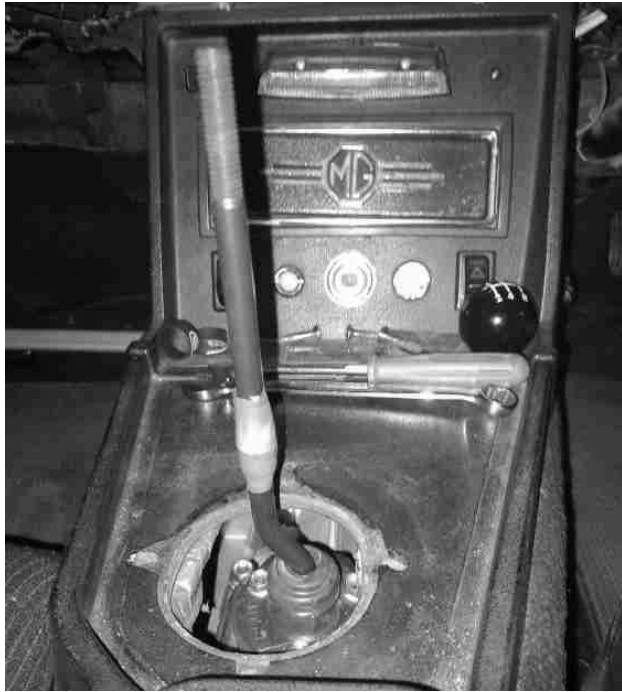
Subsequently I realise that the lever is noticeably thinner than the original at 0.375" as opposed to 0.447", so whereas before the top of the rubber gaiter was a snug fit to the lever there is a gap to the new one, and the noise is probably coming up through that gap ... and so is the draught I can feel! Pondering options I consider wrapping tape round to build it up with a bit of heat-shrink to stop it unravelling, then hit on the idea of a short length of hose. I have off-cuts of 1/4" and 5/16" but it needs 3/8" which I don't have, and that would only butt up against the top of the gaiter so may leave gaps or move around in different gears. Or successive layers of heat-shrink to build the thickness up to about .447" and fit inside the top of the gaiter like the original shaft - but I don't have any big enough. So I opt for layers of insulating tape and keep wrapping them round - the top of the rubber gaiter is less than half the height of the leather outer - until I can feel the resistance of the rubber gaiter going over them in trial fits. No heat-shrink for an outer layer to resist the tape unravelling, but as it's inside the neck of the rubber gaiter that should keep it in place. If not I'll get a piece of suitably-sized heat-shrink. Note the length of the thread:

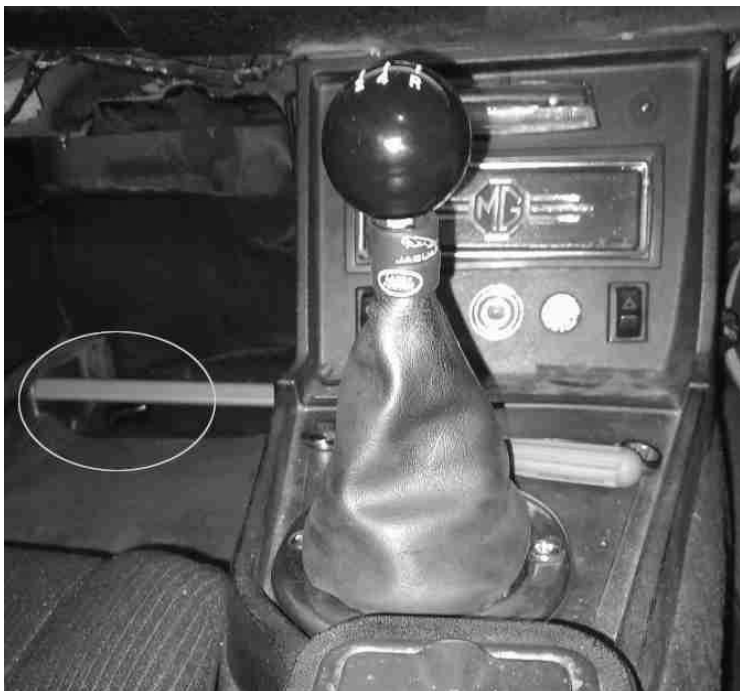
And the answer is that it has stopped both the noise and the draught, which I'm pleased about. After a 37-mile jolly on a sunny morning that involved inadvertently getting tangled up in Redditch suburbs which at least gave me the 'opportunity' to use the gearbox much more than it otherwise would have done, and once in gear either it is now the same as the old box or I'm getting used to it. Or both. Changing gear the lever still seems to have a closer physical relationship to the mechanicals - the original lever seemed 'damped' by comparison. But the lightness and (so far) no baulking is good. One thing I'm noticing is that with the original boxes I rarely put the clutch to the floor to change gear but now I find myself doing so as otherwise there is more of a sensation though the knob.

Remove the die, drop the gaiters over and push the neck of the rubber one down over the tape, pop my JLR finger-ring protectors on, then the lock-nut to the bottom of the threads, then the knob which goes all the way down to meet the lock-nut, which I tighten up to the underside of the knob. The threads are now completely covered by the knob and any remaining bare shaft is covered by the finger-ring protectors - much better aesthetically, it remains to be seen what it has done to the noise and draught:

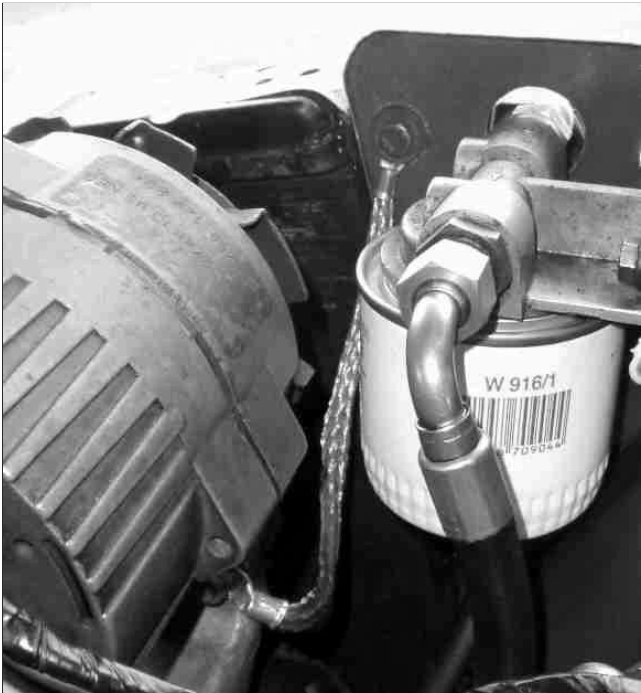
Earth strap: After a few weeks I decide to check the voltage between the engine and the body while cranking - which shows the amount of voltage being lost in that connection, to find it was about 1.3v i.e. less than 9v with a good battery instead of close to 10v so definitely worth doing something about. How it's earthing now I don't know as the factory engine and gearbox mounts completely isolate it which means if the factory earth connection fails it can only earth through things like throttle, choke and heater cables plus possibly temp gauge capillary and speedo cable, which get hot if not smoke, as well as giving slow cranking. I've also read about someone with a braided clutch hose that exploded while cranking because it was

carrying the majority of the current. Whilst cranking seemed 'normal' when I first got the car back the last couple of times on cold starts it has seemed a bit slower than normal, which was why I checked it.

In the end, given that the diaphragm panel has got to be more robust than the clutch hose bracket, and it's much easier to get at, I opt for plan C i.e. between alternator and radiator mounting bolts which is by the oil filter but not in the way of its removal. In less than an hour it's on and there is now only 0.1v difference between engine and body so well worth it. A bit of a mystery as to why - when they recommend one for DIY installation of the gearbox - Vitesse don't fit one as part of the installation you are paying them for when they have a 2-post lift, but there we are.
