Voltmeters

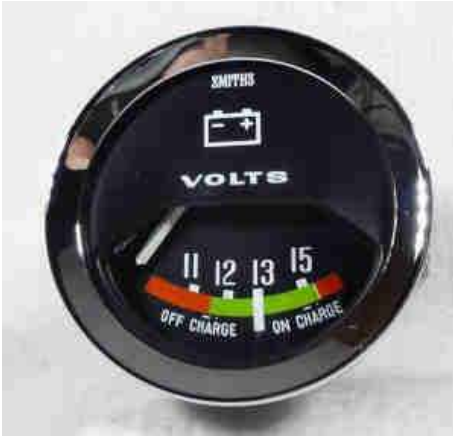
This classic voltmeter has a coloured scale which is useful for showing at a glance if the voltage is in or out of limits. Up to 15.2v is shown as 'green' and dynamo-equipped cars can show this although an alternator should not get that high. At the lower end above 11.5v is also shown as green, but for me anything below 12v may be discharging the battery - subject to voltage differences between where you have picked up the 12v supply and the battery cable on the solenoid.

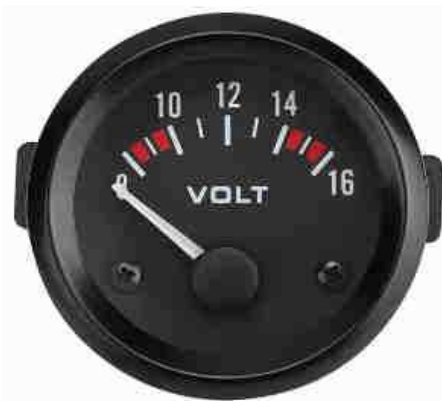
There are a few Smiths 'hanging pointer' (as above i.e. like the fuel gauge on pre-77 cars) volt meters around but they are very expensive being in the order of £50 plus. More common are 'upward pointer' types as here, they can be even more expensive from specialist shops but there are others in the £10-£15 range. This one has a less than ideal 10-14v 'good' range and a slightly compressed scale but can be lived with as I know what is good and what is bad! Interestingly these are described in some places as stepper-motor types that go up to the voltage quickly rather than slow-acting thermal like the fuel gauge on Mk2 cars. A sign of the times I suppose when components and assembly for that are cheaper than a bit of wire wrapped round a bi-metal strip! As well as 'pointing the wrong way' they only seem to be available with a black bezel, apart from some from India with a high P&P and a long lead-time. I was puzzled by a reference on one from Gorgeri to "When the white pointer stops

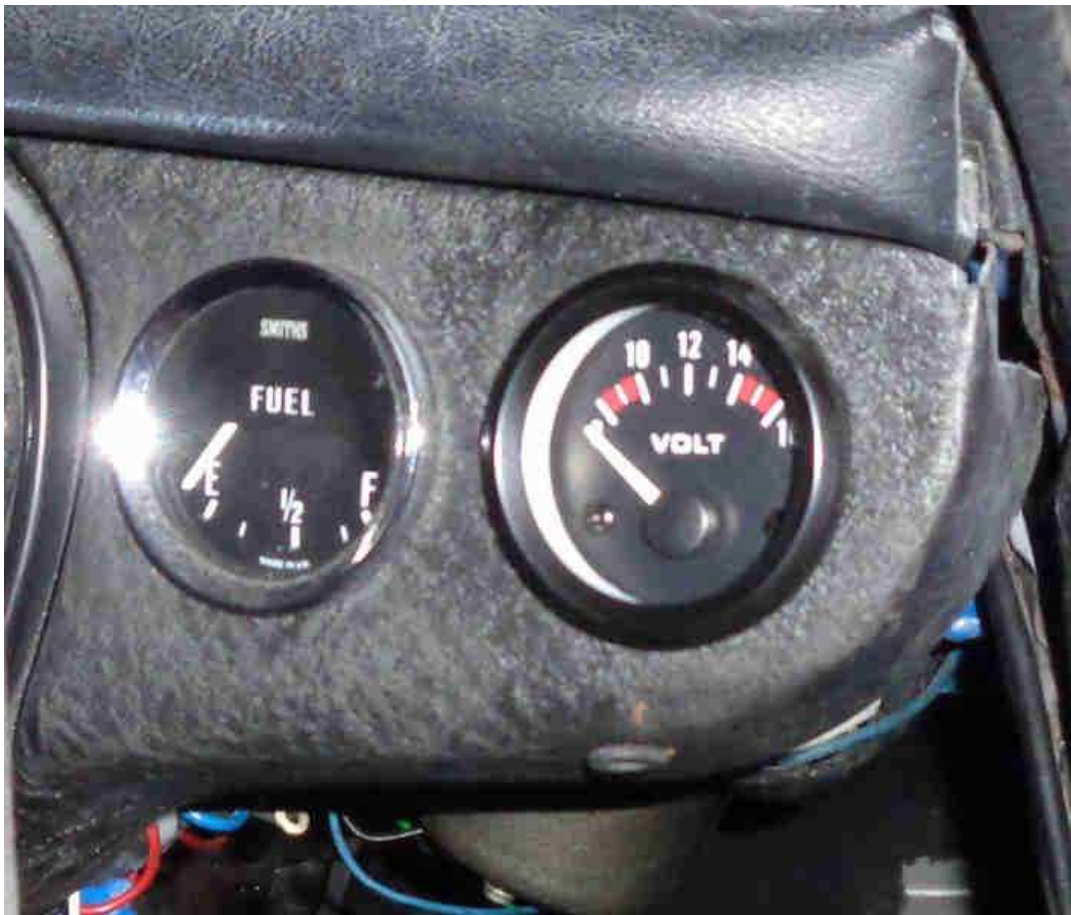
Fortunately not too difficult to access where I will have mine on the V8 in a hole in the dash to the right of the fuel gauge (where the overdrive switch was on earlier cars) that a PO had cut for some ancillary gauge which I filled in although I was never happy with the result. Fitting was more of a fiddle than expected - I hope I don't have to remove it to reset the pointer! It uses a plastic U-bracket to secure it in the dash so I'm assuming that is why there are two studs on the case and holes in the bracket instead of just one. But that, together with the wires and in the restricted space behind the dash in that far corner, made it tricky to get the bracket onto both studs, and the plain washers, lock washers and nuts.

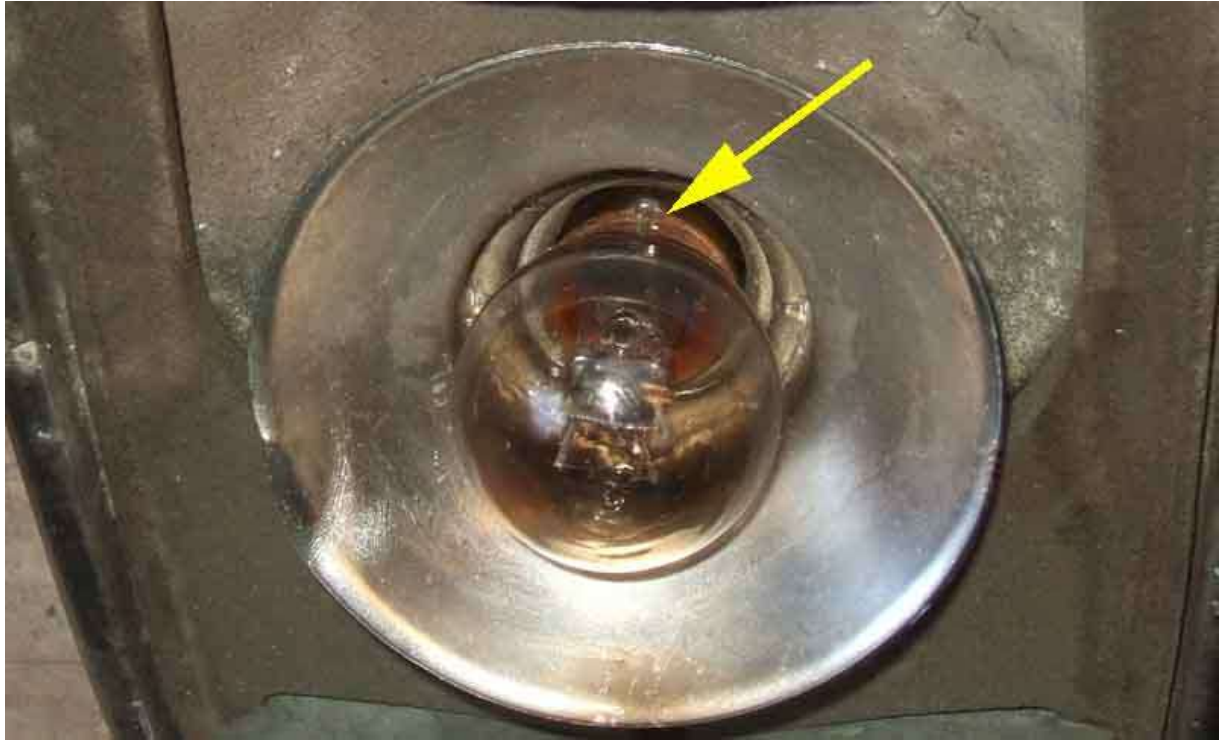
Rear light clusters can suffer from bad earth connections in three places. If only the dual filament circuits are affected then the problem is most likely between the bulb and the holder. Arrowed is the blob of solder at the top of the bulb base which can be used as a test point. If you see anything more than 0v here with the bulbs powered then there is a bad earth:

If, with the bulbs powered but not working as they should, you have an earth at point 'A' (test against a known good 12v source) then a bad connection between bulb and holder is the likely cause. However if point A shows any voltage, then the problem is more likely to be where the light unit is attached to the wing, but that should be affecting both bulbs i.e. all three filaments. This would show up as a voltage anywhere on the base of the light-unit 'B' and the ends of the fixing screws. I have heard of voltage being seen at A, but not at B, only the dual filament bulb was affected, and this was caused by a bad connection between the bulb holder and the base of the light unit. About the only thing you can do about that is solder a wire to A and terminate it under a nut on one of the fixing studs, on top of the standard 'nut':

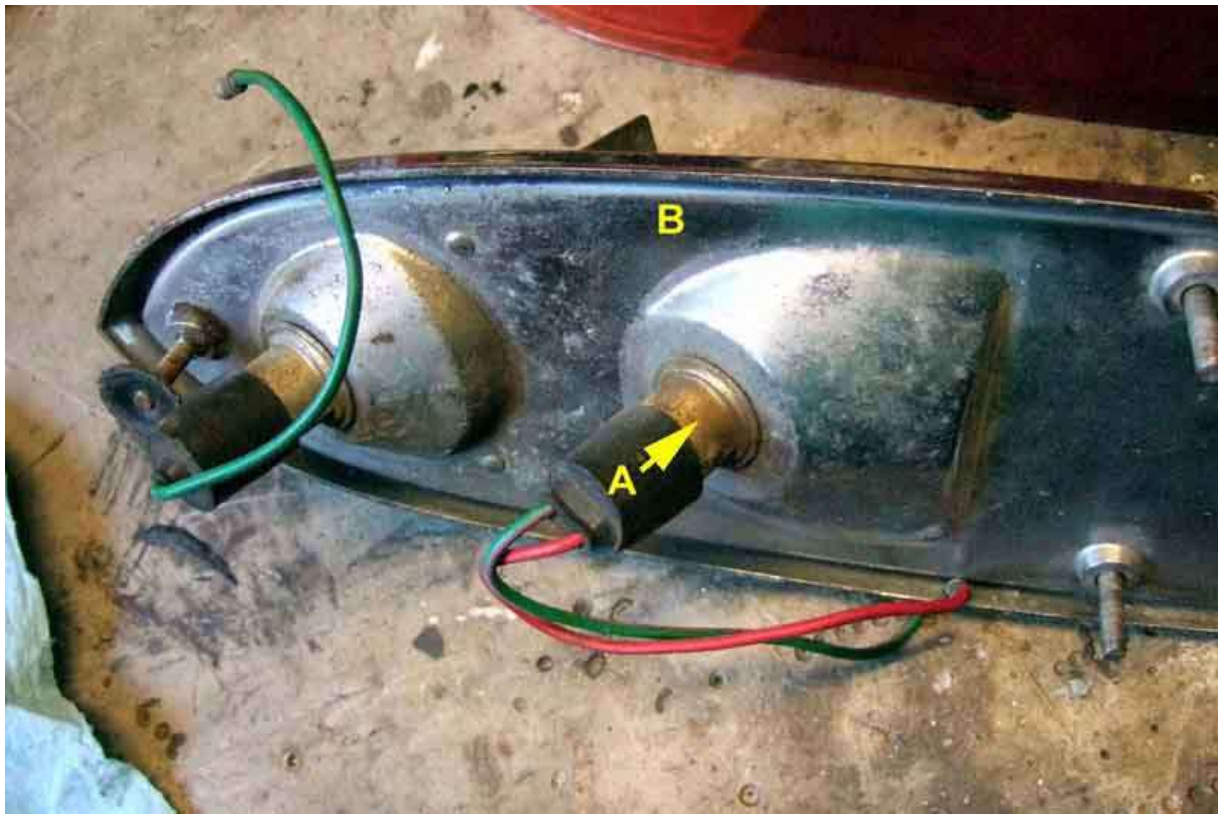
The dual-filament stop-tail bulb holder. The channel is deeper on one side than the other to accommodate the off-set pins that should exist on these bulbs to ensure they are installed the right way round:

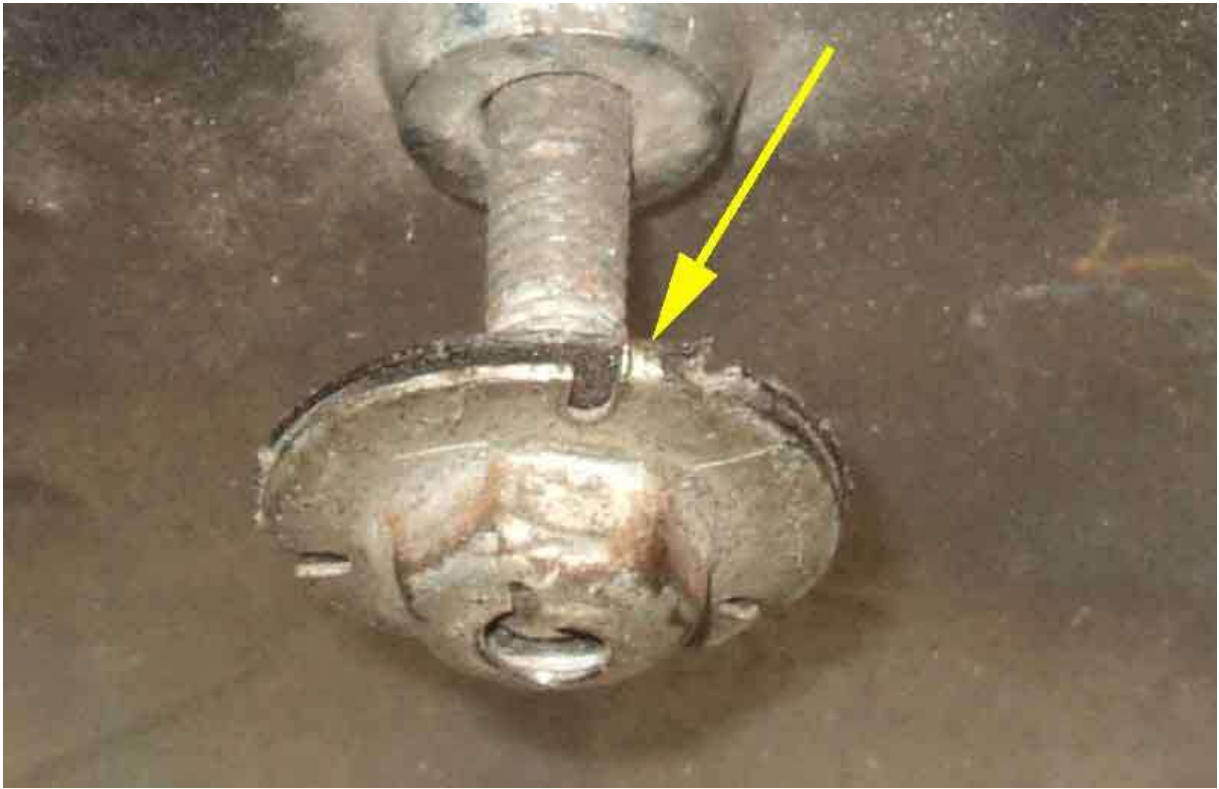
The special pressed DOTLOC 'nut' BHA4242 that has spikes (arrowed, three on each) to make electrical connection to the wing:

NLA from the usual suspects (but [seeming available here](#)) replaced typically by conventional nut NH911011 plus star washer WE702101. Take care not to overtighten the nut or you may pull the stud out of the light unit!

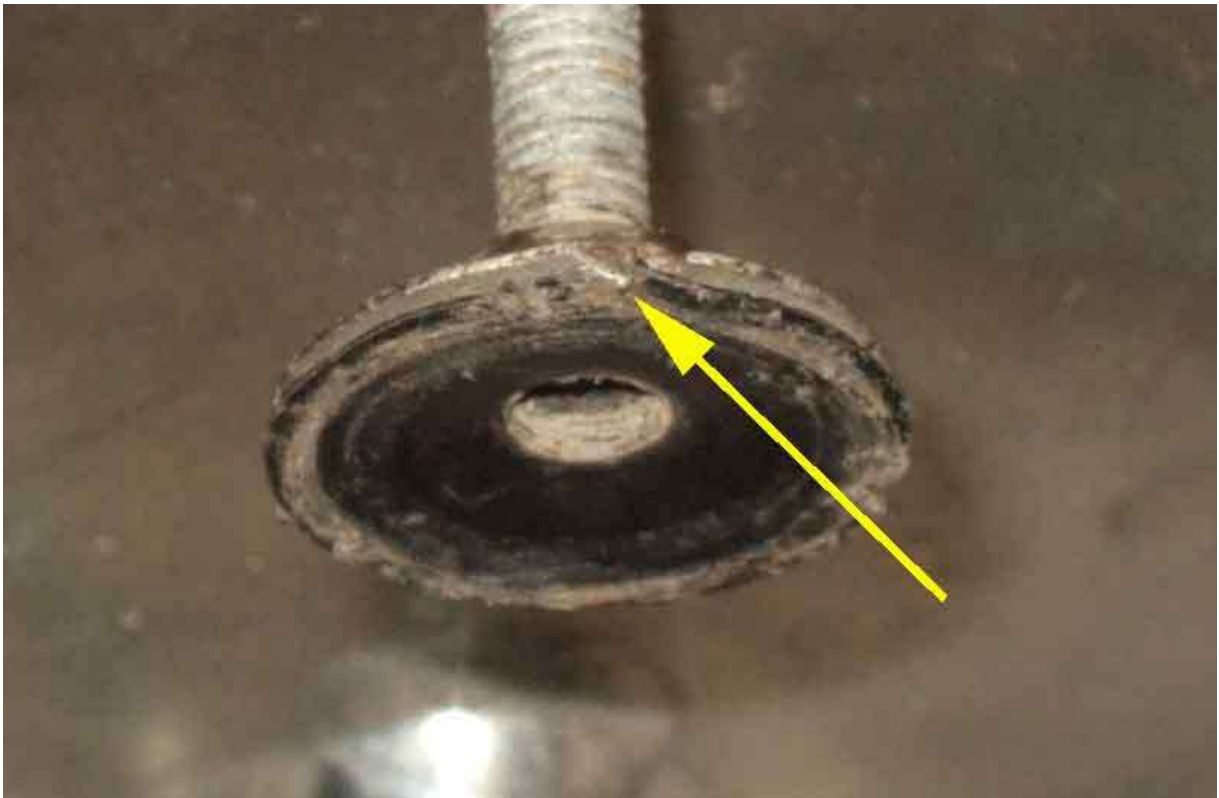
Oddly, despite the spikes to cut through the paint (arrowed), there is a plastic washer on the back of the nut:

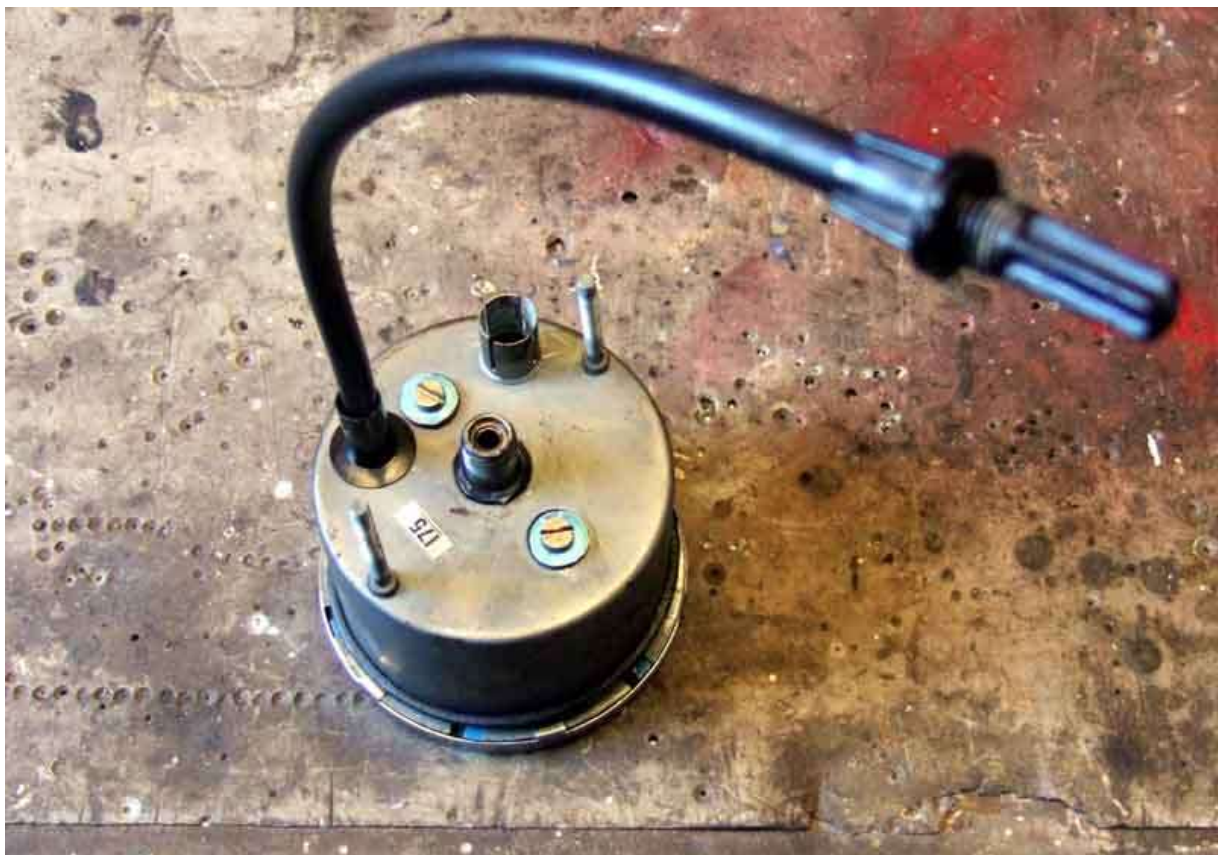
UK RB speedo and tach only have illumination bulbs, speedo (as here) still at the top but tach now at the bottom. North American Mk2 are similar, [details here](#):

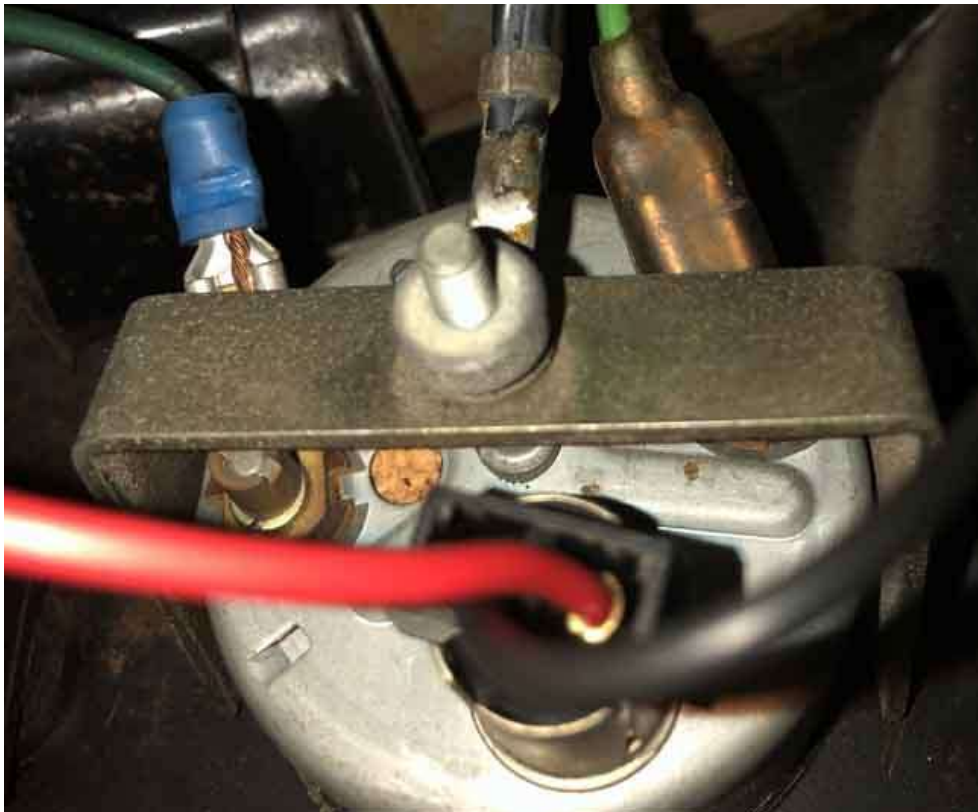
However a replacement harness for a 1980 came with holders for capless bulbs, which is probably what is shown here. These are plastic so have an earth wire as well as they cannot pick up an earth from the instrument case, which is now superfluous on all instruments except the tachometer: *(Mark Garrett)*

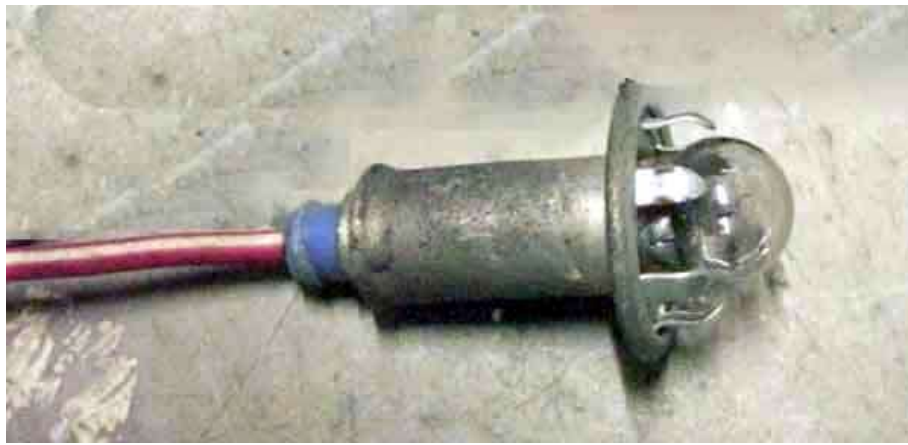
MES E10 (screw bulb) claw-type holder for 4" speedo and tach illumination:

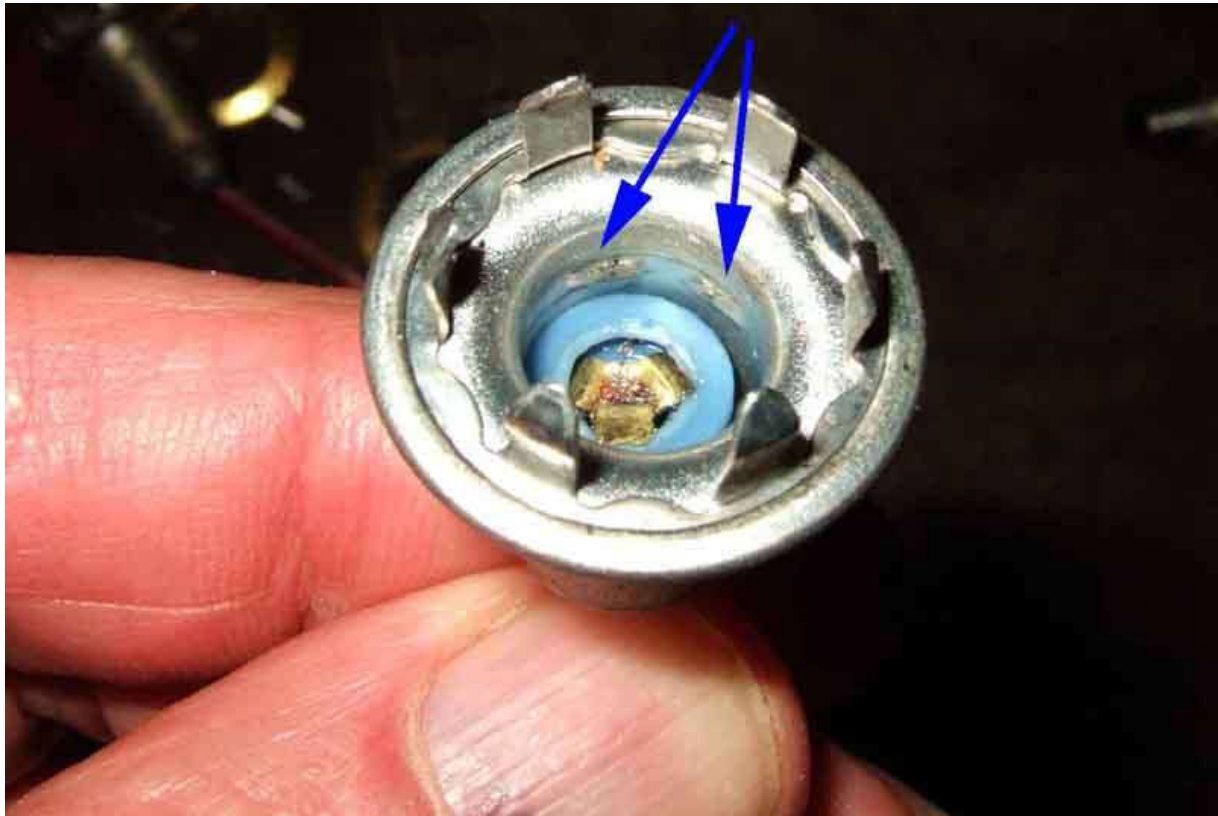
Although these take a screw bulb the holder is not fully threaded but just has these two bumps on each side:

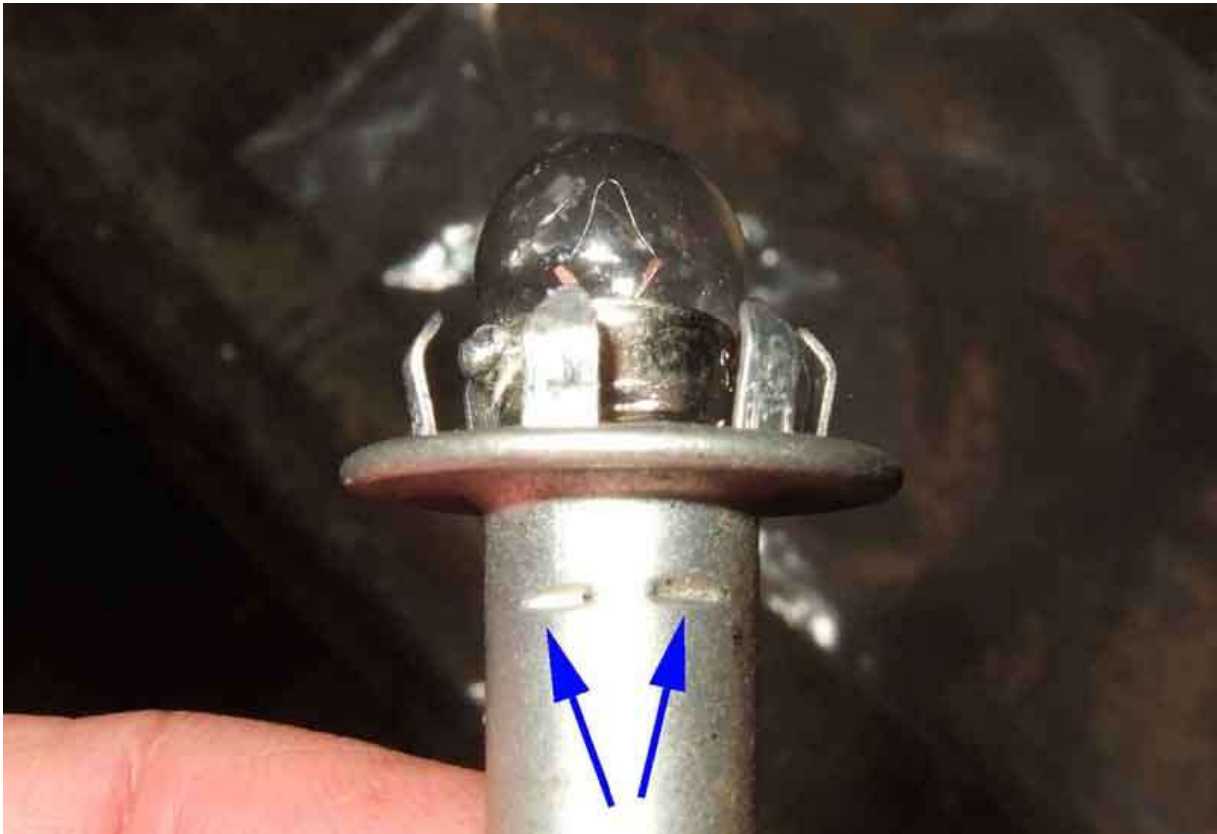
Visible as indentations on the outside. The claws make it a bit of a fiddle to screw the bulb in as you are pushing the centre contact of the holder back against spring-pressure as you screw the bulb in - this one is only partially fitted. If you hold the holder in one hand with the wire pulled back and gripped between the second, third and fourth fingers and palm while pushing the holder forwards with thumb and fore-finger to retract the contact pad, the bulb screws in more easily:

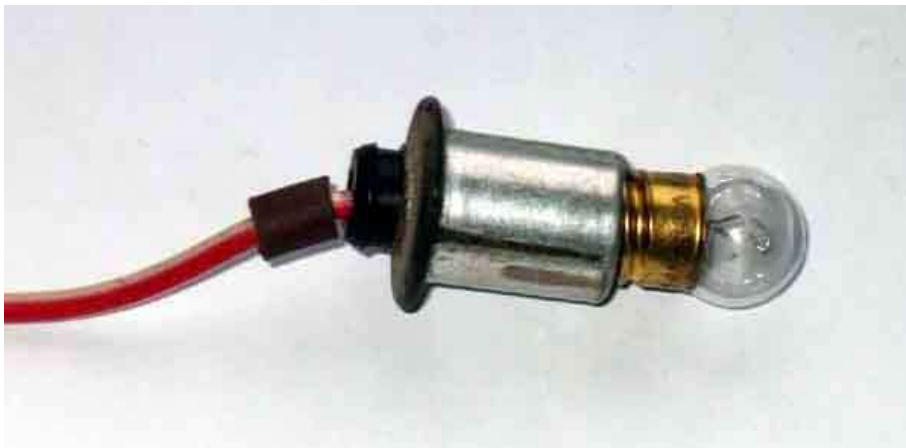
MES E10 (screw bulb) tube-fitting for 80mm speedo and tach as well as fuel and dual gauges, easier to screw in than claw holders:

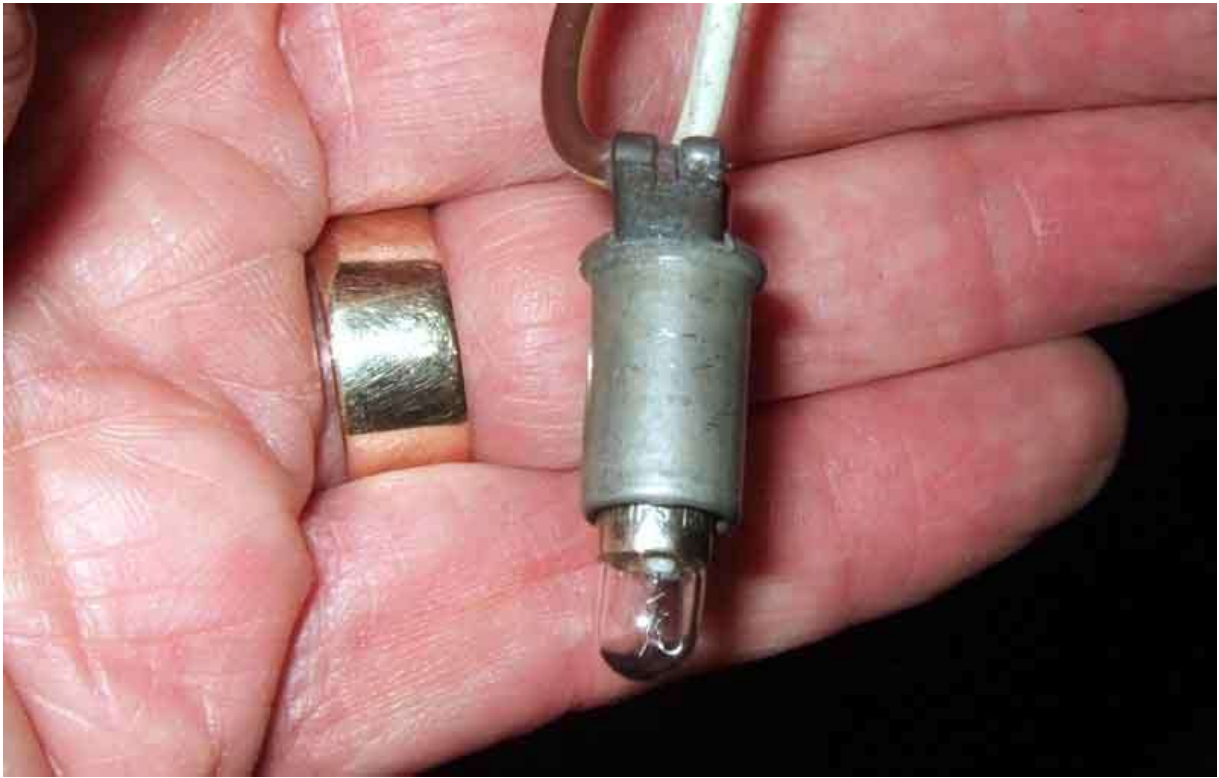
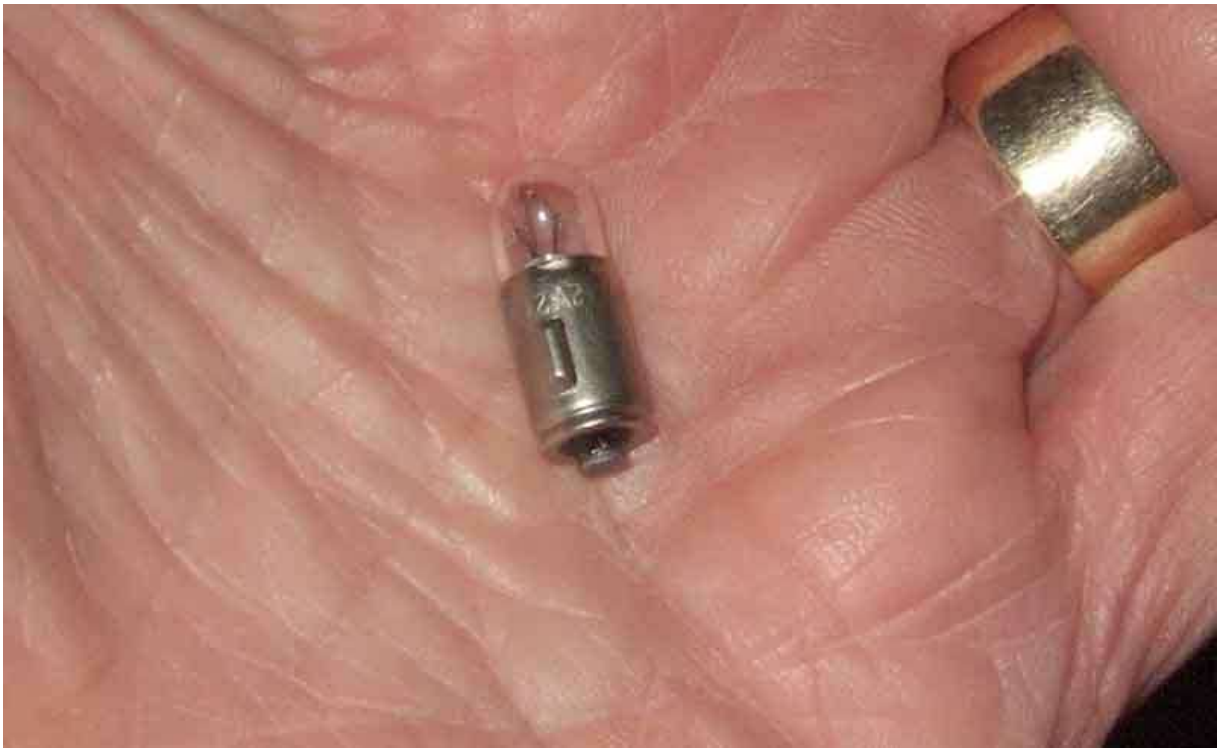
V8 and RB have slimmer warning light bulbs and holders, the fitting is a type of bayonet but the bulb can be fitted and removed by pushing and turning 90 degrees in either direction:

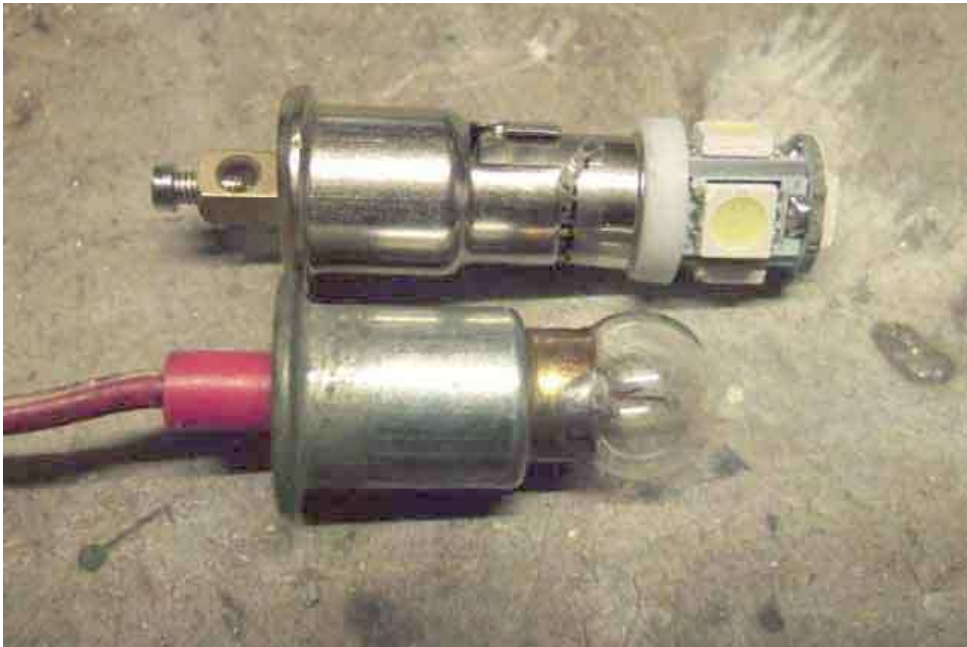
Alternative BA9 (bayonet) fitting (top) to replace tube-type when I was experimenting with [LED illumination](#):

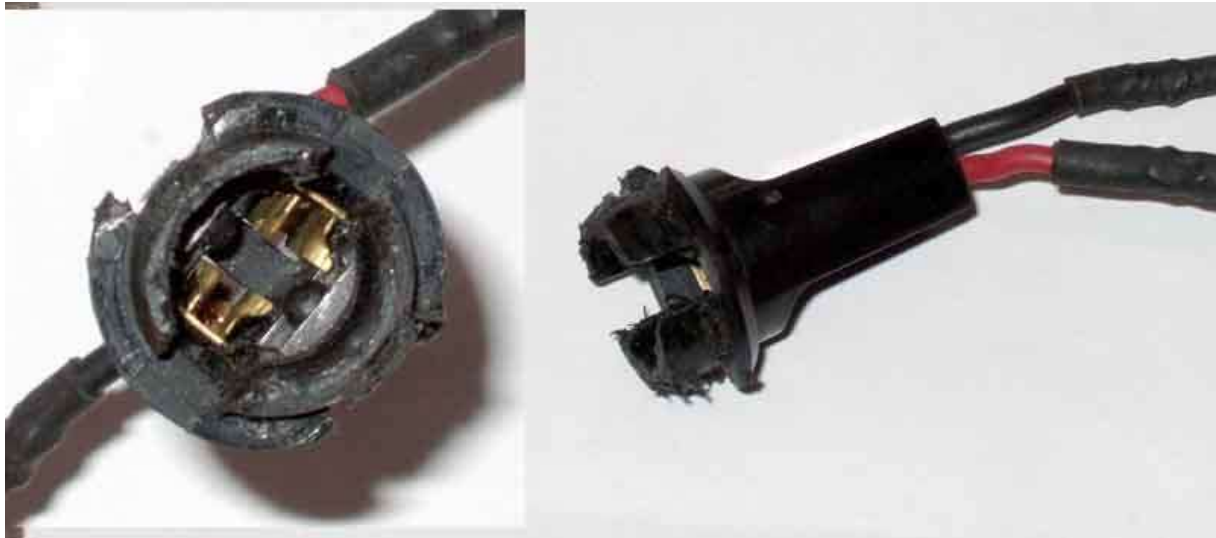
T10 (capless/wedge) holder as received on a replacement harness for a 1980:

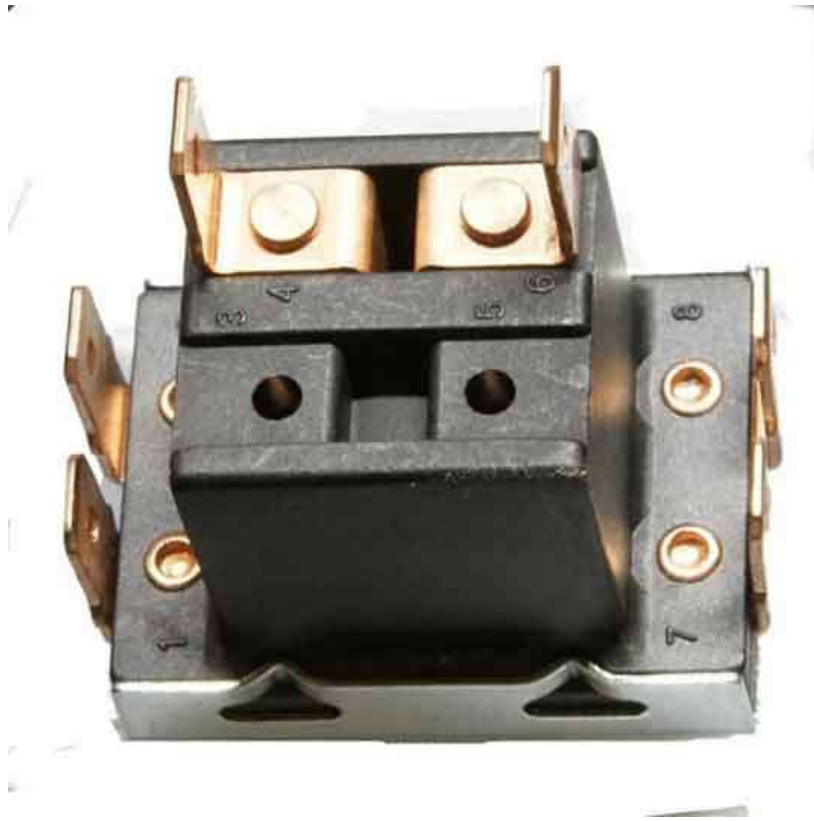
Push-pull and toggle switches - Brown to 4, Red to 7, Blue to 8: ([Car Builder Solutions](#))

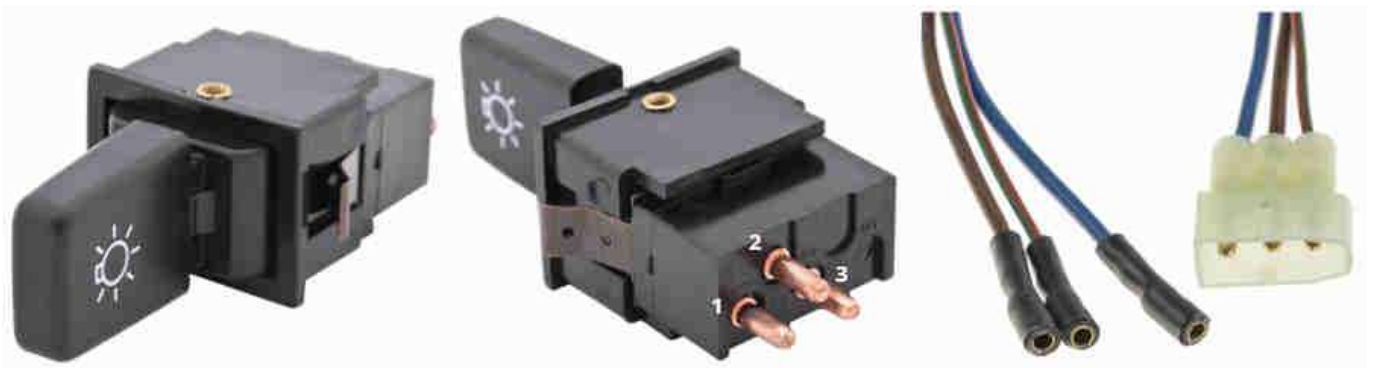
Cowl-mounted toggle switch 77 and later - connections as above: ([Moss Europe](#))

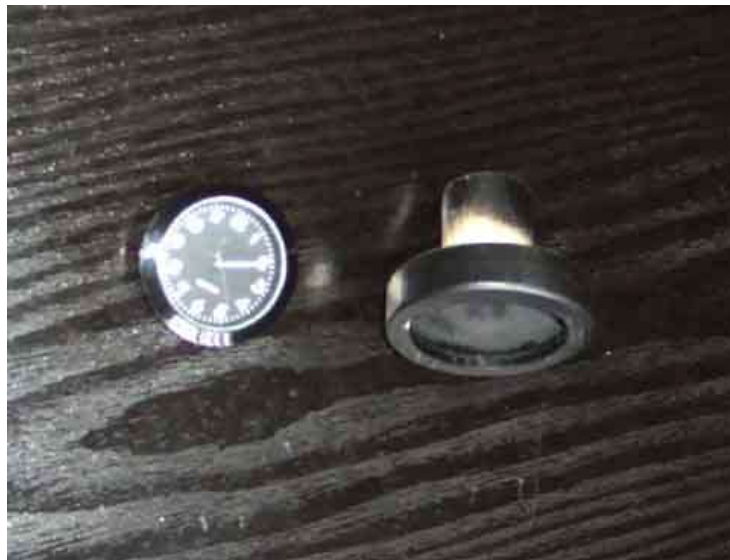
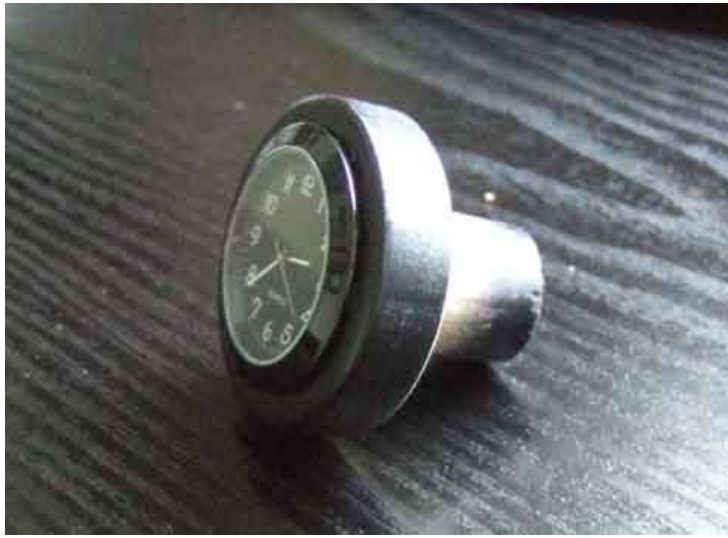
For Bee a watch insert and holder ...

... slots into the her lighter socket. The hands are reflective and being low down often one or another hand was reflecting something dark which meant I couldn't see the hands. So I hit on the idea of a thin coat of Snopake on each hand, which meant I could see them clearly. However the flaw in that argument was that having done the second hand I couldn't tell that from the minute hand until it moved at one second intervals! So cleaned the Snopake off the second hand and it's unambiguous now.

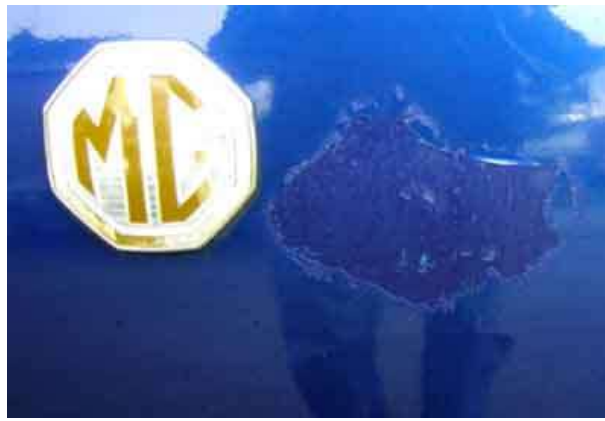
The body has always been very good, just minor chips here and there, pretty good for 15 years albeit only 54k, kept outside and used more in winter weather than anything else. But gave it a once in a blue moon wash as it's got very mucky with unusually frequent use over the last few weeks. Giving a final rinse down with a garden hose nozzle on low pressure (NOT a Karcher!) and I spot something that looks like it's sticking to the vertical part of the boot lid, and as I'm spraying it chunks of colour coat start flaking off to leave beige primer! I leave it to dry in the sun and wind, and on my return there are more chunks flapping in the breeze. Pick those off to leave several square inches stripped. When I got the car 12 years ago they gave me a plastic pot of paint for touching up, which stayed liquid for many years. Gone to a creamy consistency now, I've used it to disguise it a bit, although the colour match is poor.

It's a bit of a mystery, although the back of the car faces south-east it's the vertical surface not the horizontal which one might expect to suffer more from sun damage. Also why now, in winter, when the summer before last was more notable for hot sun than last year? I've sent off for some spray paint, it's not worth spending any money on a full strip and repaint at a body-shop. Next day after more wind and rain more lifting edges are showing, so how extensive the problem will be is anyone's guess.

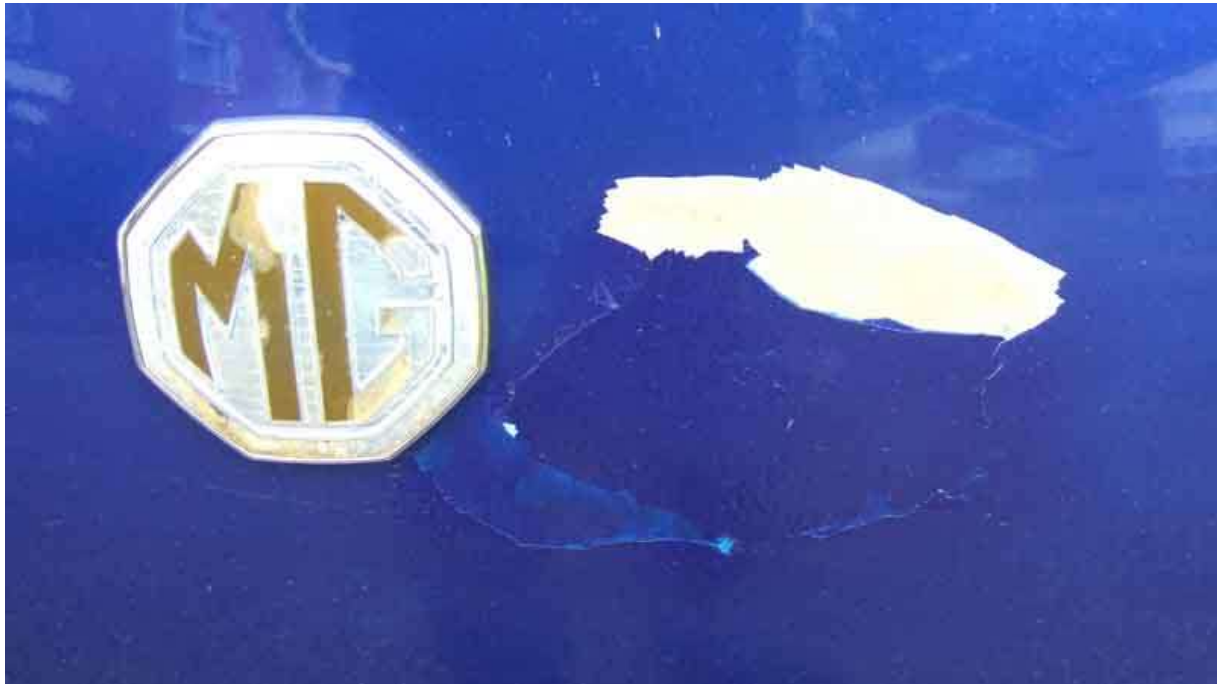
Washing it (just a hose and brush) and I saw some marks on the boot lid just to the right of the MG badge that I thought were streaks of dirt. Squirted the hose at it and chunks of paint started coming off! 'Just' the colour coat, leaving the primer behind. There were further wrinkles and they peeled off as well over the next few days. I could blame the sun (the MG badge has faded) but the boot only starts getting any in the afternoon, and then at an oblique angle. I had some paint from first getting the car that had gone pretty thick, which smeared over it to disguise it to some extent while I pondered what to do. I got a couple of aerosols of colour and clear coats, not enough to do a proper job on the whole of the lid under the spoiler, so I'll just have to go for a patch repair, of a better quality than so far. It looks like quite a good colour match, but more has peeled off since. So whether it's worth doing a better job only to have more come off is another matter. I could get the whole of the panel under the spoiler done professionally, but it's getting more advisories these days, and can't be far from a significant failure, so I'm wondering if it will shortly be time to move it on. Which will be shame as I really like it.

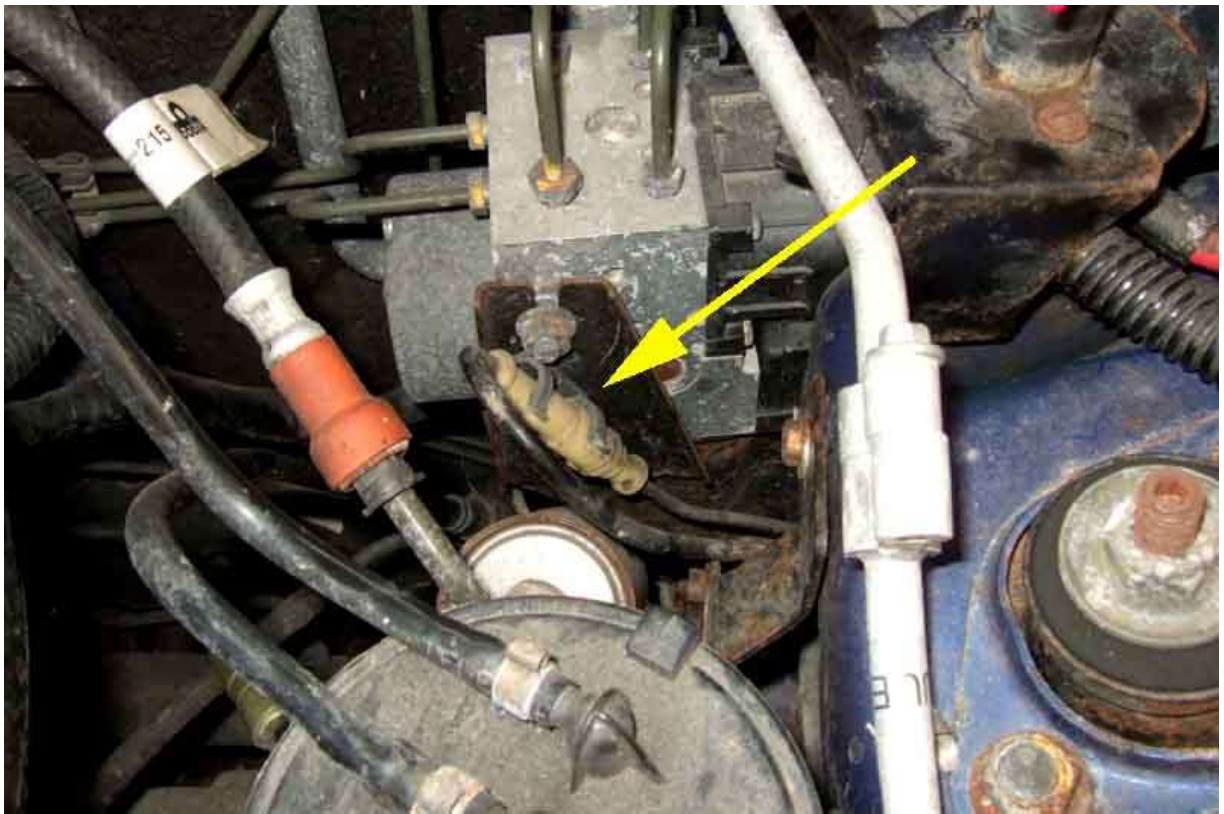
Haynes indicates that both front connectors are by the ABS unit, but I could only see one:

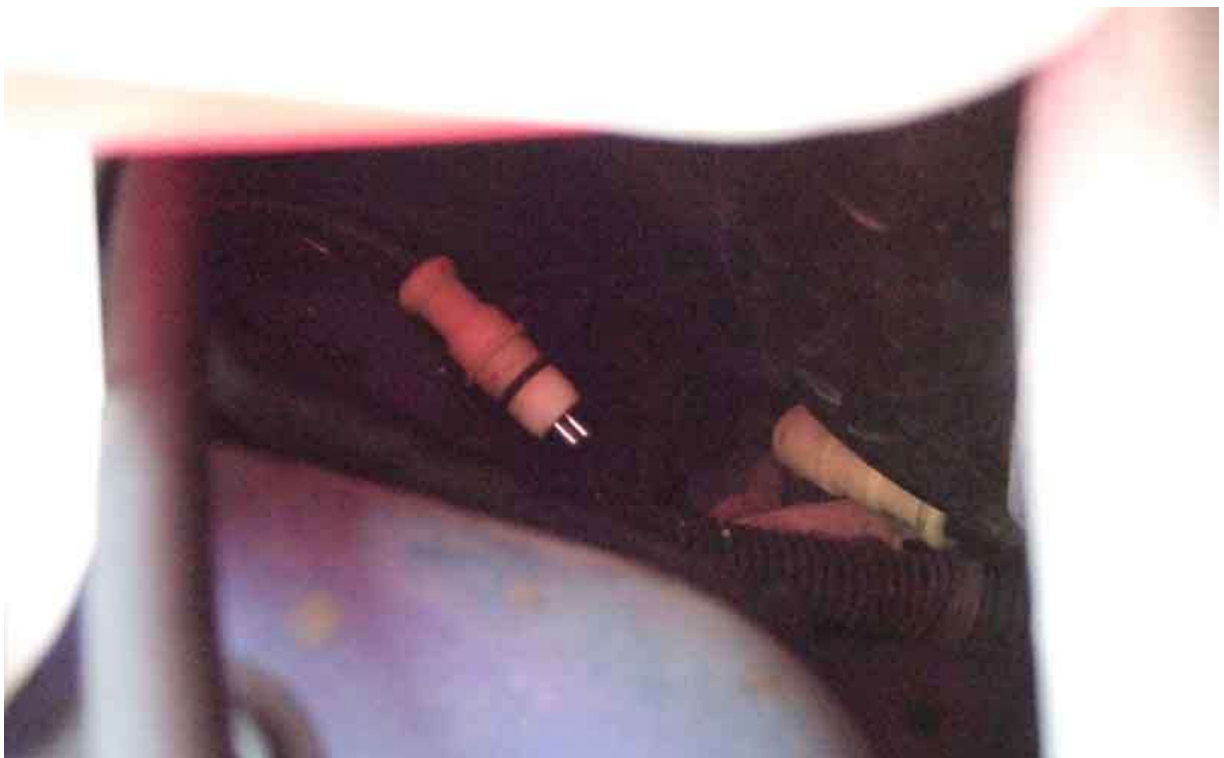
Surely more logical to have the other one on the other side, so I peer under the coolant reservoir ... and spot this:

Now I did [change the coolant reservoir](#) in early November, but this problem didn't appear until mid December. I can't imagine pulling it apart when I was working on the reservoir as there is loads of slack in the hoses and level switch harness. Maybe the ABS connector was draped over the main hose and lifting that up was enough to part the connector. Maybe it wasn't fully pushed together in the first place. And whilst the other three connectors have a clip over each half, keeping them together as well as stopping them flapping around, I can't see or find by feeling around any clips for this connector. Anyway, pushed back together, ignition turned on, and the ABS light comes on and goes off again as it should. Ten minutes work for the find and fix after spending several hours messing around with the reluctors and ABS connector!

I did, but found it very difficult to push the peg on the clip into the hole (which was clear) while the connector was in the clip. It didn't take much to dislodge it, but I left it pushed in as best I could. Maybe it's better pushed in first, or maybe for some reason this hole doesn't want to accept the clip, which was why it was missing. As the same time I parted and reconnected the connector, as it didn't seem to be pushed fully together, which needed a very firm push.

As the connector was obviously parted, and reconnecting extinguished the warning light, I didn't bother going any further i.e. checking resistance or output, just checked the diagnostic plug pins for the ABS with the ignition on and light out and they were the same as before.

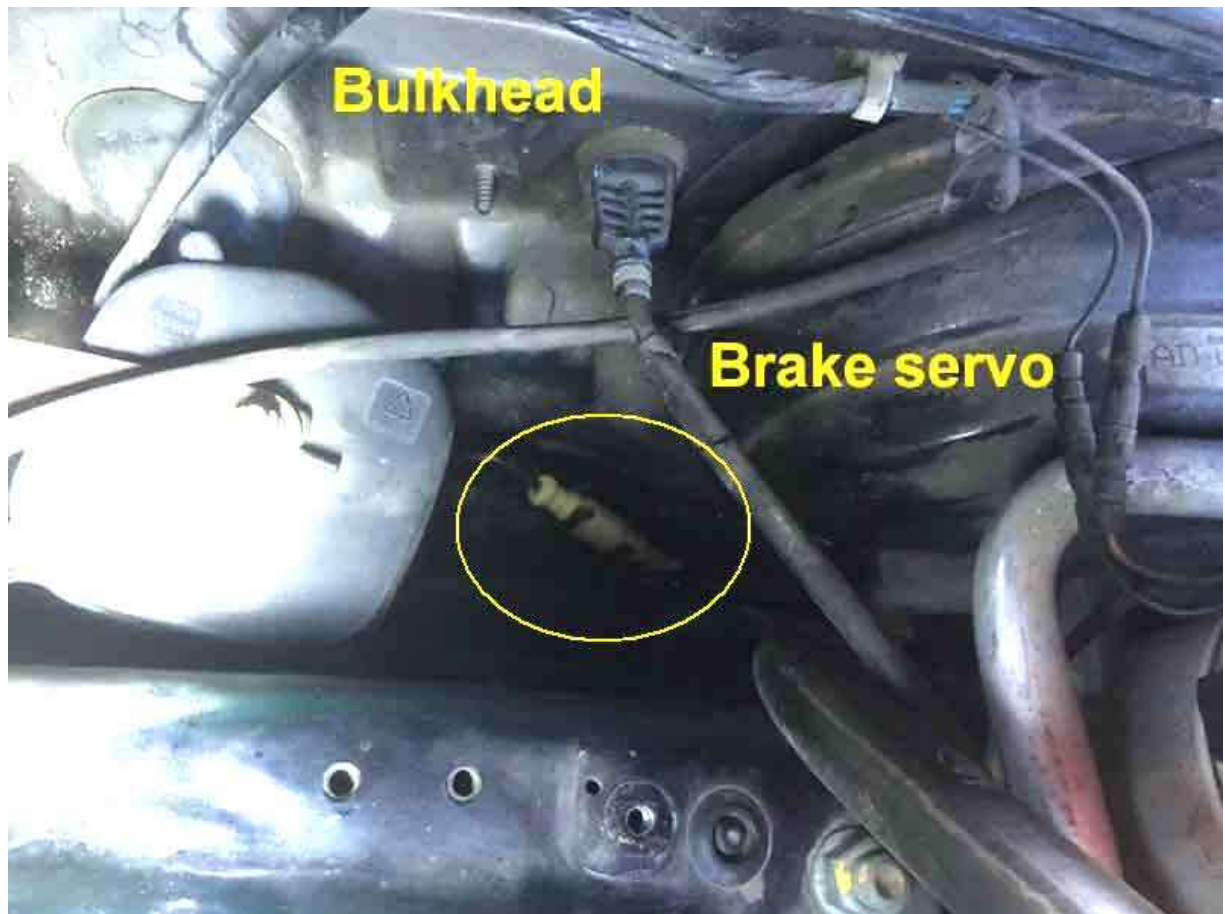
Jim Farrell via the MGO forum posted this picture that shows the connector in its clip (CLP8934A, available from several of the usual suspects), which sits on a small shelf on the bulkhead several inches below the accelerator cable. I have what looks like a hole there, but no clip, so for the princely sum of £1.20 I shall get one with my next order from [B&G](#):
