Voltmeters

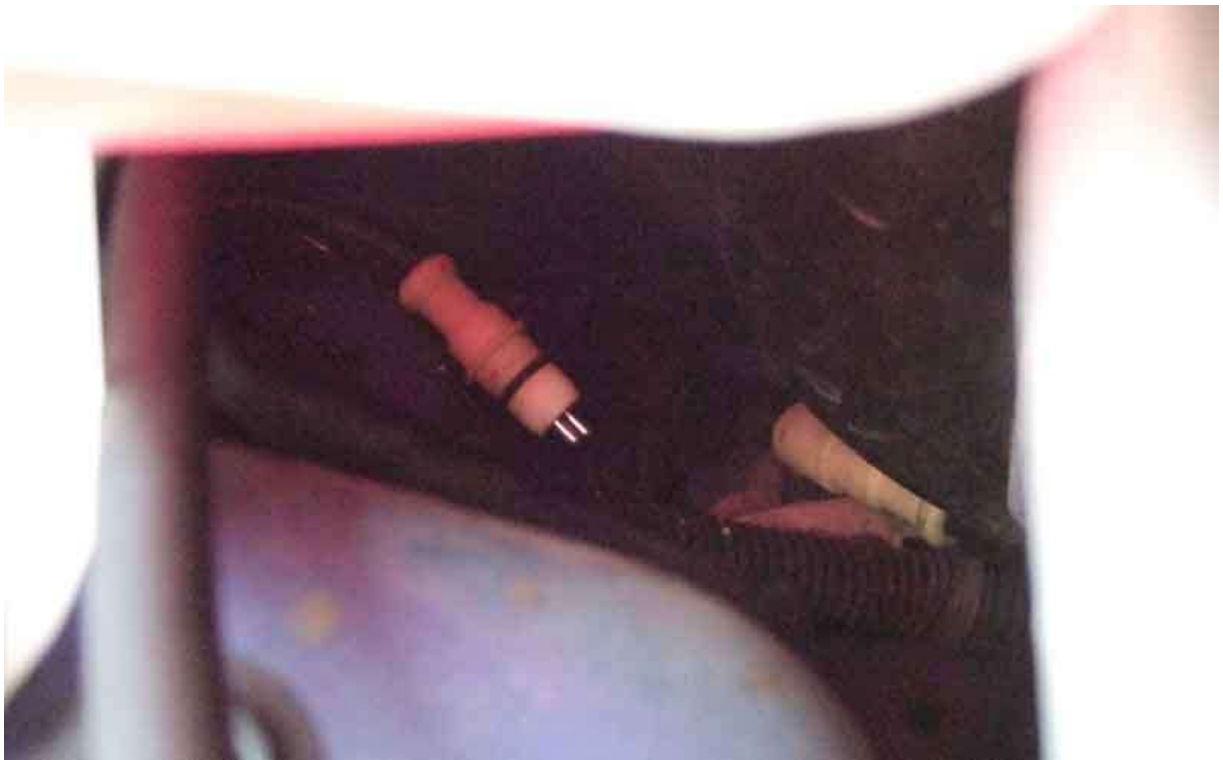
January 2020: In mid December I noticed the speedo was a bit erratic at 70, and then that the ABS light was on all the time the ignition was on. [Way too much time spent messing around checking reluctor rings later](#), I decide the problem is more likely to be with a sensor. The fronts are easier to get at than the rears, so I start with those with a view to testing the resistance from the sensors and voltages from the ABS unit. Looking to see where both are first I find this under the reservoir:

I can't find any clips that support this connector, unlike the others which have two each that hold the connector together as well as stop it flapping around. So if removing your reservoir, make sure that connector is fully pushed together before you refit it.

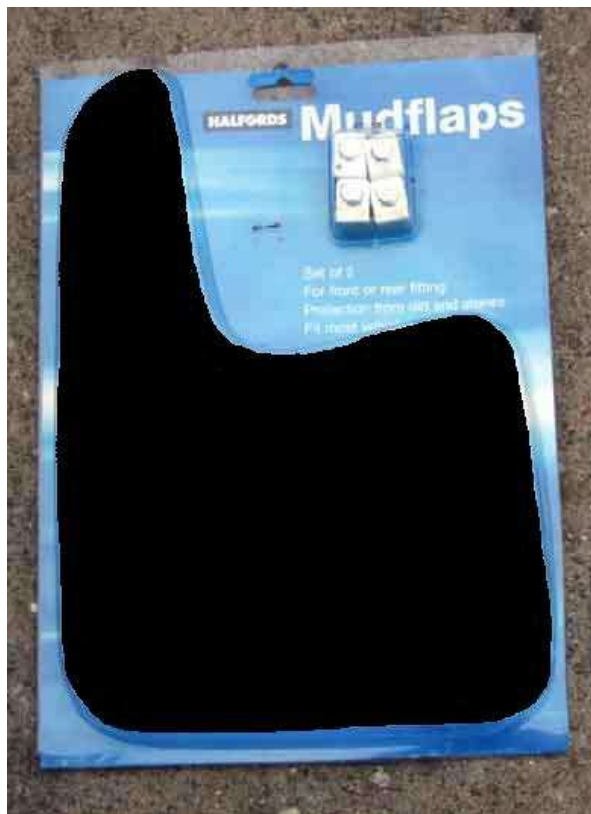
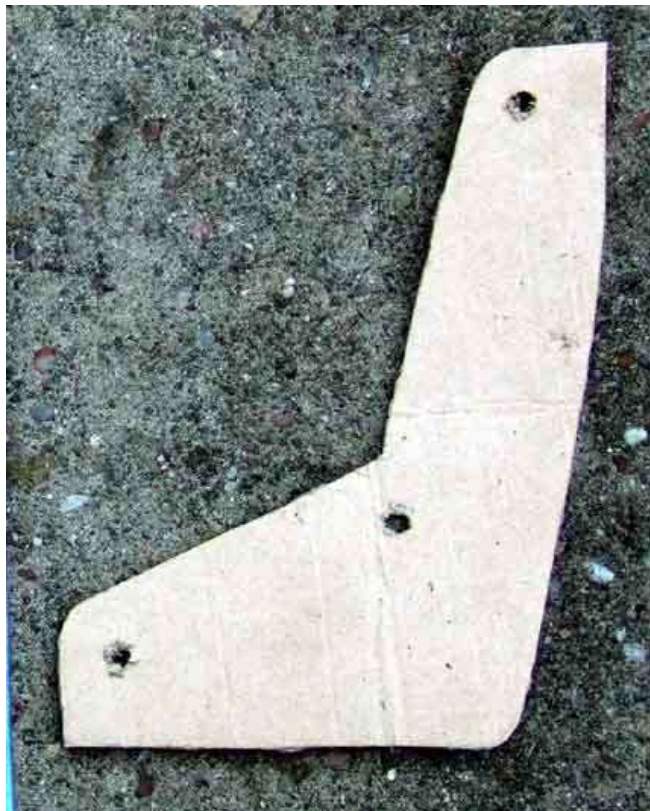
There was a bit of peppering from stone chips along the lower sides of the car where parts of the body kit faced forwards, obviously from little stones flipped up from the wheels. Although all the body-kit is plastic I still didn't like the look of it, so touched them up and investigated mud-flaps. I didn't want the full-size things which are way too big and agricultural, just small pieces sticking out from the lower side and bottom of the front arches, some cars seem to have something like this as standard. Spent some time searching with Google, but could only find the big ones. Ditto in Halfords, and nothing in the local car spares shop. However the Halfords ones were only £7, quite thin and without any deep moulding on either side which meant they would butt up against the arch quite nicely. The ZS also has three screws securing the body kit and arch moulding in that area, in an ideal position for the mud-flap.

I made a template out of card drawing down the lower edge of the arch and across underneath, then back to encompass all three screws. Cut that out, then put a blob of paint on the head of each screw, carefully lined up the template with the arch, then pressed the template onto the head of each screw, which left a perfect imprint of where to make the holes. Then I could position the template over each arch (turning the template one way for one arch and over for the other) to get the amount of overlap I wanted, and scribed round the template for what needed to be cut off. The material is quite rigid plastic rather than rubber, and so was easy to cut with a jig-saw.

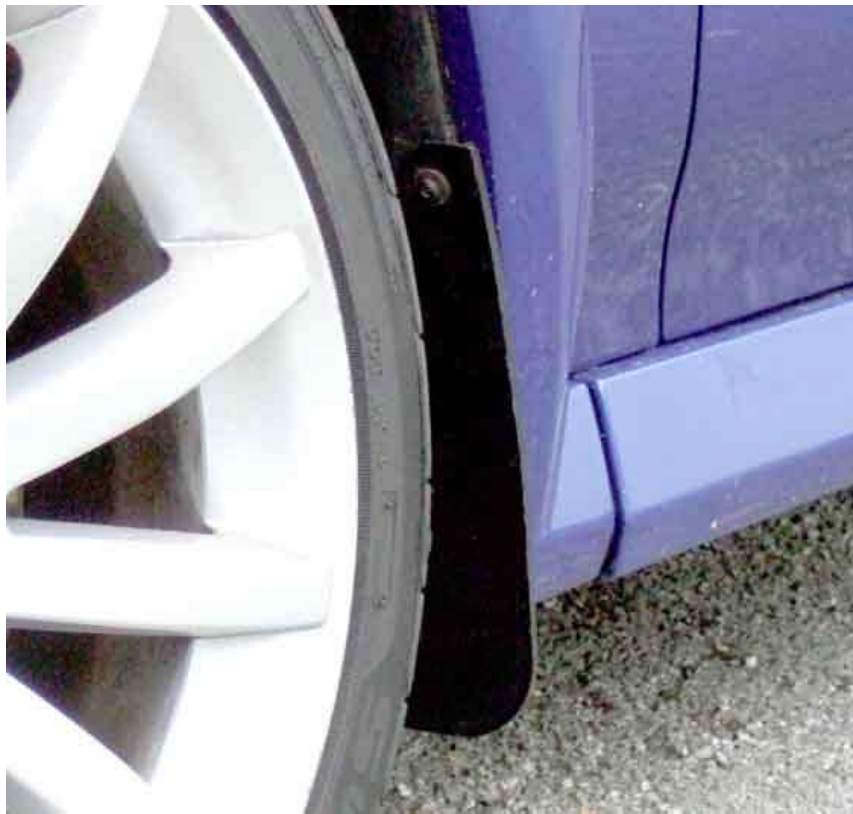
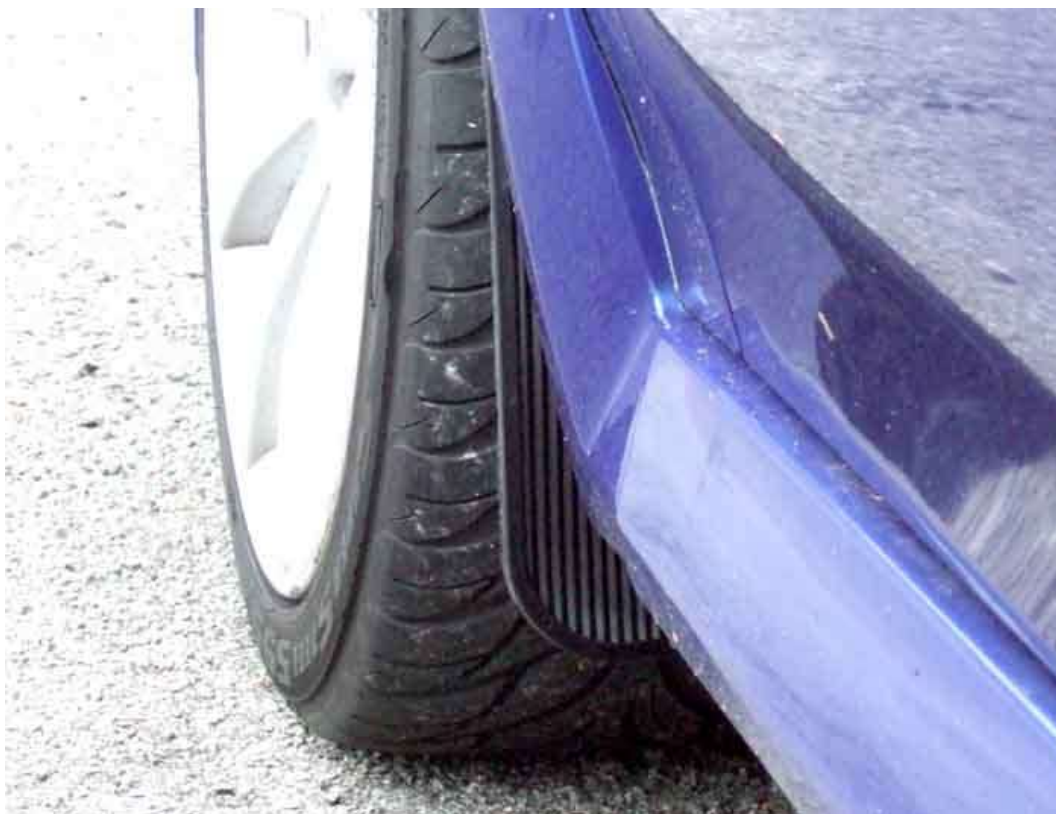
Removed each road wheel in turn, the three screws with washers, then fitted the flaps. Being thin there is still plenty of thread left to hold them and secure the body-kit and arch liners. Replacing the road-wheel I put a little copper-grease round the centre hole, as this is a snug fit to a boss on the hub, and you can get corrosion here which makes the wheel difficult to remove.

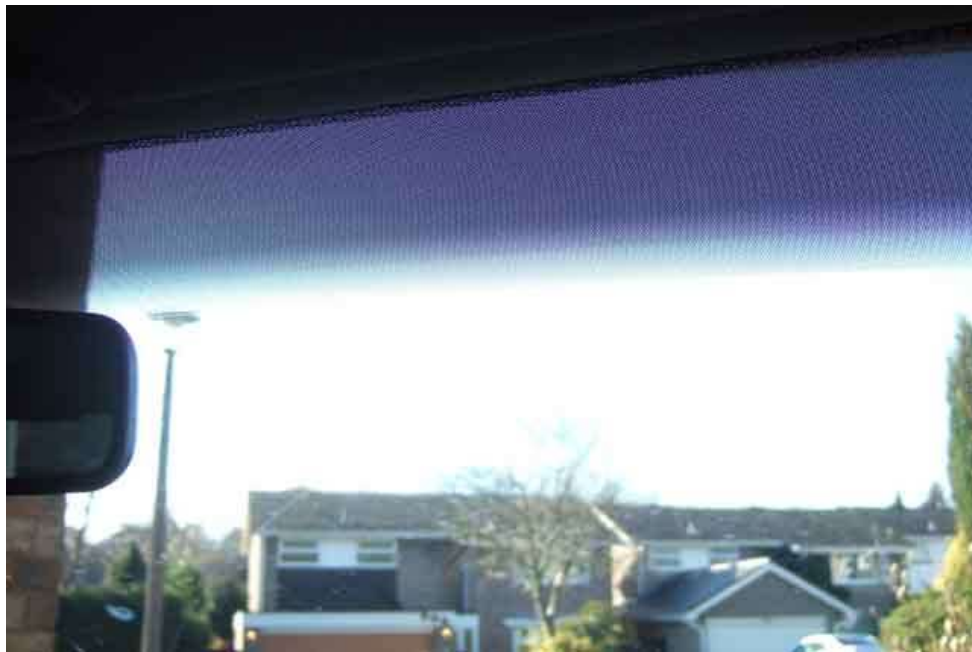
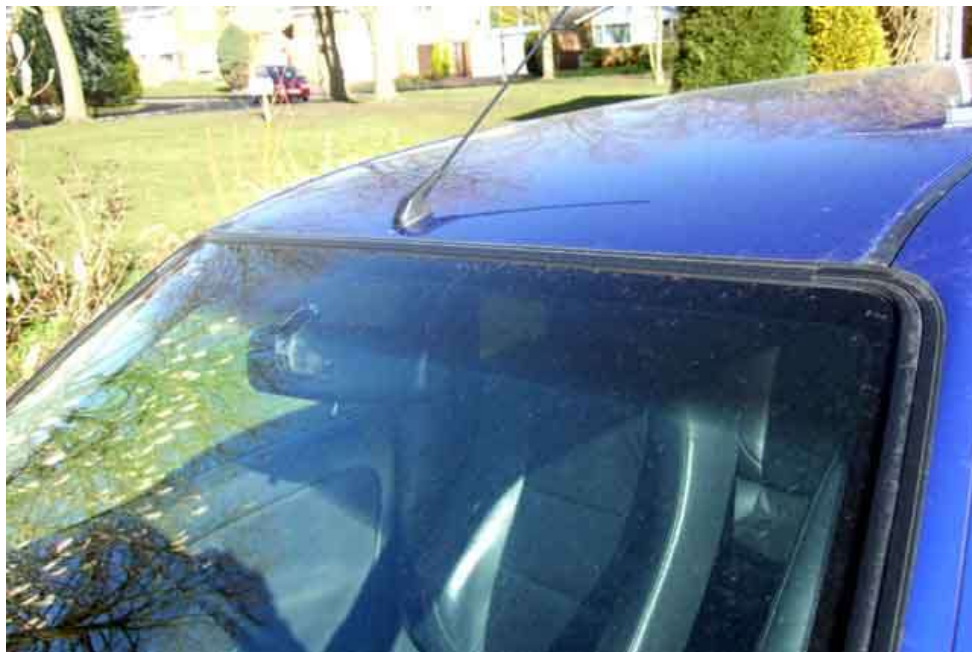
With the much deeper screen on modern cars compared to the MGBs, and even the old Celica, we were getting dazzled with the sun much higher in the sky than we were used to. The ZS has sun visors of course, but there are gaps around where the mirror is which was irritating, and we found we were needing them even for a bright cloudy sky and not just sun dazzle. Even with its shallow screen the V8 has a shade band across the top edge, so I spent some time searching the web with various terms looking for a plastic strip I could stick on, which I felt sure existed. Found loads of references to tinted film to stick over the whole of the glass, but not this top strip. Eventually I gave up. Then months later I saw a reference to 'sun strip' in the Sunday Times motoring section, searched on that, and bingo! What's more, [Halfords have them](#), in various colours. I decided on black as the pale blue they had, despite possibly matching the colour of the car, looked like it might have been a bit obvious.

Followed the instructions to the letter cleaning the glass with meths, then wetting it, before attaching the film. This helps it slide into position as well as stick well afterwards. The only tricky bit was cutting out round the mirror, which isn't perfect, but doesn't really notice. The film consists of clear plastic film covered in dots, which start off at the top being more dot than space, then the dots get smaller towards the bottom edge, to give a graduated effect. Makes a noticeable difference, but if anything a deeper or double strip probably wouldn't be too much, it still dazzles more than the V8.

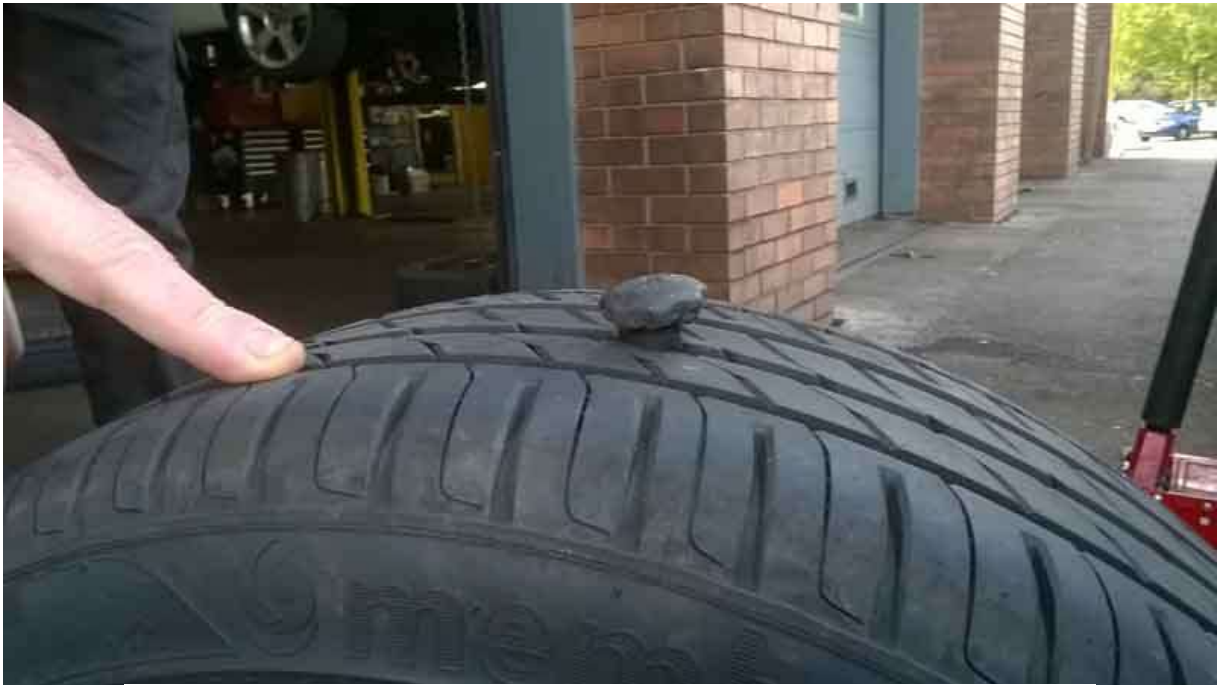
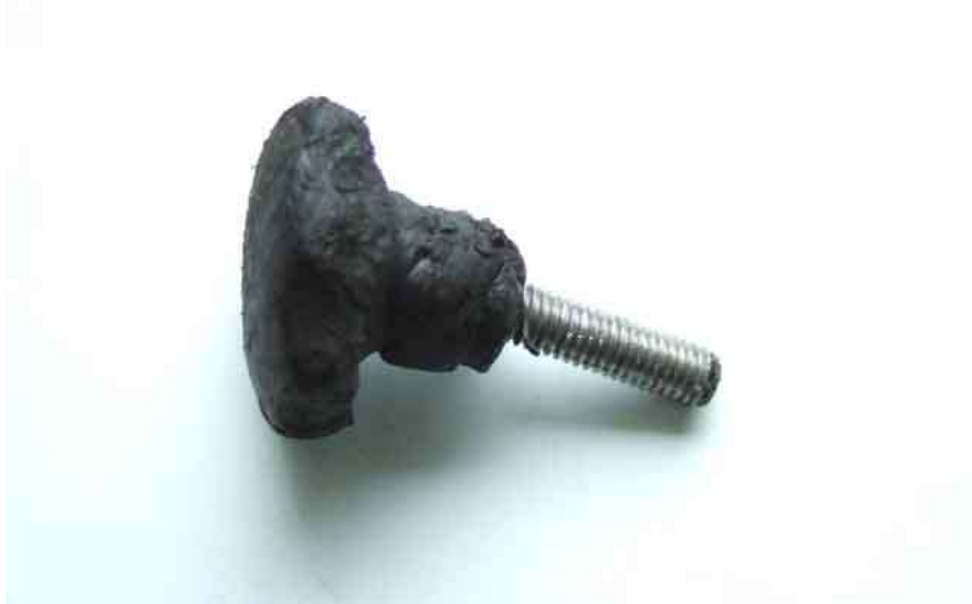
September 2017: Yet another puncture, this time in a tyre barely a month old, from a massive hand-tightening clamp like something off a bike carrier or roof rack! Halfords manager said it trumped anything he'd seen before.

Fortunately outside Halfords (but on the public highway ...), they got the wheel off and once the offending item was unscrewed they declared it repairable - good news. However once done it was still bubbling very slightly - bad news, but they didn't charge me. First thought was it would be scrap, but second thought was yet another can of TyreWeld - it really should be able to repair this tiny leak. OK, if I get another puncture the tyre will be scrap, but if I don't then it's only cost me a tenner instead of about £60.

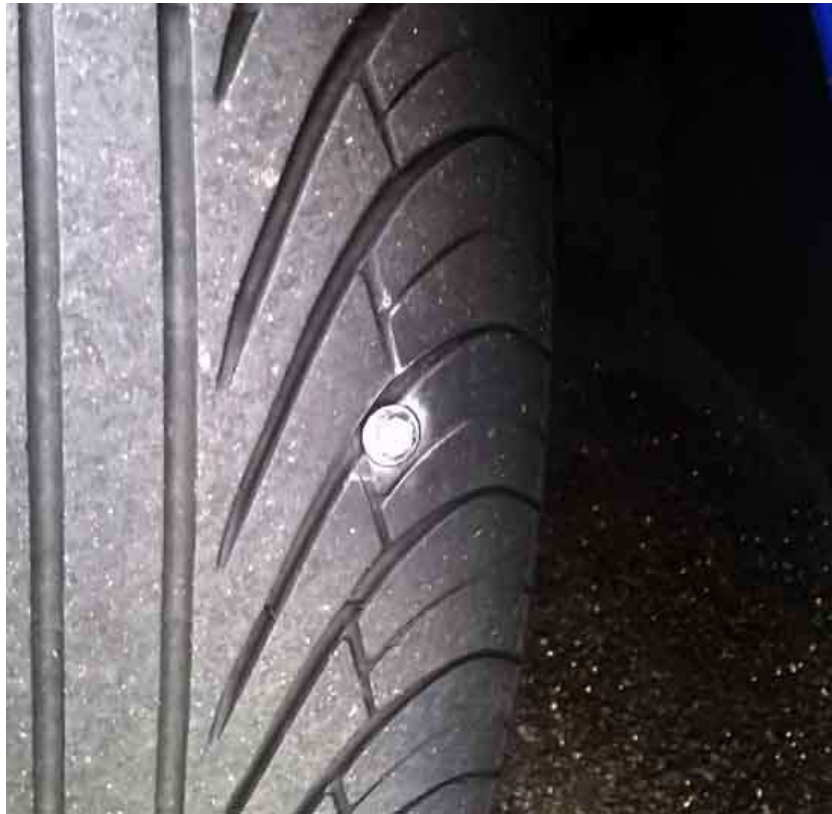
But then I discovered the front offside completely flat, after having found it 10psi down and reinflated a few days ago - the first time I'd checked that wheel for ages. Jacked up that corner - trolley jack only **just** fitted under the sill with it right down, and turned the wheel to find a screw in the tread.

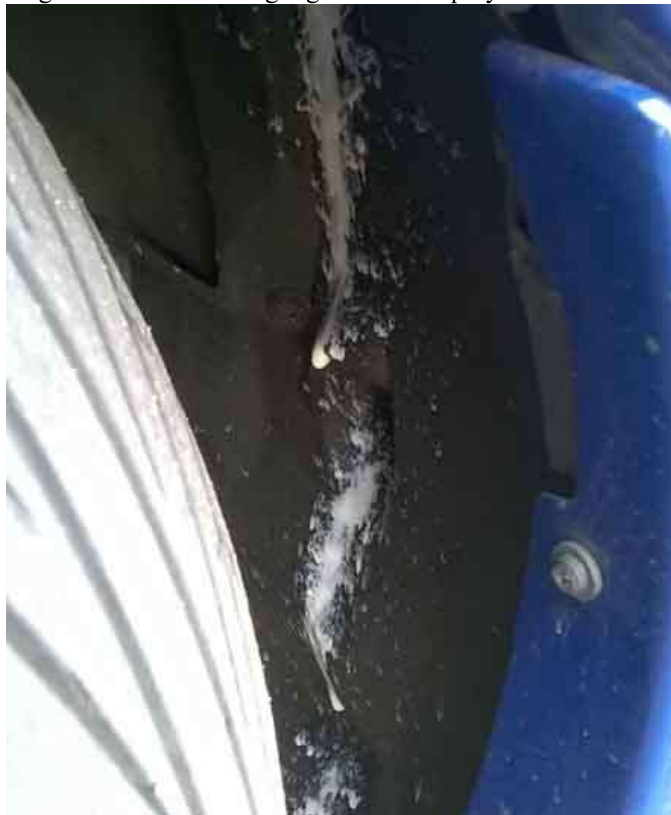
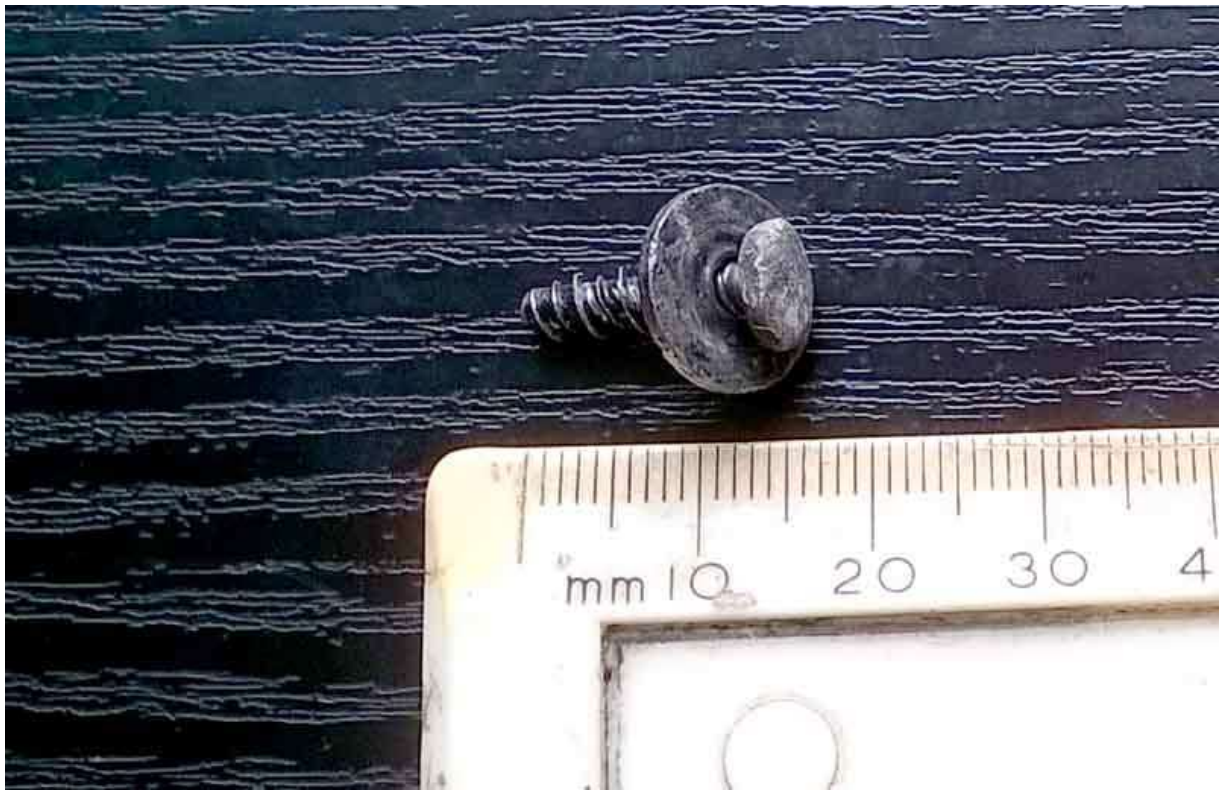
Will need replacing soon, but still some life in them, so I decide on another can of Tyreweld - never used it before in over 40 years, and now twice in a couple of weeks - as to fit the space-saver spare it has to go on the rear, and a good rear wheel moved to the front. Reinflated, only going down very slowly, slowly enough to allow a quick trip to Halfords. Removed the screw and turned the wheel so the hole is at the bottom as instructed, and connected the can. It's immediately obvious the gunge is coming out of the hole - hmmm. Nevertheless I persevere, and when complete reinflated from about 20psi as before to 33. Drive six miles, and get home to find the gunge has been sprayed around the wheel-arch!

Double-hmmm. Still hissing very slightly, but pressure OK, so I leave it for a couple of hours. Come back to find the gunge has dried, and the pressure at 40psi! Deflate back to 33 and leave it another couple of hours, and no change. Next day it is down to 20 again, so I reinflate, and that afternoon it is back down to 20 again. I know it is only a temporary 'repair' and should have a proper repair as soon as possible, but I'm not impressed that it can't cope with a screw this size. It's all some cars have from new - maybe I should have left the screw in! I did wonder afterwards whether I should have left it just with can pressure and only inflated it to the correct pressure after the six miles, but too late now.

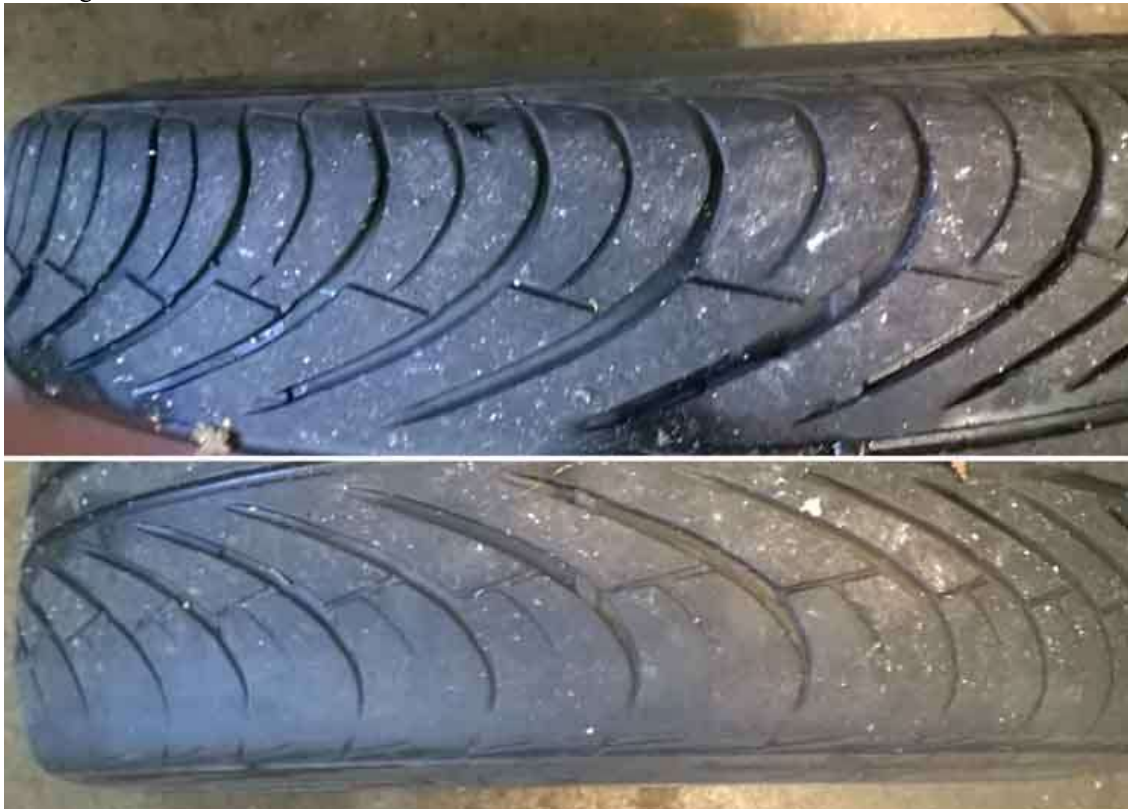
Next working day a quick trip to JustTyres for repair, but a) the inside edge has worn smooth (not easy to see on the car) and b) they won't repair tyres where a product such as this has been used anyway! So on balance definitely not a good idea unless you were really desperate like had already used the spare ... and who is going to carry a can just for that eventuality? So two new tyres, fortunately they were near the wear bars anyway and would need replacement soon. Top - outer edge, bottom - inner edge.

A couple of days later I went back for a tracking check. Only slightly out, +1 on the OS and -1 on the NS when they should both be zero. I expressed surprise they (the other was the same) had worn like that and they said low-profile when they are near to replacement do that. However I always put new tyres on the back and move those to the front so they don't get too old, and have changed them a couple of times before without seeing it before. As with so many things - 'time will tell', and as usual I swapped front to back.

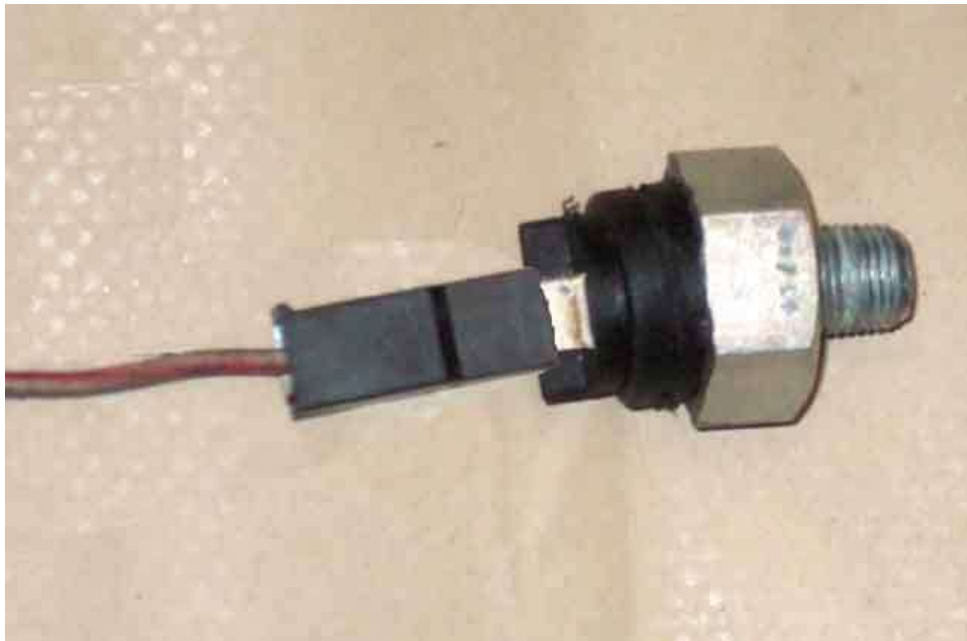
With this type of spade connector the cover cannot be pulled back but you can test the voltage on the wire but putting the meter or test-lamp probe in alongside the wire, as well as reach the spade.

You can't pull the connector off the spade by pulling on the wire as a sprung pin on the connector engages with a hole in the spade. Slide the cover back to depress the spring and move the pin out of the hole to release the connector from the spade. Remember electrical tests need to be done with the connector on the spade, not removed from it.

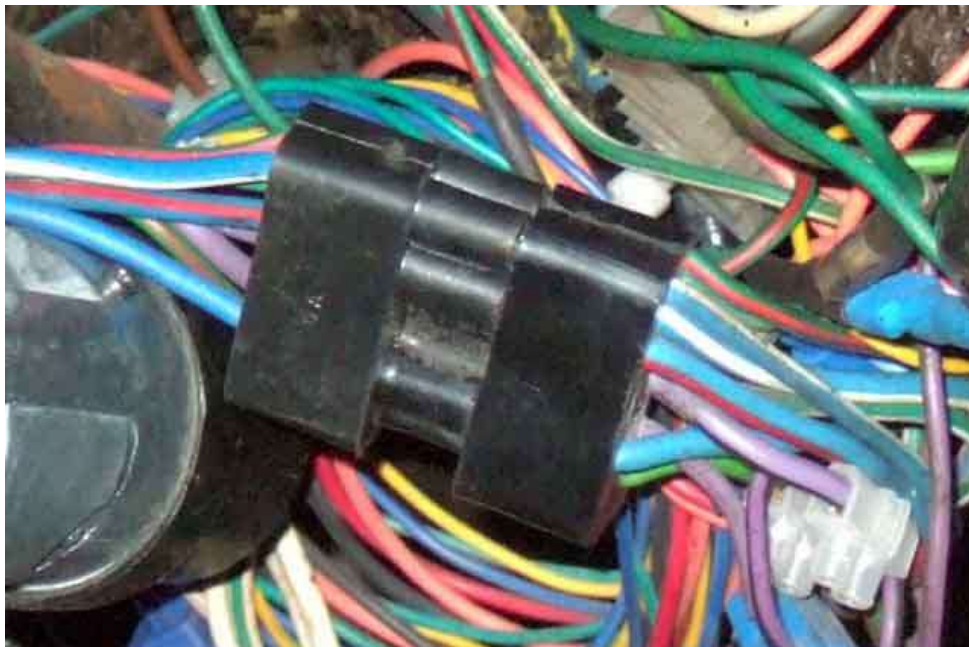
However black and grey multi-plugs are usually moulded onto the wires with no access from the back. In this case all you can do is slightly part the connector just enough to expose the pins, and even then only the pin-side.

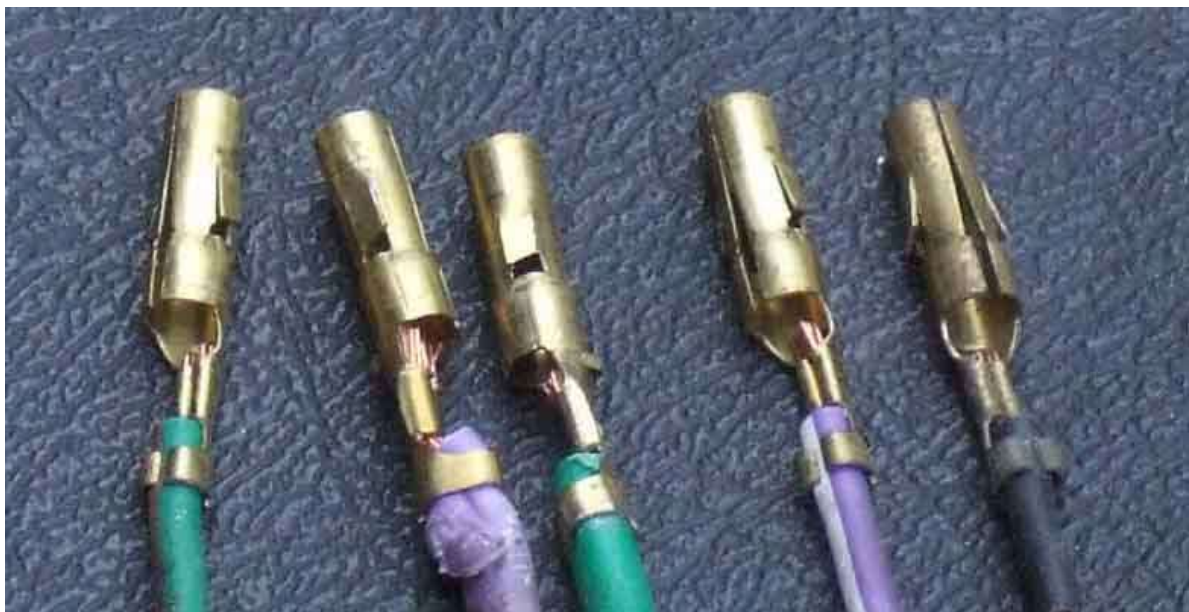
Connector pins can be teased out of the non-moulded type by sliding a bit of tubing over the open end, to depress the two little tabs that can be seen here:

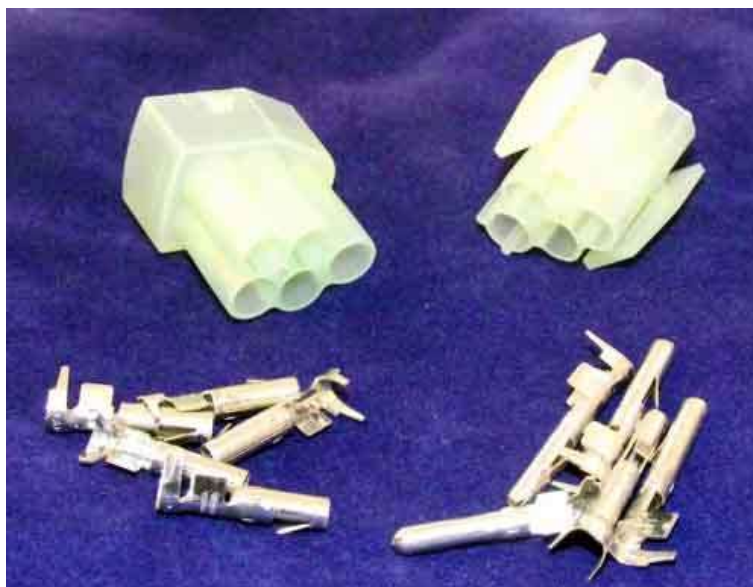
For projects and modifications [Autosparks](#) sell multi-way kits in 1, 3, 4, 5, 7 and 9 pin configurations - at a price!

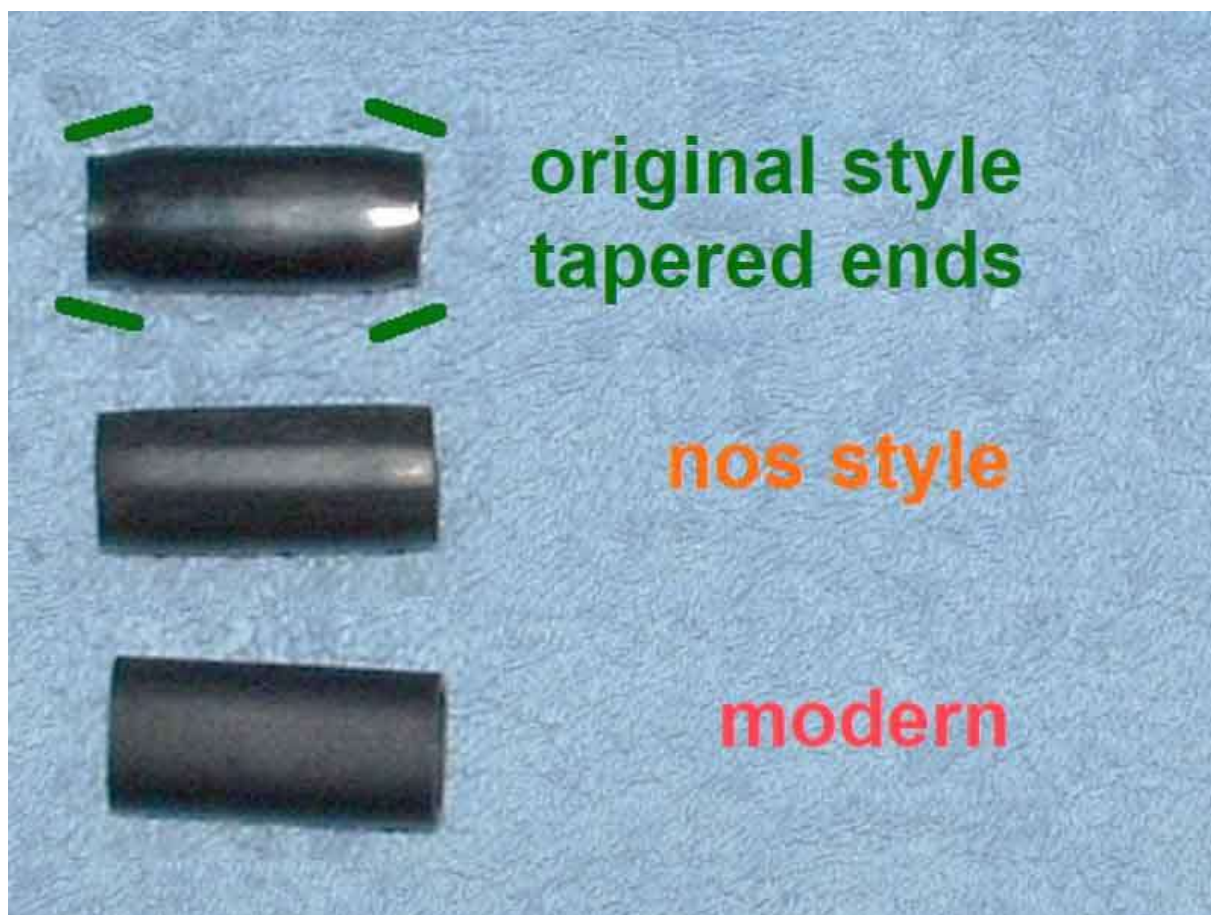
Typical original (top) and current stock (bottom) bullet connectors. The original have rubber sleeves slightly smaller than the metal part so is a tight fit. Modern stuff uses plastic sleeves of these same size so the metal part can easily slide out of the insulator and short out on surrounding components: *(Nigel Atkins)*

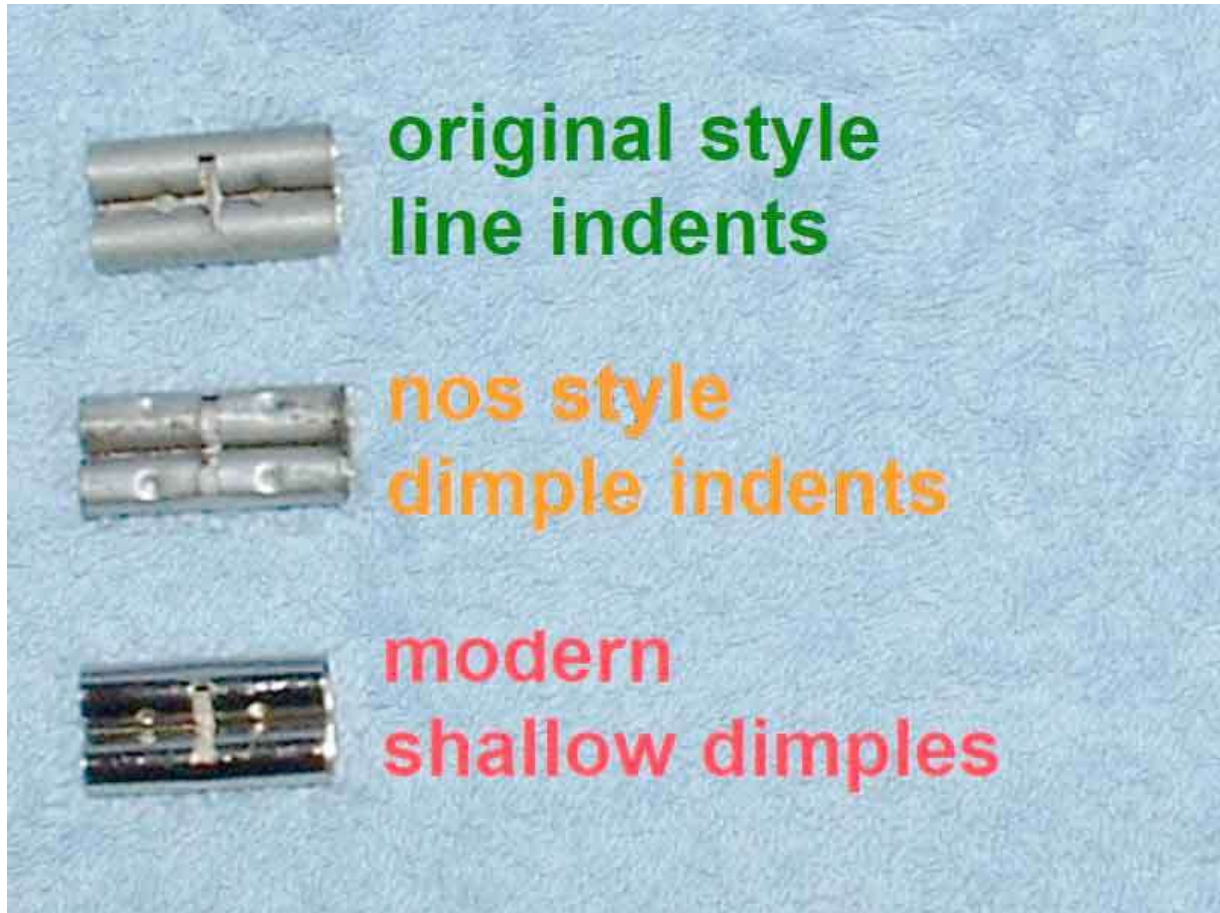
Original connectors have a pronounced dimple that the head of the bullet must be pushed past to snap into position, which also retains it very firmly. Modern connectors have a much less pronounced projection so the bullet can be pulled out more easily: *(Nigel Atkins)*

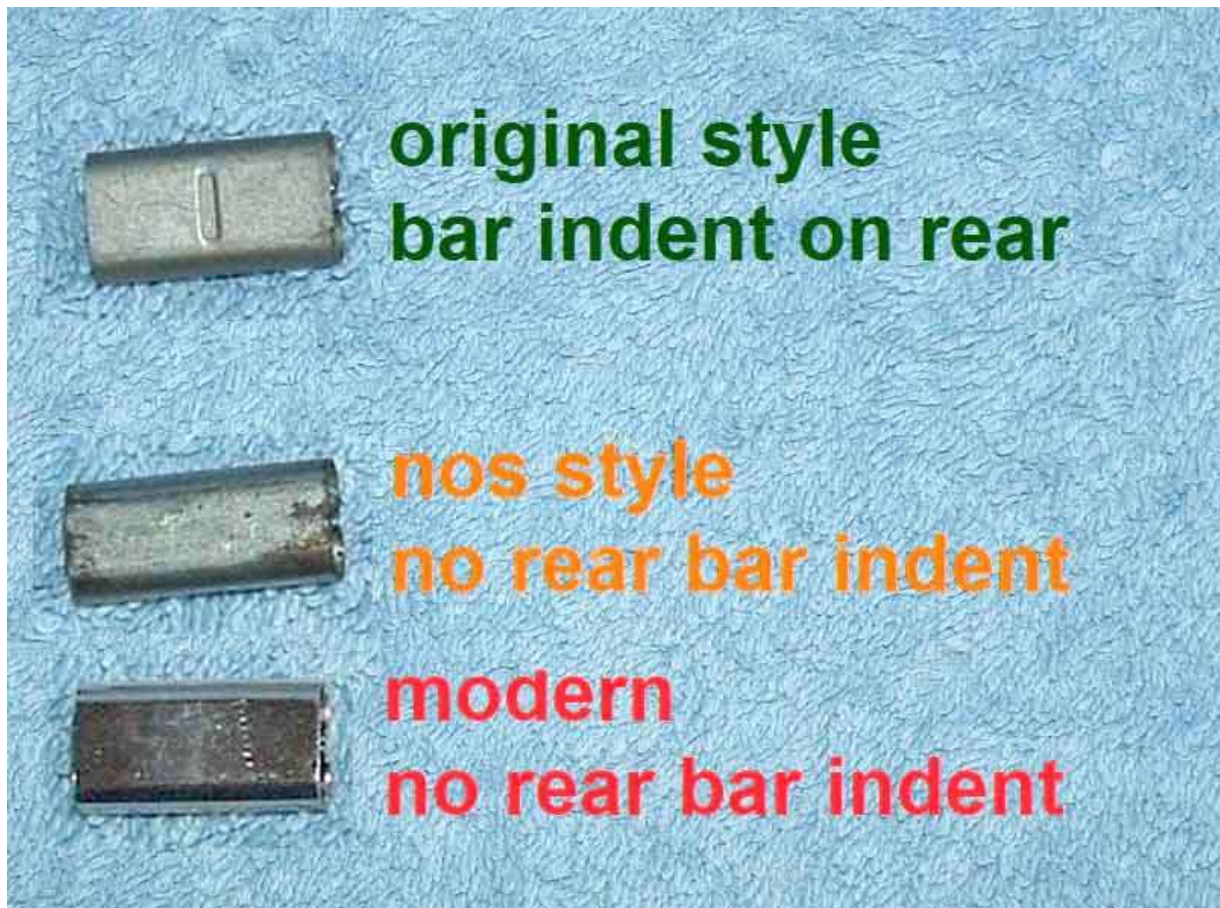
Original connectors have another projection in the middle of the metal part (arrowed) which helps prevent one bullet being pushed too far in, so preventing its opposite number being pushed in far enough. Modern connectors don't have this: *(Nigel Atkins)*

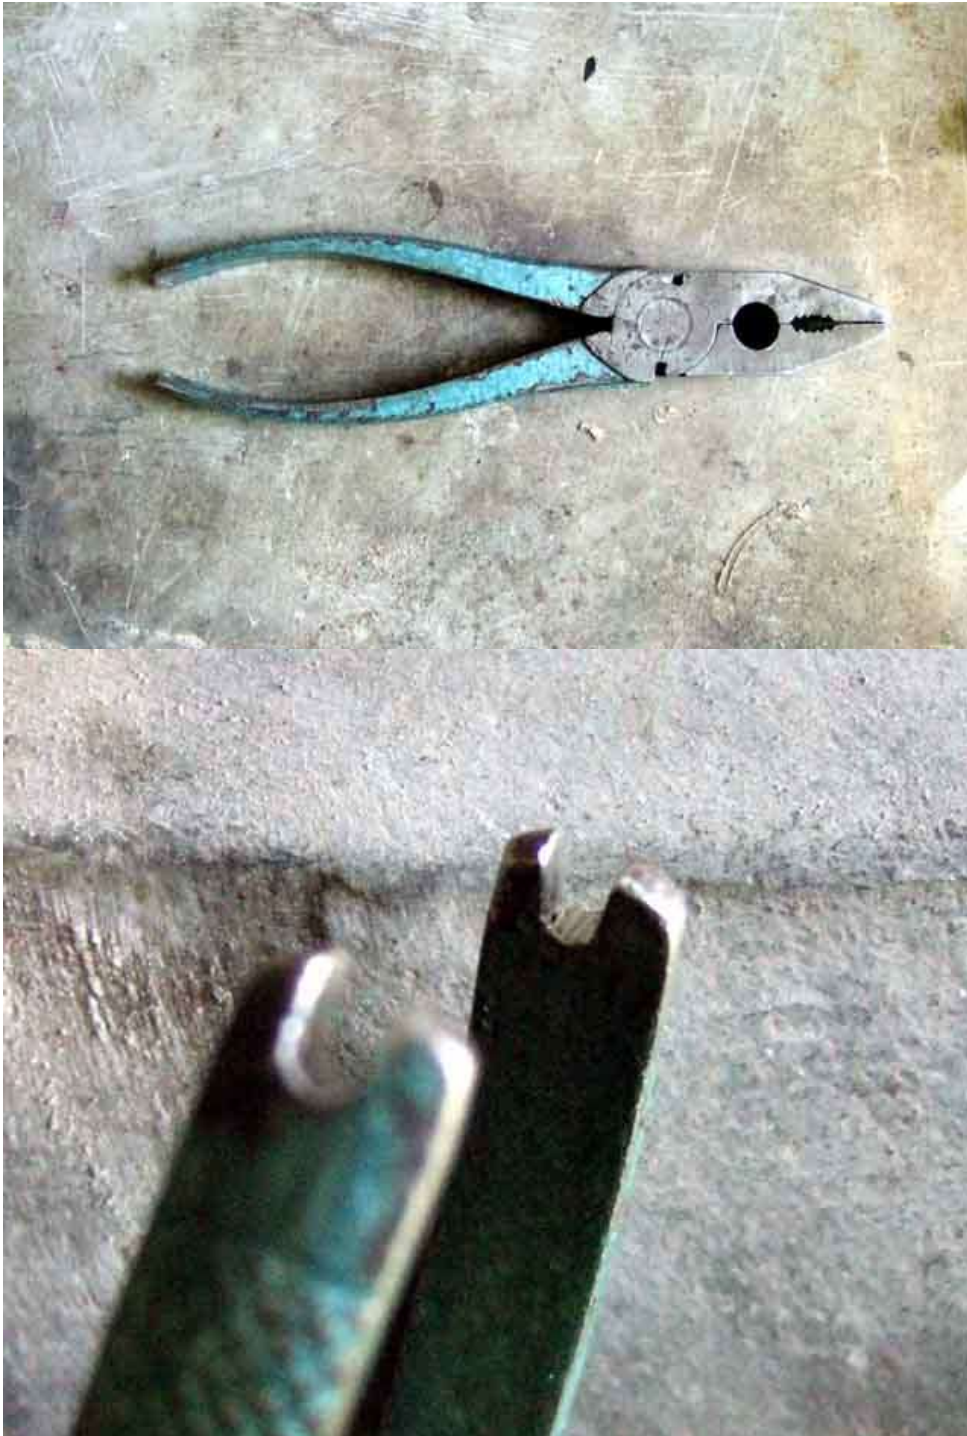
For easy of assembling cut a notch in the handles of a pair of pliers just large enough to slip over the wire but press on the back of the bullet.

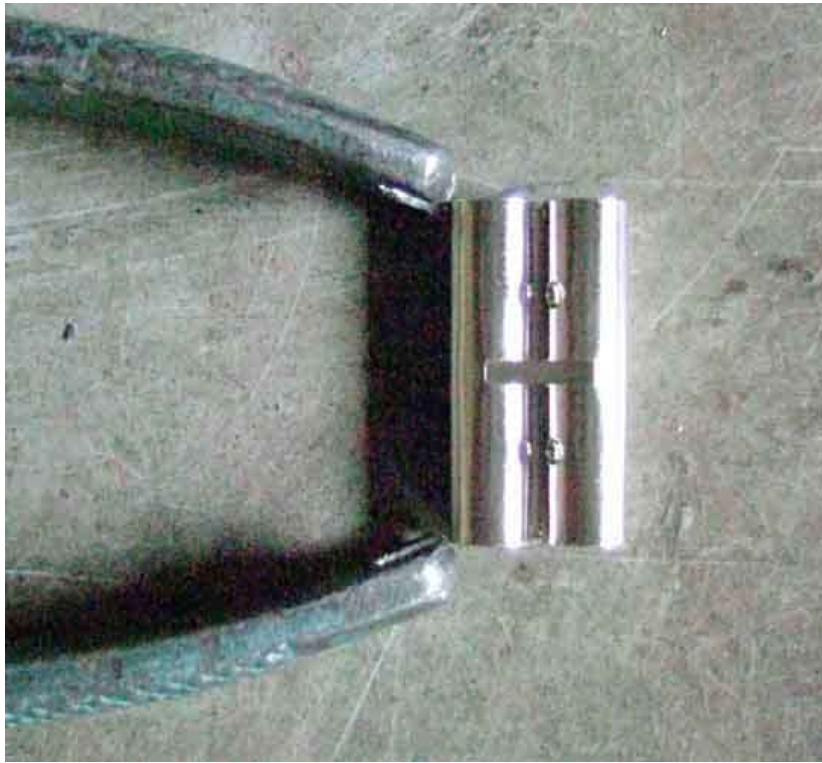
Make sure the closed distance between the handles is less than the length of the metal part of the connector or the bullets won't be pushed in far enough.

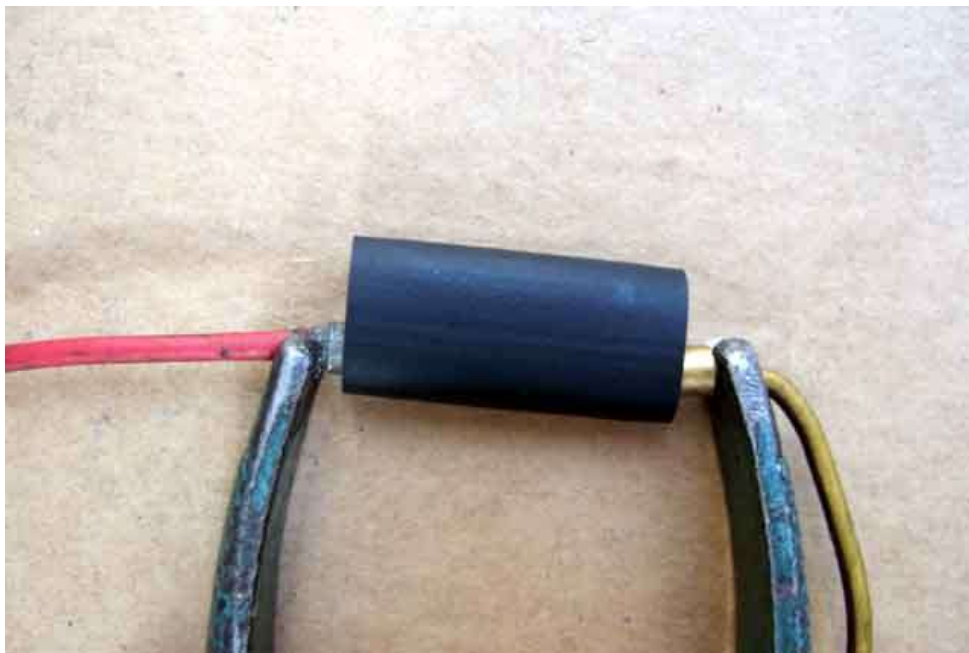
Preparing to push the bullets in ...

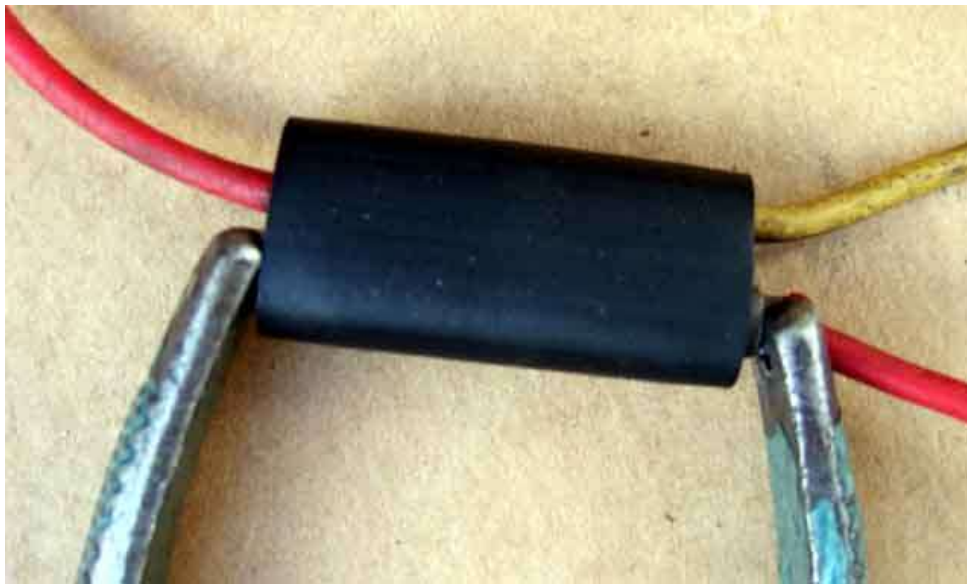
'Odd' bullets i.e. only 3 wires are dealt with in the same way. Finally make sure the metal part is centralised in the outer covering

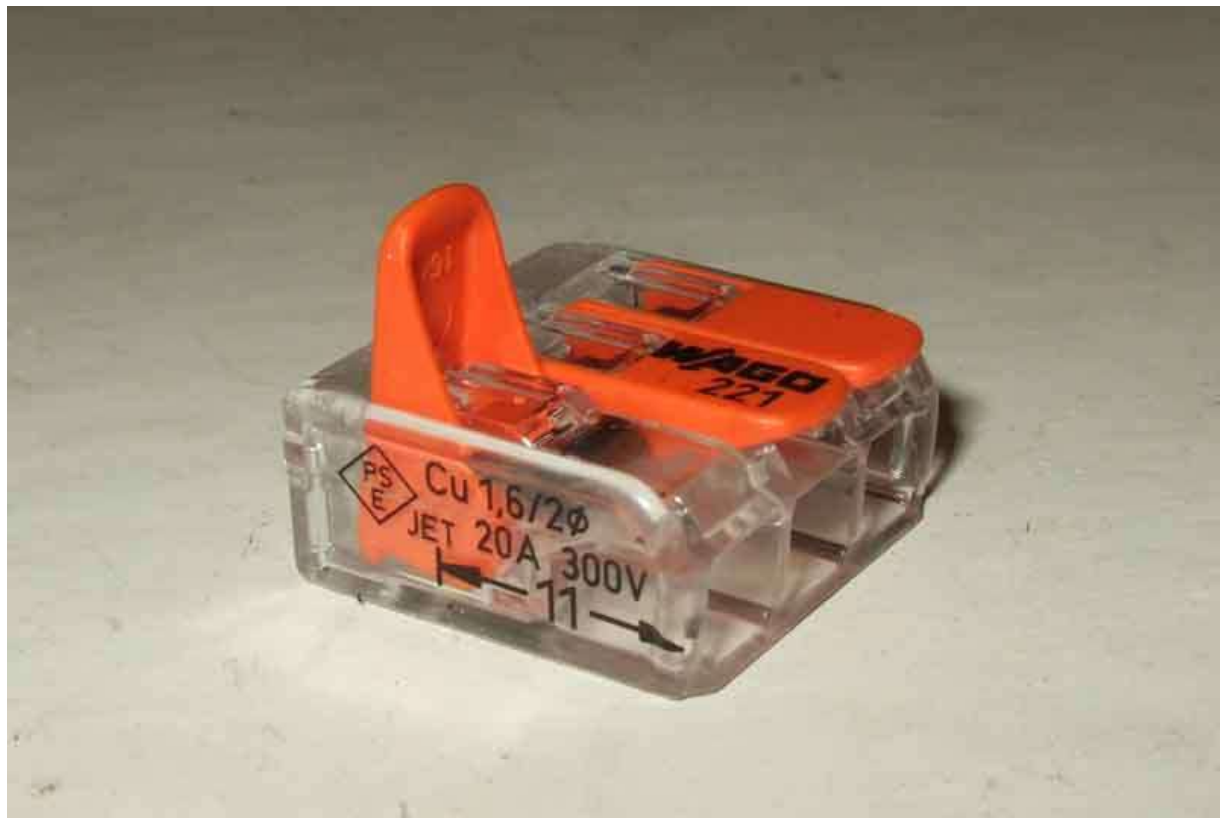
If you need to power several additional circuits from the same power supply whilst you could piggy-back off piggy-backs it's not the best. For those situations you can use one piggy-back to pick up the supply from a convenient location, and take that to one of these WAGO221 connector blocks which allow you tee-off anything up to four other wires. You could cut a factory wire but that would take up two positions and personally I don't like cutting in to factory wires if it can be avoided. Rated at 450v and 32A (although when mine came they are marked 300v and 20A) with slots for a test-meter probe you flip up the orange lever to insert the wire - 24AWG to 12AWG, then press back down to clamp it firmly. If you need more than four circuits they can be daisy-chained. There are cheaper push-fit versions but they are no good for stranded conductors. Available from various sources, [RS Components](#) may be slightly dearer than some but at the time of writing they have no minimum order and free P&P for standard postage.
