Voltmeters

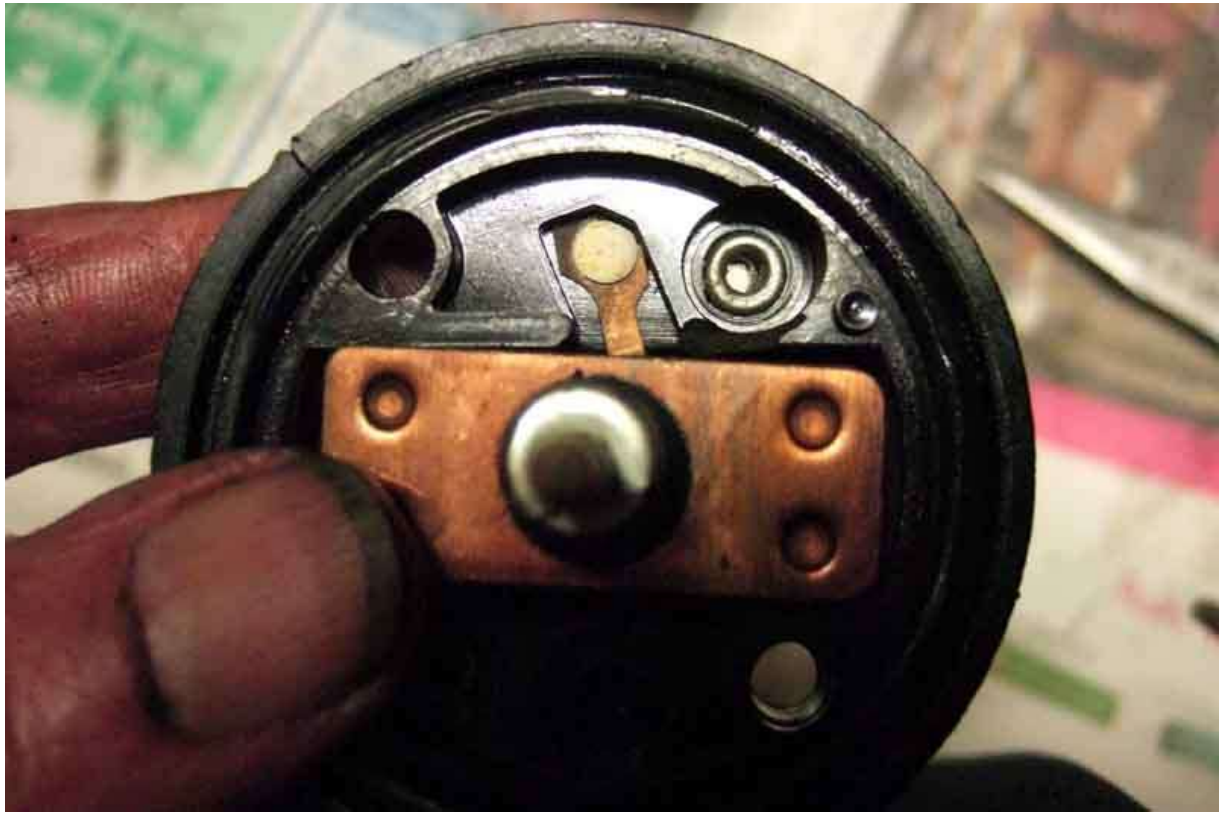
The coil boost contact is straightened and positioned so that the copper bar touches it and pushes it down just before it reaches the two studs:

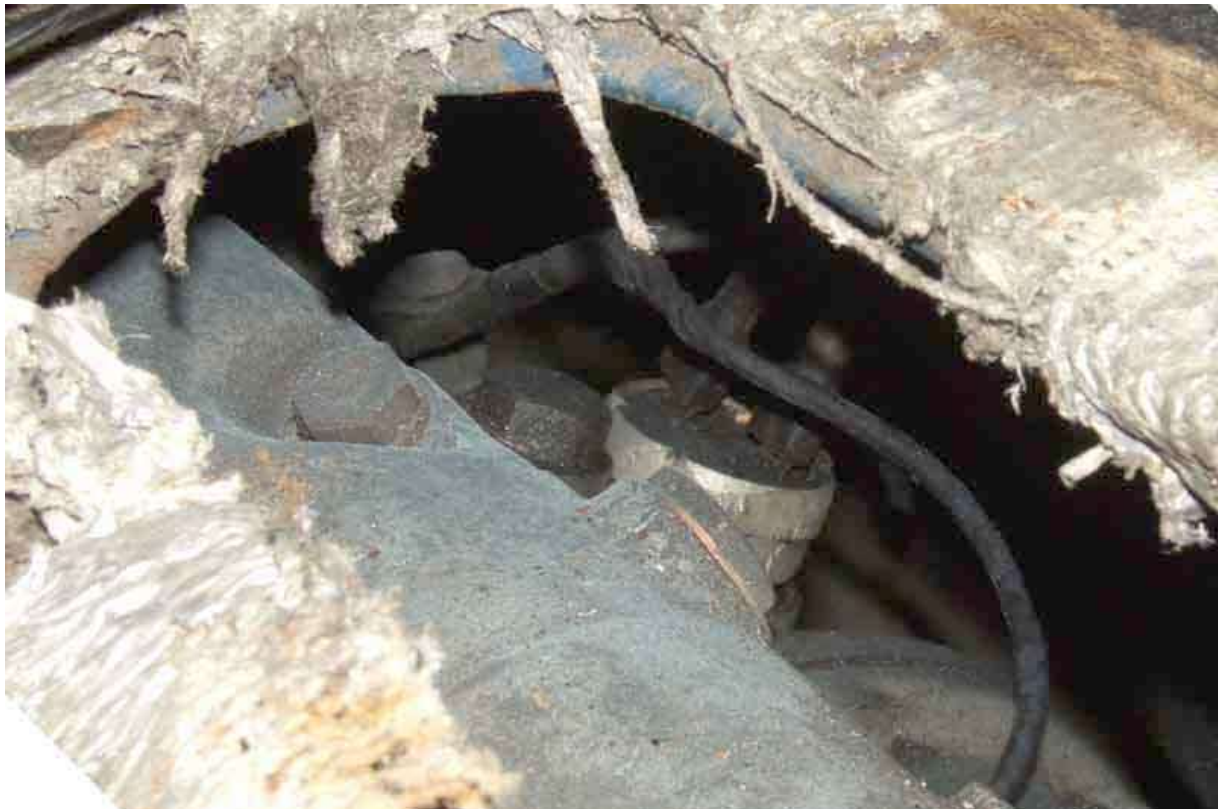
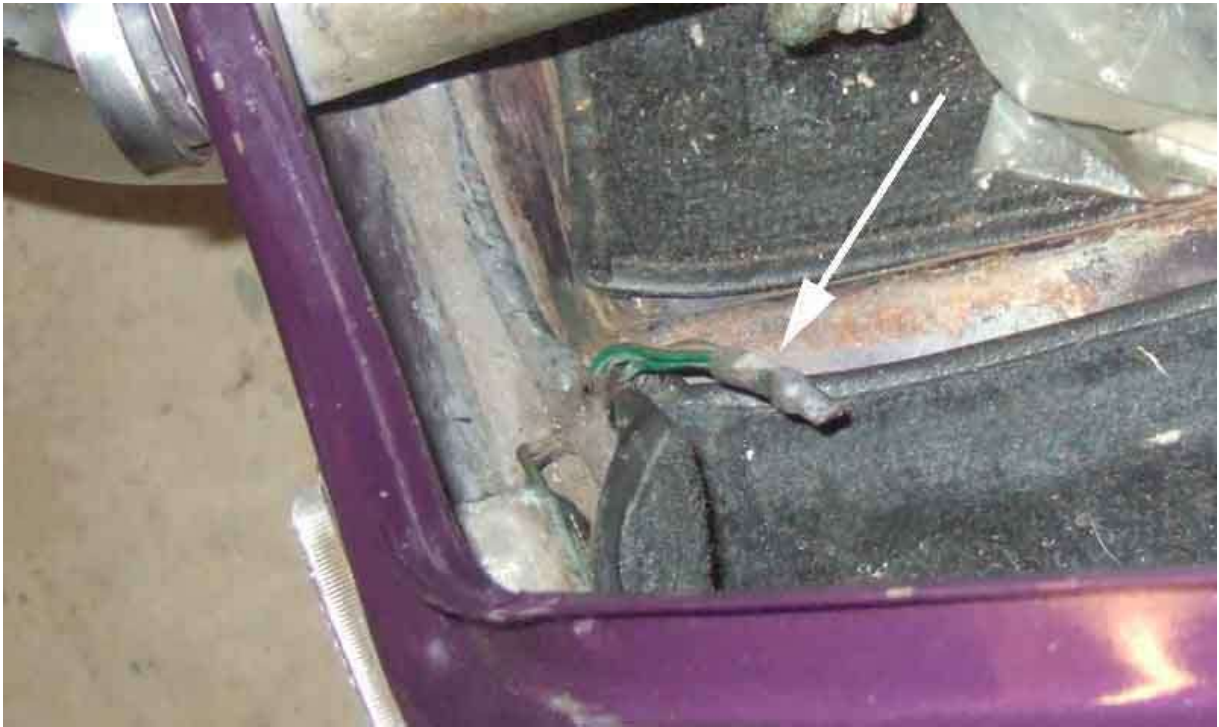
The reverse light switch seen through the gearbox tunnel, right-hand side:

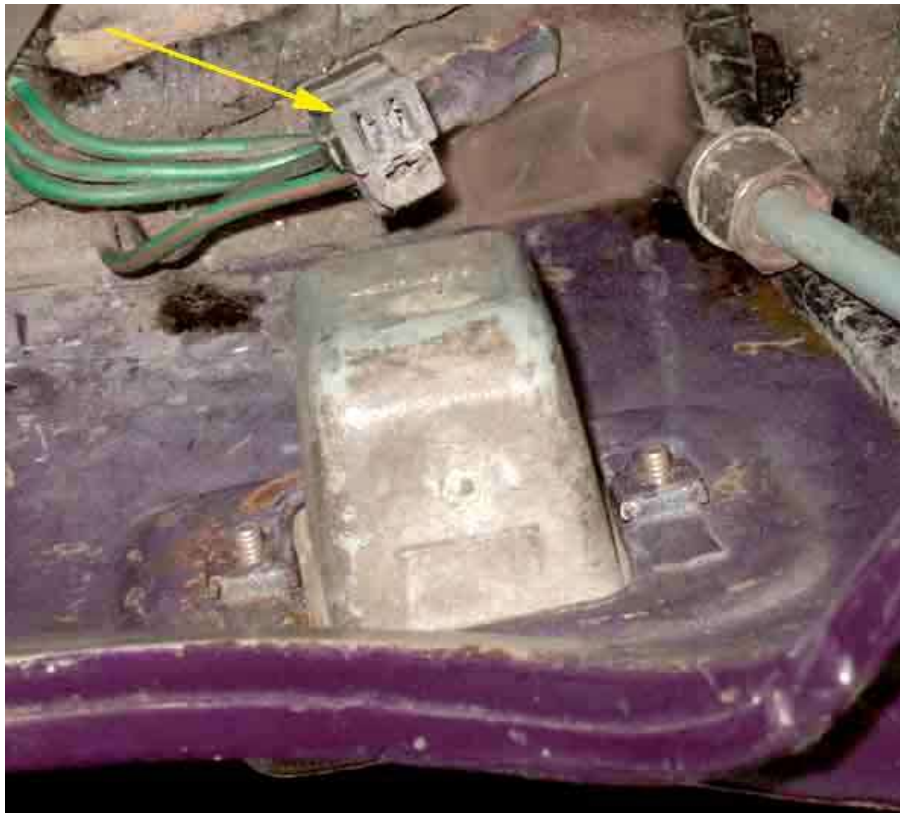
The 2-'pin' (actually two female spades in a three-position holder) arrowed:

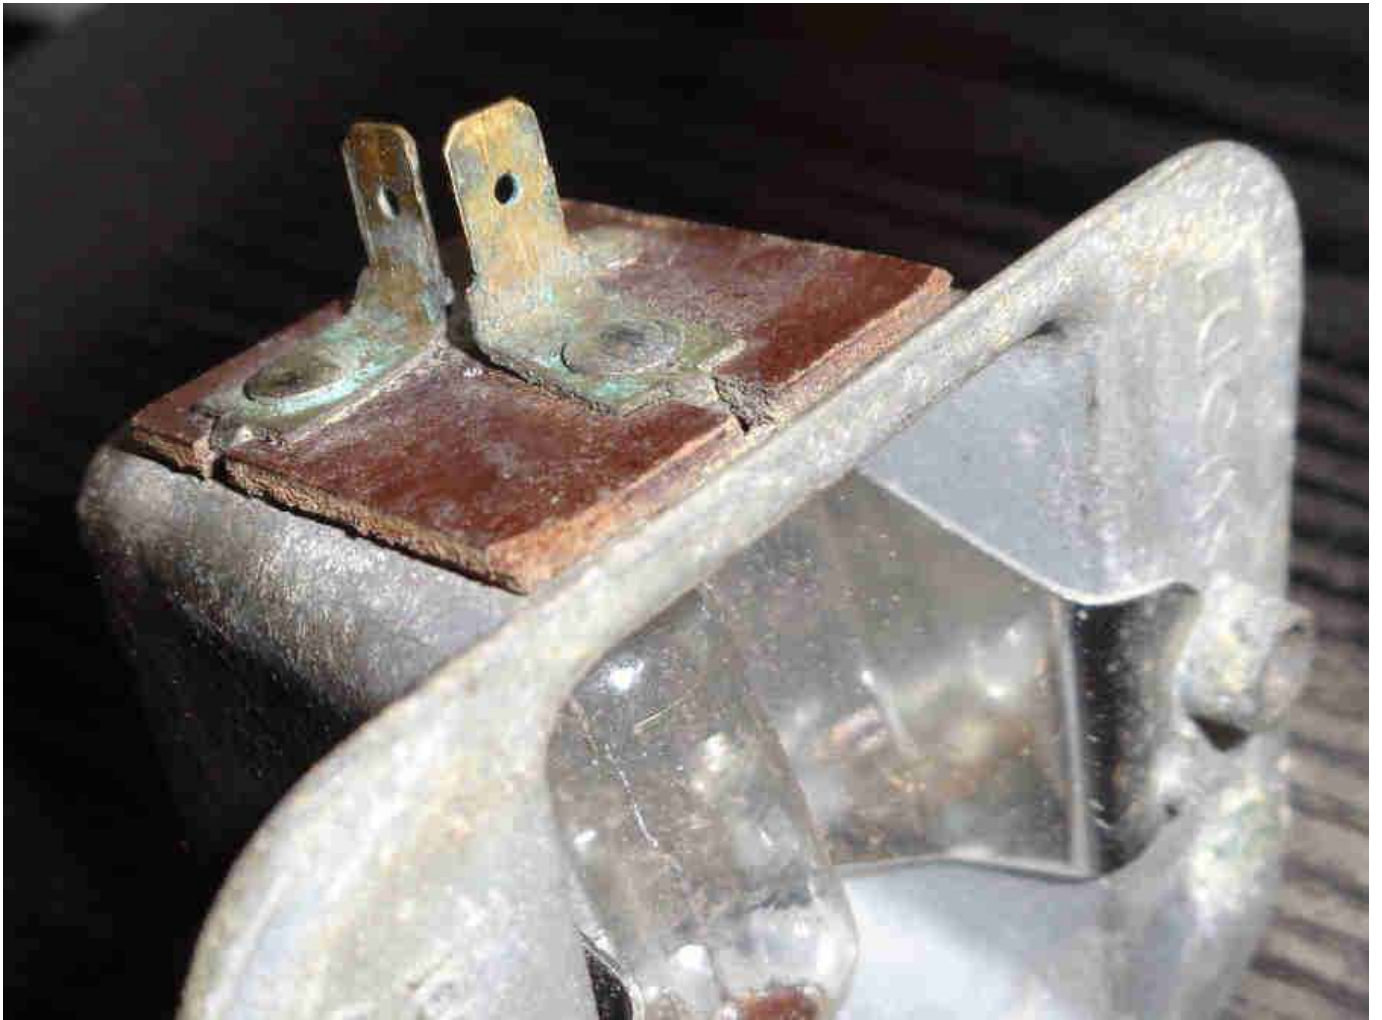
The spades are smaller than the 6.3mm standard at 4.8mm:

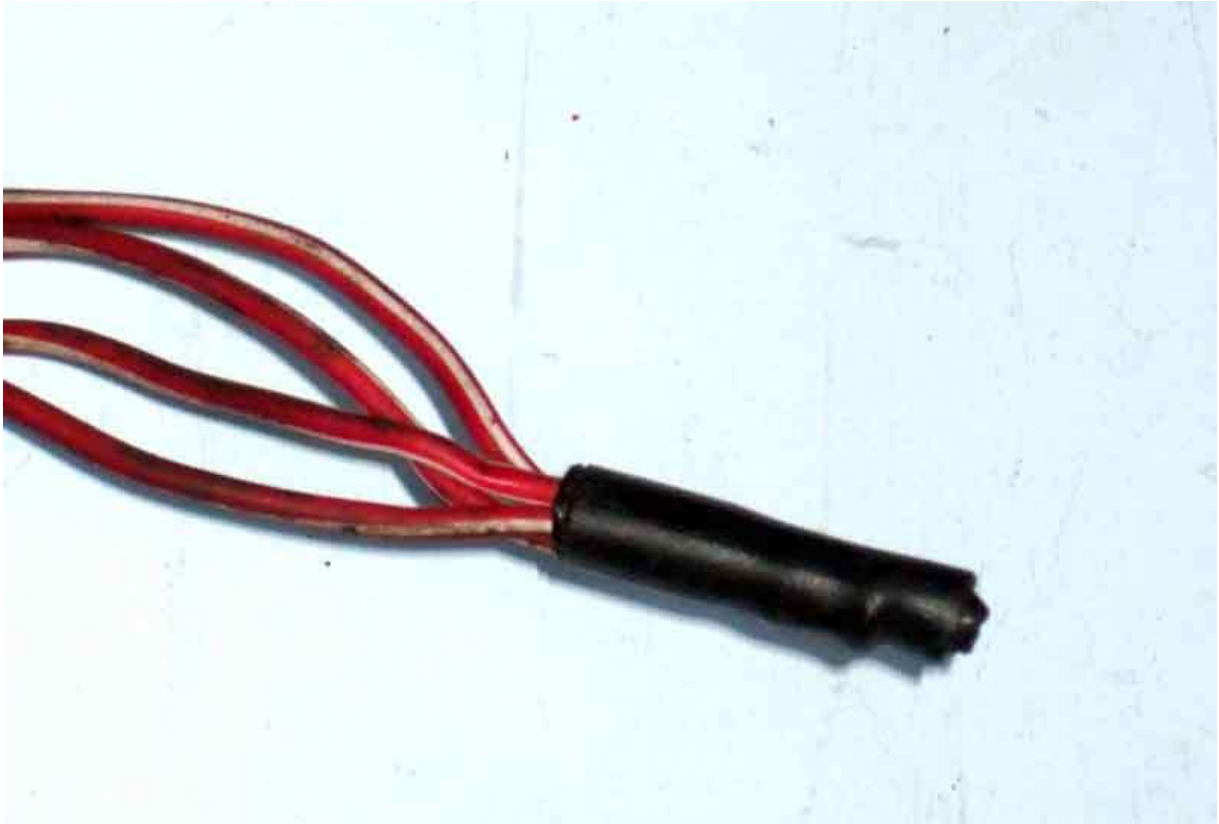
Typical sealed junction, in this case in the red/white instrument illumination circuit

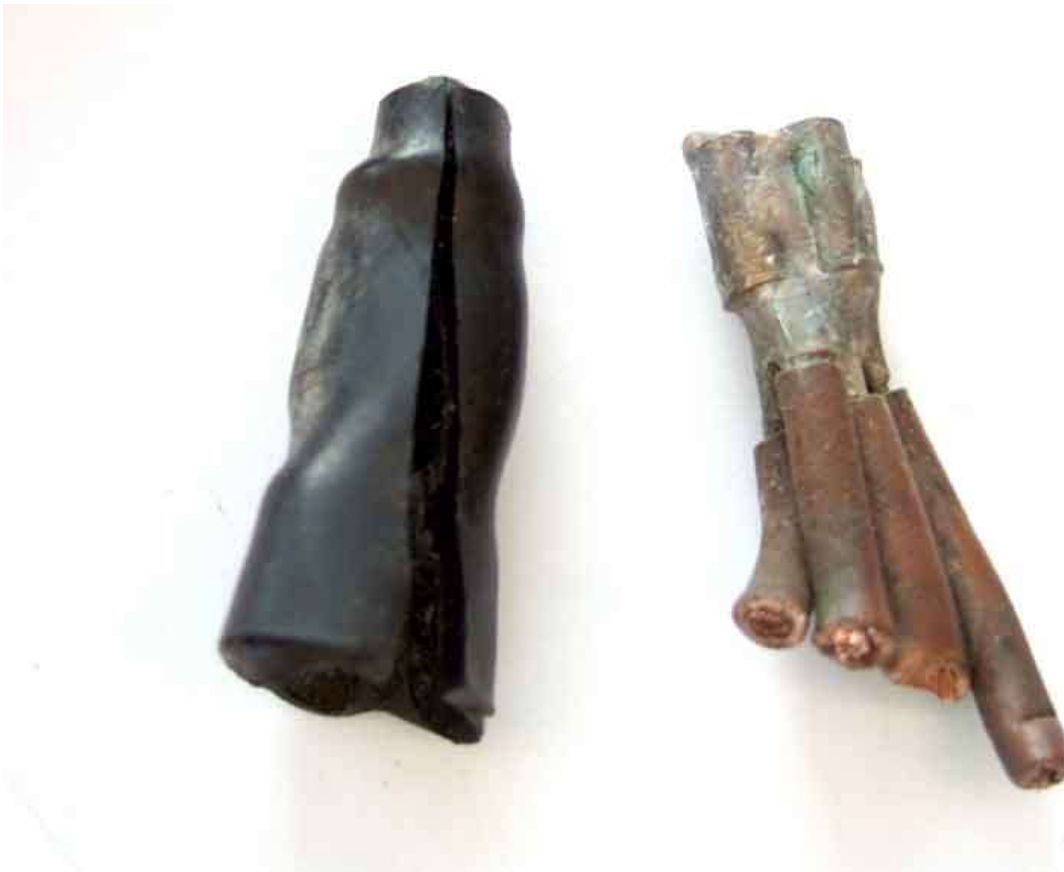
Brass 'staple' crimped round the wires and soldered ...

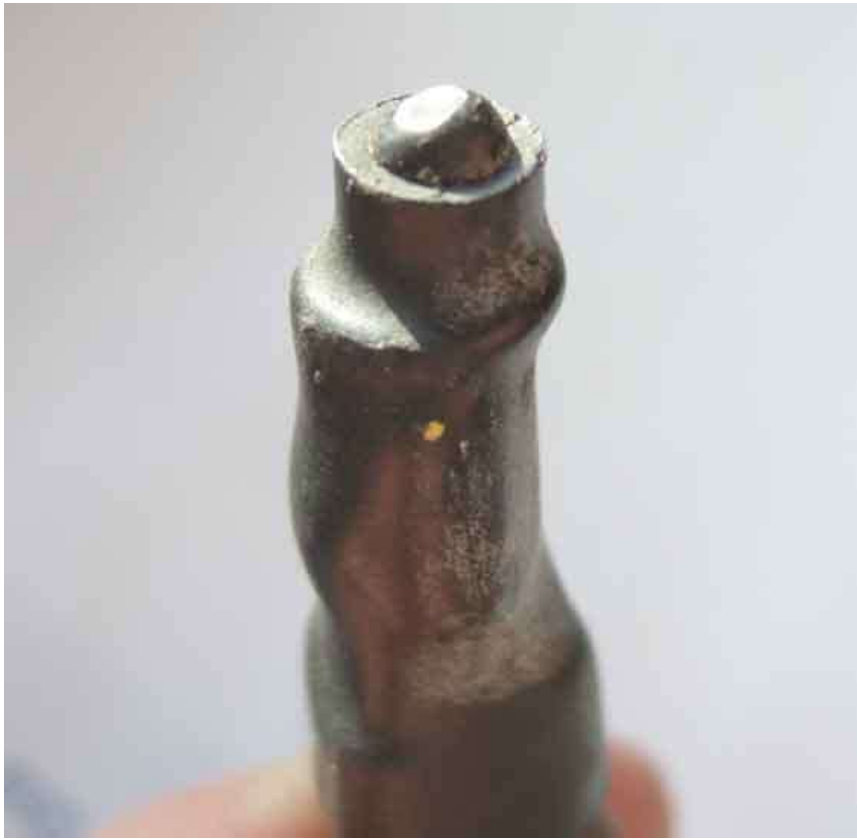
... with a heat-shrink end-cap plus a length of standard heat-shrink tubing over the junction

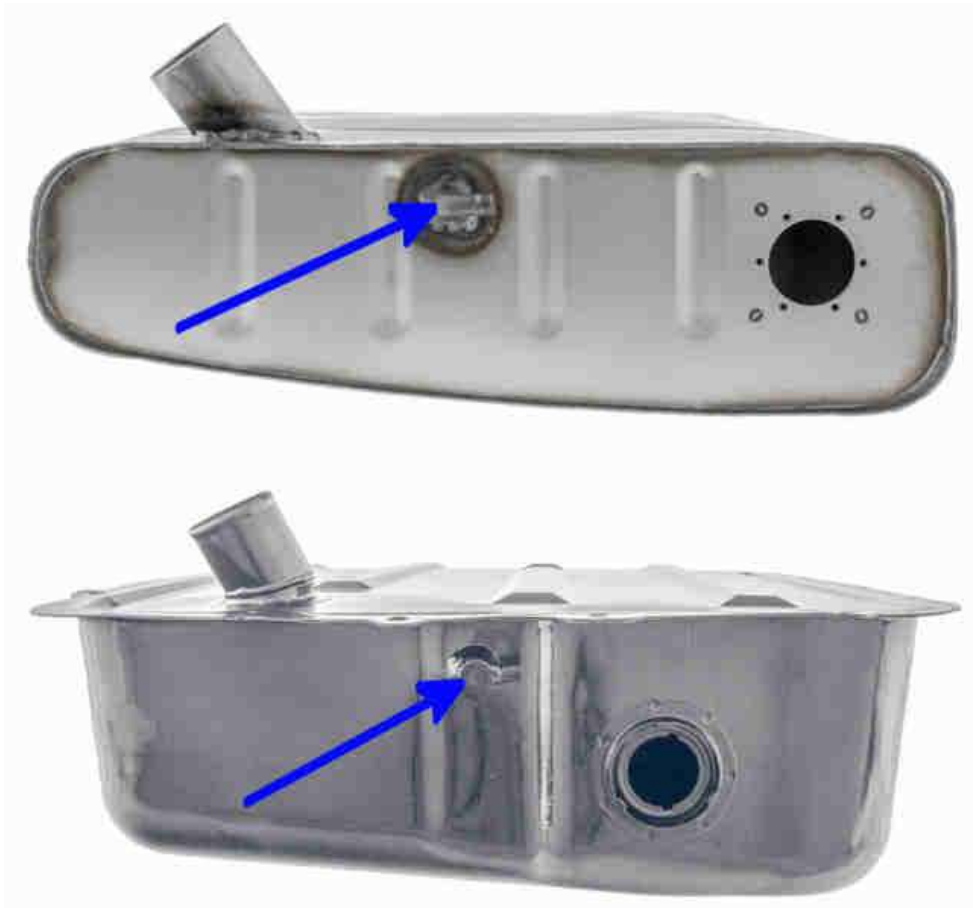
Relative positions of the screwed sender on the original strapped tank and the locking-ring sender on the later bolted tank, fuel outlet positions indicated (prior to 1977): ([Moss Europe](#))

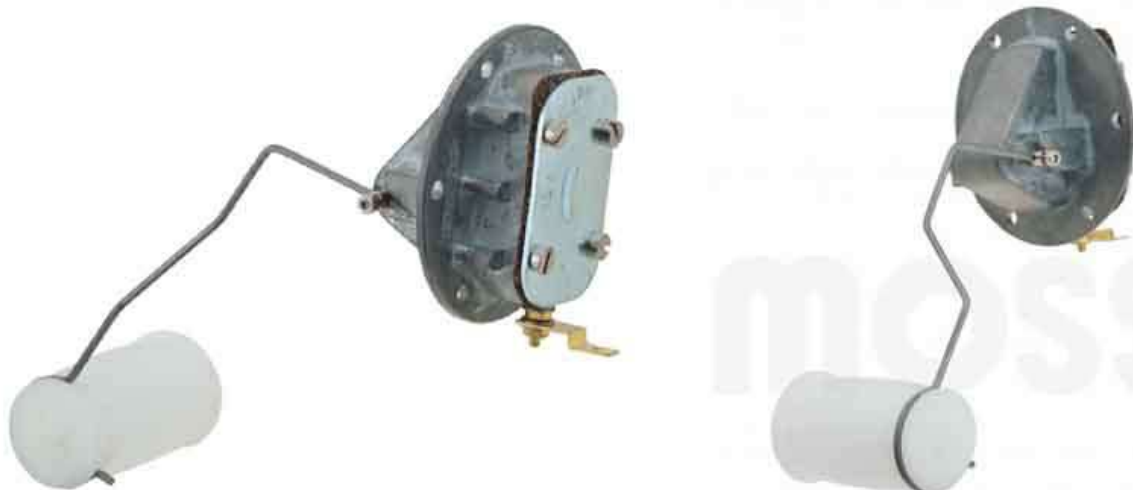
Early screw-fitted sender for the Jaeger undamped gauge, with a housing on the outside with a cover and four screws: ([Moss UK](#))

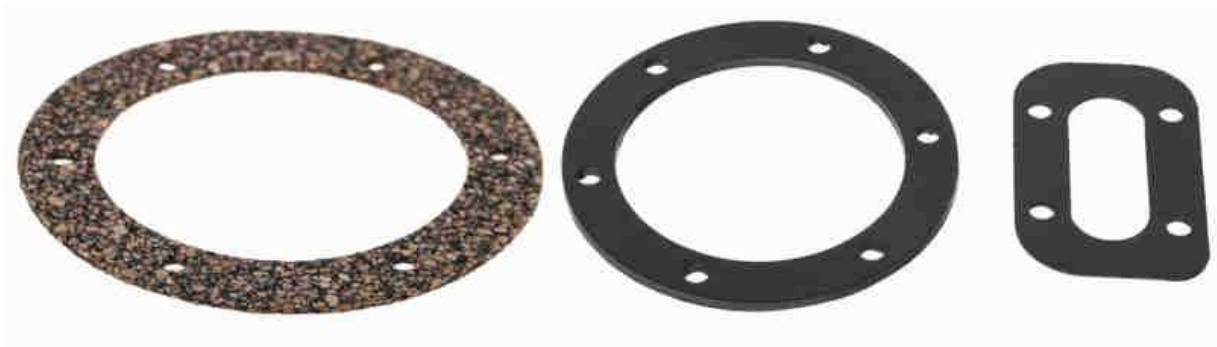
Original cork gasket on the left, more recent Viton alternative 'for all fuels' (at five-times the price) plus a gasket for the cover: ([Moss Europe](#))

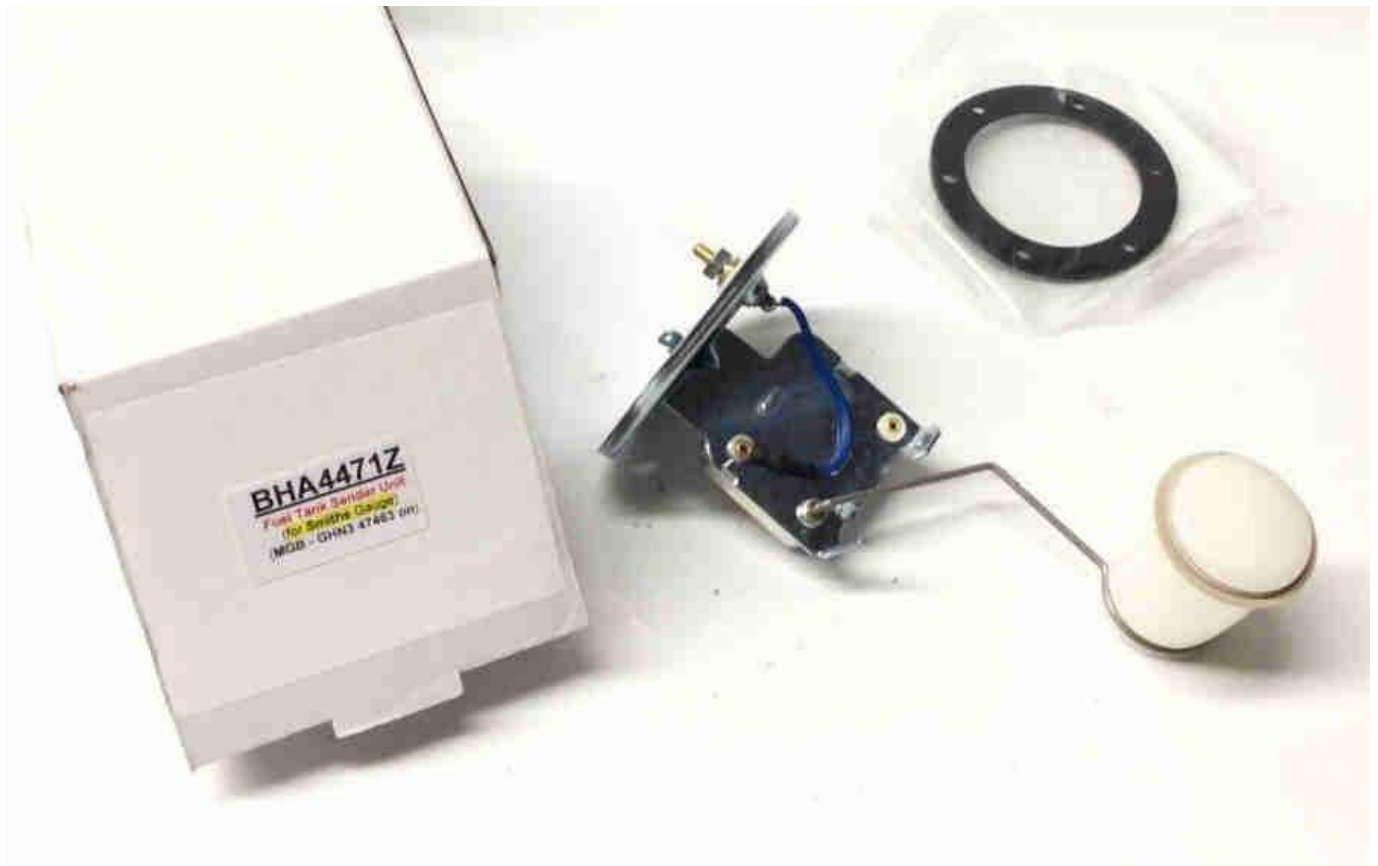
Screw-fitted sender for the early Smiths thermal gauge used from October 1964 for the remainder of Mk1 production, this seems to have the 'flat' outer face like the later senders. Long NLA a re-manufactured item from two sources - [jmccspares in the UK](#) and [Bastuck in Germany](#). Note this version of sender was used from October 1964 to March 1965, not from 1962 as indicated on the suppliers web sites, however if you have to replace the original Jaeger gauge with [17H 299](#) new stock of which are bi-metal and not magnetic you will need this sender as well as a [voltage stabiliser](#):

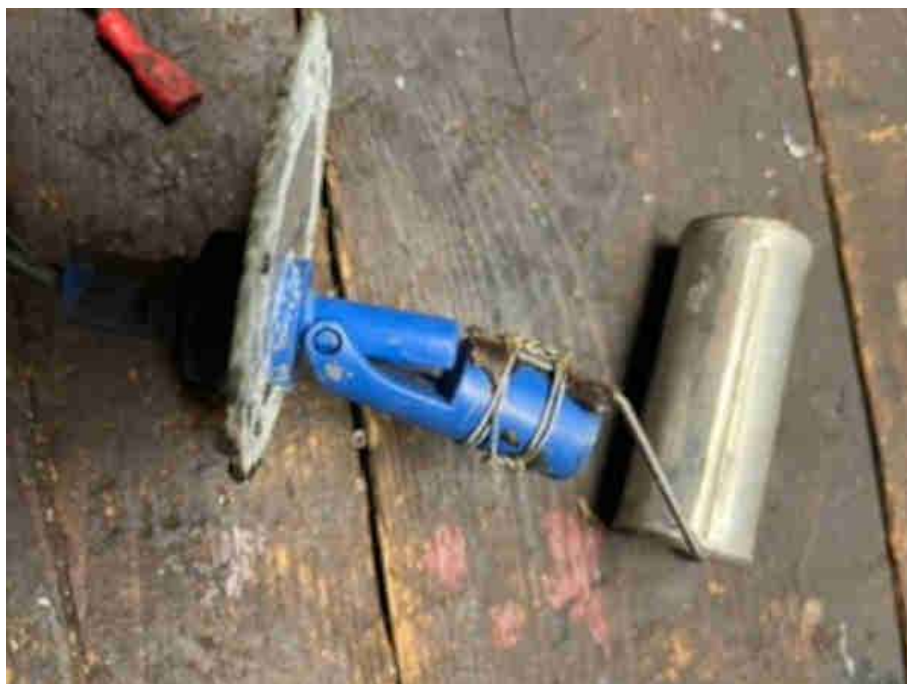
Geoff replaced it with the remanufactured interim type above and as well as the existing sender being completely different externally it is even more different internally! It looks like it could be a magnetic proximity system. There are float switches similar to this but they open and close a contact which isn't much use for fuel gauge, so would have to be part of a tuned oscillator circuit, needing a whole mess of electronics at the gauge end. I can't make up my mind whether it is a home-brew experiment or from a very different marque and model, although perhaps a bit too much of a lash-up for the latter:

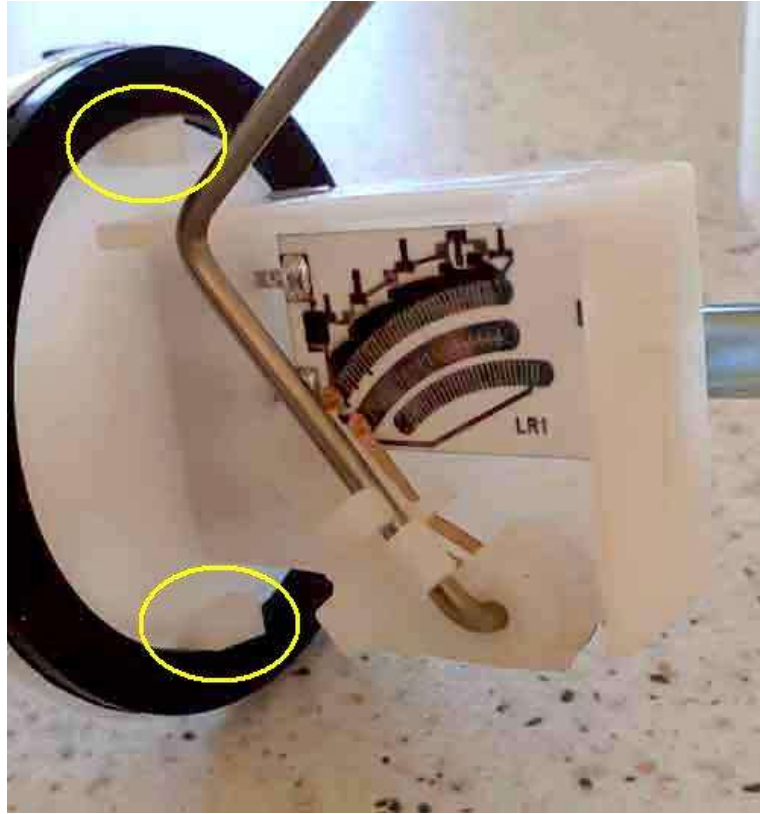
Similar offset tabs on the later plastic senders: (*Mark Morris*)

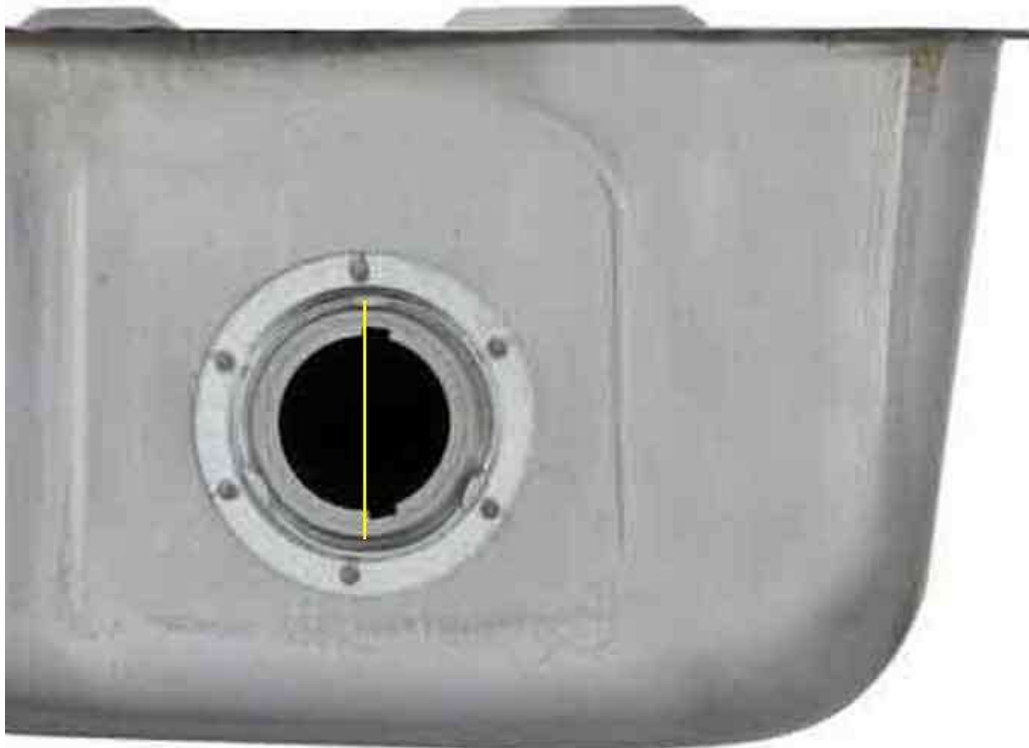
Matching offset cut-outs in the tank:

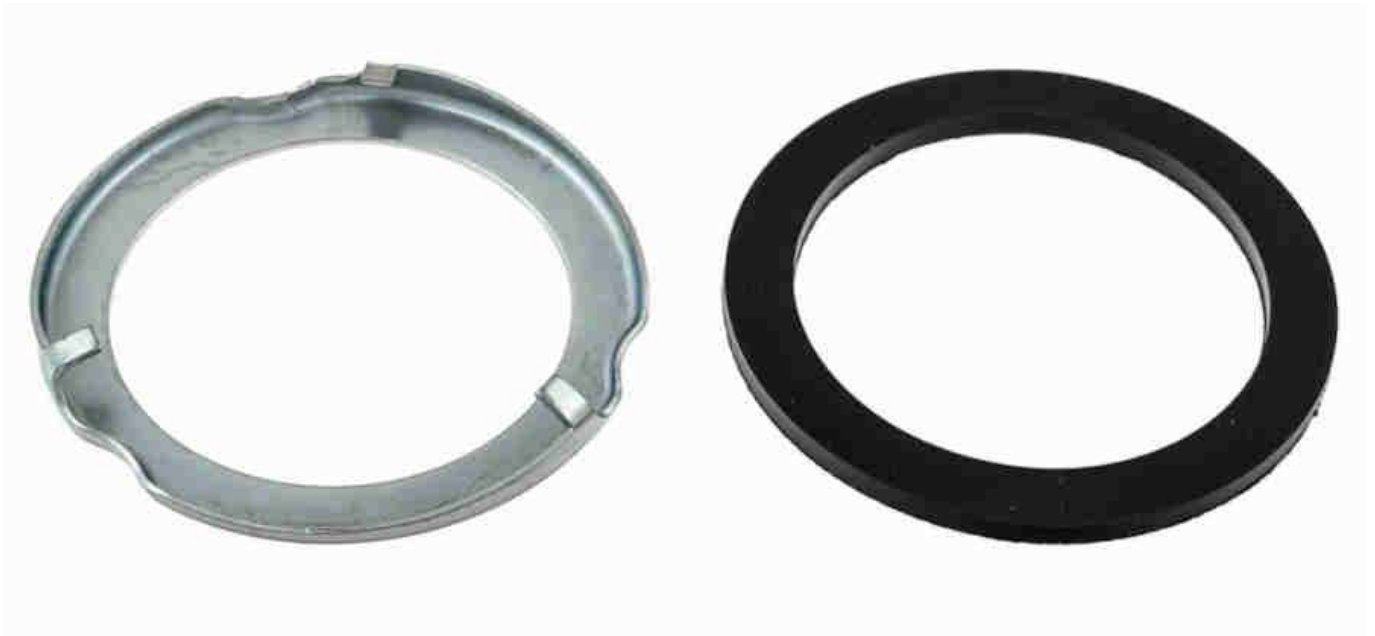
Three tapered sections (A) on the ring slot under turned-over lugs (B) on the tank. Originally [Service Tool 18G1001](#) would have been used, but in the absence of that I've always done it by going round the three tabs (C) on the ring in turn bit by bit tapping carefully, turning the ring anti-clockwise to remove and clockwise to replace. If there is petrol in the vicinity you should be careful not to make a spark, perhaps by using non-ferrous tools, but you shouldn't be striking it that hard anyway. When removing turn the ring anti-clockwise far enough to align the three recesses in the ring (D) with lugs 'B' so the ring can be completely removed, reverse for refitting. When tightening tabs 'C' should stop short of lugs 'B'. All three tapered sections should be locked under their respective lugs or the sender will not seal:

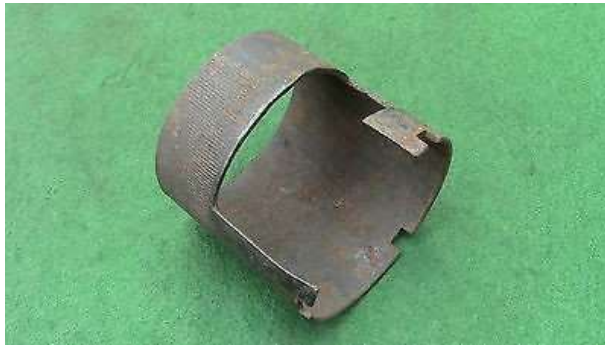
Locking ring removal tool 18G1001. On the basis of that not difficult to fabricate one. I'm not sure why it needs a cut-out, much less an L-shaped one, surely one would disconnect the wires before undoing the locking ring?

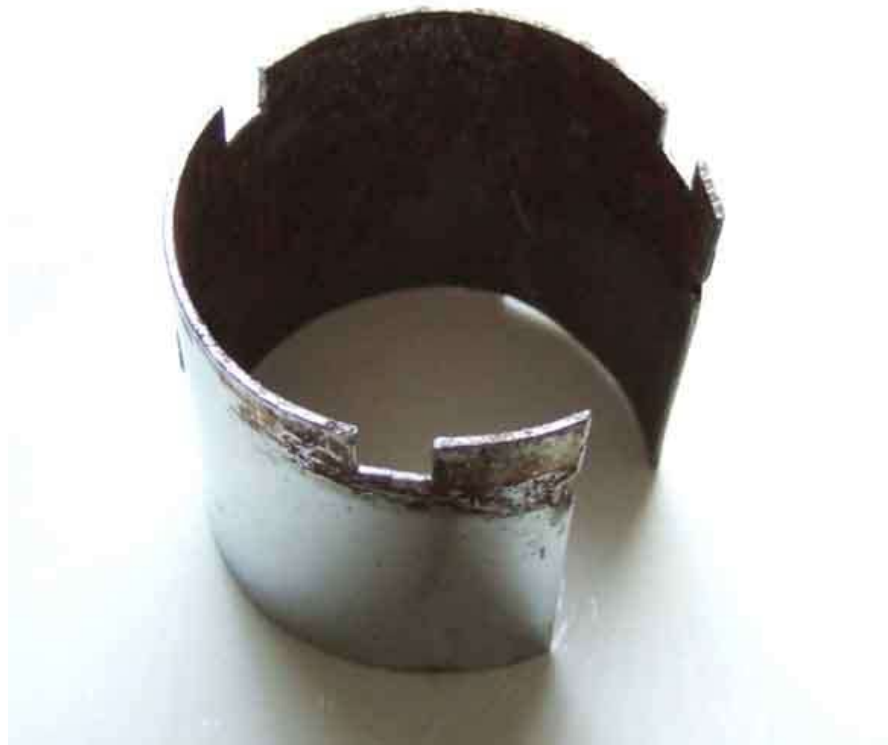
A couple of hours - first looking for something about the right size (plastic cap of aerosol contact adhesive) to act as a pattern, then for a suitable bit of metal (an off-cut from an exhaust trim that's been in a box of metal bits for years). Longitudinal cut so I can open it out to the right size (about 6cm), then three slots at 120 degree spacing (about 5mm square), and Bob's my uncle. Haven't used it anger as I don't want to break the seal until I need to. May need a couple of holes drilled through the outer end for a tommy-bar. I don't think that end will need welding up like the above as it's pretty hard metal and needed quite a bit of effort with two pairs of pliers to open up:

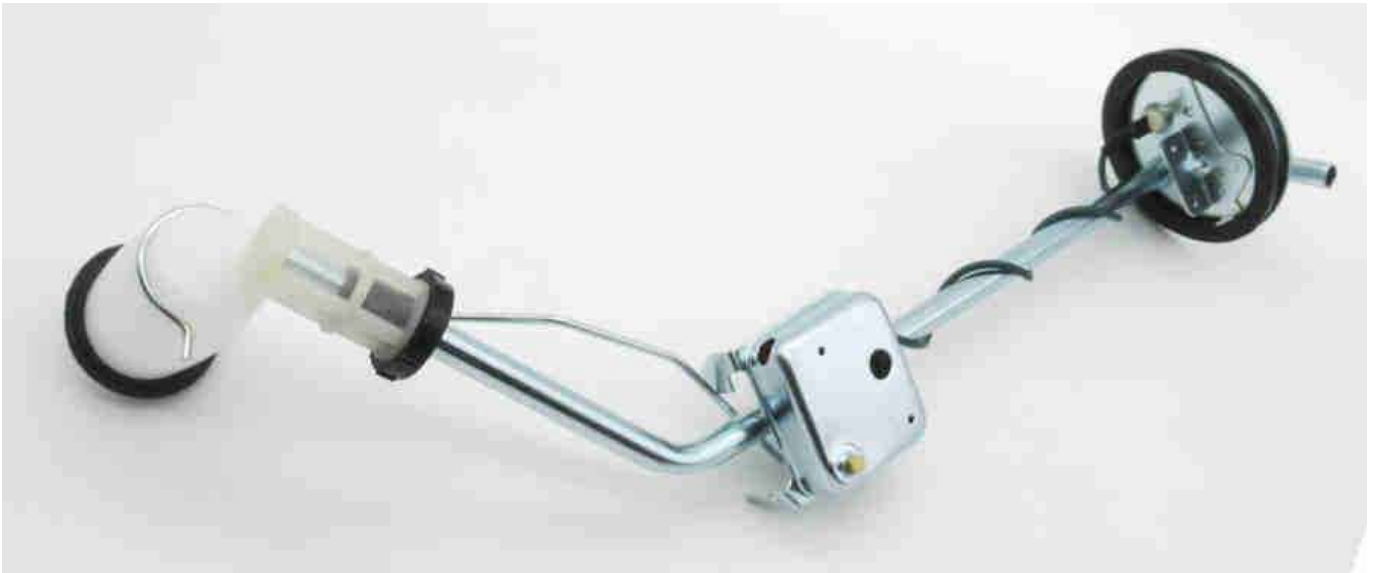
The plastic version, float nearer the side of the tank as pre-76 so the gauge reading is still affected by cornering. The centre terminal must be earthed to a point nearby with the provided wire as there is no earth wire in the harness of these cars. The original sender had a metal base and relied on earthing via the tank mounting, not possible with this plastic base. The harness wire goes on the top terminal, and as above the bottom terminal should be covered with a plastic sleeve: [Moss UK](#)

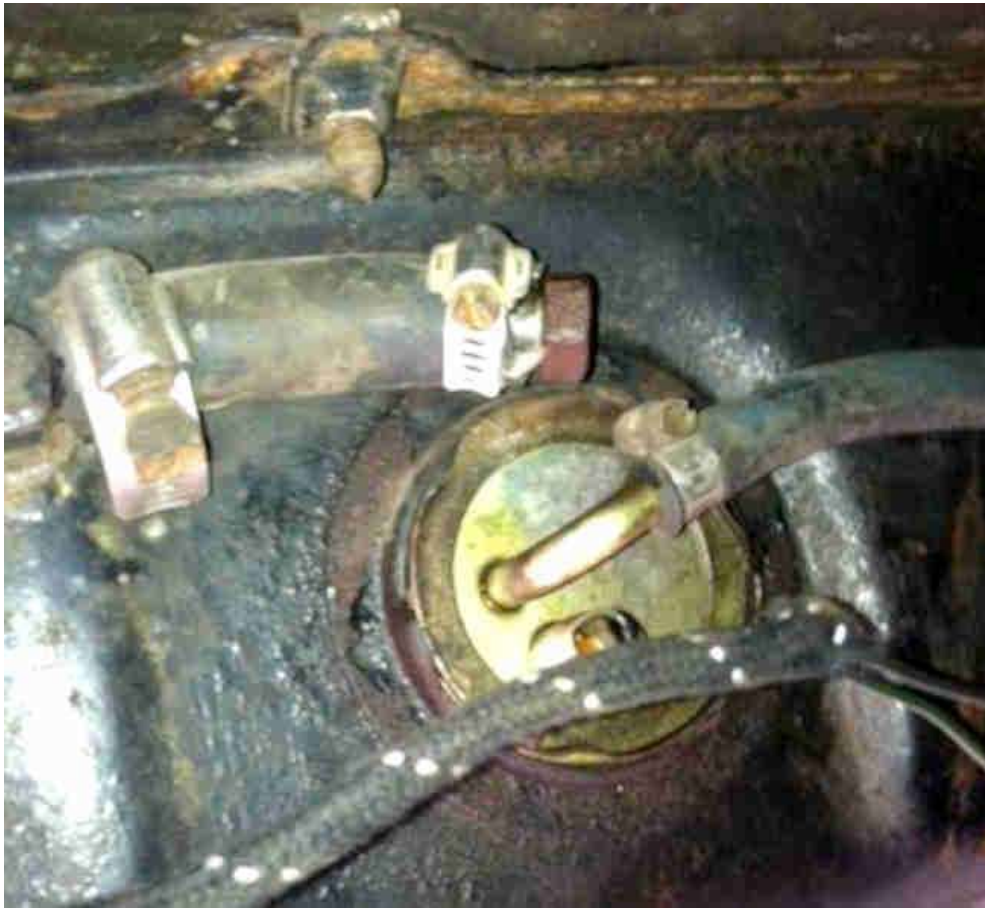
Note that for some reason the installer of this used the later sender on an earlier tank, which has the original port with a short length of hose and a bolt plugging the end. It's possible this was done because the original pick-up pipe inside the tank had rotted through meaning the full contents of the tank were not available:

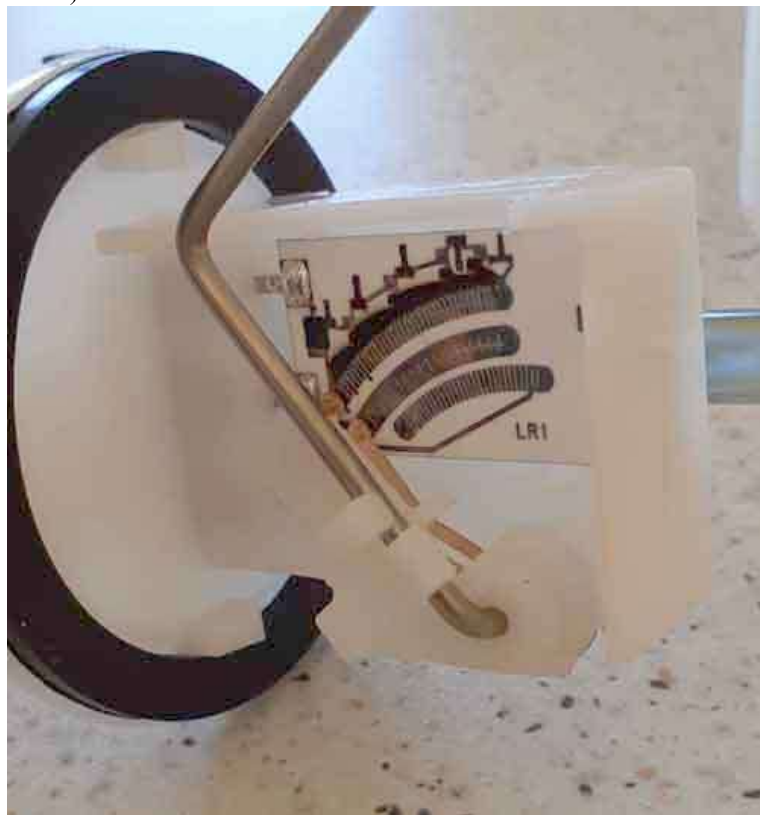
The business side: *(Mark Morris)*

'A' - the earth connection to the earth track 'B'; 'C' - the output track; 'D' - the linked wipers that connect the earth track to the output track as the fuel level changes. The float is in the 'full tank' position so the wipers are connecting the earth to the output with just the minimum value resistance (left arrow from 'F') in series; 'E' - the output terminal; 'F' - the network of resistances that cause the sender resistance to vary with the fuel level; 'G' - not used on the MGB, the 'low fuel' track which outputs an earth on the third terminal when that wiper (not fitted for the MGB) reaches the point indicated:

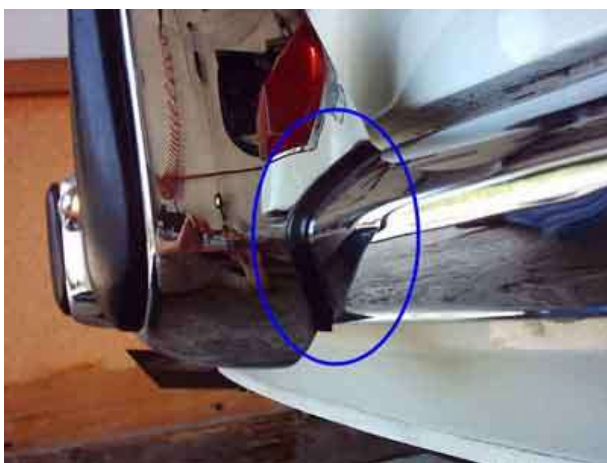
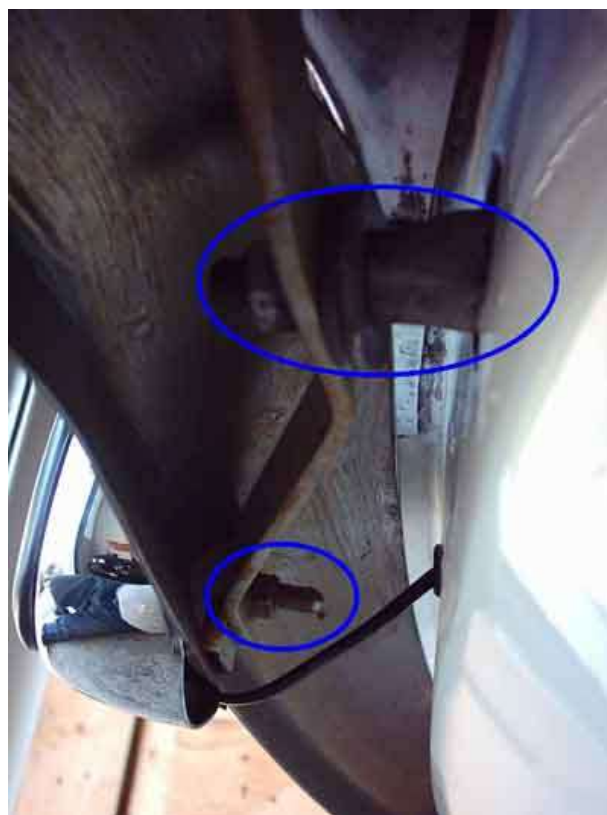
- first we have wires of copper and this wires have a electrical resistance (R_{Wire})
- then we have the chassis, where the current tries to go back to the battery ($R_{Chassis}$)
- there is also a resistance from the override to the bumper. Because the override sits on a rubber band on the bumper this is an electrical isolation (R_{Bumper})
- as the bumper is mounted with screws on the chassis, we have a resistance called R_{Screws}
- if You look close, the lamp is just hold by pressure on the fixing bracket on the override. So, there is another resistance. ($R_{Bracket}$)
- if You look even closer, the lamp is fixed with the standard bayonet. (R_{Lamp}) Additionally to all this, we have corrosion, oxidation which all increases the named electrical resistances.

Just have a look and see how many unwanted resistances there are. What this means is that instead of all the battery voltage being available for the lamp - which in itself is a resistance, some of the voltage gets 'lost' in the unwanted resistances leaving less for the lamp, making it less bright than it should be.

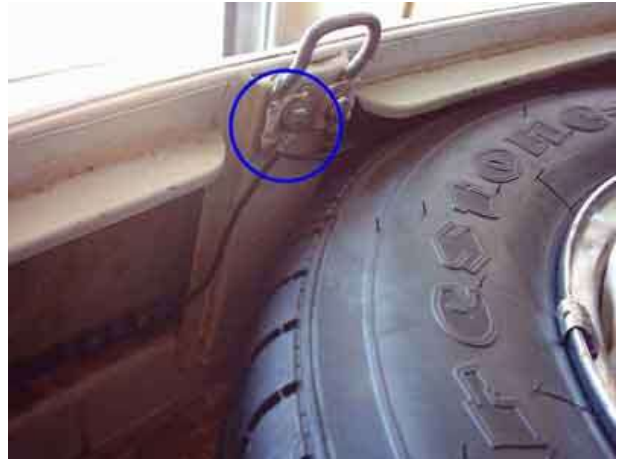
I put a wire from the bracket of each the two lamps to a solid (not rusty) chassis mounting bolt. The best and nearest mounting bolt I found is the lock bracket of the boot. There I fixed two wires in a ring terminal and crimped both wires. (see picture)

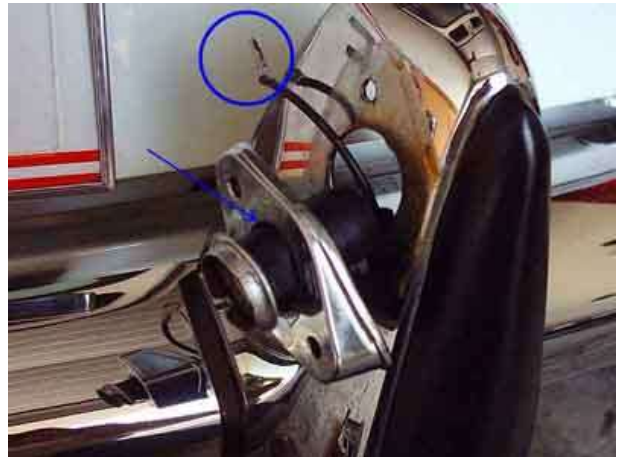
Then I put the wire into the hose where the red wire goes to the lamp. This is a little bit a fiddle, but it looks nice. For 'water'-protection I used some heatshrink hose on the end, so dampness has no chance. On the lamp-side I also used a ring terminal to fix the wire on the mounting screw where the lamp is mounted on the overrider. (see picture) This action shortcuts the two resistances R_{Screws} and R_{Bumper} . The resistance $R_{Chassis}$ is a little bit lower. The next thing is to minimise the two other resistances.

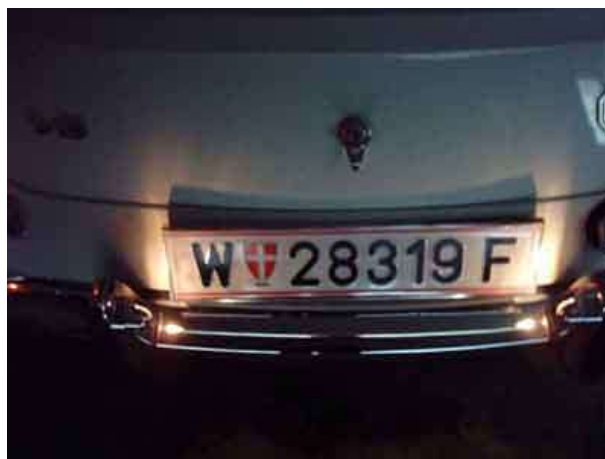
As You can see, my numberplate lamps are brighter then new.

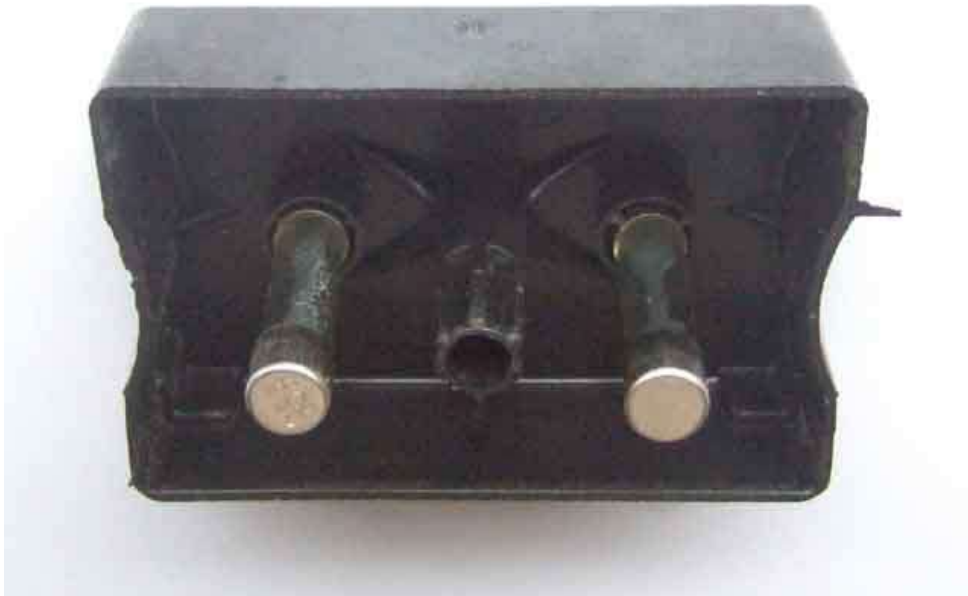
Fusebox cover with spare fuses.

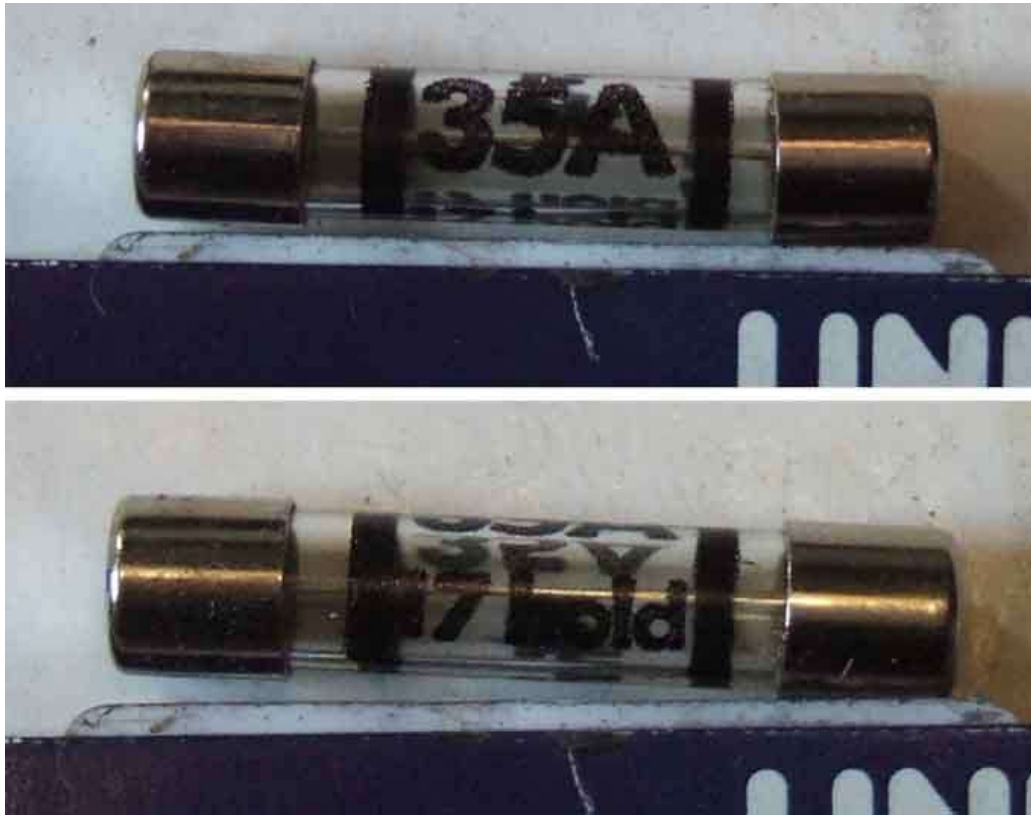
Glass screen-printing showing '35A' and '17 hold'.

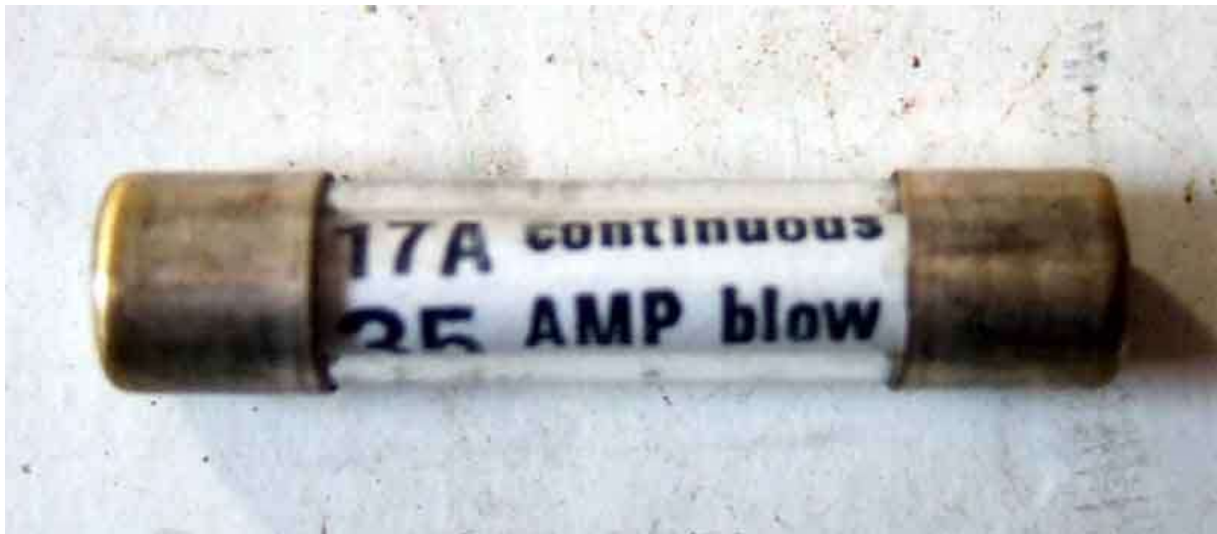
Slip of paper showing '17A continuous' and '35 AMP blow', both unambiguous.

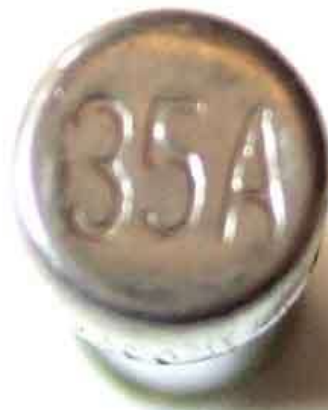
'35A' on an end-cap ...
