Voltmeters

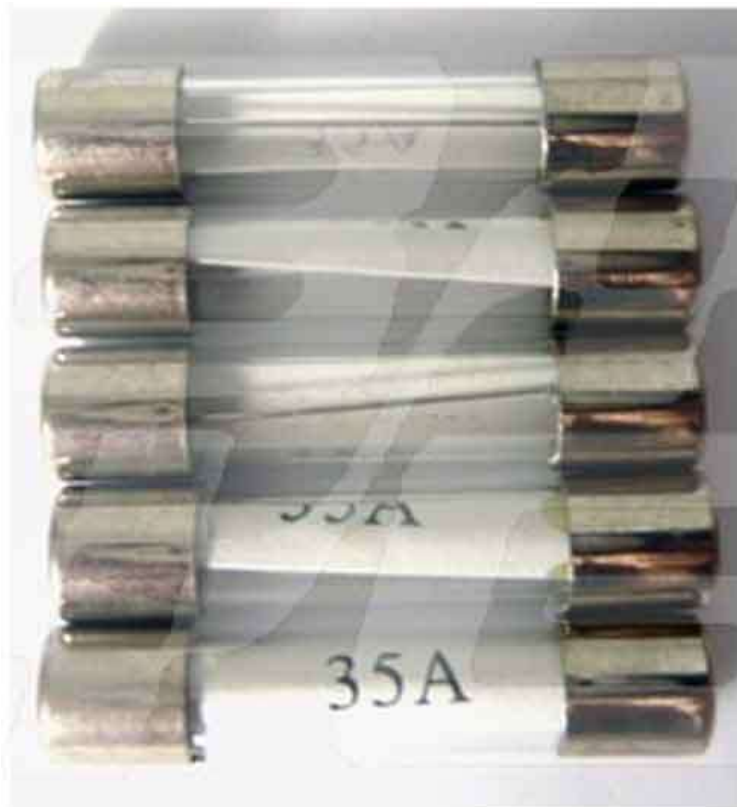
... and the only number on a slip of paper less so.

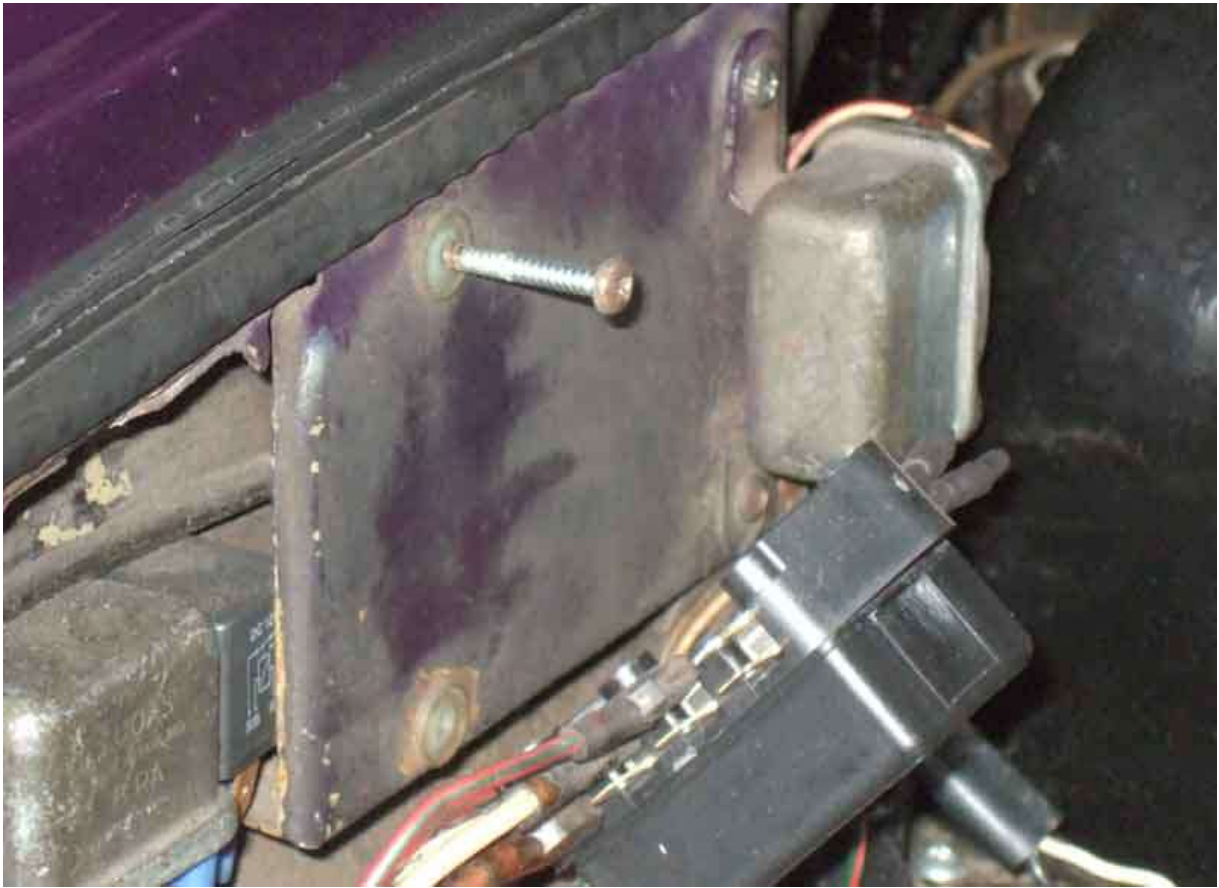
... with 1 1/4" self-tapper screws into nylon sockets. No insulating sheet or spacers.

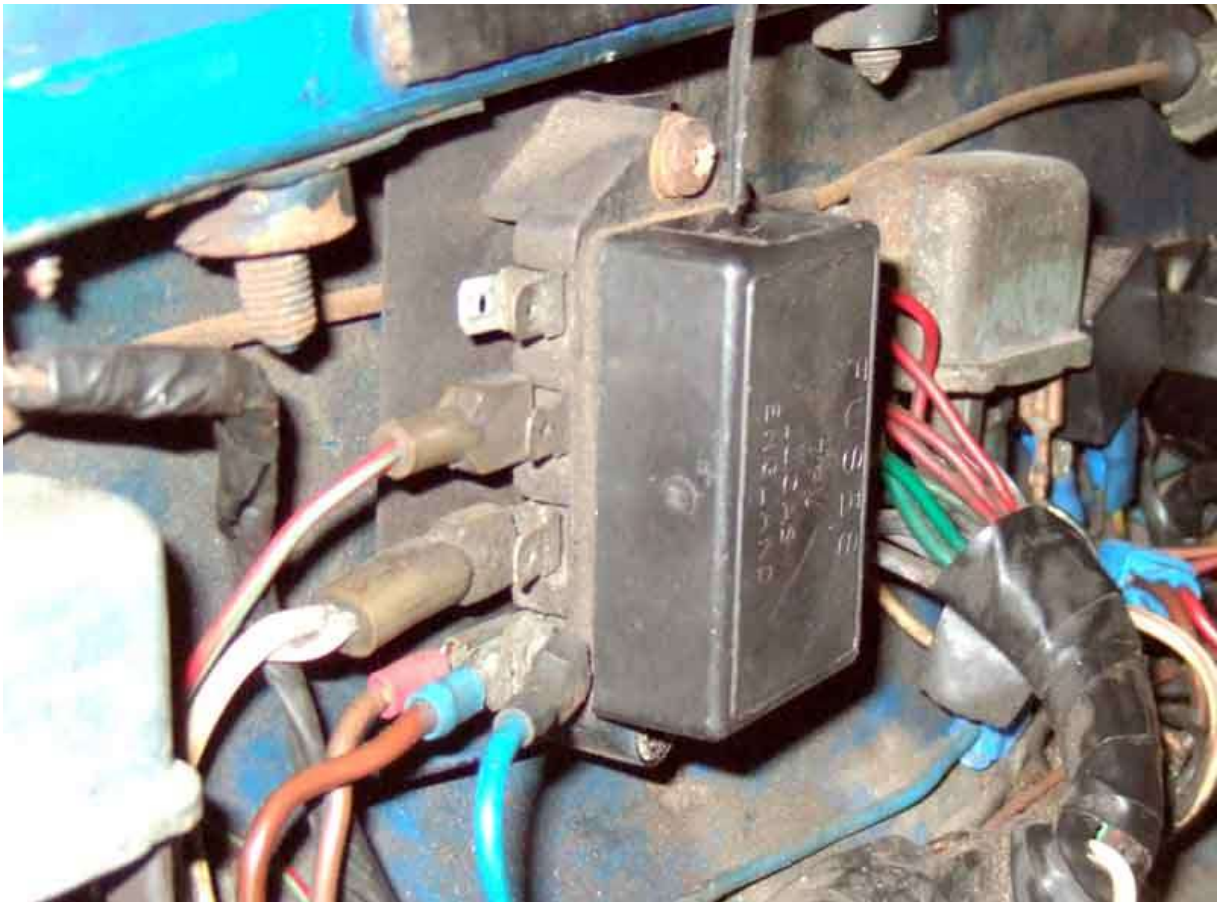
V8 no plinth - what looks like a plinth ...

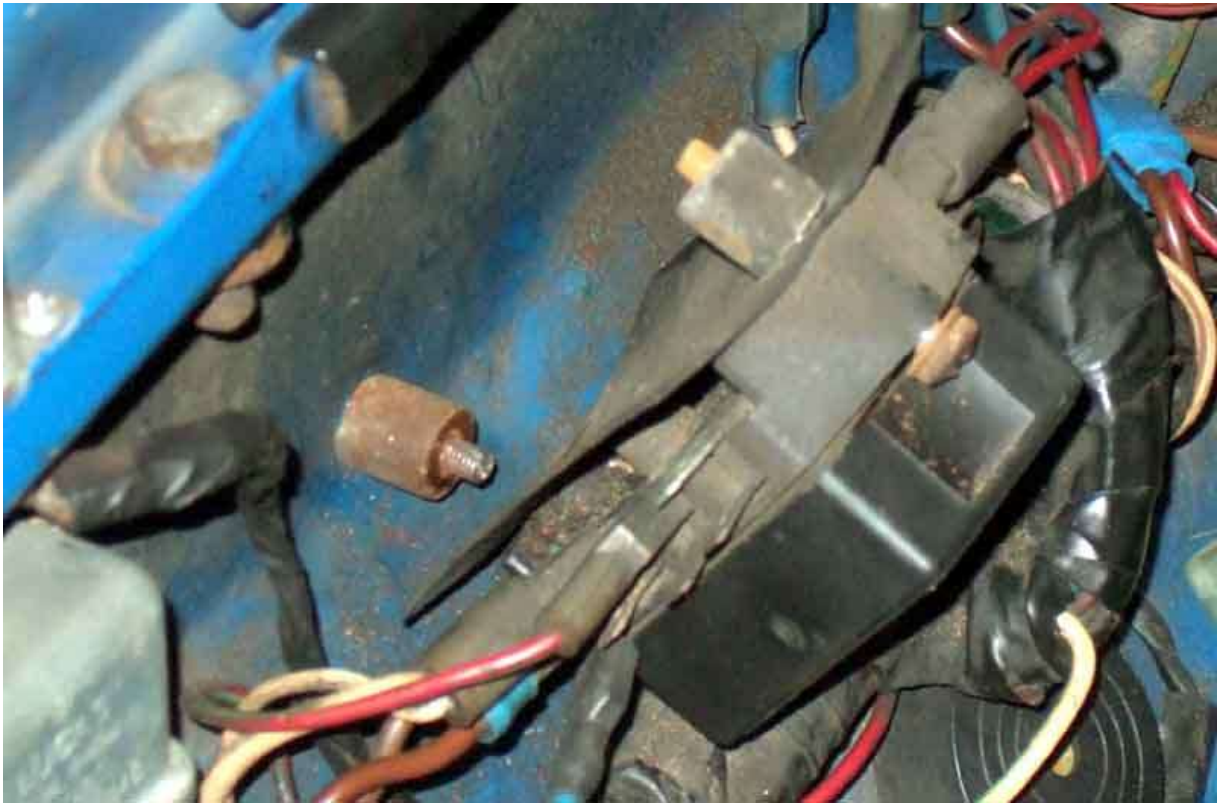
... is an insulating sheet between the fusebox and the spacers. 3/16" UNF screws (note the lower one is sheared) into welded nuts on the back of the inner wing.

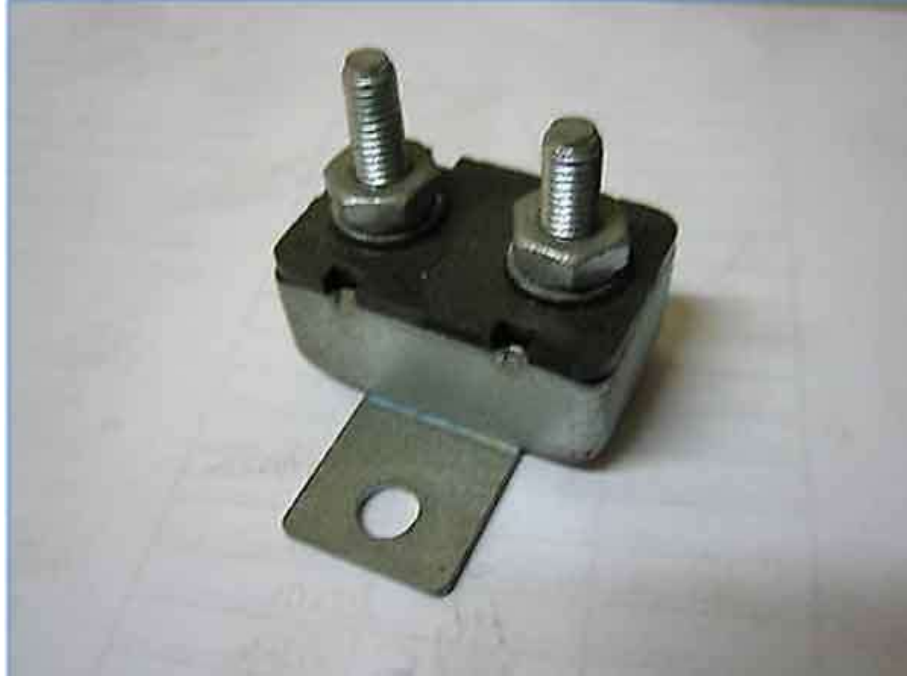
Probably only applicable to the North American spec 4-cylinder from 77 on with two cooling fans is [this thermal cut-out](#) in place of the conventional in-line fuse fitted to UK cars with the single fan:

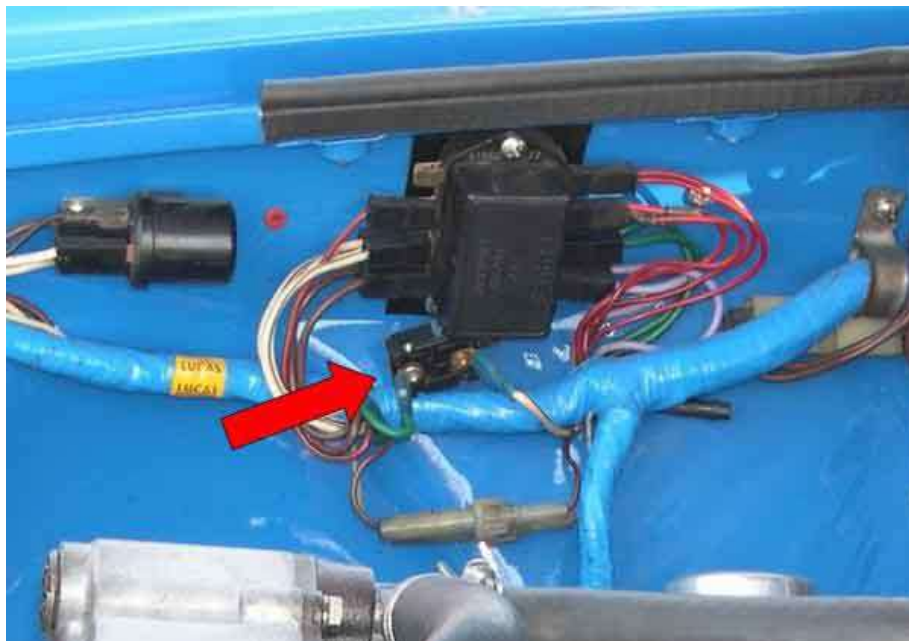
However that differs from this on-car example with spade terminals ...

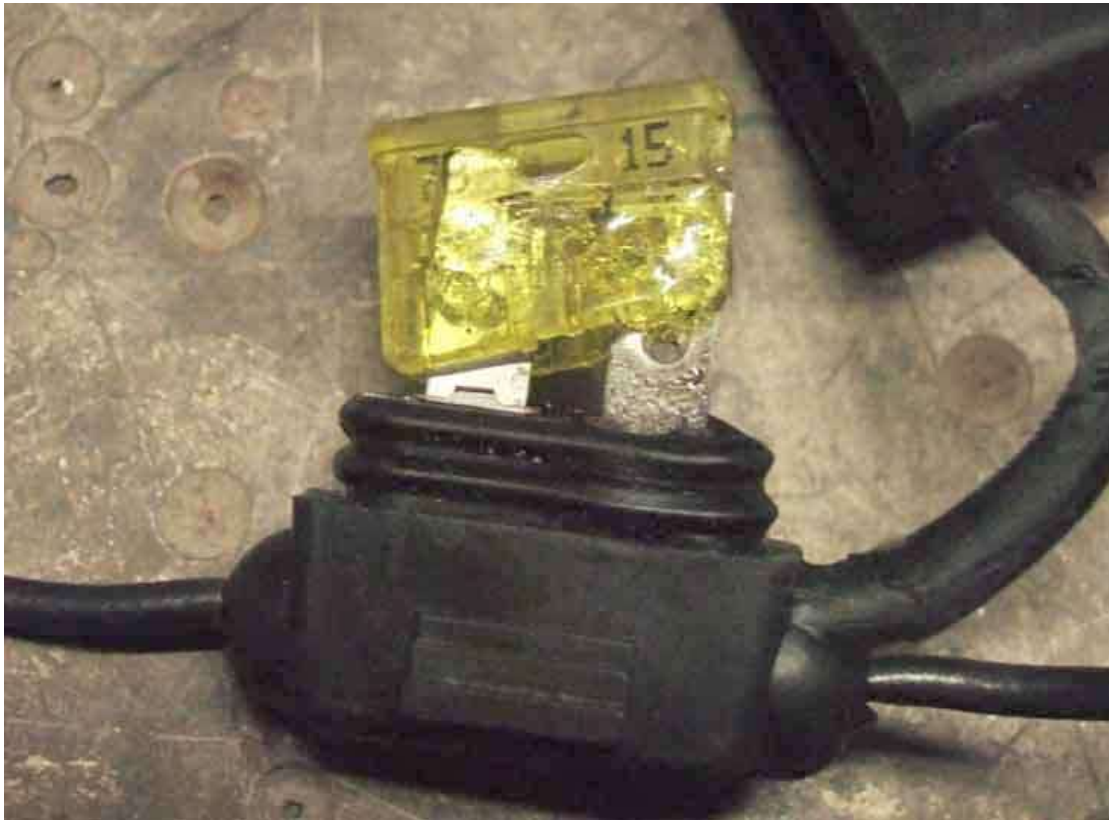
The first fuse I fitted to Vee - melted in normal use but still functioned:

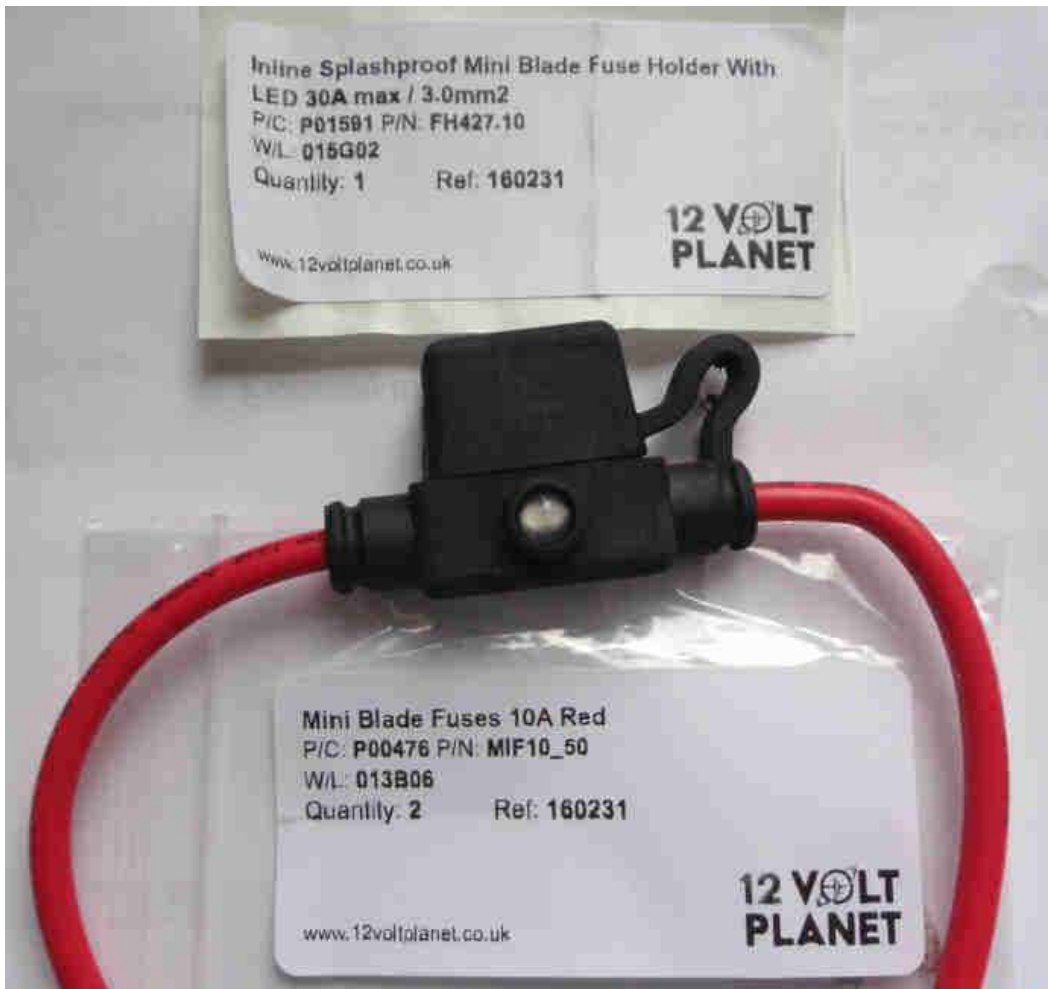
So this time go for a 30A blade-type fuse (with an LED to show when the fuse has blown ...), but a new one and hope it makes better contact than the previous one:

I hadn't realised they were this small. The 'standard' size might have been better, the fuse is a bit of a struggle to pull out as it is gripped so tightly - which is hopefully a good thing!

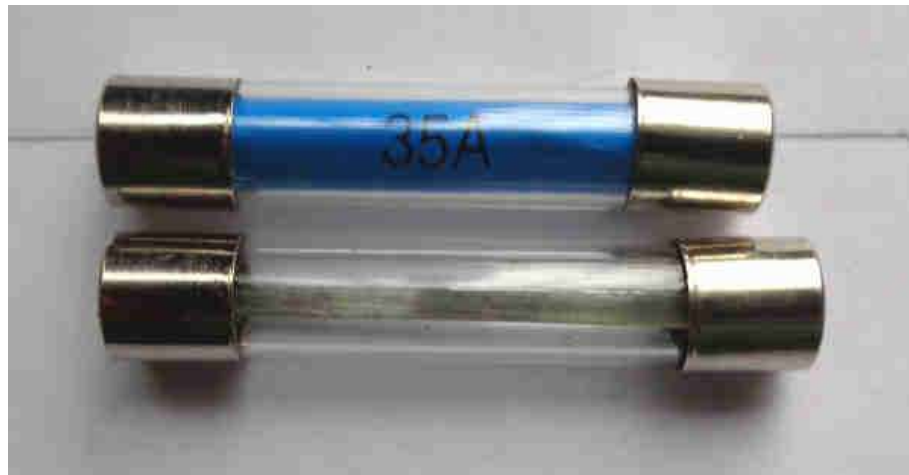
Comparing glass-tube in-line holders the fuses included with the eBay items (lower) are noticeably longer (as well as slightly fatter not visible here) than separately bought (top) fuses. Both types are fine in the main fusebox:

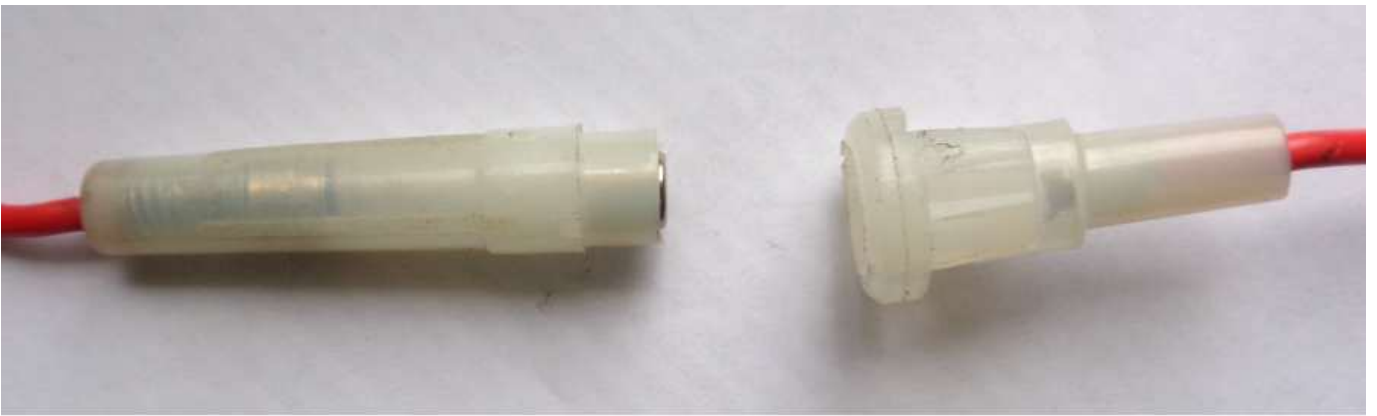
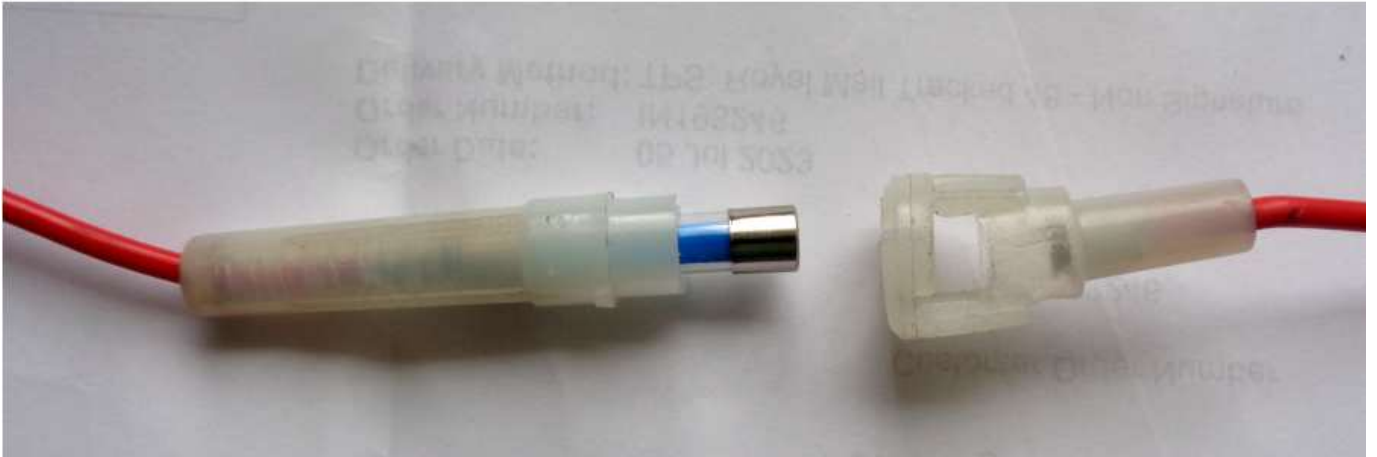
However the longer/fatter fuse jams down in the eBay holder (top), whereas the shorter/slimmer is pushed back out by the spring with no hint of jamming (bottom):

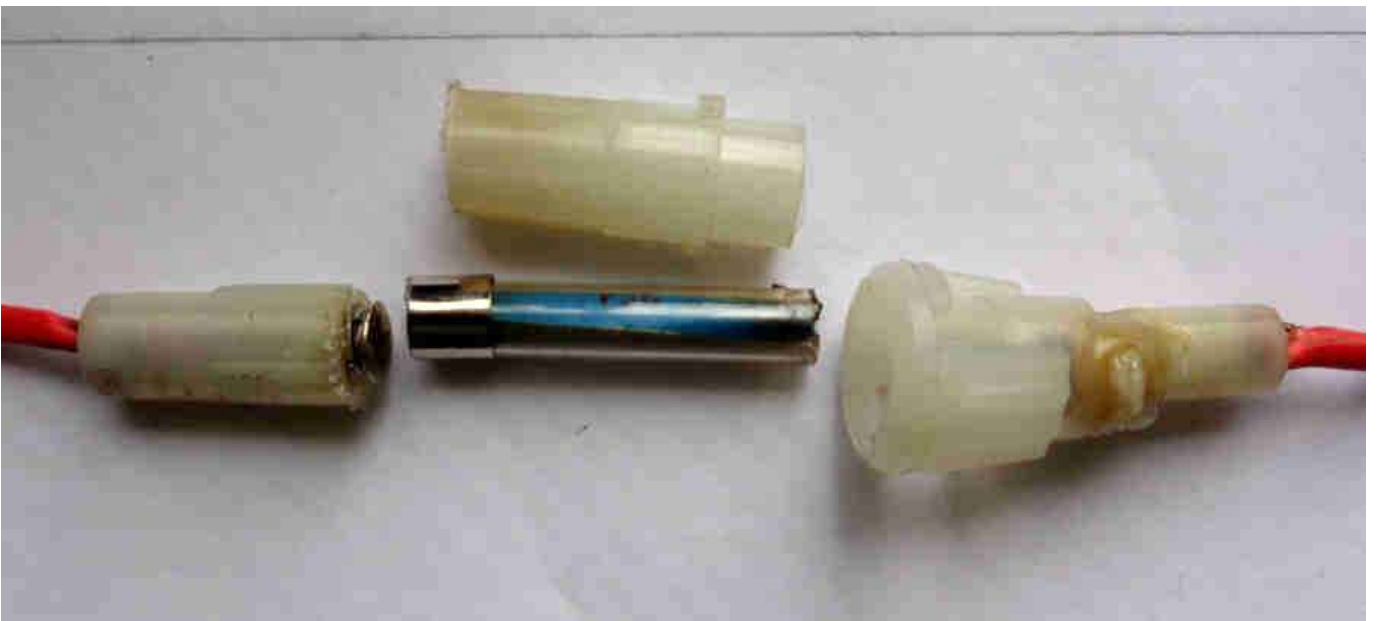
No hint of jamming in the [12v Planet 20A holder](#) (green wires, available with and without spade terminals) which also has a longer free-length of the spring (top image) and is stronger (lower image) so avoiding both issues:

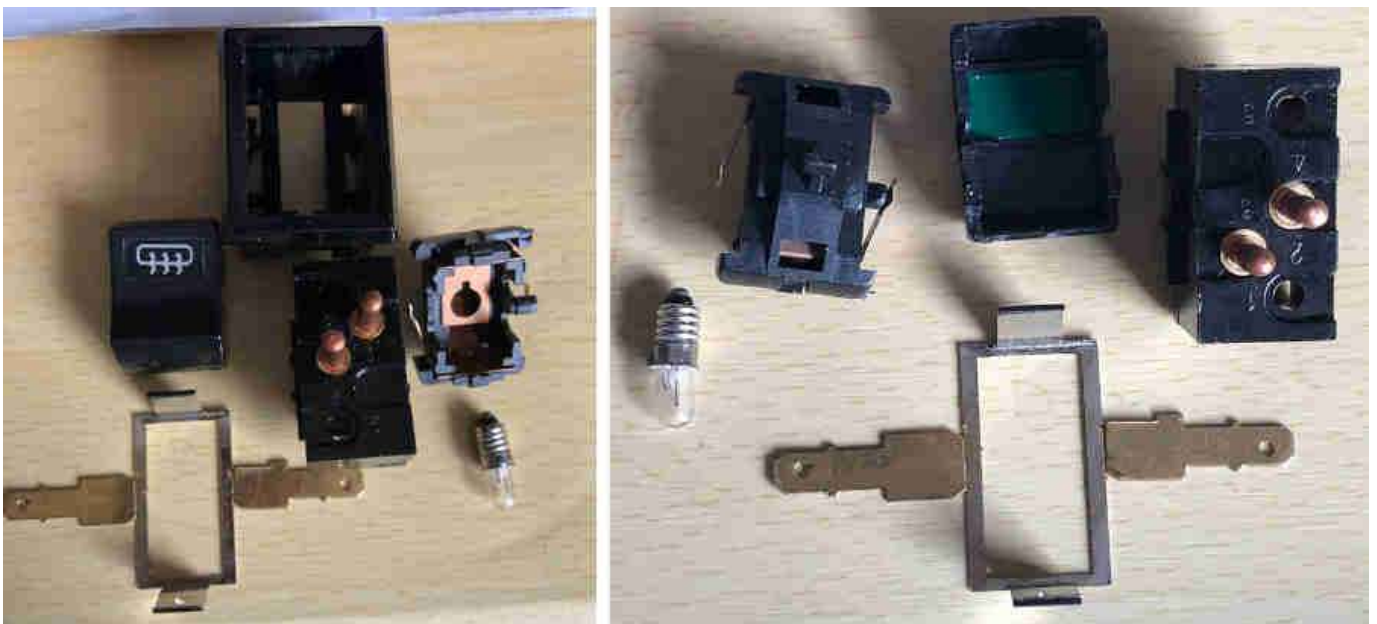
Albert Ross show this wiring on the connector to his 1980 HRW switch, which is rather confusing. There seems to be a green (12v, correct), three white/blacks (there would only be one to the HRW, plus one to an external tell-tale which he doesn't have), and a red/white for night-time illumination which would normally go to one of the spades on the side of the switch, plus a black (earth for night-time illumination to a spade on the other side of the switch) which isn't shown:

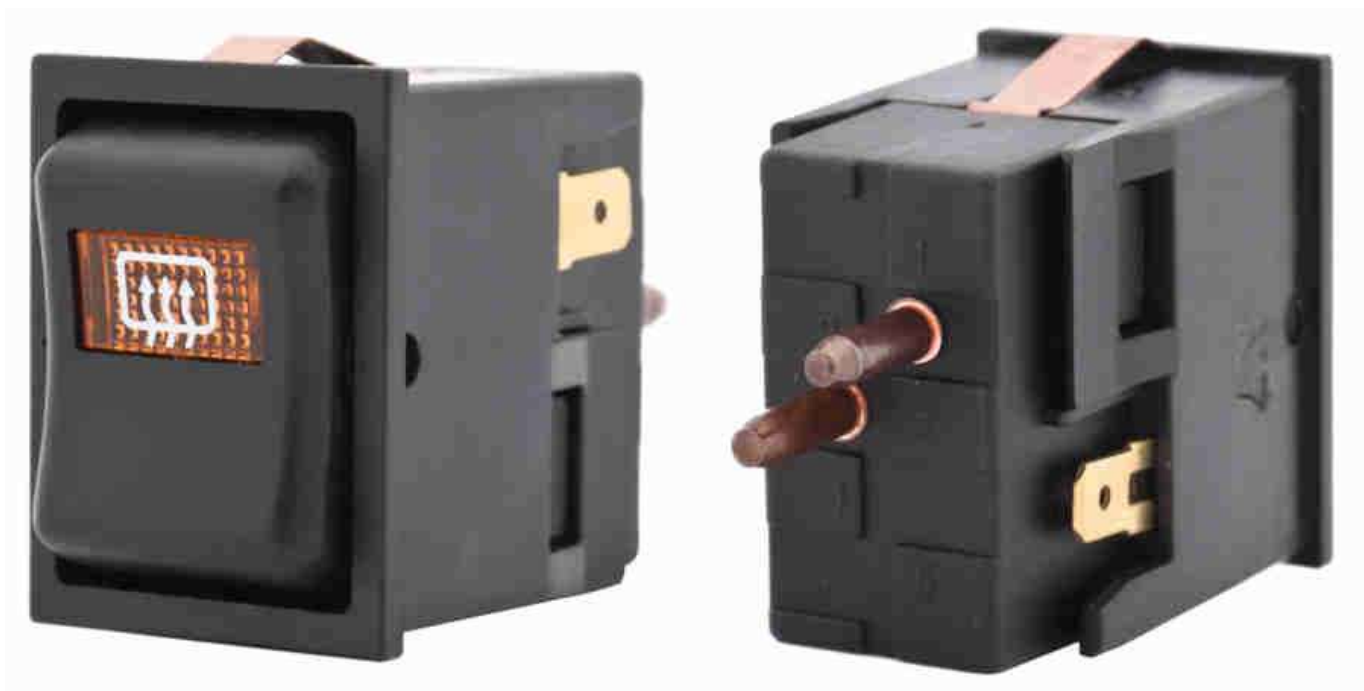
As the original switch part number is unknown this 1977 and later Mini switch YUF101680 might be suitable, although it has a yellow lens on the rocker instead of probably a green, and the edges of the rocker look more rounded. It still has the two spades on the side for the red/white and black wires, but has only two pins on the back for green and white/black wires (which is all it needs ...): ([Moss Europe](#)).

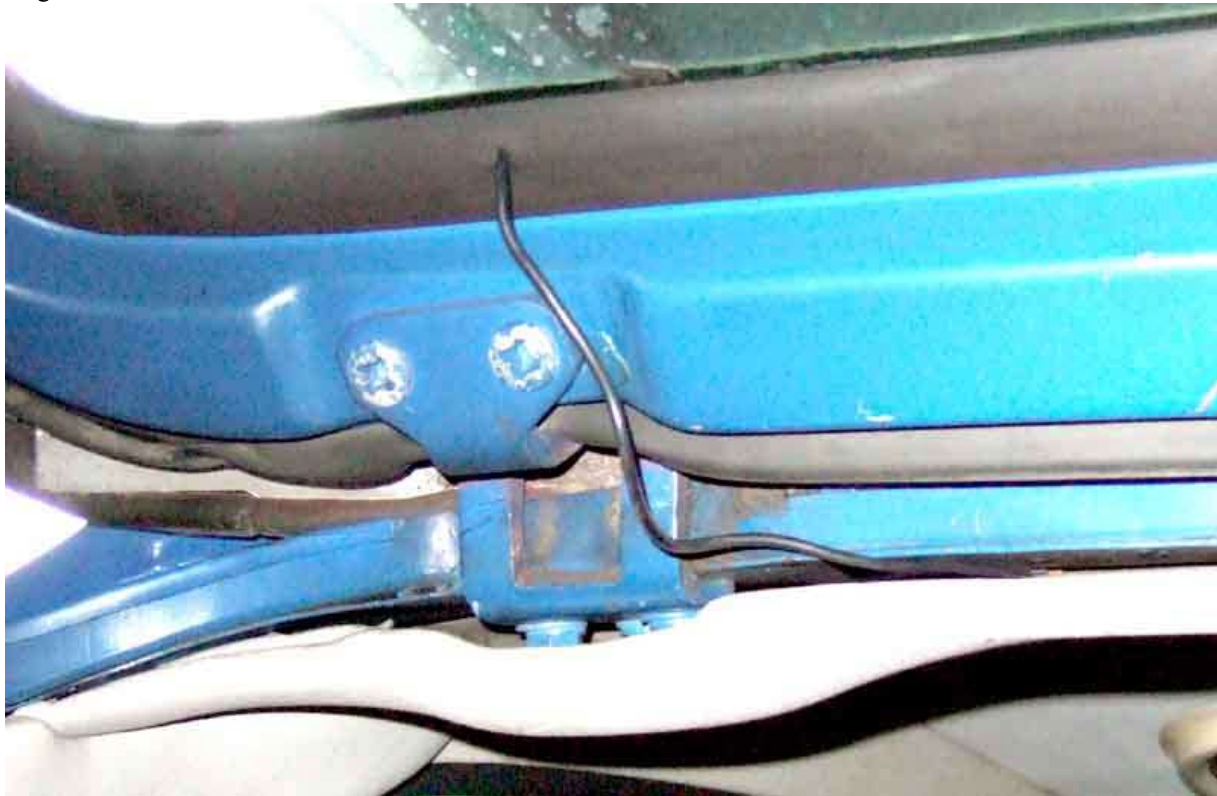
Hatch open, wire exiting from the window seal rubber and going to a bullet connector above the rear header rail of the headlining.

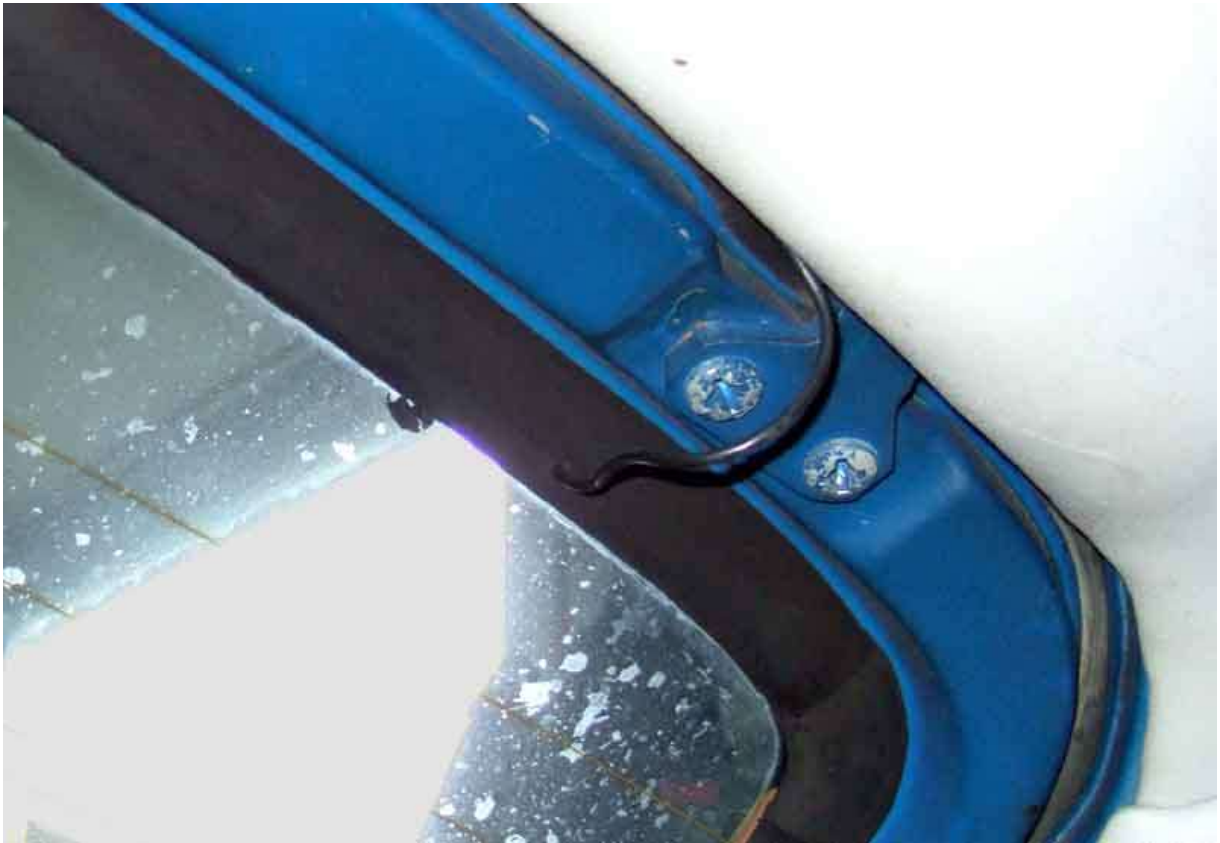
Hatch closed, just a small loop of wire visible

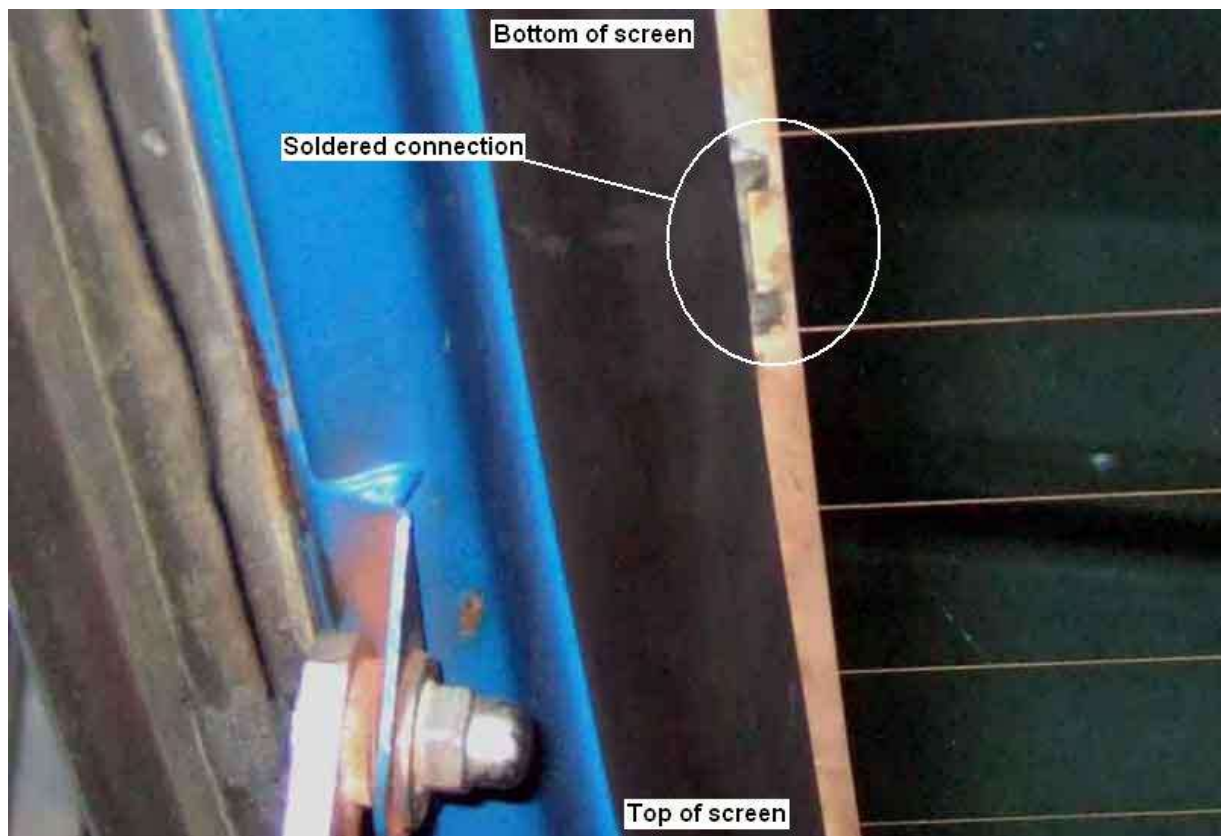
The soldered connection point on the surface-printed element, about mid-way down the side of the glass, with the connections and wiring covered by the rubber seal, but exposing a test-point.

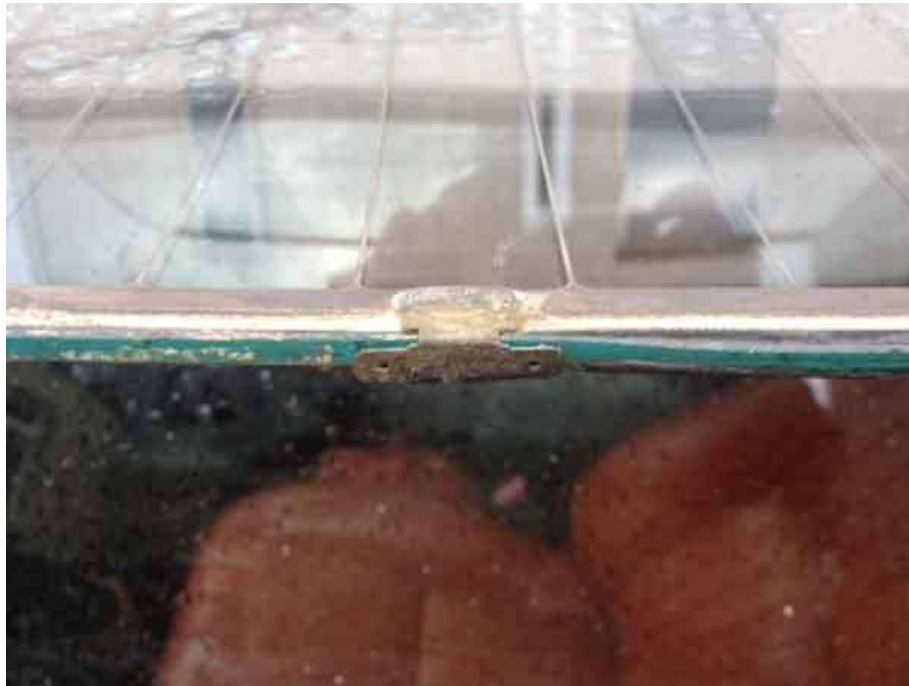
Robert Kerr's car, glass removed, showing the two spades on the inner edge of the glass. I'd say extreme care needs to be taken if you need to disconnect/reconnect the wire attached to this connector, say when replacing the glass, to avoid the risk of detaching the connector from the screen.

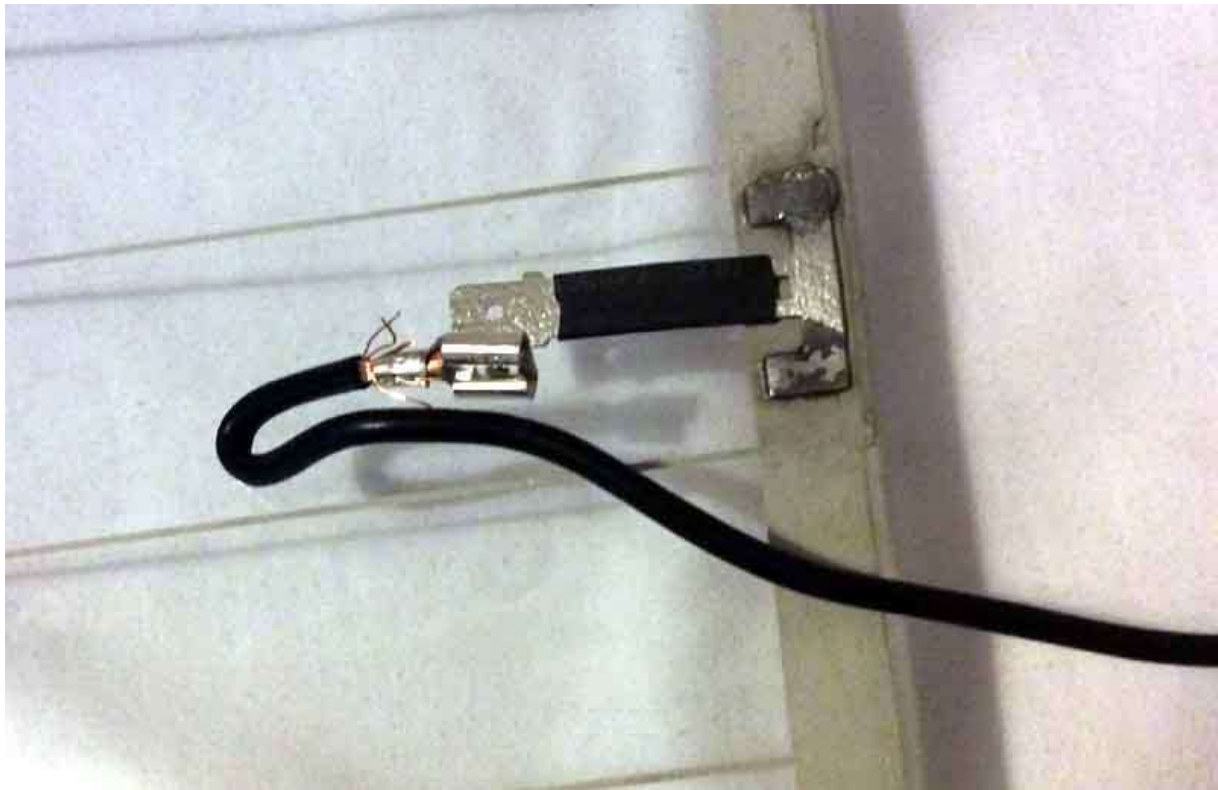
Roy Marshall's replacement glass, showing the very inconvenient connection arrangements.

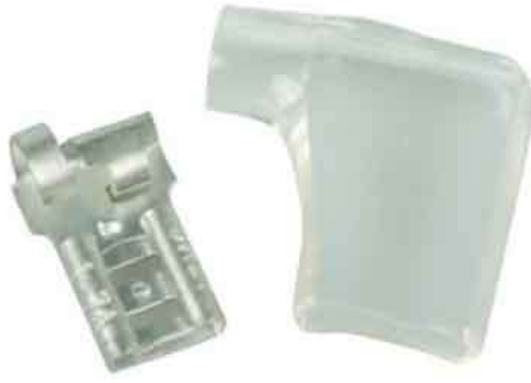
I suggest a right-angle wiring connector is the best way to get a half-way neat installation, however check the size of the spade on your glass first.

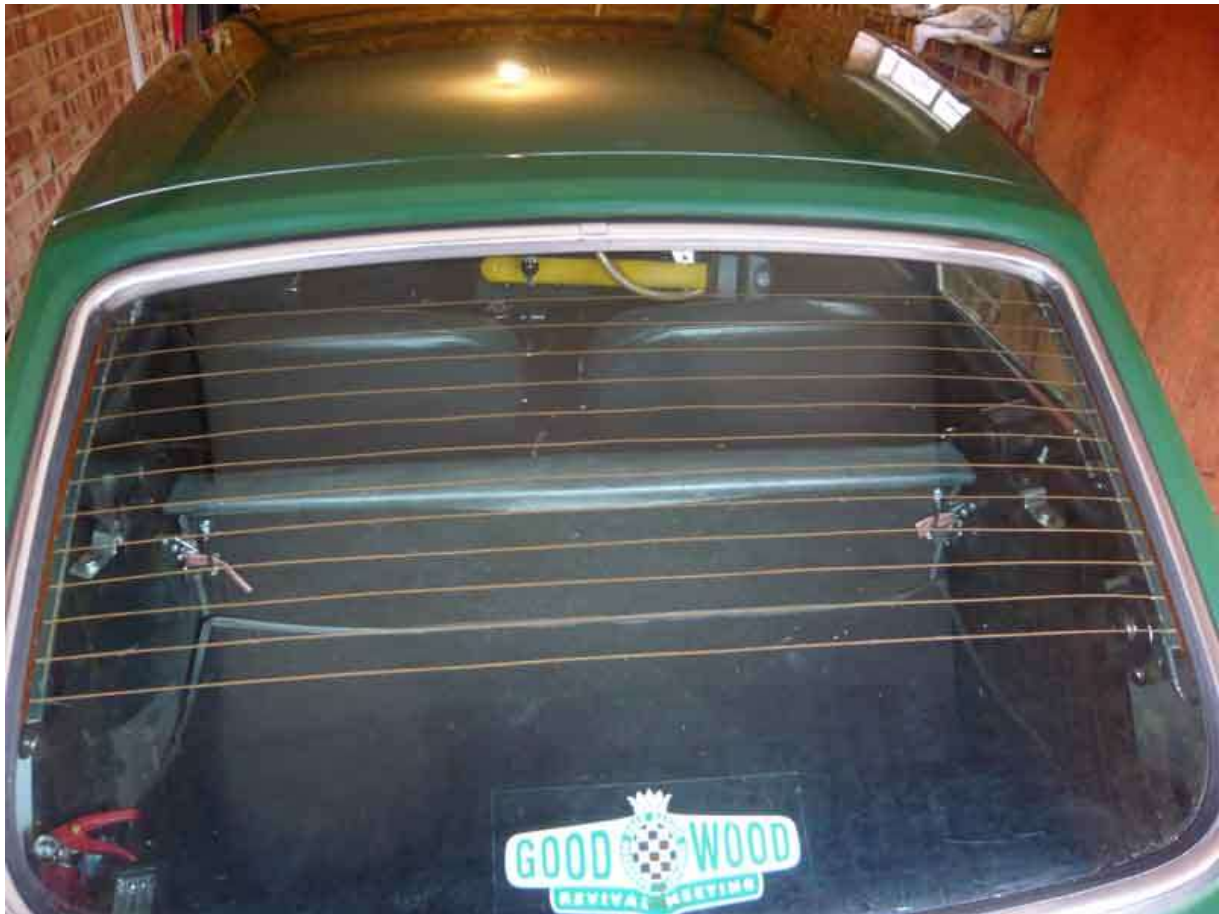
An extremely neat kit from [DS Demist](#), and an equally neat installation job by Peter Ugle. Whilst it isn't essential to remove the glass or hatch to fit the kit it obviously makes it much easier to get a neat finish working from above on a horizontal surface as opposed to trying to fit it lying on your back, even if the hatch is propped in the horizontal position.

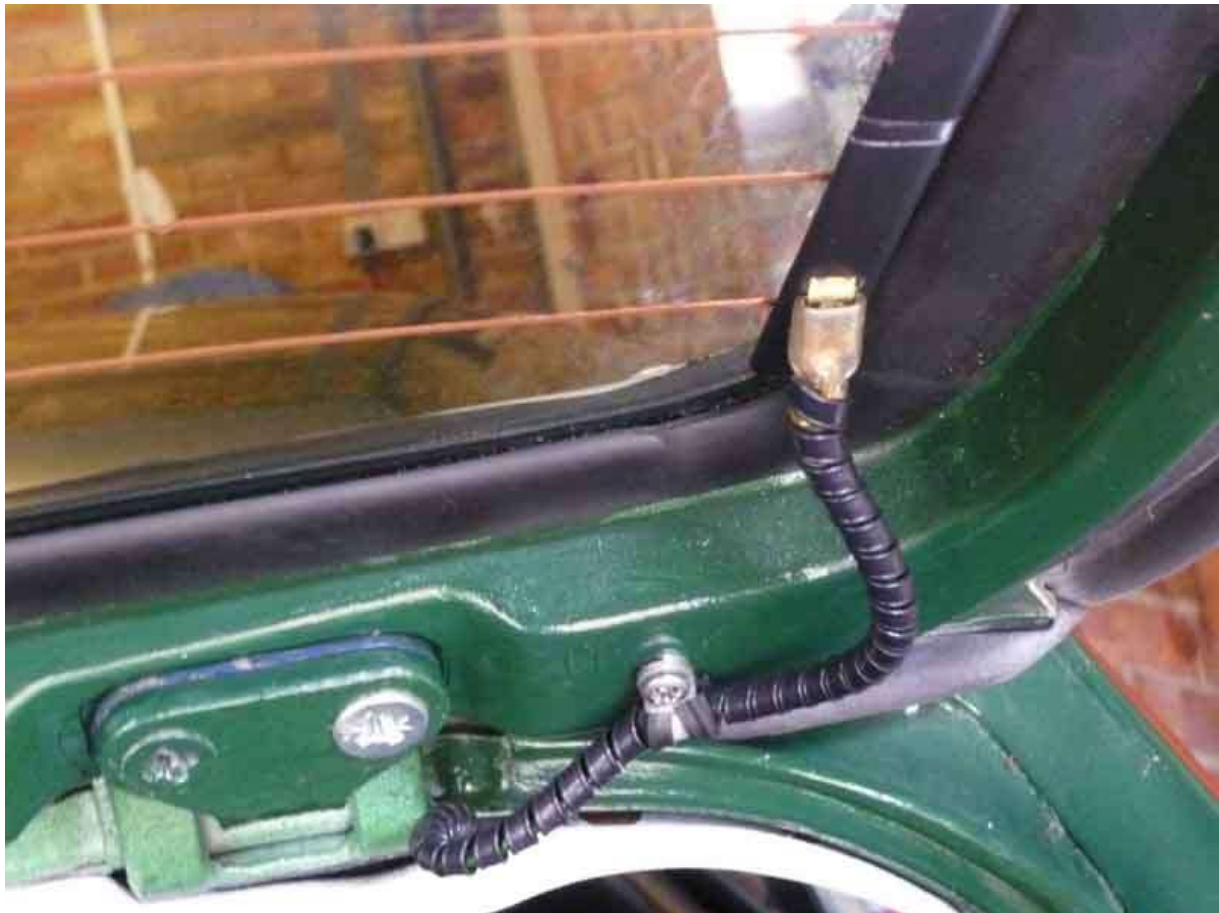
This should be the off- i.e. right-hand side to pick up the 12v supply ...

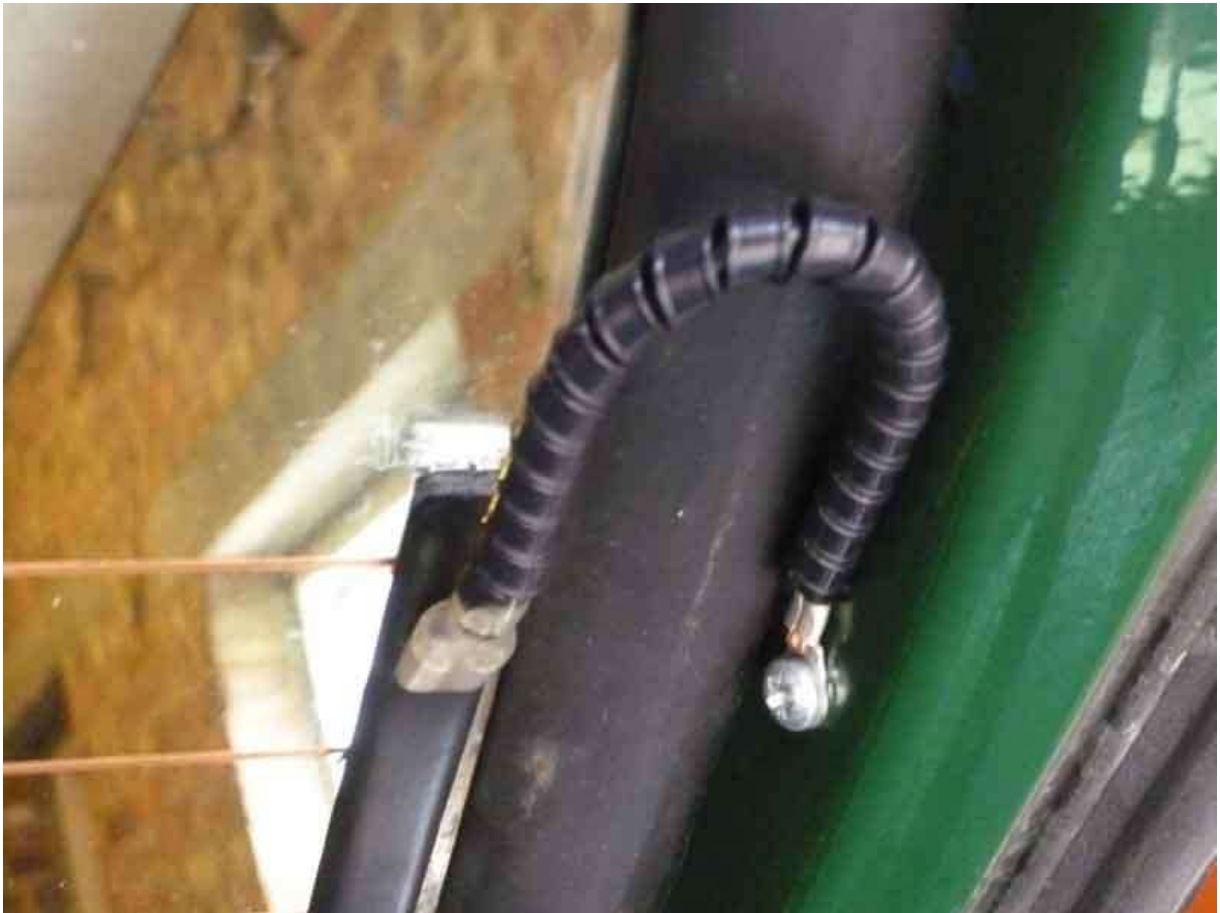
... as the earth can be taken to a screw in the hatch frame.

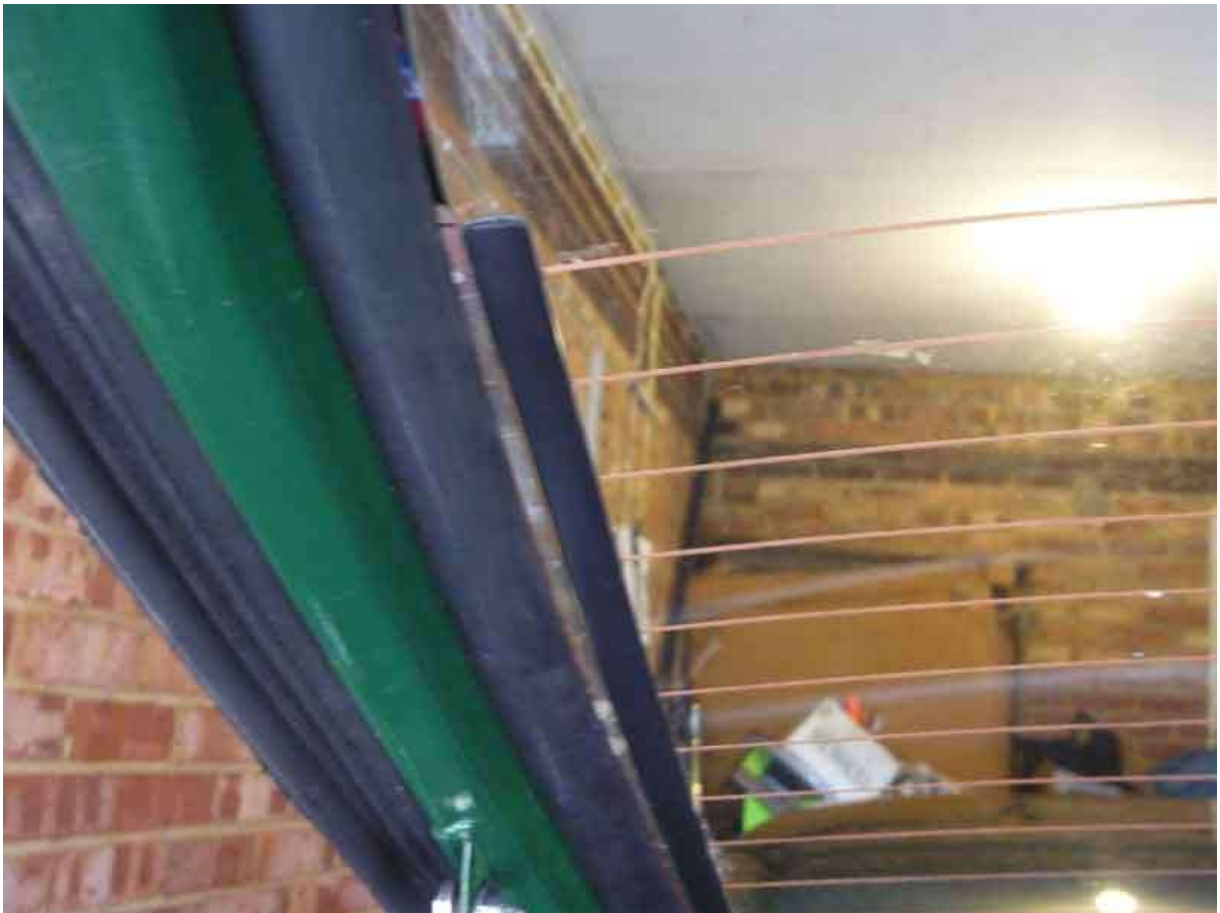
The other side of the kit just has the stick-on end-strip.

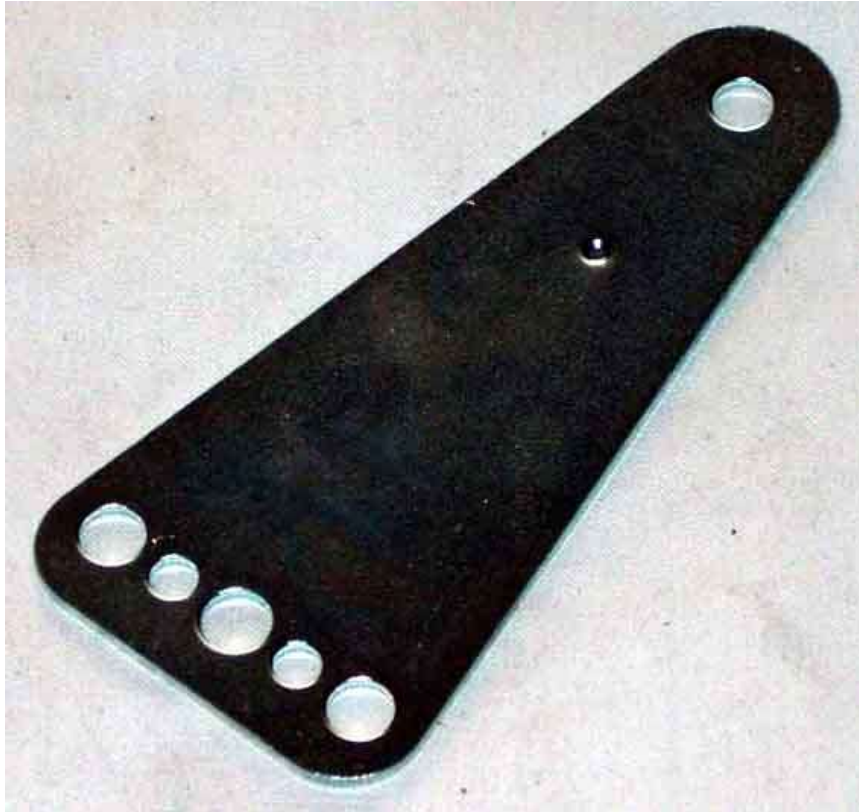
Originally a flat bracket 57H5309 mounting the horn (optionally 2) on the slam panel: (*Motaclan/Leacy*)
