Voltmeters

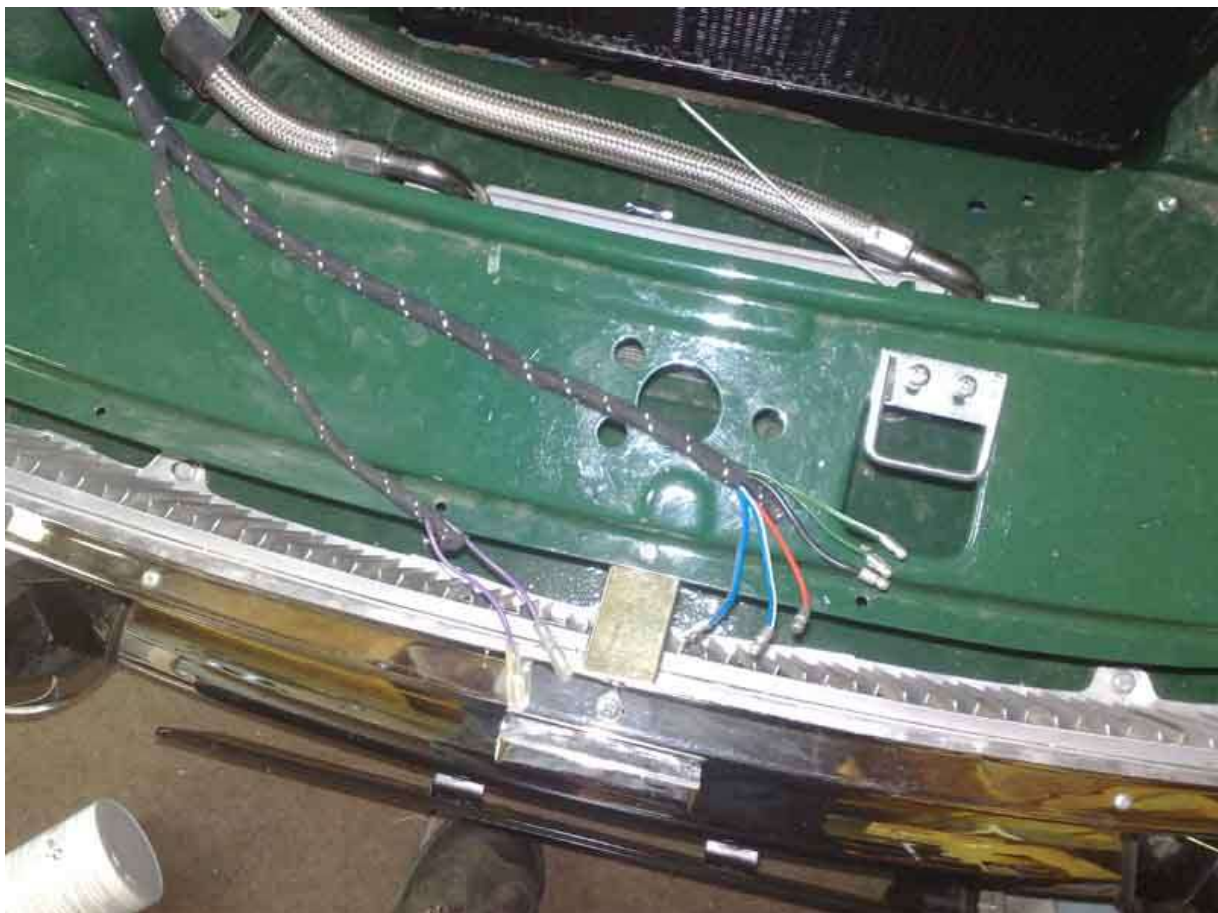
The early main harness only had wires for the single horn on the off-side:

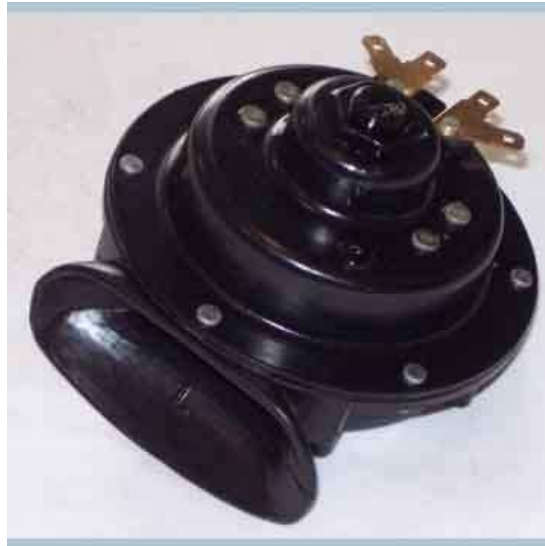
For the optional second horn a sub-harness was needed, and the original horns had double-spades like these BHA4514 and BHA4515 horns from Motaclan/Leacy:

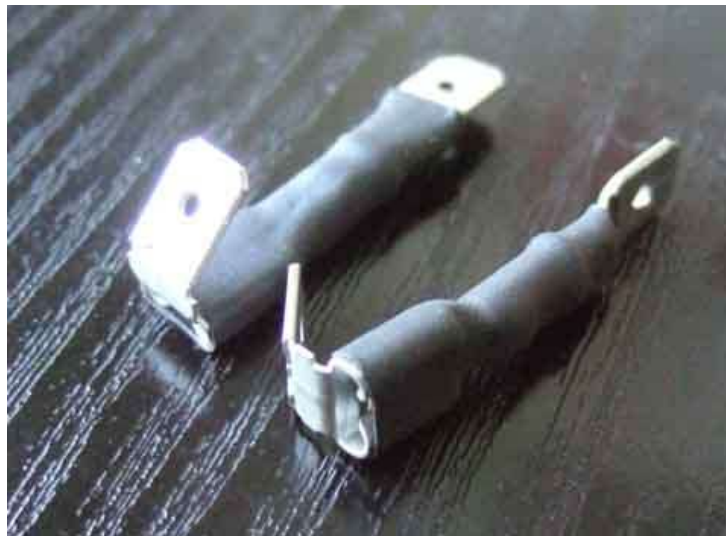
But if you have the later single-spade per terminal horns you can avoid mangling the harnesses by using a male-male-female spade adapter. Loads in America apparently, but I've not been able to find any in the UK, or even China (which is surely where they come from). I'm not paying the ludicrous postal charges that seem to be the norm from America, so looked at making some up. It occurred to me that I could use a piggy-back (one male and one female) and a male spade, back to back. Conveniently my piggy-backs have an second tube around the main crimp tube, and extending back from it, so with the insulation stripped off both the back of the male slots neatly into that. A copper nail that extends through both components, crimped, soldered and the whole thing heat-shrunk makes a neat job:

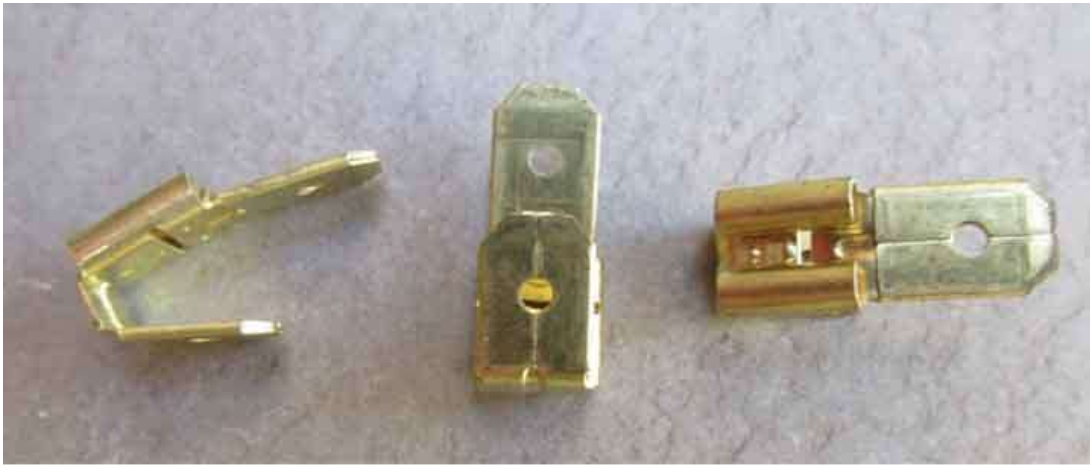
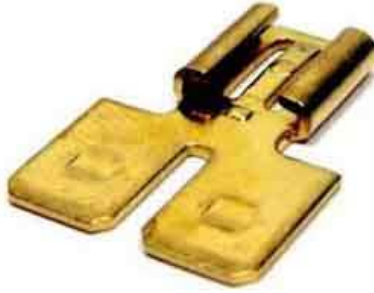
Subsequently I came across these via Google. 6.3mm from several sources - [UK](#), two in America, [in side-by-side or back-to-back configuration](#), another here [in side-by-side configuration](#), and one in [Australia](#). However the 'side-by-side' type look as if the spades are too close to each other to fit two insulated females:

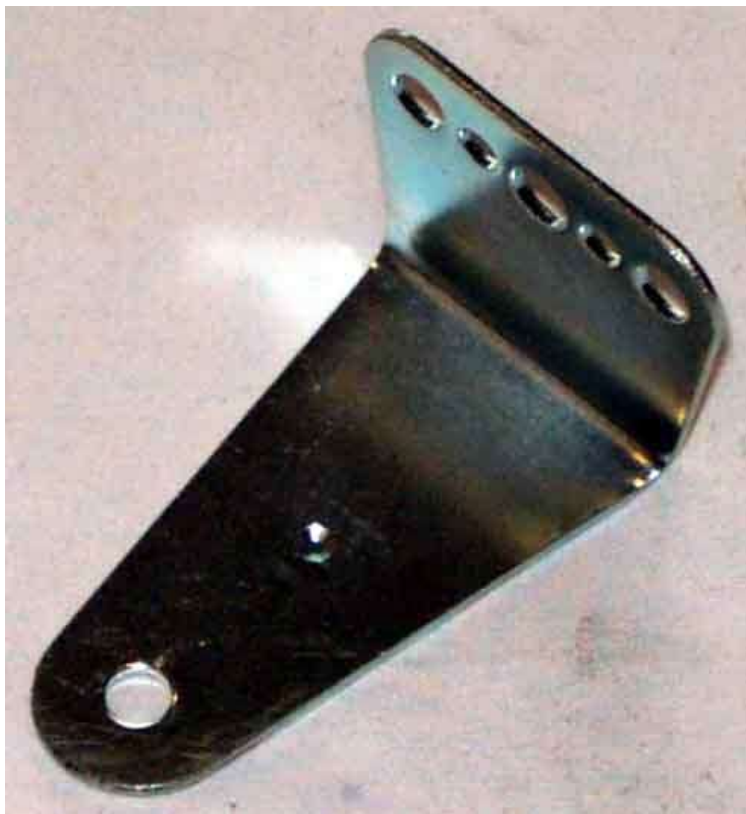
In January the bracket changed to angled GCE110 mounting the horn(s) in the inner wing(s). Two horns became standard in October 69 at the start of the 1970 model year: (*Motaclan/Leacy*)

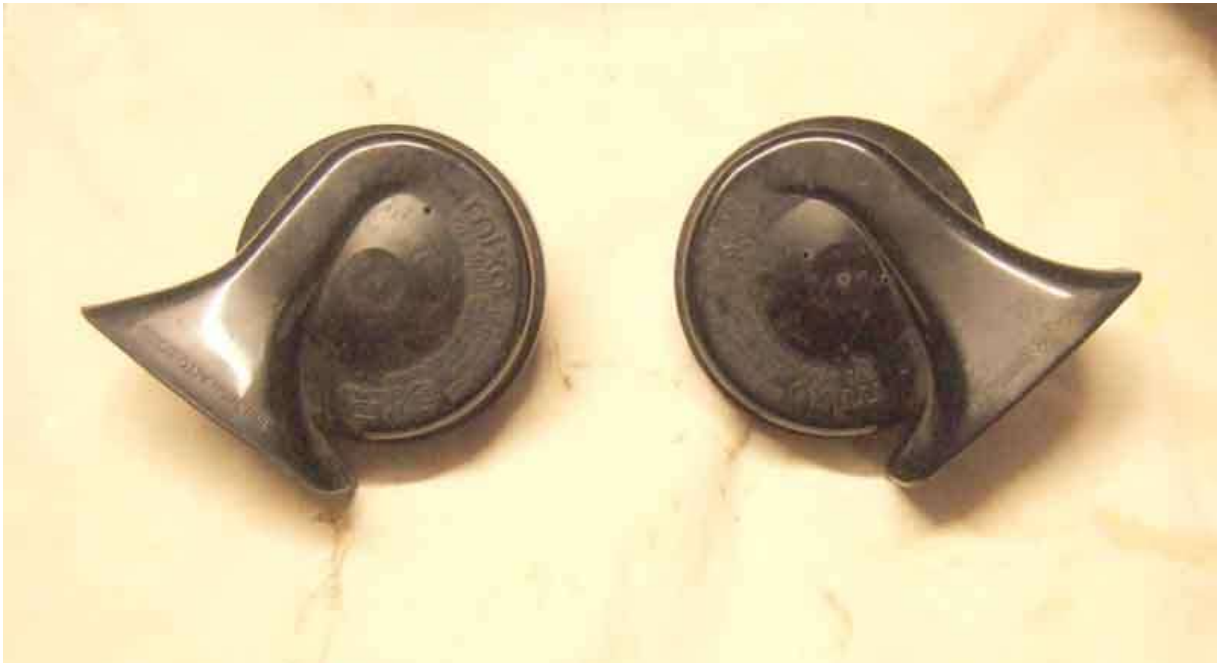
Mixo horns at least are mirror-images:

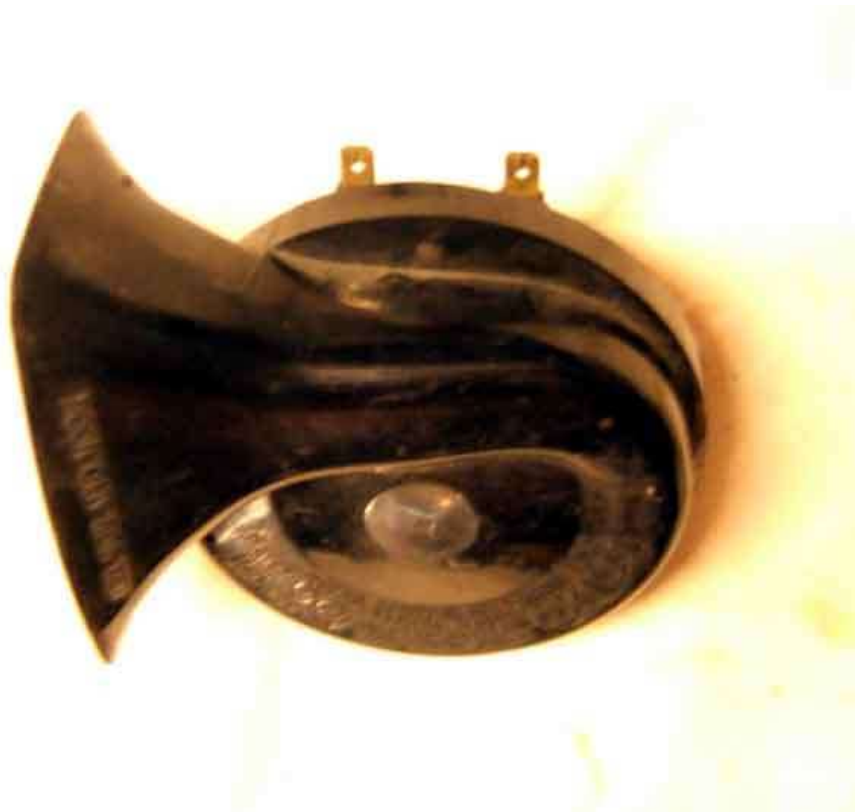
Mounted vertically with the trumpet facing forwards and the spades uppermost ...

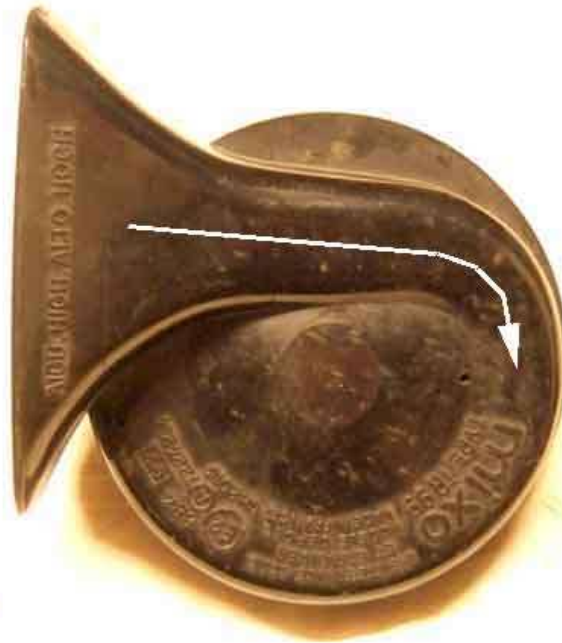
... the curve of the trumpet is downwards (as indicated by the arrow), so anything that gets inside will lodge there:

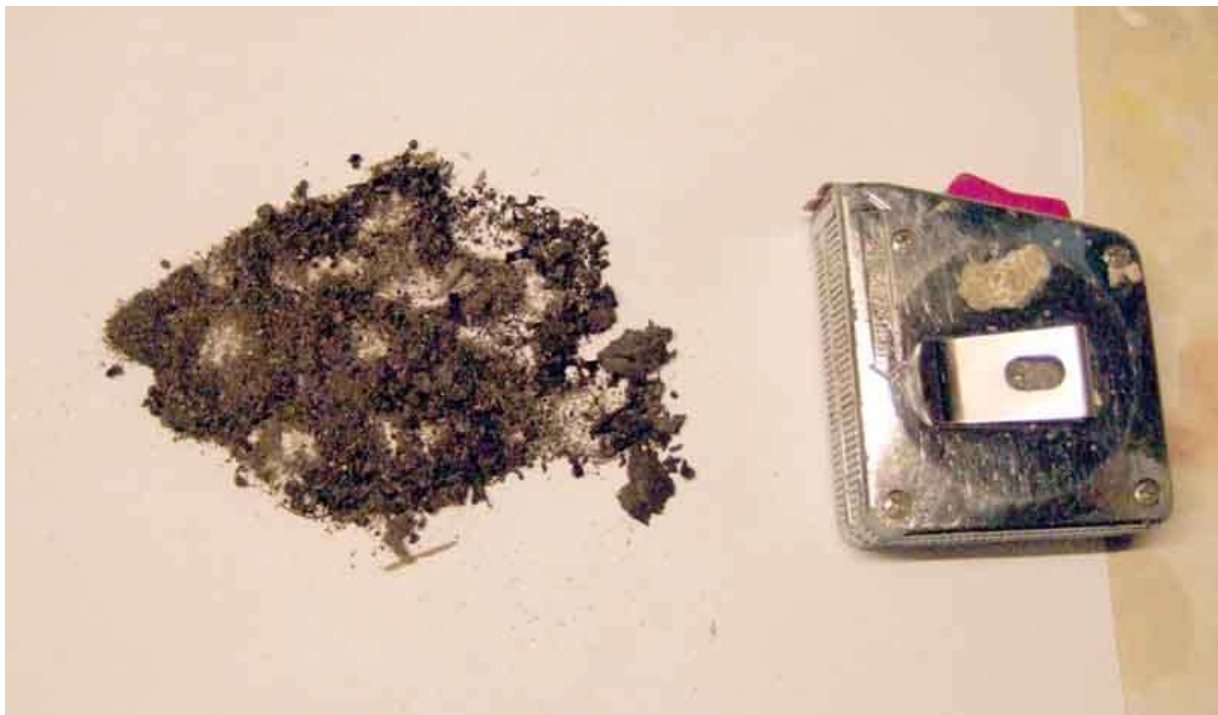
This is what came out of just one of mine (not the tape measure, that's just to indicate the scale ...):

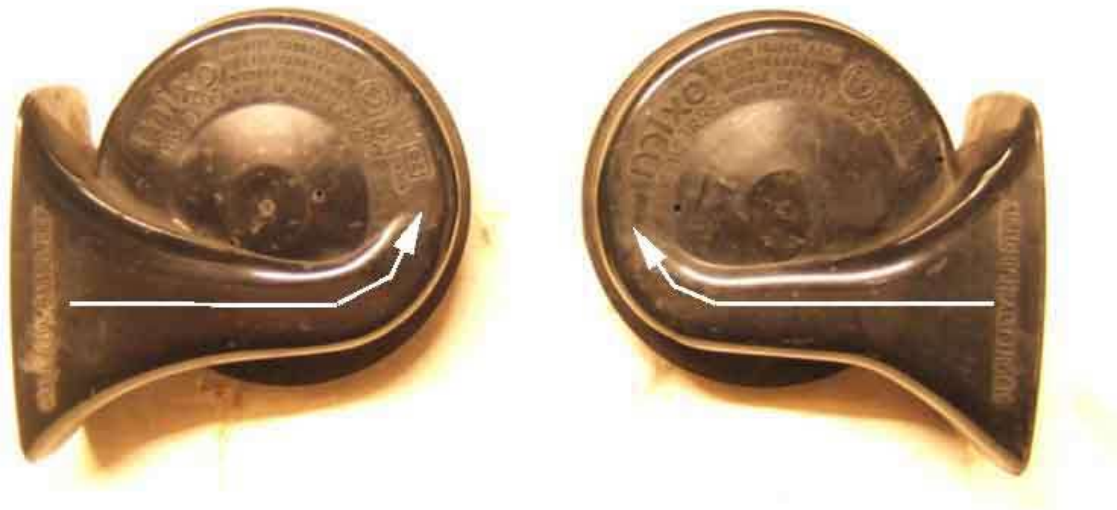
They would need to be mounted such that the curve of the trumpet is upwards (see arrows), which will resist water and debris getting stuck inside, even though this puts the spade connections at the bottom. This can be partly alleviated by angling the open end of the trumpet downwards to some extent, which will further help avoid muck getting inside:

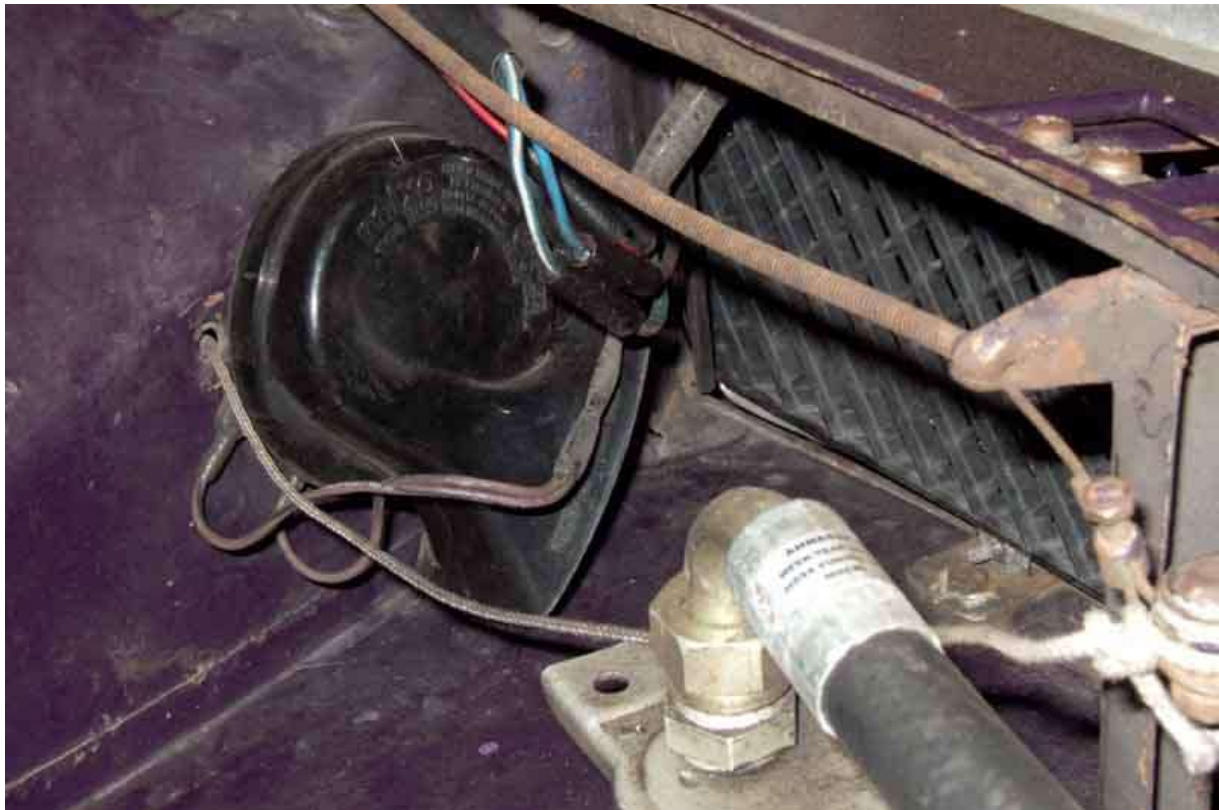
Bee came to me with them mounted direct to the inner wing and not on brackets, I've left them that way, but orientated to resist dirt and water going into the trumpet. Connections now underneath, but still accessible by touch:

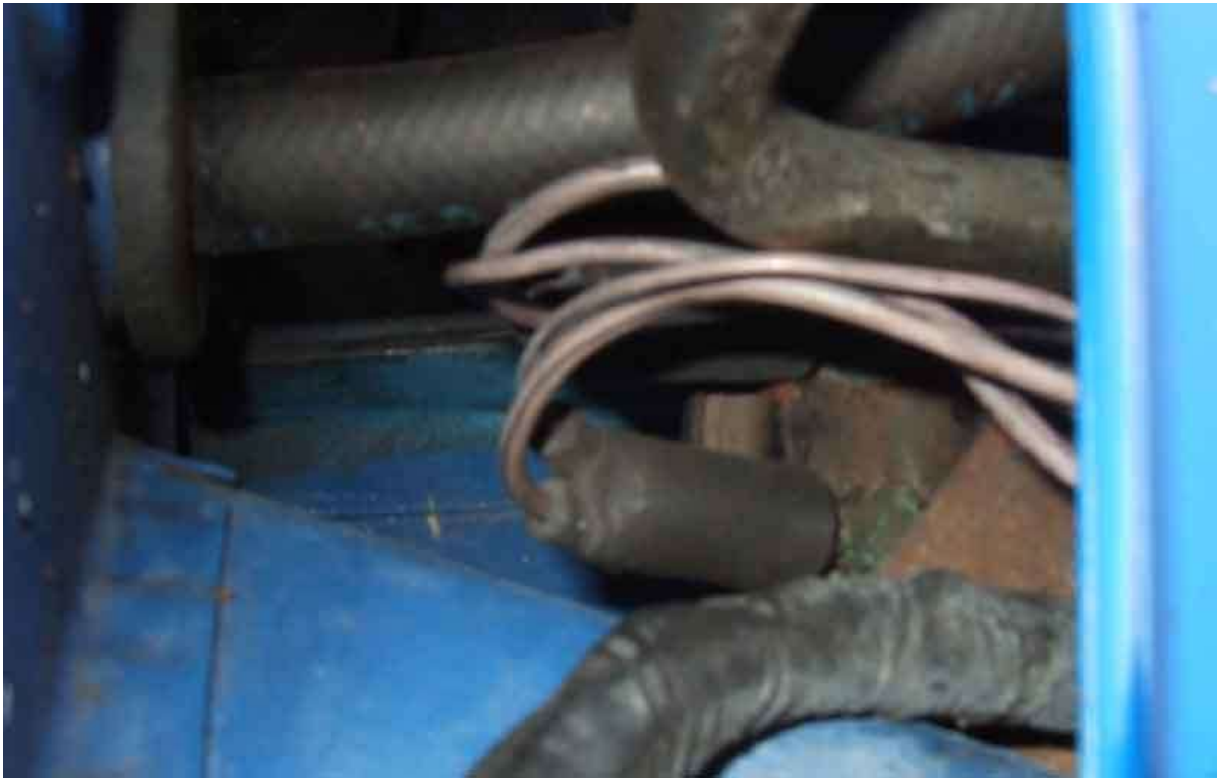
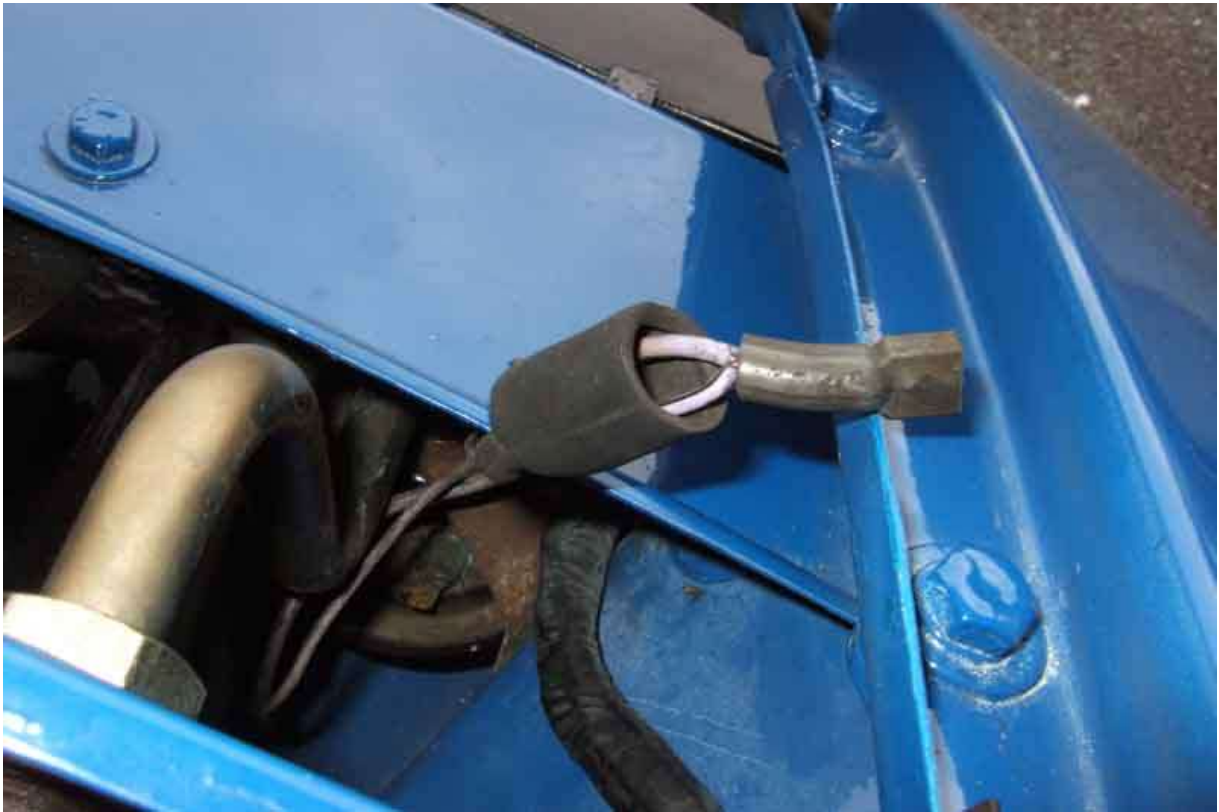
At some point - possibly with rubber bumpers - each off-side connection gained a rubber boot with two separate holes for the wires, possibly to protect the connections from the worst of the weather:

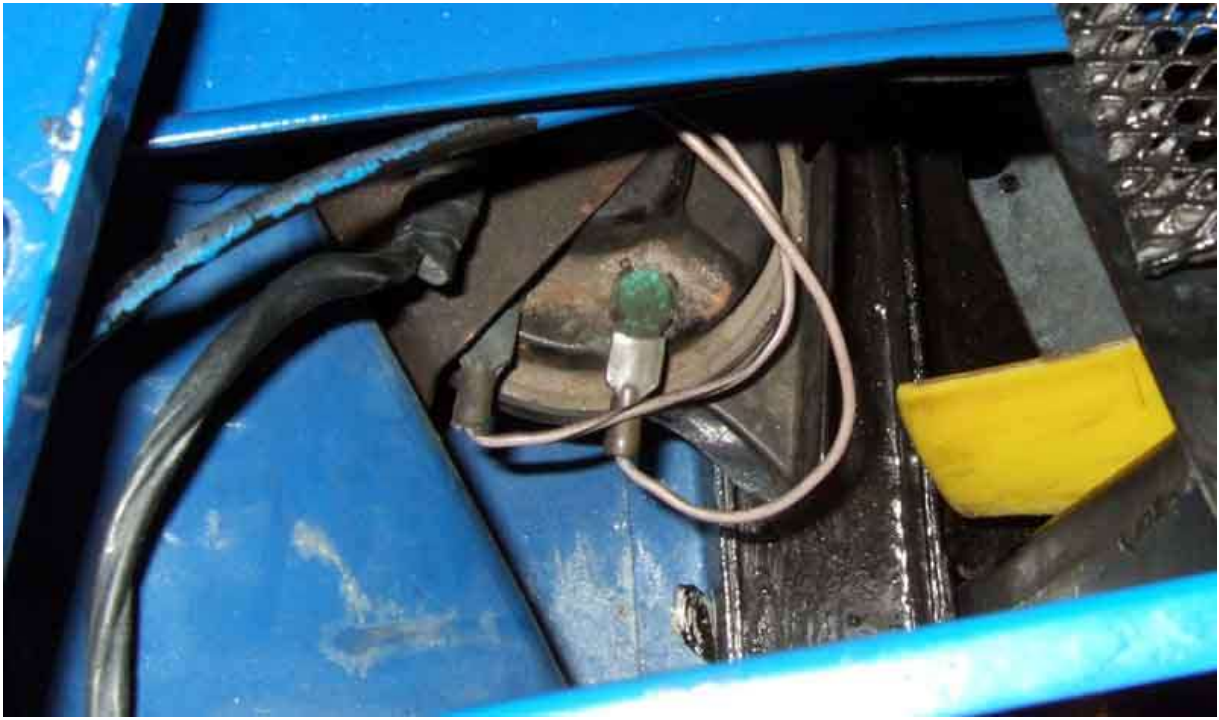
However going by Vee at least the near-side didn't. Both the Mixo horns on the roadster and the different make on Vee have the spades to one side which means they can be mounted so the trumpets face across the car and avoid the worst of the weather driving into the trumpet. Clausager shows a 72 model (p65) like this, but bear in mind the horns in his pictures may not be original, as mine aren't:

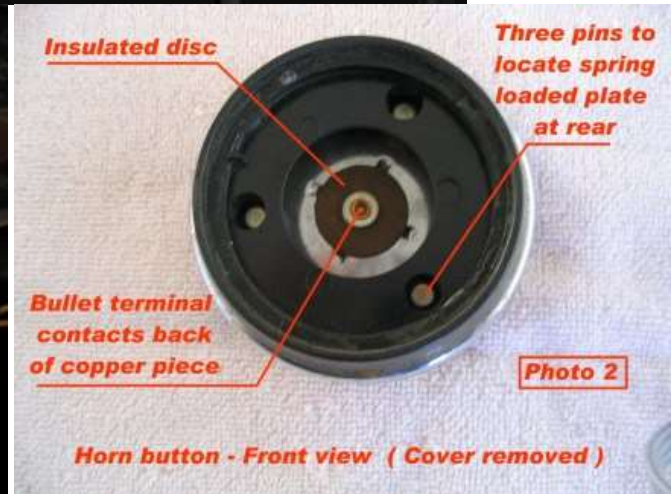
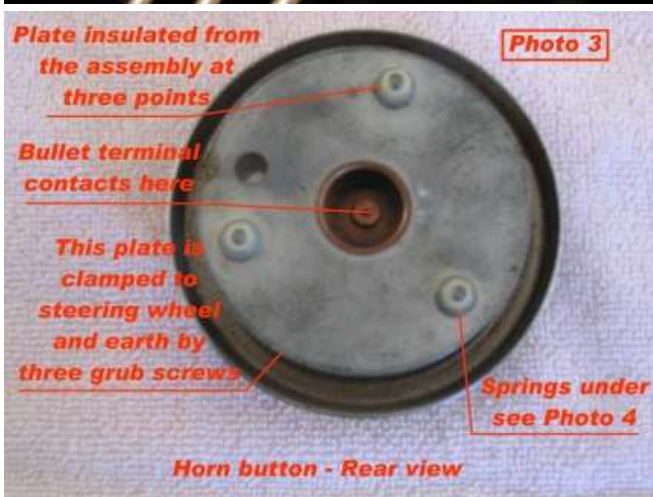
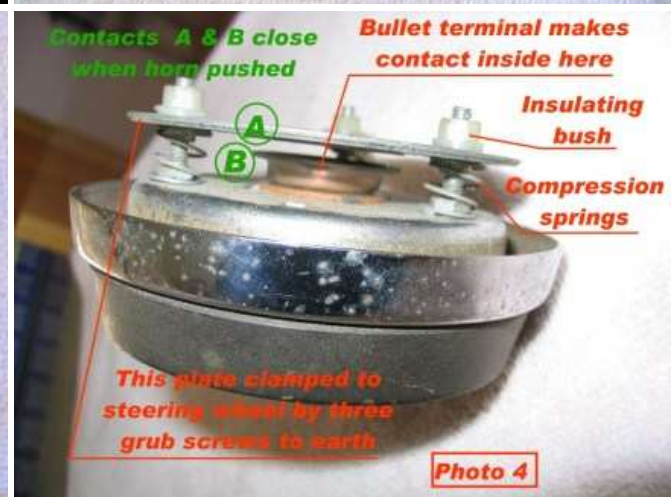
North American Mk1, and up to and including 1969 (other markets): The brush rubs on a brass cylinder (slip-ring) attached to the column, but insulated from it. A wire comes from the slip-ring up through the centre of the column to a ball-shaped end ('bullet' below). This presses on a brass contact attached to the middle of the horn push. Operating the horn push connects the brass contact to a metal plate which secures the horn push to the wheel. The wheel and this metal plate are at earth potential, so when the brass contact touches it the horns sound. This series of photos are from John Minchin:

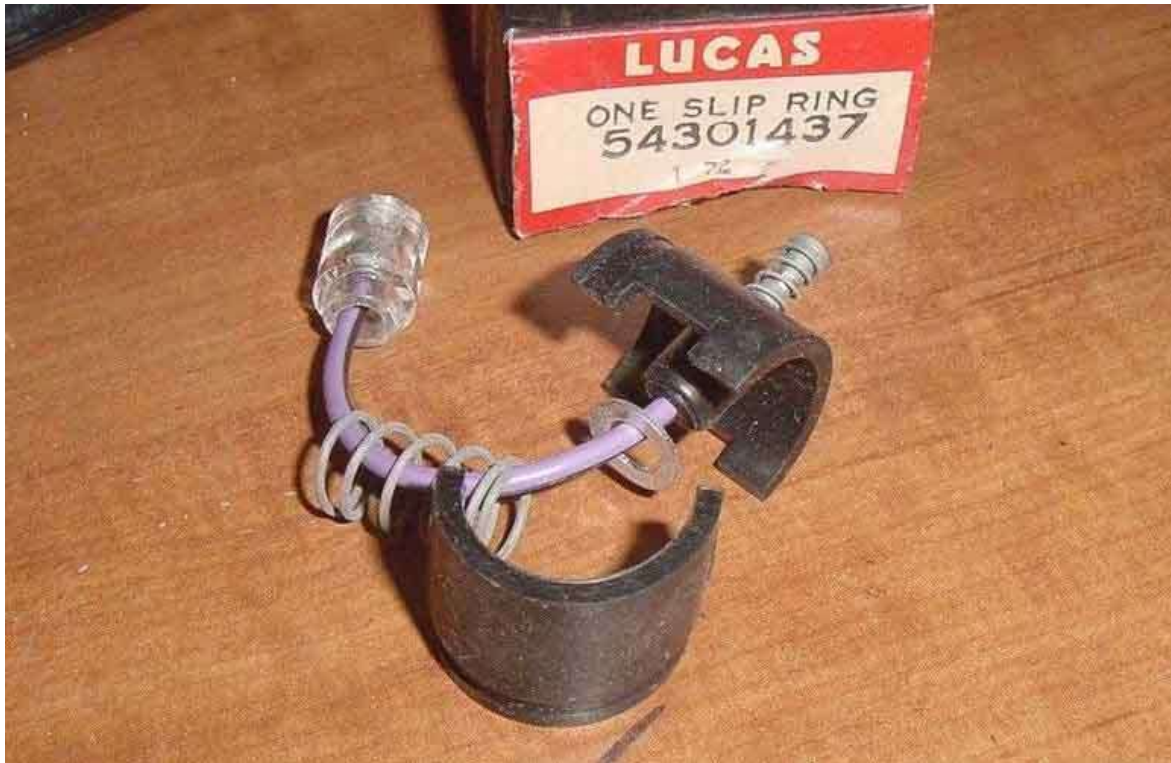
This [ebay](#) item shows the column gubbins more clearly. The box describes it as a slip-ring, although the slip-ring itself isn't shown, just the split plastic sleeve it slides over, and the wire that connects it up to the 'bullet' at the end of the column, part

number 27H3387. The cylindrical brass slip-ring that fits round the plastic part is 27H5401, both Not Currently Available:

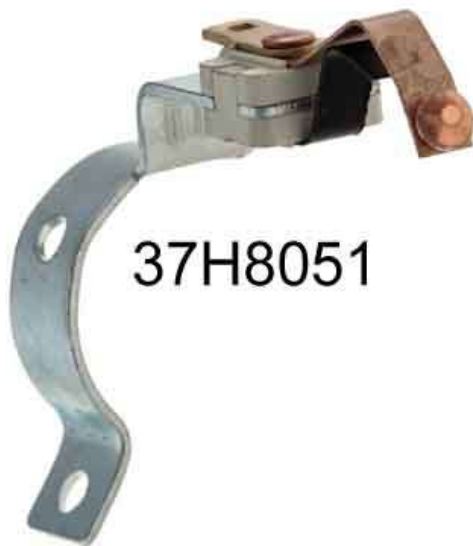
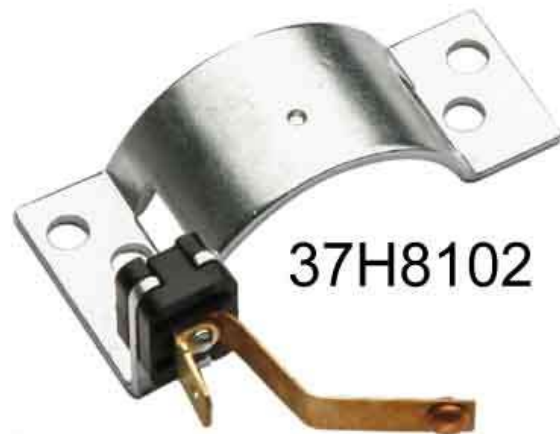
71-on CB 37H8051 on the left, RB until 1977 37H8102 (for twin stalks) on the right: ([Moss Europe](#))

August 2020: As you can see these have copper pips on the end which rub on the brass slip-ring on the wheel, hopefully silently. However these can fall out and the copper spring then makes a loud scraping noise against the slip-ring. I eventually lost Bee's so put a dome-head screw and nut in its place, which worked fine for very many years until it started squeaking again. Put a spot of grease on which worked but squeaked again after a year or so, so really I ought to bite the bullet and replace it. But when someone asked about this very problem on the MG Enthusiasts forum just a few days ago Chris @ Octarine Services said he just put a blob of solder on the end of the spring, so worth a go. Initially it just flowed round the hole, but dabbing more on eventually filled the hole and made a dome-shape, so we shall see. But along the way the steering was clonking, which looks like the off-side track-rod moving laterally as well as in and out with the steering, so that will need investigating. New racks are c£200 and reconditioned £100, but the quality of the latter in two recent cases has been appalling, and there have been cases of new grease-filled racks from Argentina not even being assembled correctly.

August 2021: A while ago it started squeaking again, solder gone flat, so put a bit of grease on. Then at the pre-MOT check the horn wasn't working which turned out to be a build-up of grease between the slip-ring and the contact insulating the two. I had used copper-grease, and I note elsewhere that I had used it on heater dash controls and it got very sticky and made them stiff, so best kept for bolt threads. I'll have to get a new contact next time I buy anything ... unless I can find a little copper button in my tin of nut, screws, washers and bolts. What I actually found was a contact button on the end of a little copper strip, which I soldered to the original copper brush arm over the hole for the missing button.

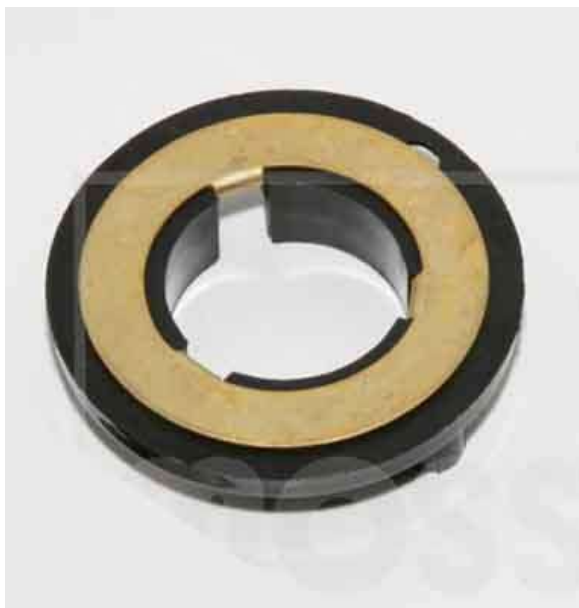
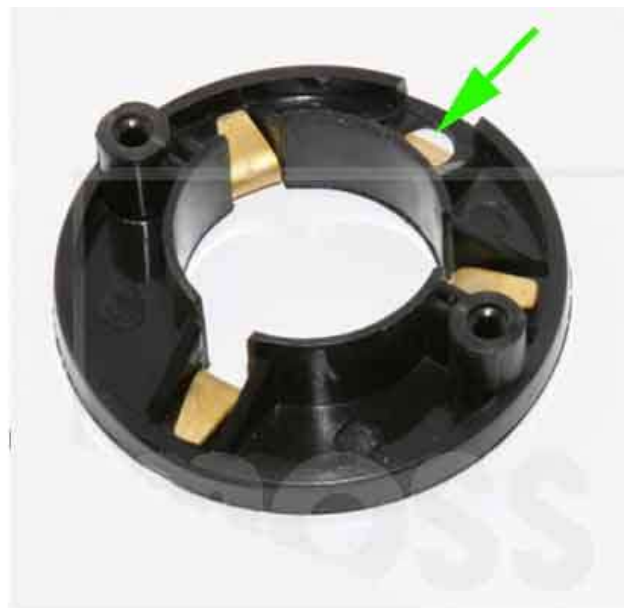
Slip-ring BHA5042. I've not found the screws for this listed anywhere, and checking one from both Bee and Vee against taps they have a very coarse thread for their diameter. D A Jenkins in Australia wrote on the MG Enthusiasts forum that a new slip-ring came without a tapped thread in the (plastic) holes, so I suspect they are self-tappers of some kind, but without a point or other specially-shaped tip. He tapped them for a 6-32 UNC screw by 3/4" long. Incidentally arrowed is the hole for the sprung 'pencil' (it's not a brush) that connects the back of the slip-ring to the horn push: ([Moss Europe](#))

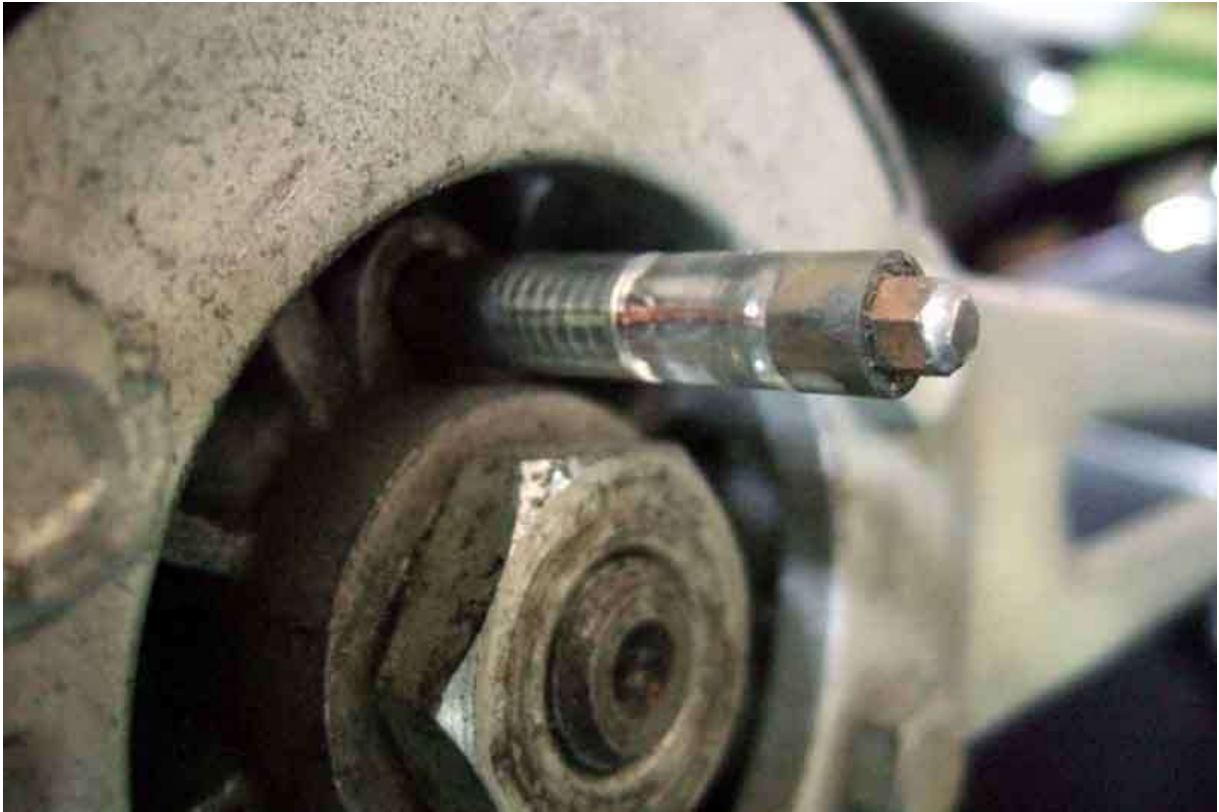
... it should be fitted with the fixed contact facing outwards so the insulating sleeve can prevent the contact touching the horn push body as it is fitted or if it is twisted once fitted. *Update March 2010:* Tim Schorn queried this saying he fitted a new one this way round and it very quickly broke, adamant I had it wrong. This has to be a faulty part, once fitted it only ever operates in compression. Not only is this logically the correct way round but [Moss \(Europe and US\)](#) and the Leyland Parts Catalogue all

show it this way round. Also John Twist says ["The longer piece should go in there first" and shows it compressing before refitting it at 0.55 here](#). Tim says he paid \$43(US) for this part, in which case he was robbed as they are only £8/\$12 at Moss, even less elsewhere:

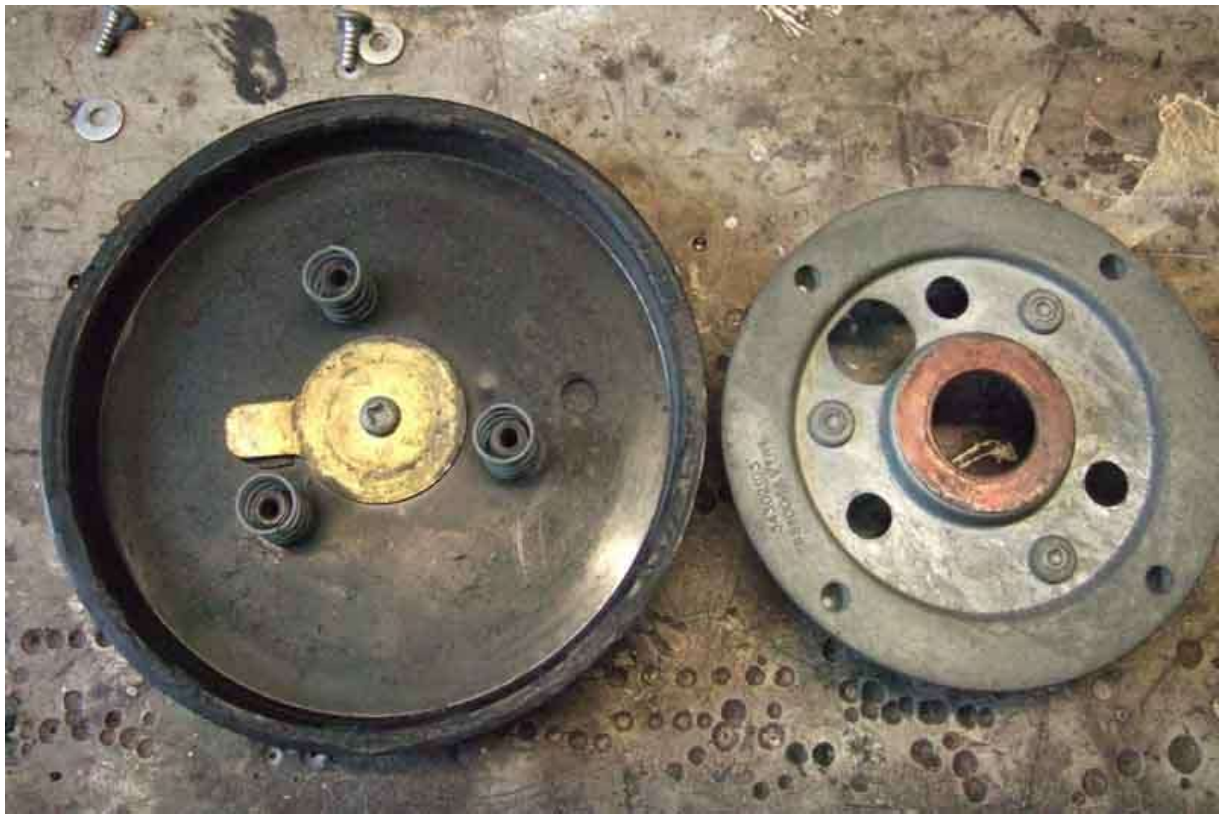
April 2019: Discovered the horn was only sounding when depressed at a particular point, so an opportunity to dismantle this type. Three screws through the grey part and springs into bosses in the rubber cover:

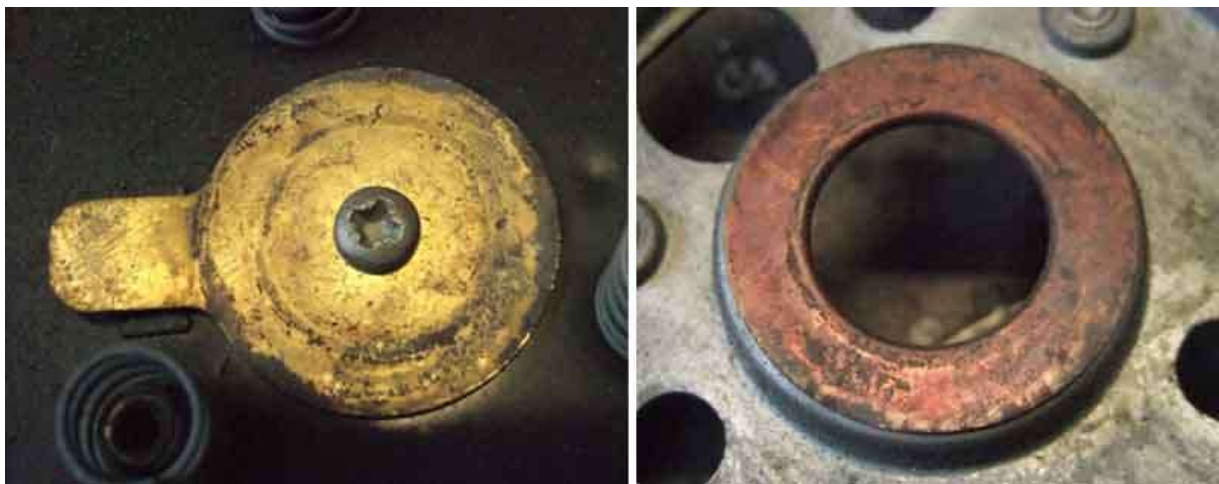
Brass contact on the rubber part and copper on the grey part pretty manky after 45 years:

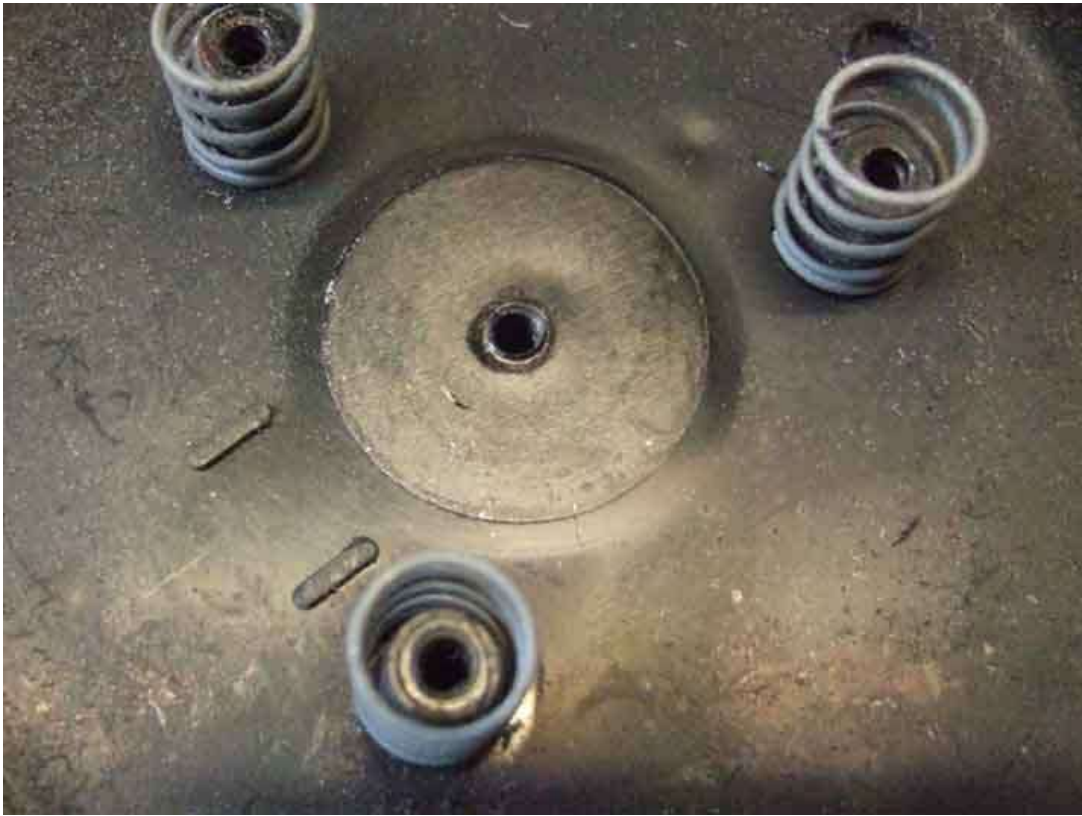
The brass contact can also be unscrewed, note the location ribs in the rubber:

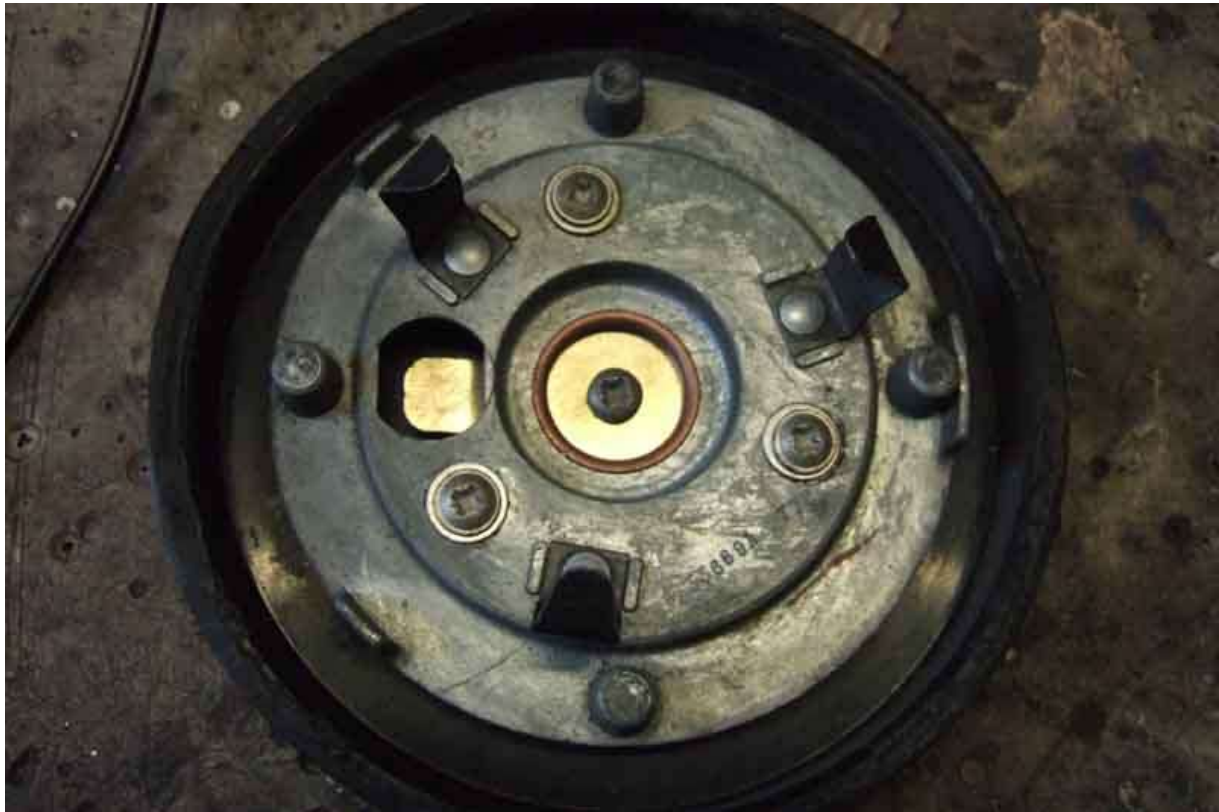
Cleaned up with fine wire wool and reassembled, horn sounds all the way round now:

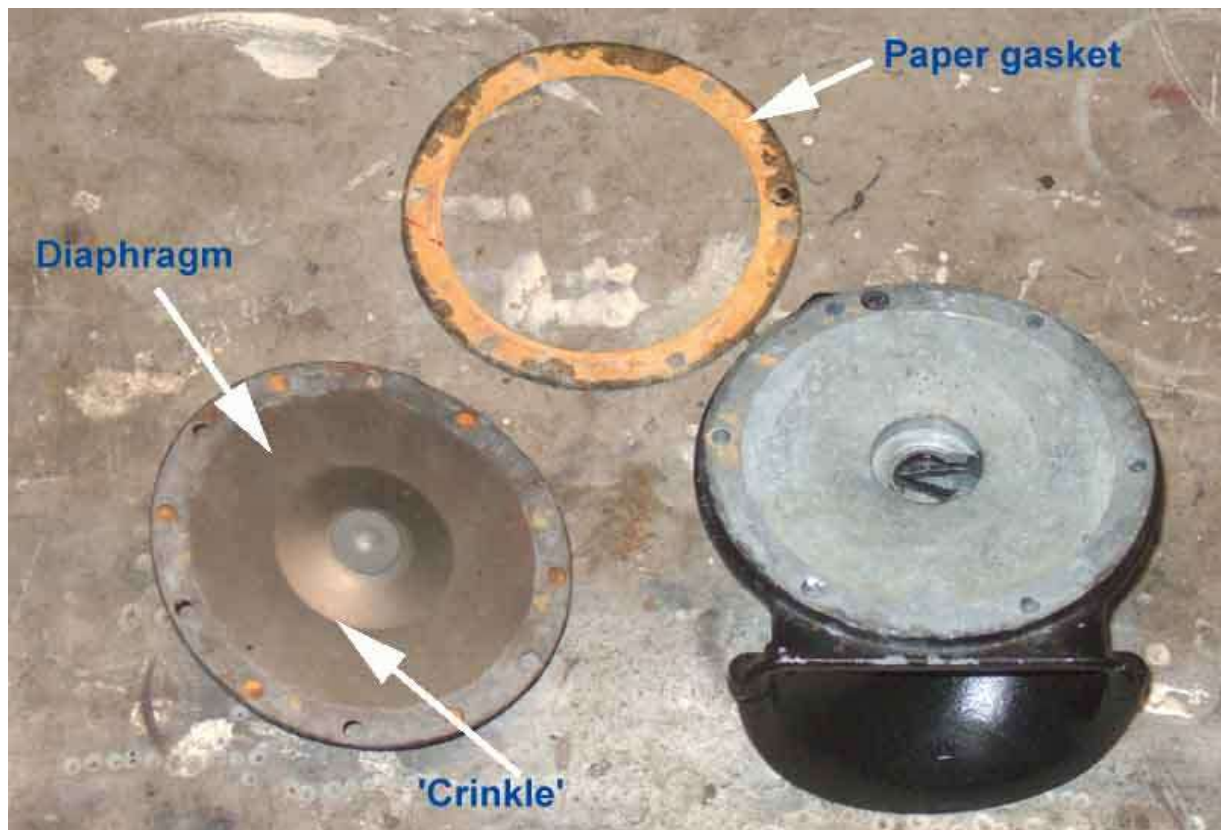
The 'crinkle' in the diaphragm has the effect of making it 'snap' between the operated and released positions (like a [pop-o-matic dice shaker](#)), which greatly amplifies the sound the horn makes. This half of the casing is alloy.

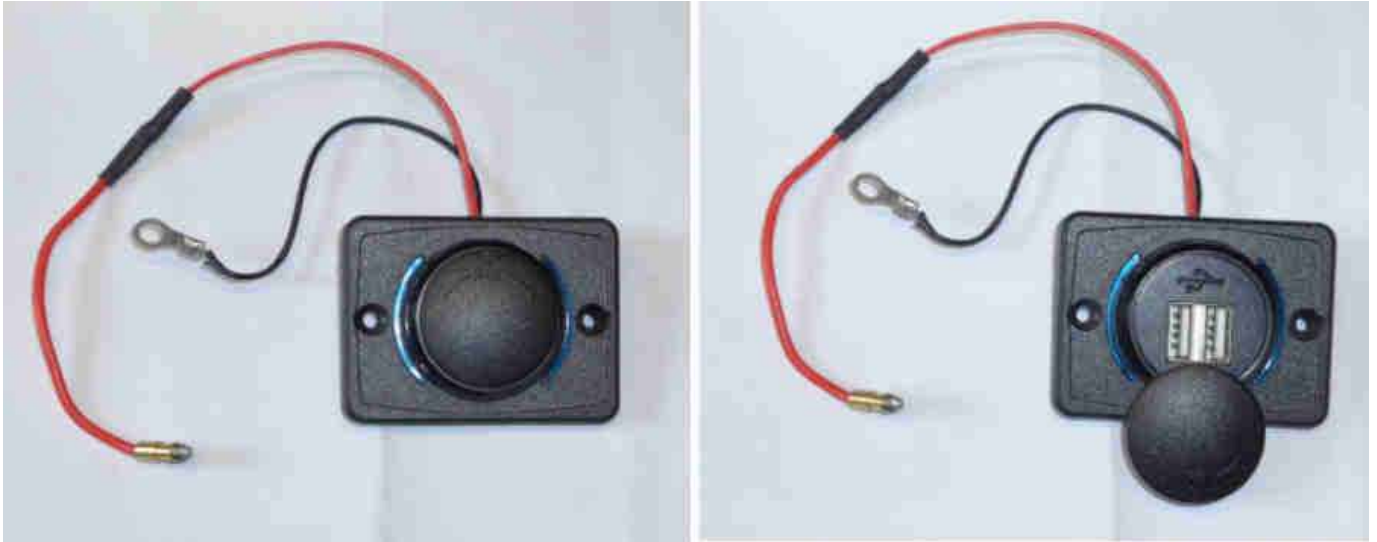
Cover swivels round to reveal the sockets. Glows blue round the edge when powered and white from the sockets aiding location. All you have to do is get the USB plug the right way up ... or round ...:
