Voltmeters

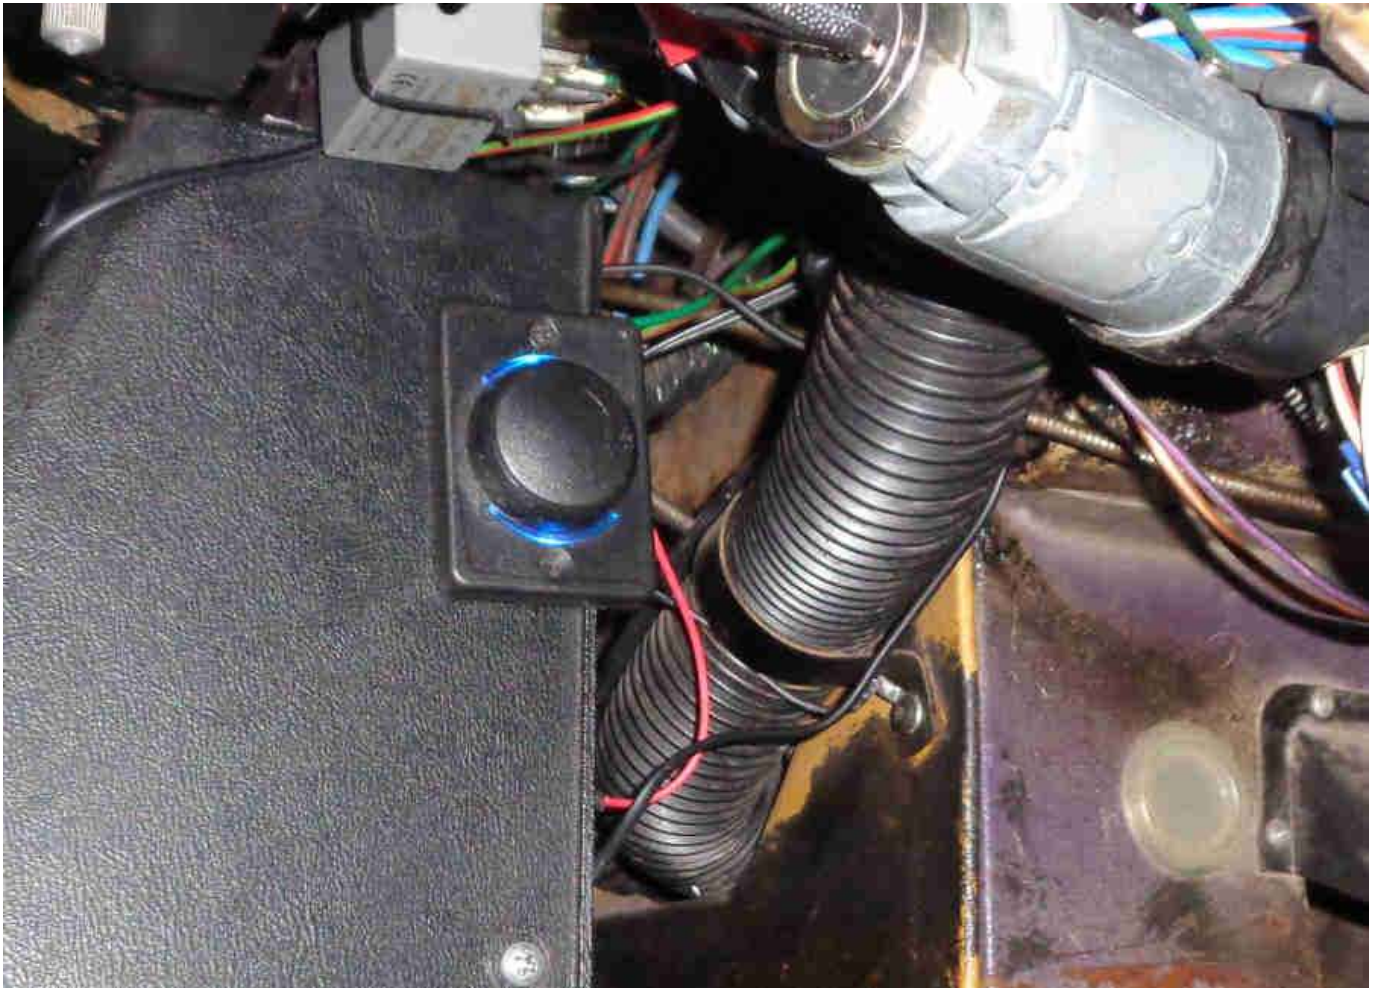
Subsequently I moved Bee's to the top screw to give more room for accessing the tunnel plug for the gearbox dipstick. I had no problems making an earth connection initially but found it not working after a 320-miler, so as well as moving the socket I moved the earth to the screw for the screen vent hose clip. Still visible and easily accessed from the driving seat:

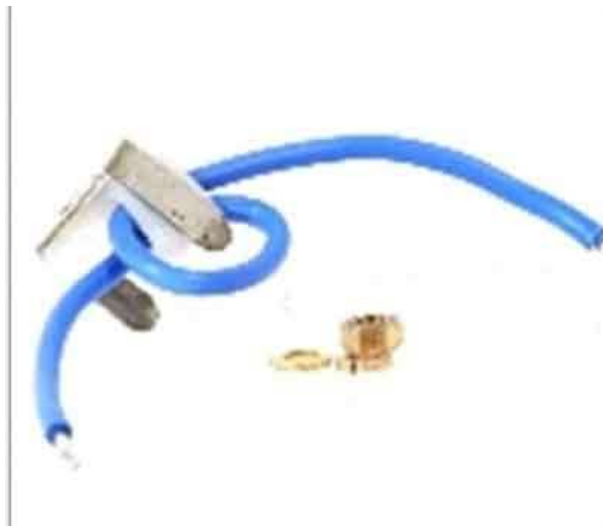
One of the metal parts of the pickup, and the nylon part that acts as a former for the wire, are detachable and may get lost. The Parts catalogue indicates these are 27H8215 for the 'Core', and 13H784 for the 'Loop-sleeve (nylon)'. Googling the first of those has a couple of suppliers describing it as a 'tachometer retaining strap', which doesn't seem to be the right thing, and they also give applicable dates from 64 to 76 and say it is also for the V8, both of which are clearly incorrect. But A-Head 4 Healeys converts that part number to 1S4150, which appears to be the complete assembly of metal and nylon parts, plus wire, washer and nut, at £22. Rimmer only has the first part, Moss both at £19 but without the washer and nut. (Image: [A-Head 4 Healeys](#))

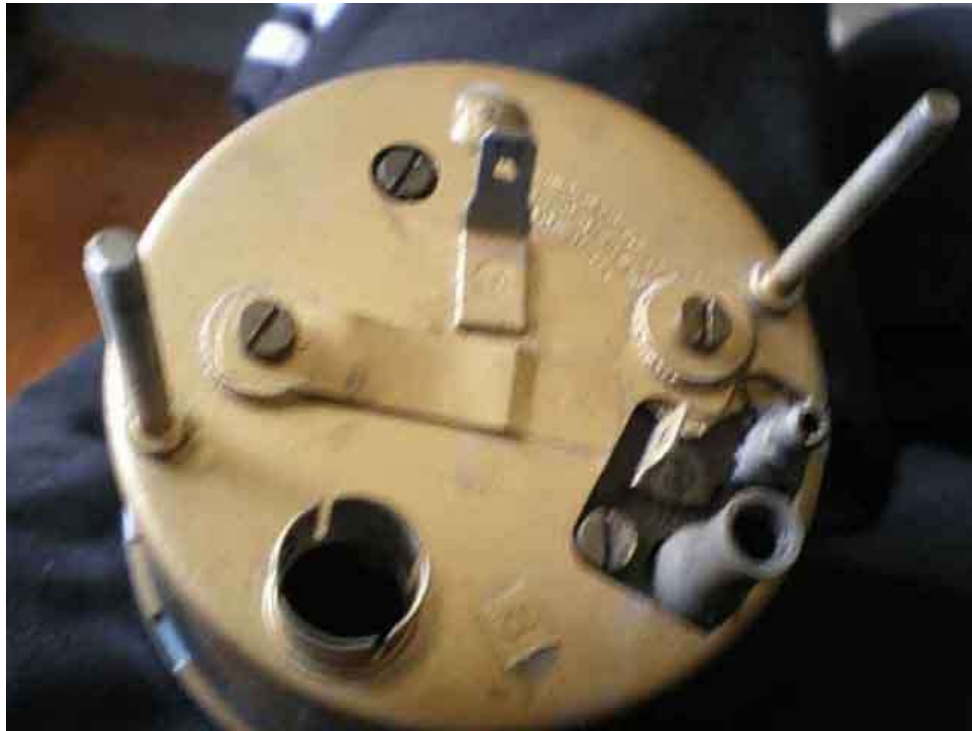
... this time with earth wires going to a spade spot-welded to the tach case instead of under one of the knurled screws. This type only has the night-time illumination in the gauge. *Photos: Bill Mason*

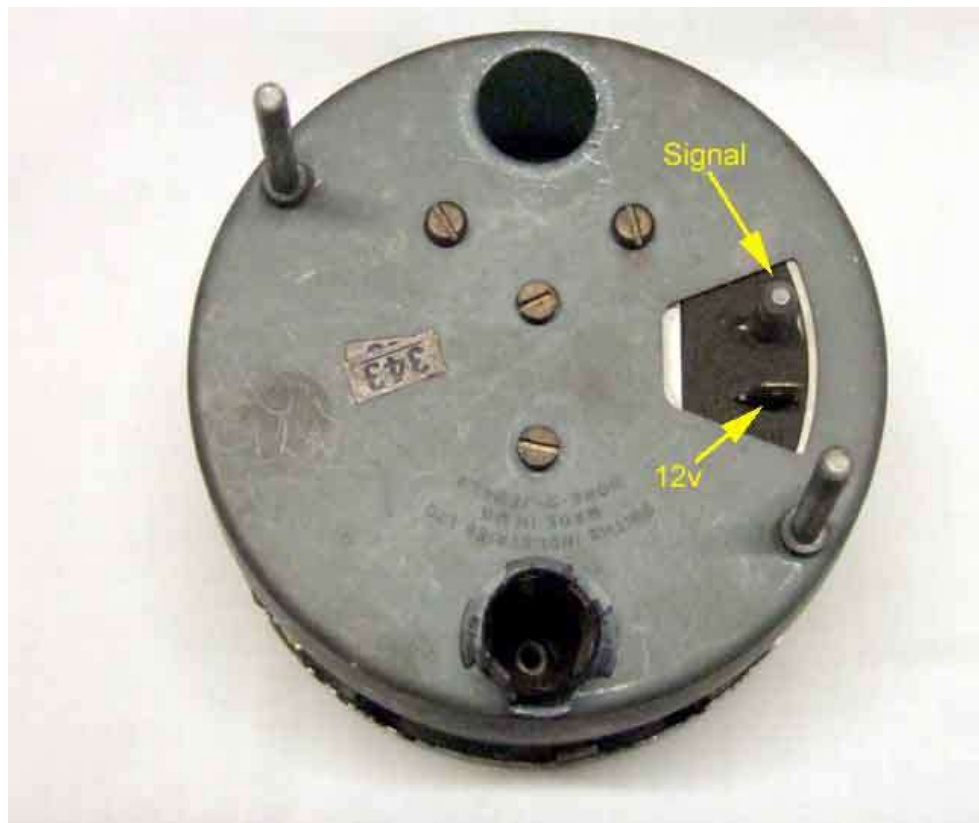
Chrome-bumper voltage-triggered 4" RVC tach i.e. 73 and 74, with male bullet for white/black signal wire and 12v spade (green wire) close by. The earth will be a tag under one of the knurled nuts that fix it to the dash. Plain hole for the night-time bulb at the top, insulated hole for the ignition warning light at the bottom. The signal bullet on this tach (and the rubber bumper version) seem to be the standard bullet size:

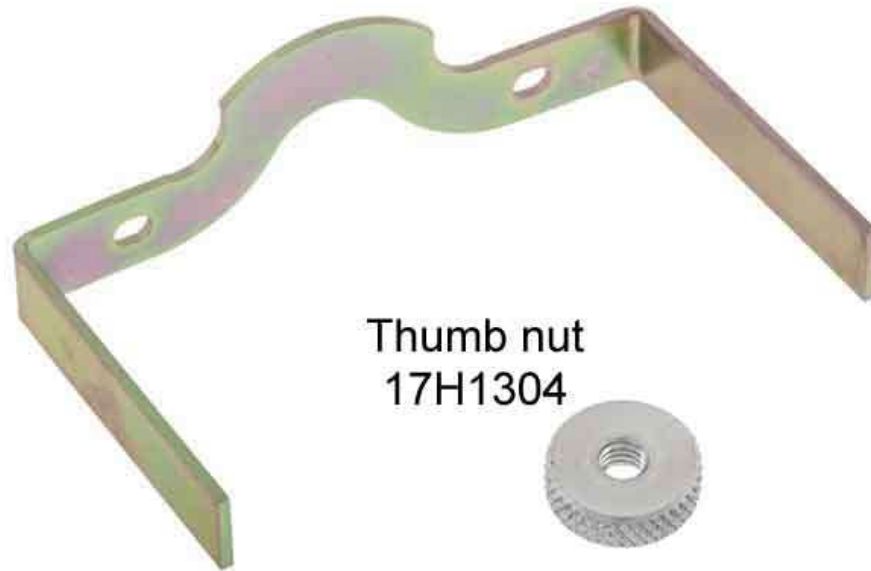
AJH5176 for 62 to 64 speedo and tach with thumb nut 17H 1304 and spring washer: ([Moss Europe](#))

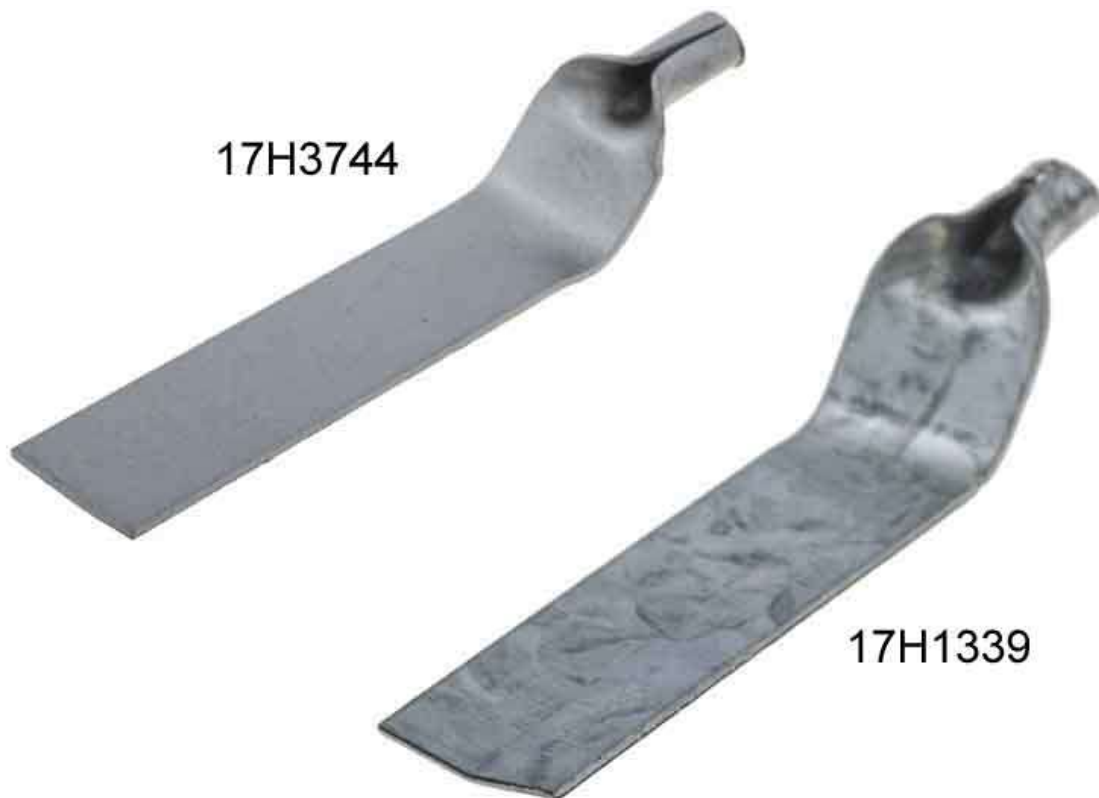
17H3744 for 65 and on CB speedo and tach, subtly different 17H1339 for RB, using the same thumb nut as above with a shake-proof washer: ([Moss Europe](#))

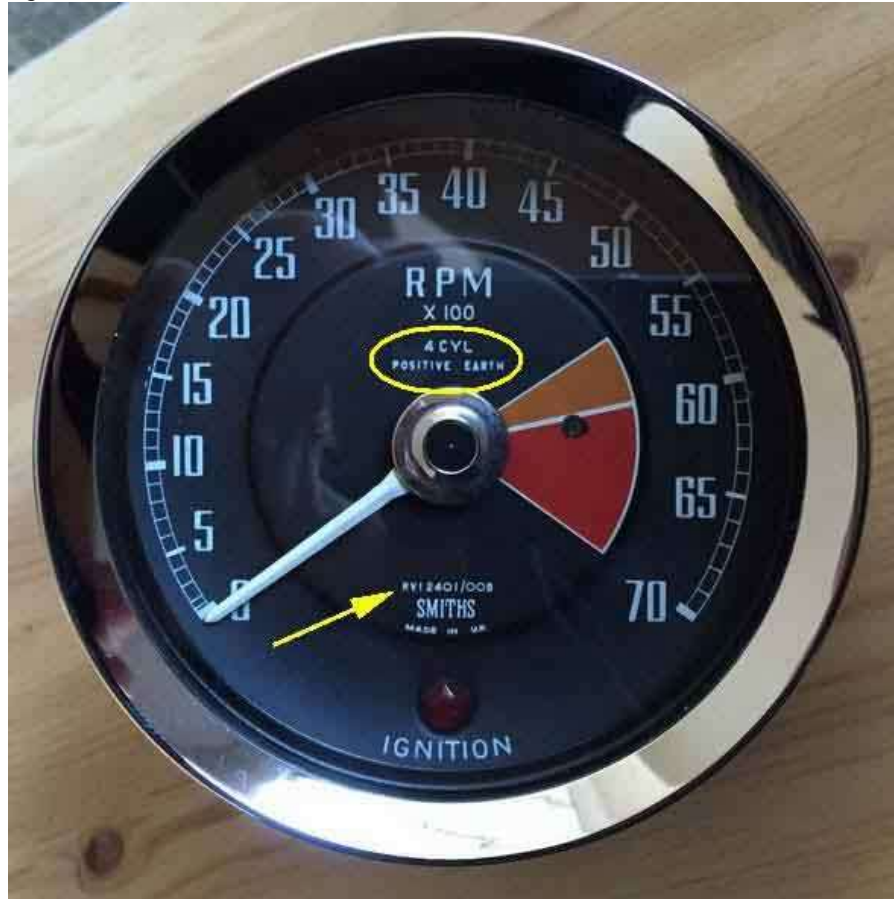
RVI/RVC designation and reference number is positioned by the 'SMITHS' (arrow). The **original** polarity is also indicated (circled), probably on all chrome-bezel tachs, but not the 77 and later plastic tachs. This is an RVI 2401/00B positive earth for 1964 to 1967 as used in all markets. Note that a PO may have changed the internal wiring to convert it to negative earth and not changed the legend on the face.

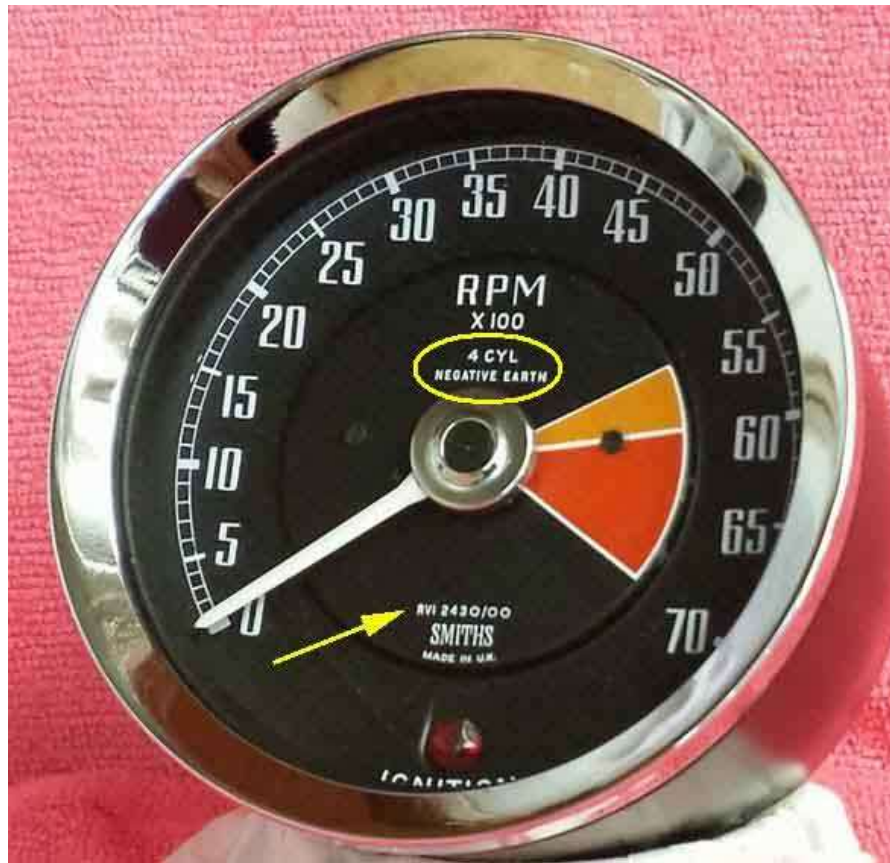
This is an RVI 2430/00 negative earth for 68 to 72 as used in markets other than North America, but also used in Canada for 1968.

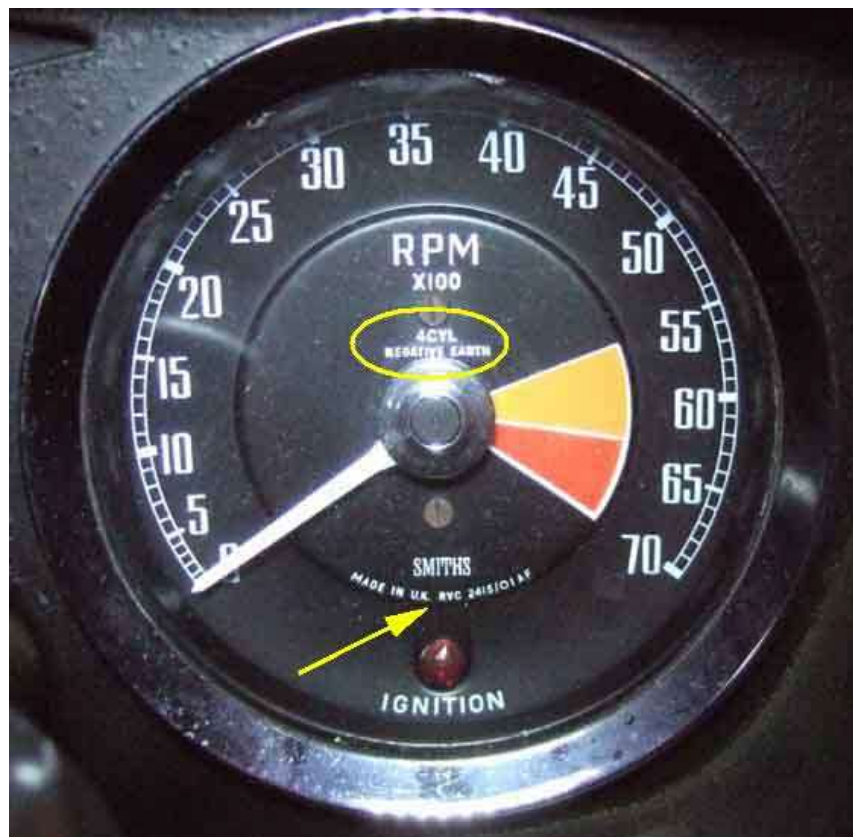
An RVC 2415/00AF (and hence negative earth) as used in markets other than North America, Sweden and Germany from 1973 to the end of chrome bumper production.

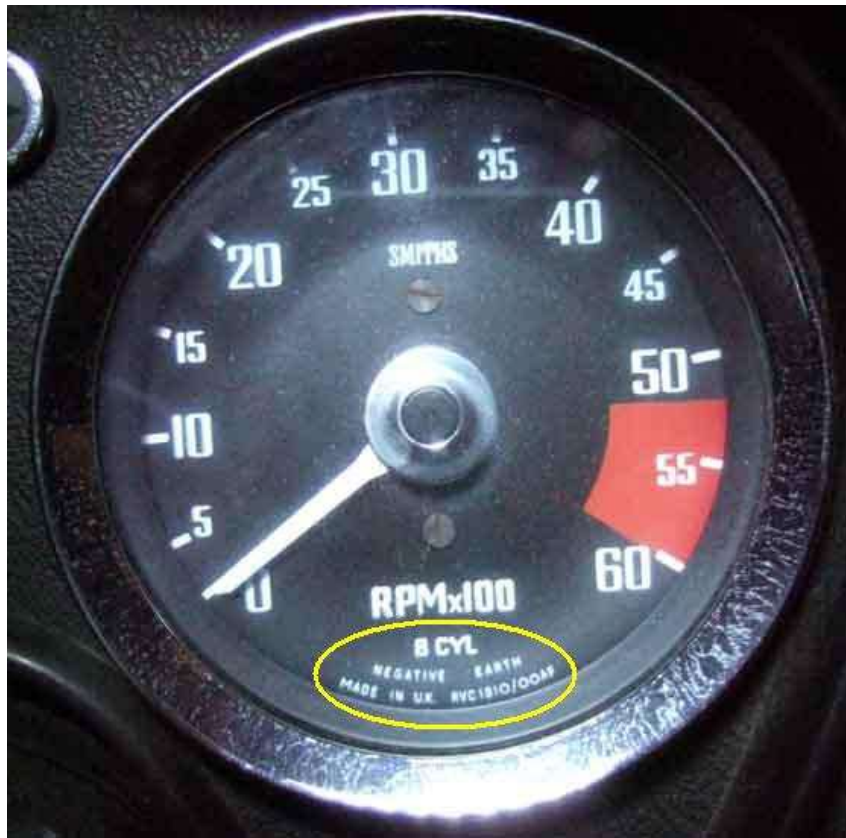
An RVC RVC/1810/00/AF used on V8s, still carrying the polarity indication.

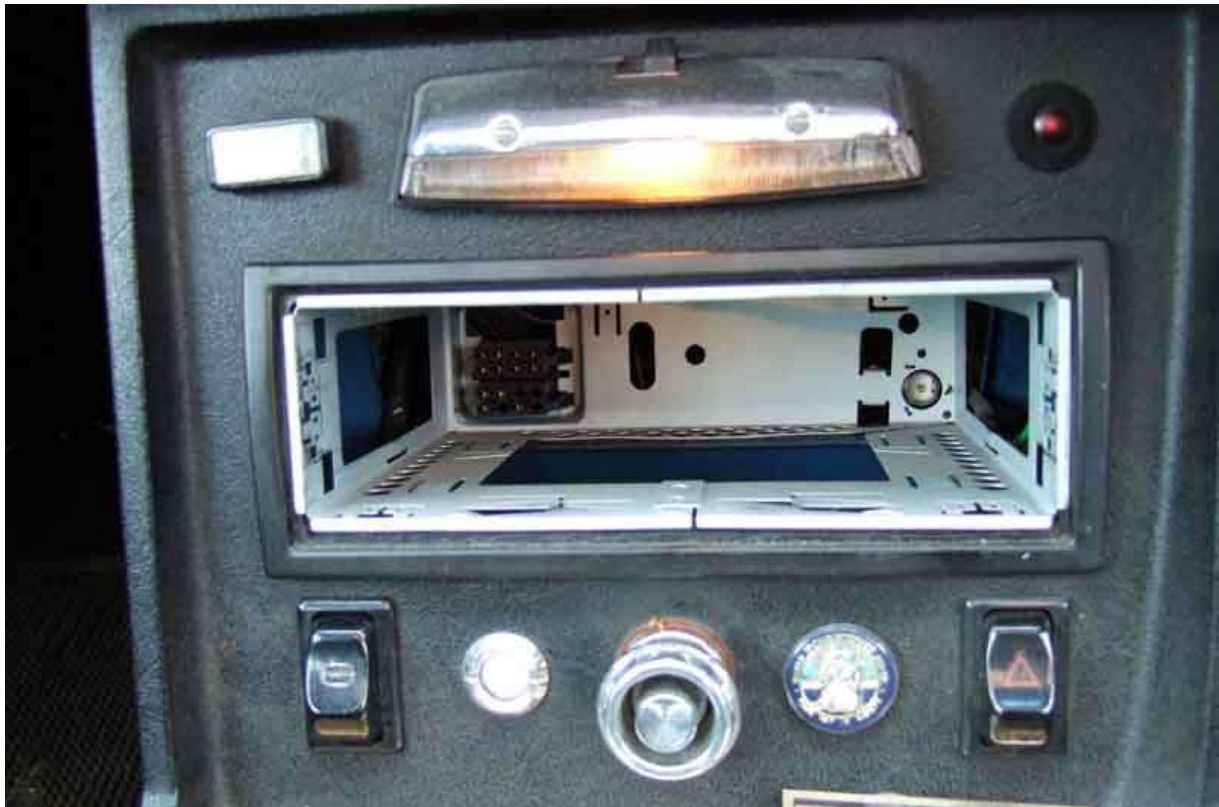
... removed (the surround is cut from an old Metro blanking plate to cover up a mass of holes a PO had drilled around the edge of the opening):

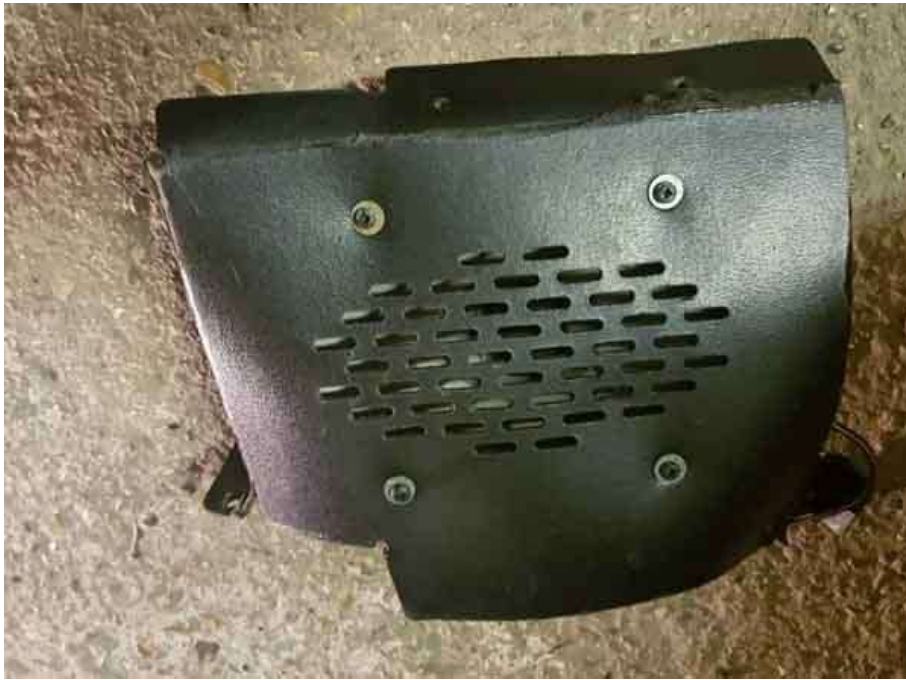
Factory mono speaker baffle:

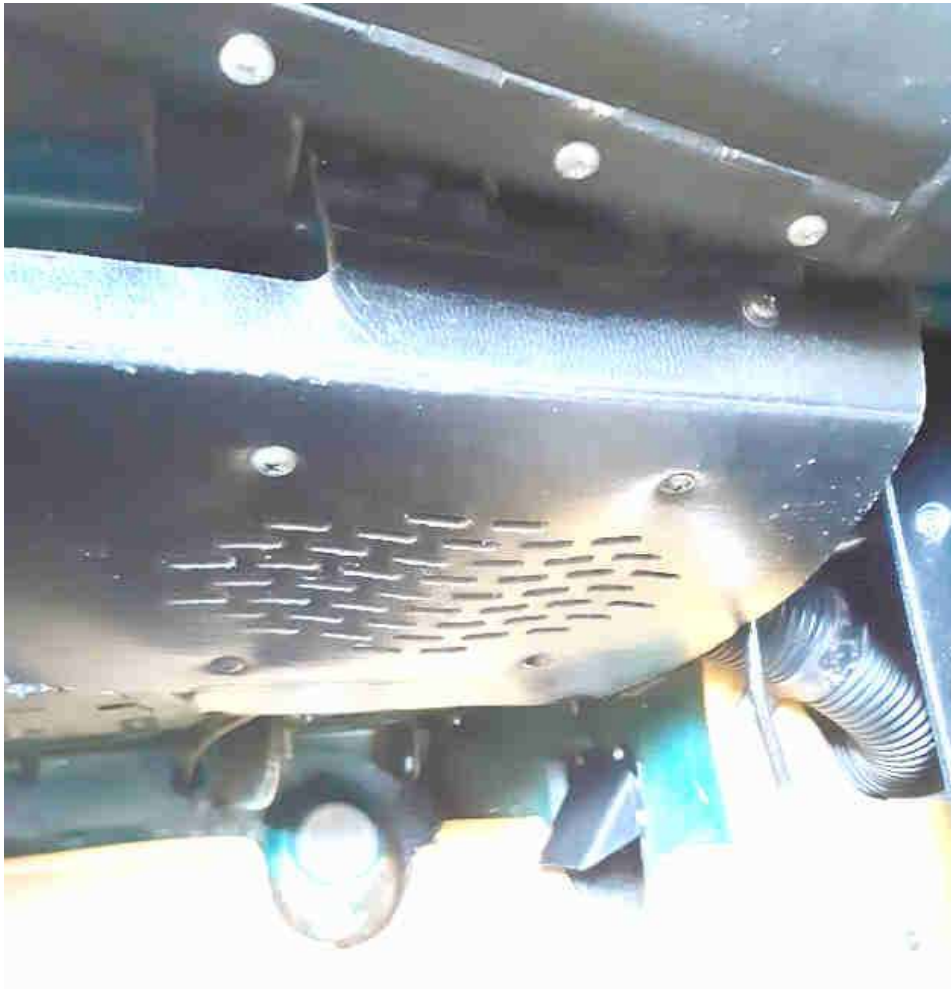
Different mounting points to the above drawing in this installed picture from Mark Denny:

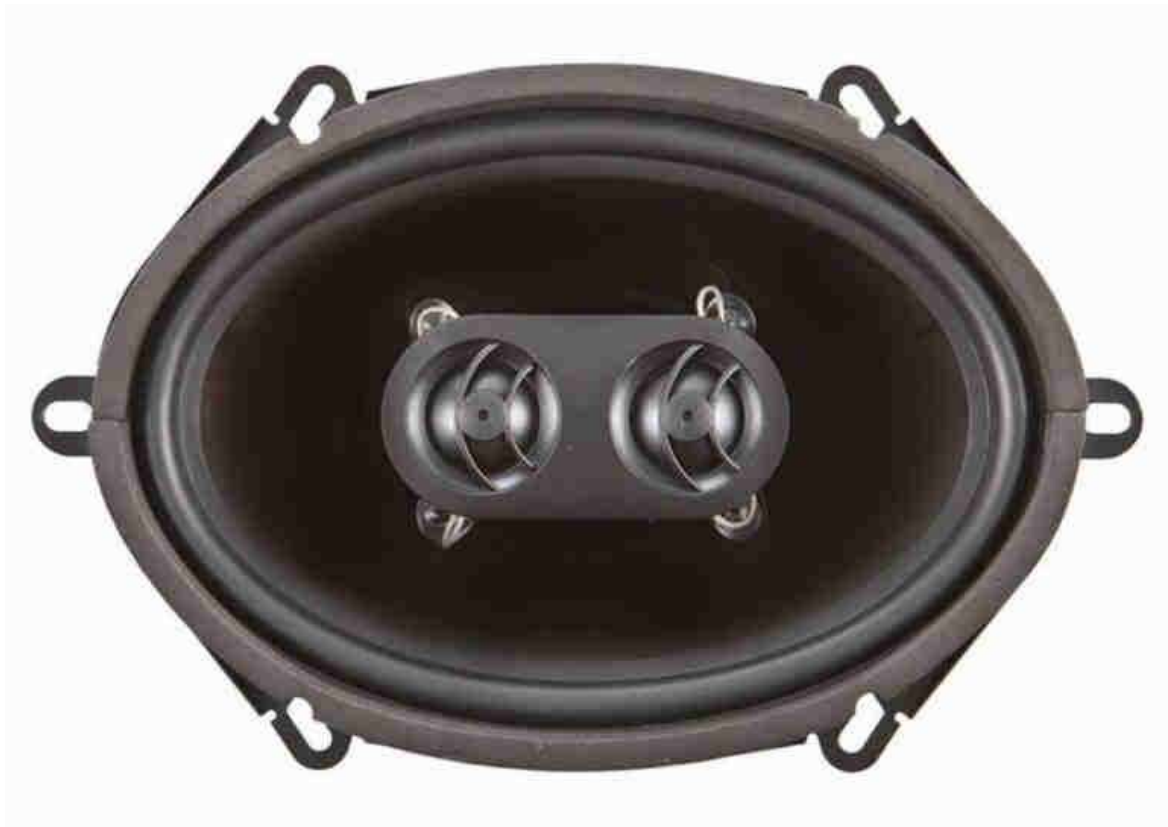
'Dual voice-coil speaker' (Google it), ideal for stereo output using a single speaker, particularly in the early centre console. There are many types, this is just one example: ([Classic Car Stereo](#))

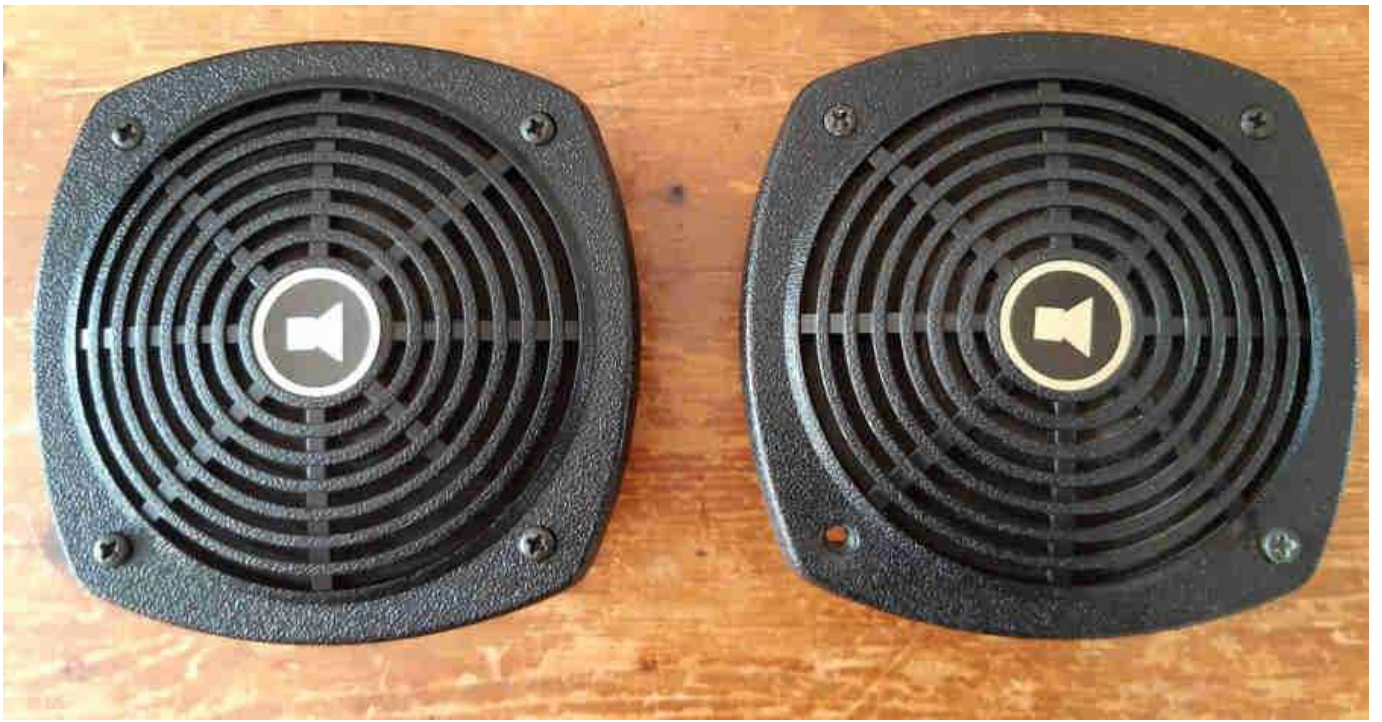
77-on (America) and 78/79 (UK) factory speakers: ([Mark Denny](#))

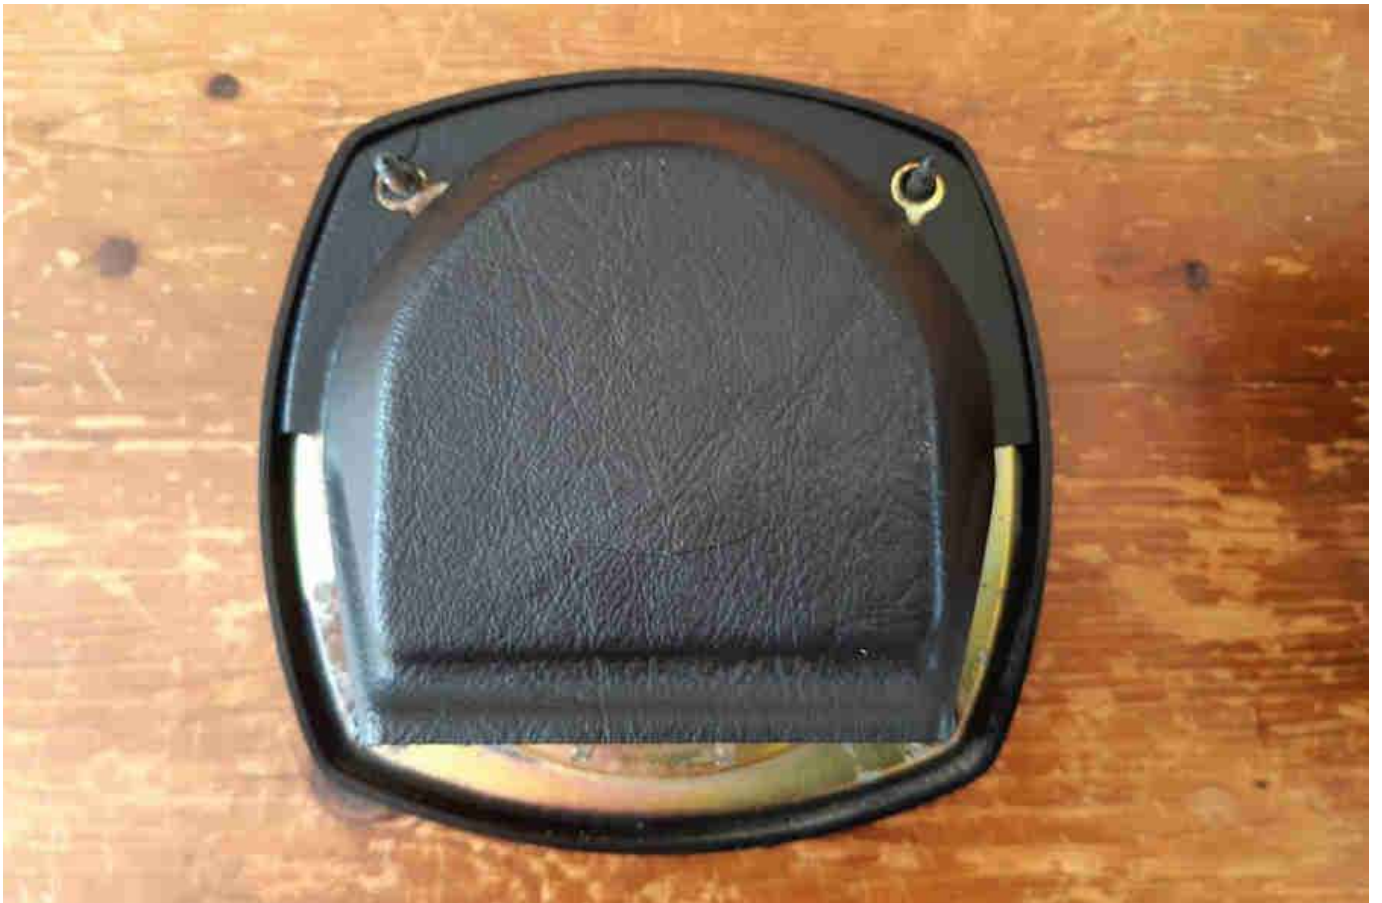
Shrouded to protect the cone and voice-coil from water getting past the drop-glass seals:

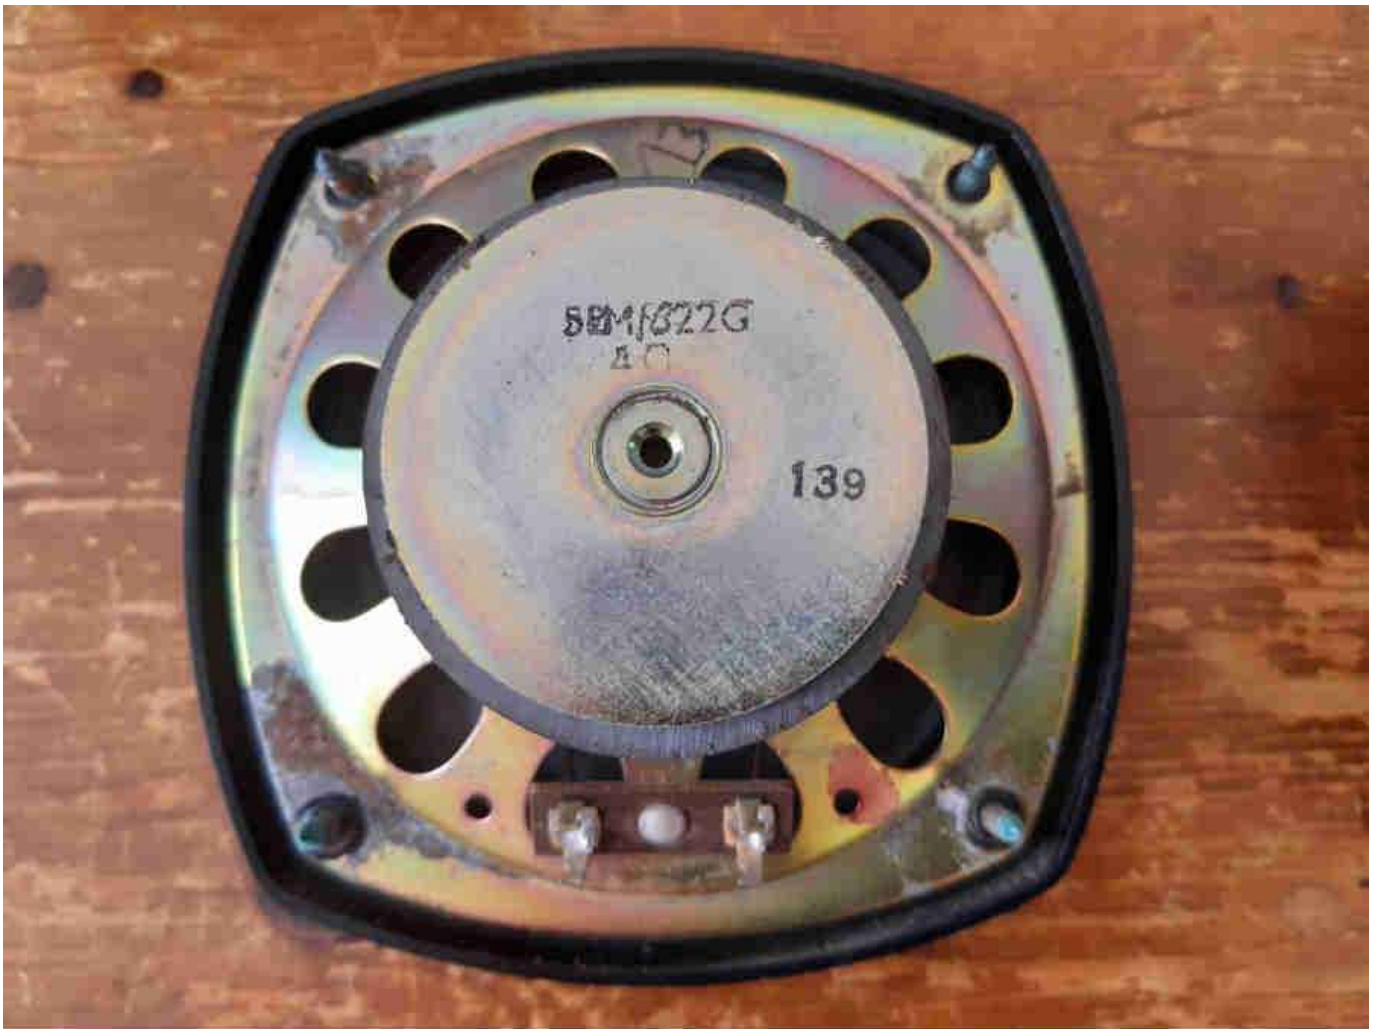
Shroud removed:

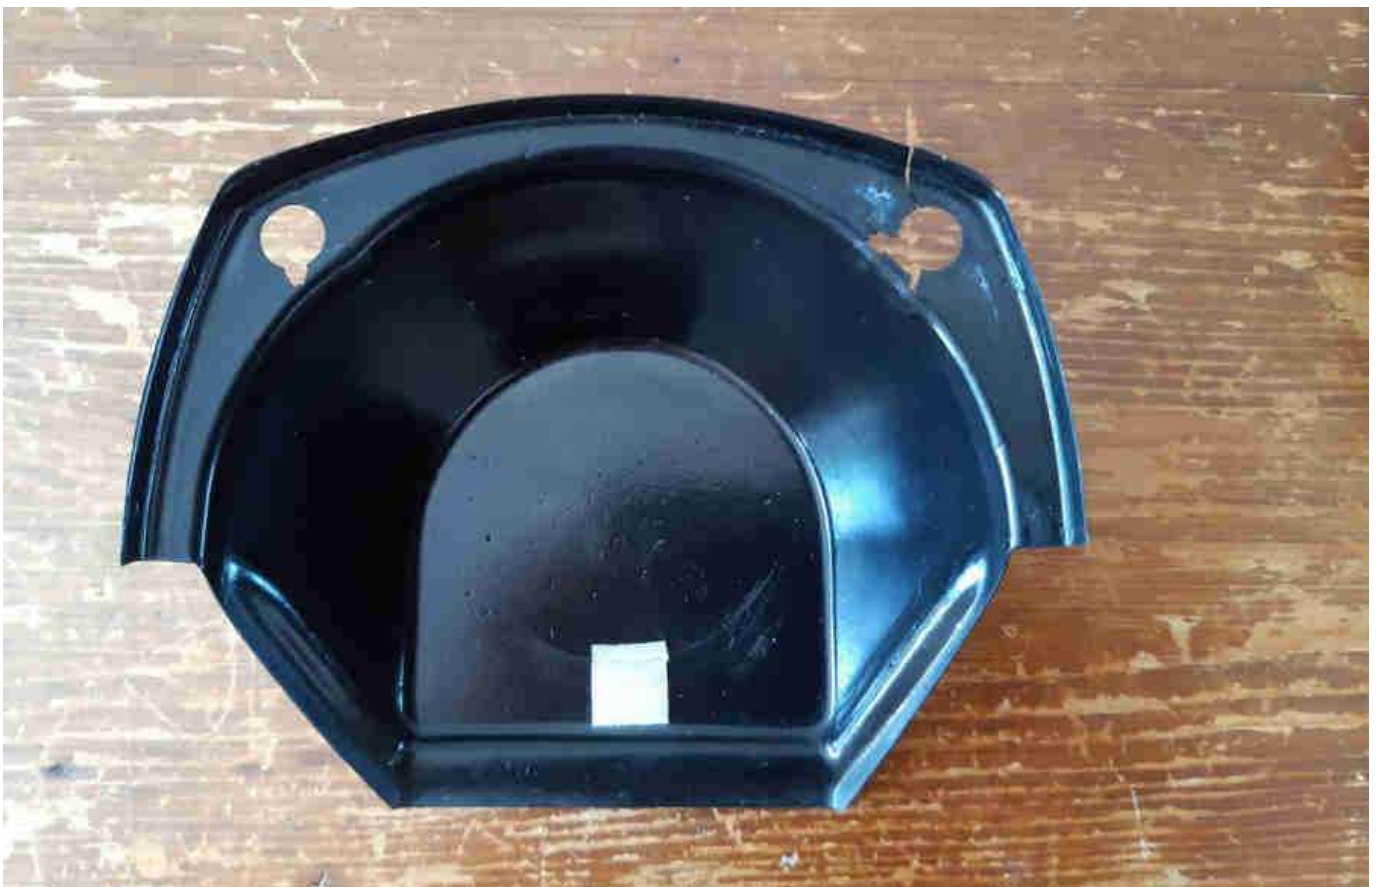
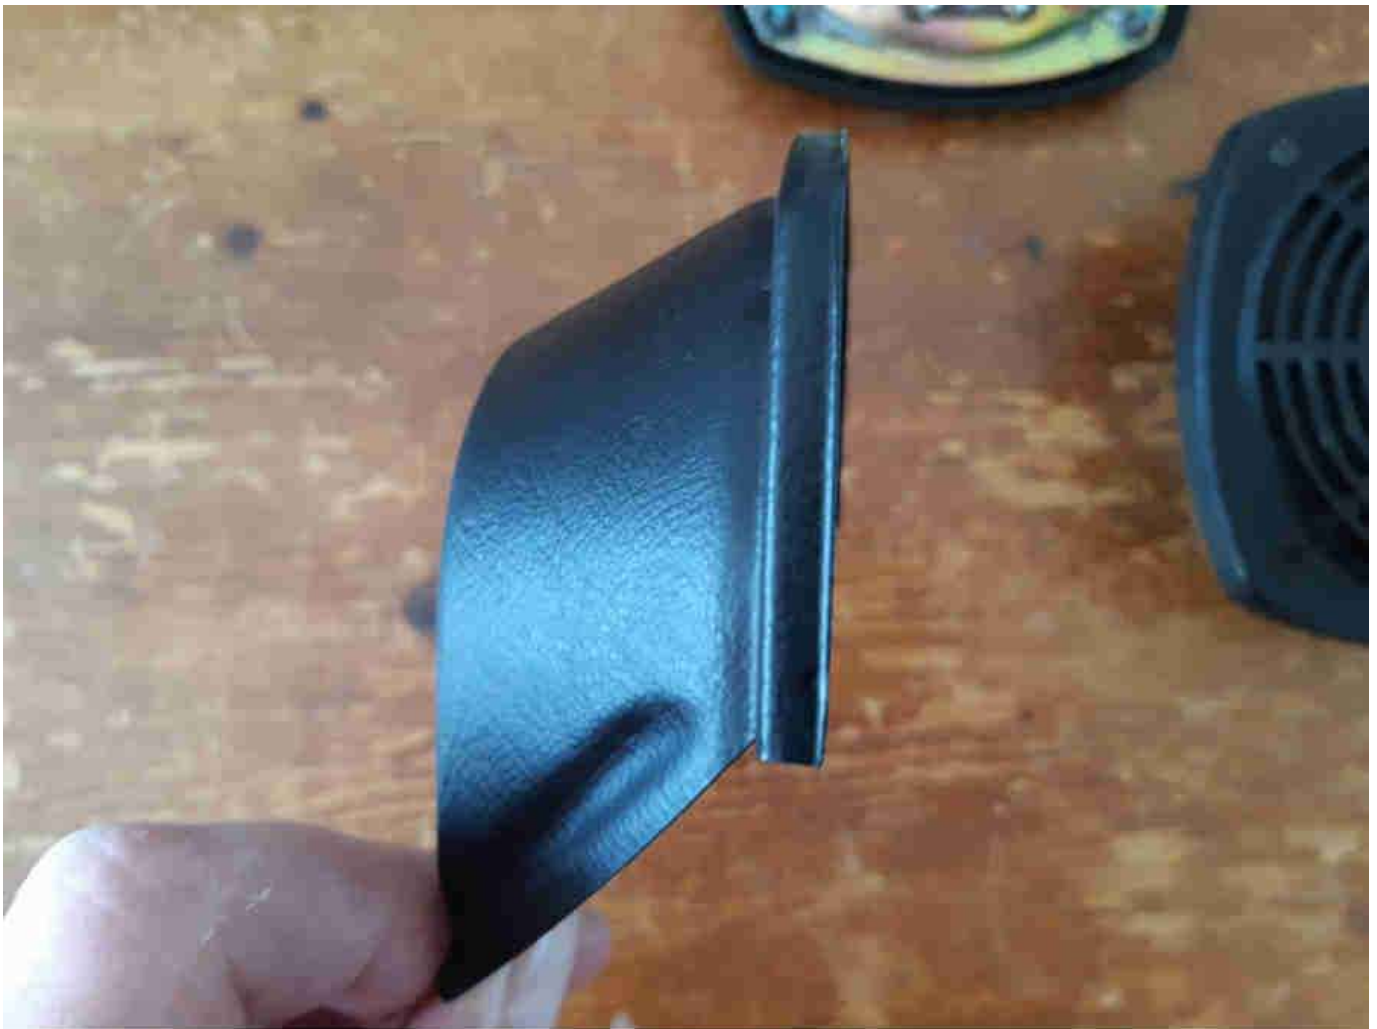
The shroud:

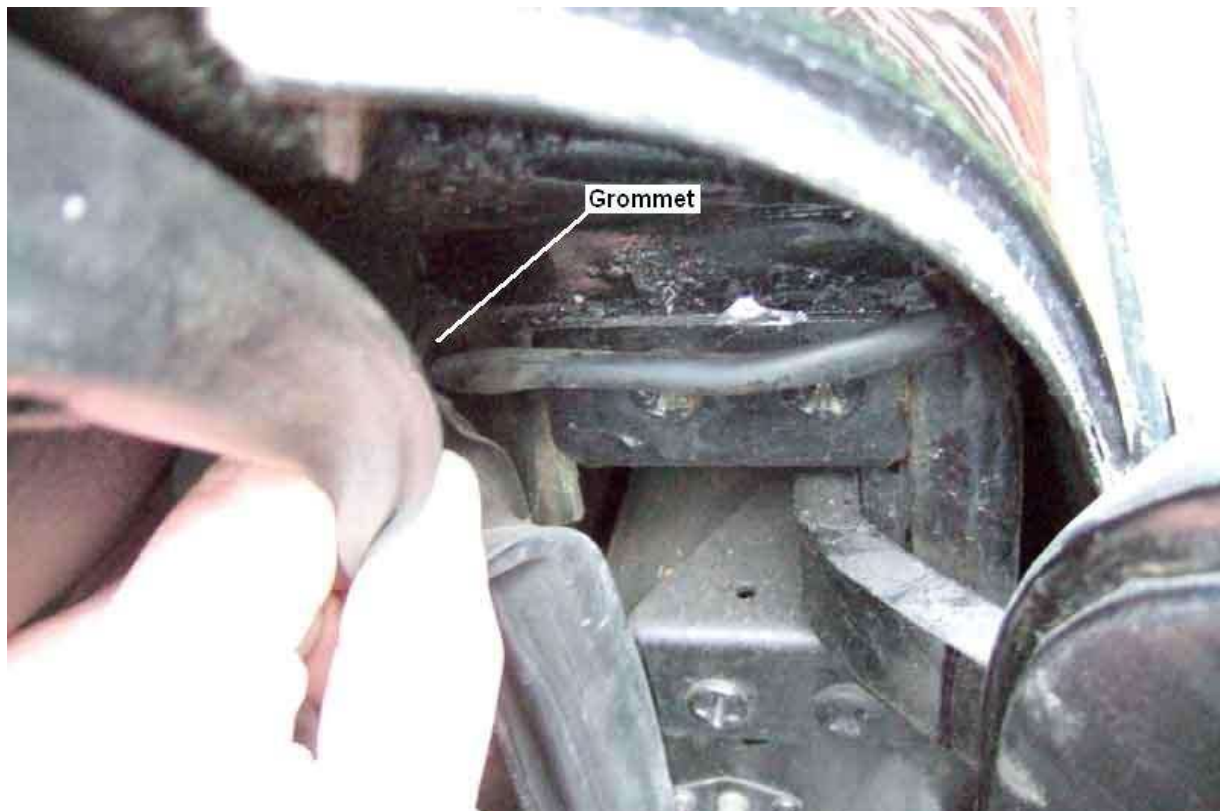
Factory cable routing, showing the grommet in the panel between door space and cabin ...

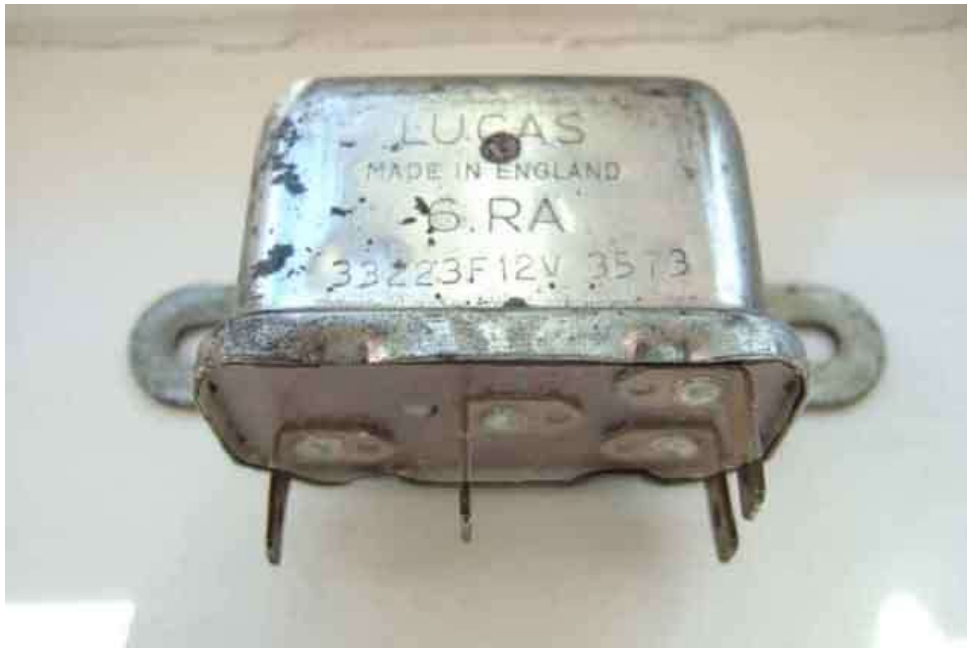
A general view of a typical 6RA 4 terminal, 4 spade type:

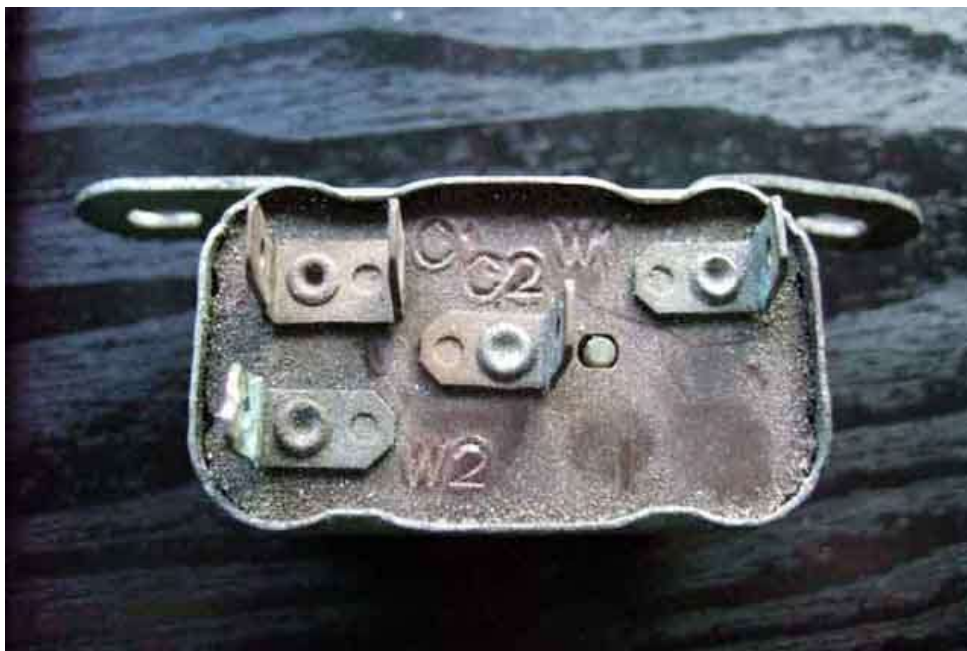
Four terminals but five spades. The double spade on terminal C1 offers a convenient branching point for a 12v supply wire to another circuit:

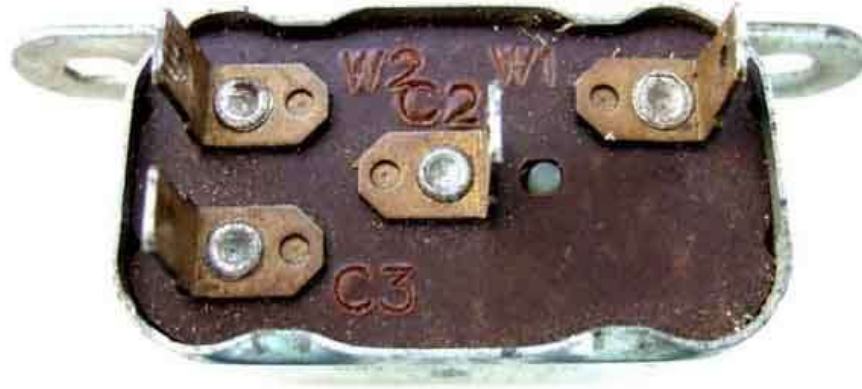
An alternative 4 terminal, 4 spade but with W2 in a different position and a C3 instead of a C1. This is a relay where the contact is 'normally closed':

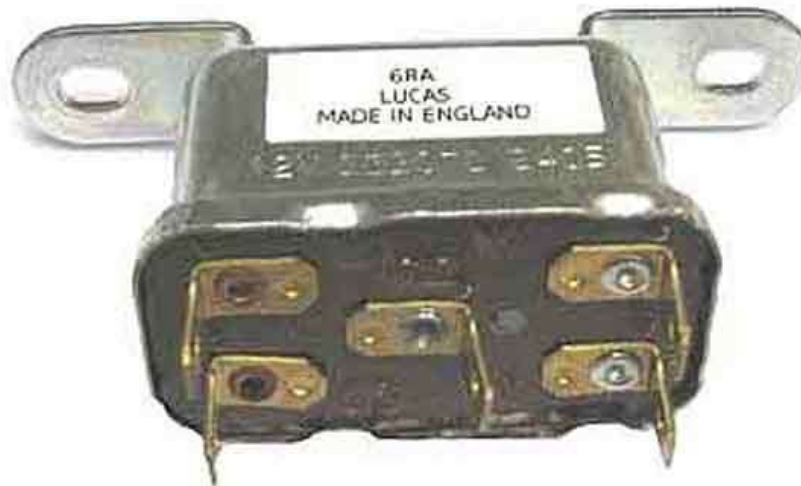
Five terminals and five spades, this has a 'changeover' contact i.e. when the relay opens it switches a common contact (C2) from a 'normally closed' contact (C3) to a 'normally open' contact (C1):

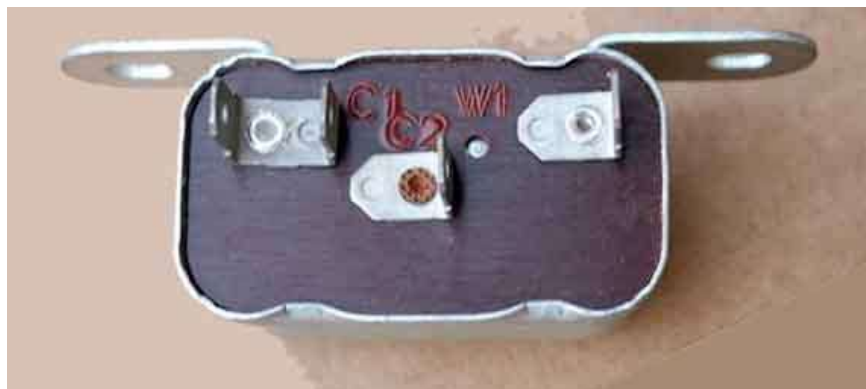
The three terminal, four spade relay 33188/SRB102 originally used for the cooling fans in V8s. The system may have been dealer-modified with a 4-terminal, 5-spade relay to take the load of the fans off the green circuit fuse. Seemingly obsolete, they were also used on Standard/Triumph, BSA motorcycles, Cobra, Jaguar/Daimler and Ferrari, for the horns and other circuits. Contrary to several opinions the missing fourth terminal (W2) is not replaced with an internal earth i.e. via the can, but instead is internally connected to the C2 terminal. The 12v supply is connected to this terminal, an earth from the switch is connected to W1 to operate the relay to the C2 12v supply, which is then extended out through the C1 terminal to operate the fans or horn: ([TR Register](#))

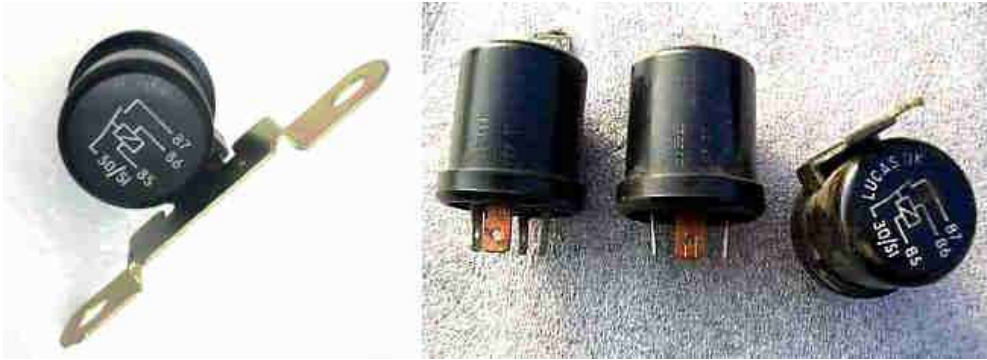
Cylindrical Lucas relays used on later MGBs, designated 26RA, SRB402. These can have either the same mounting points as the 6RA (left), or a single mounting point creating space for an additional relay if needed:
