Voltmeters

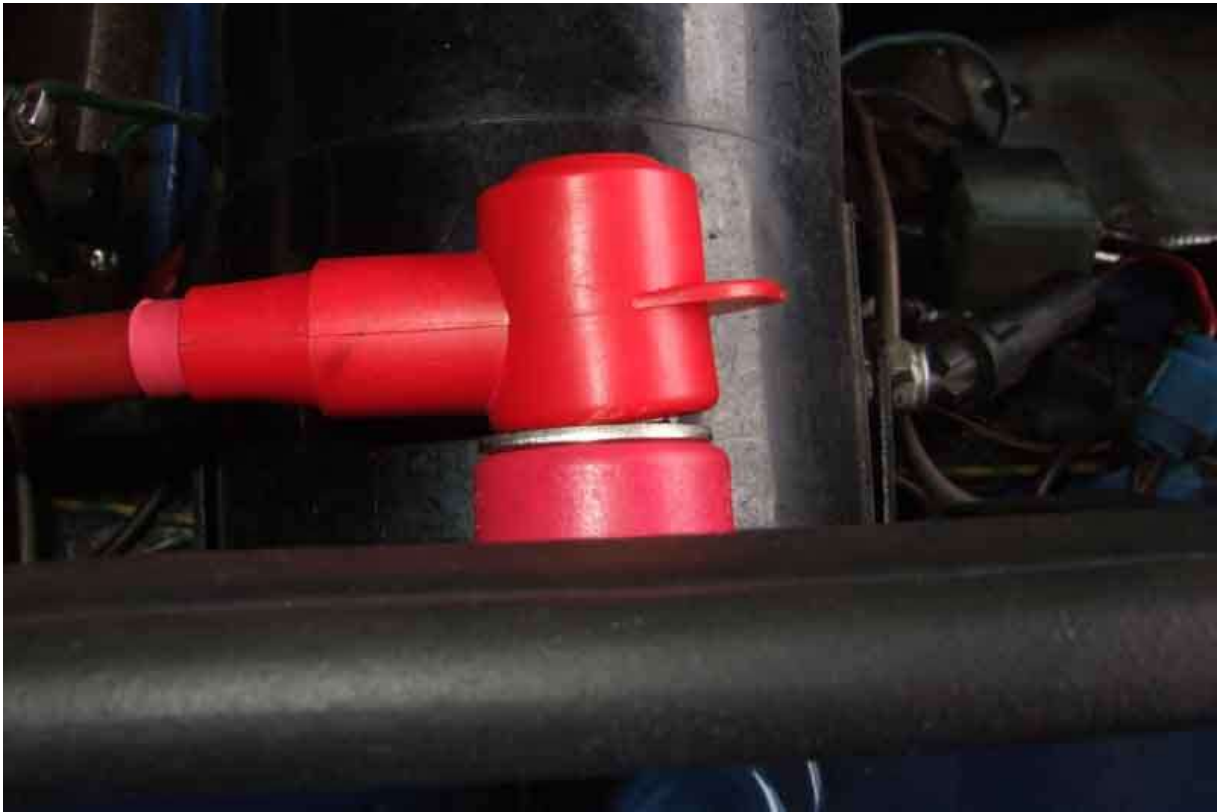
The cap is a good fit over the cable and the nuts on the post but there are two problems - one is that it leaves a washer exposed which is live:

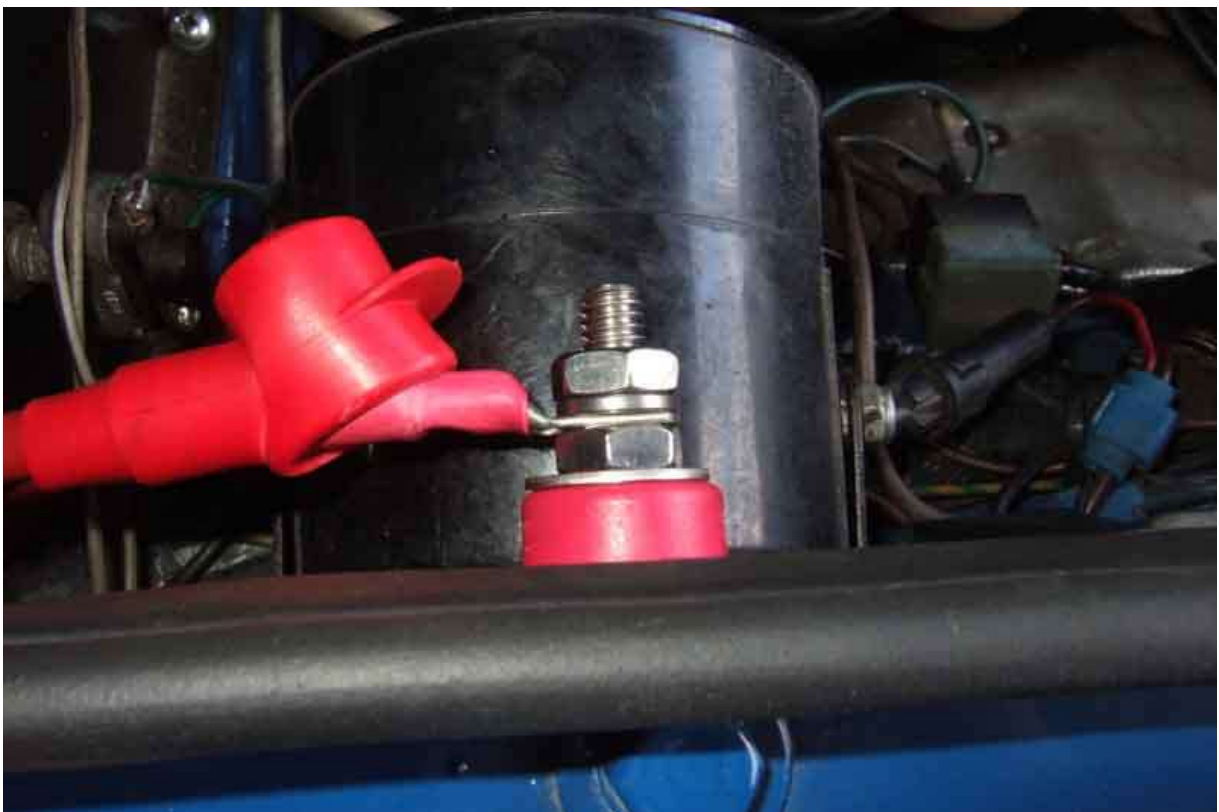
And the other is that the stud is too long for my specific needs which makes it difficult to get the cap over it:

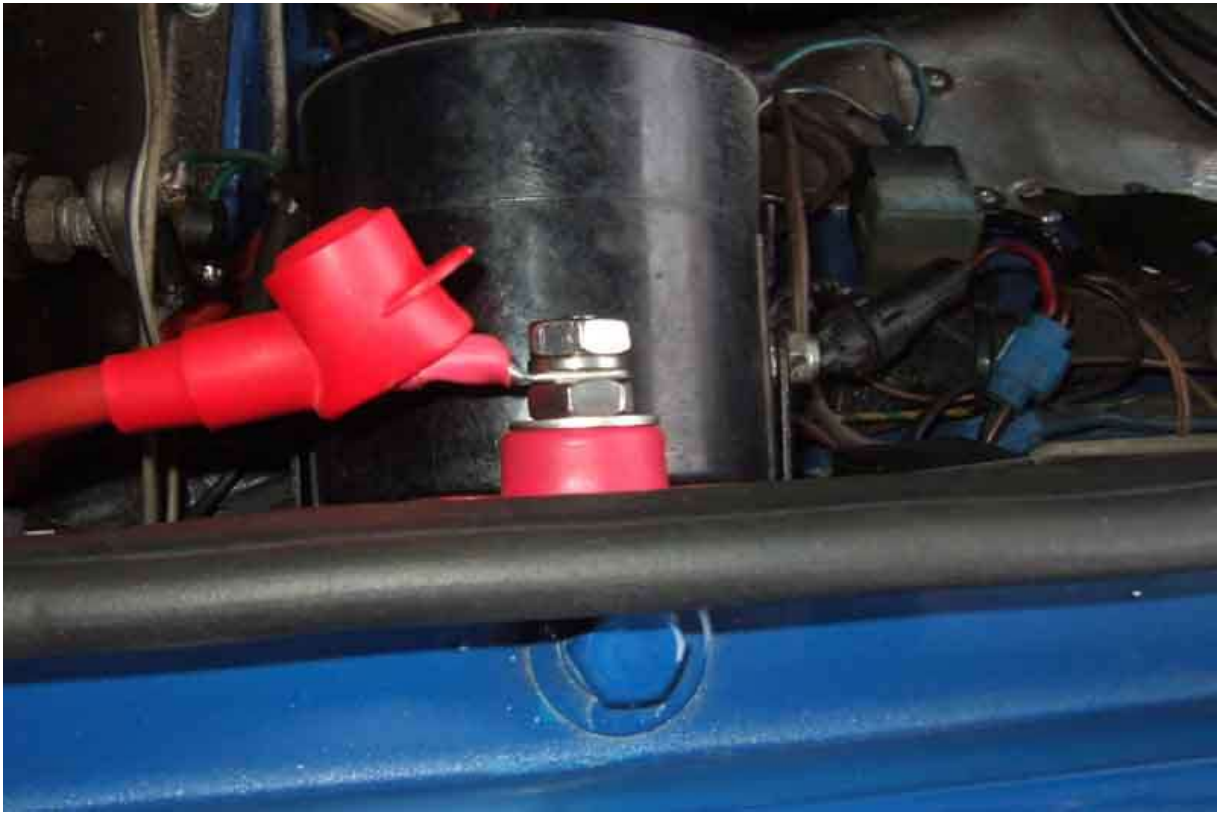
With the stud shortened the cap is much easier to fit:

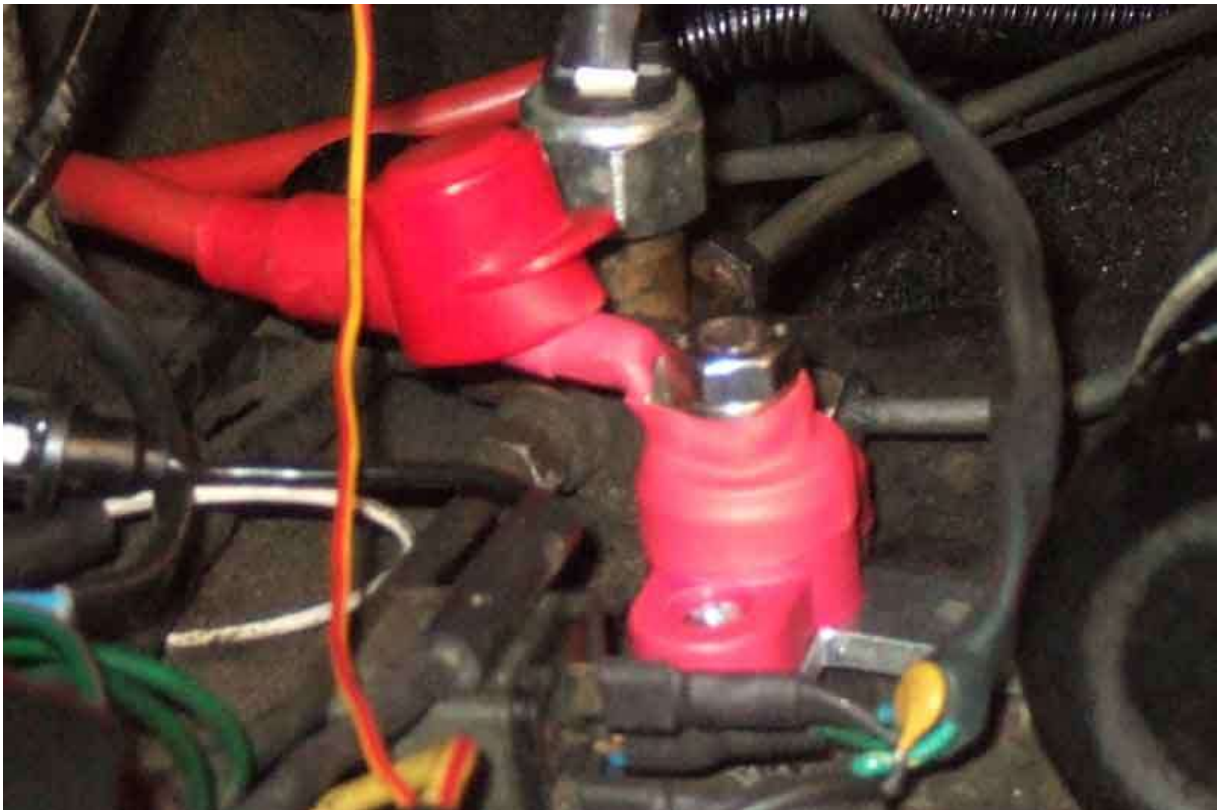
I did wonder if that would then allow the cap to be pushed over the washer onto the base of the stud, but it's not quite big enough. So I have ordered some 1" red heat-shrink to fit over that part of the base (which is 0.96" dia), the washer, and the lower nut.

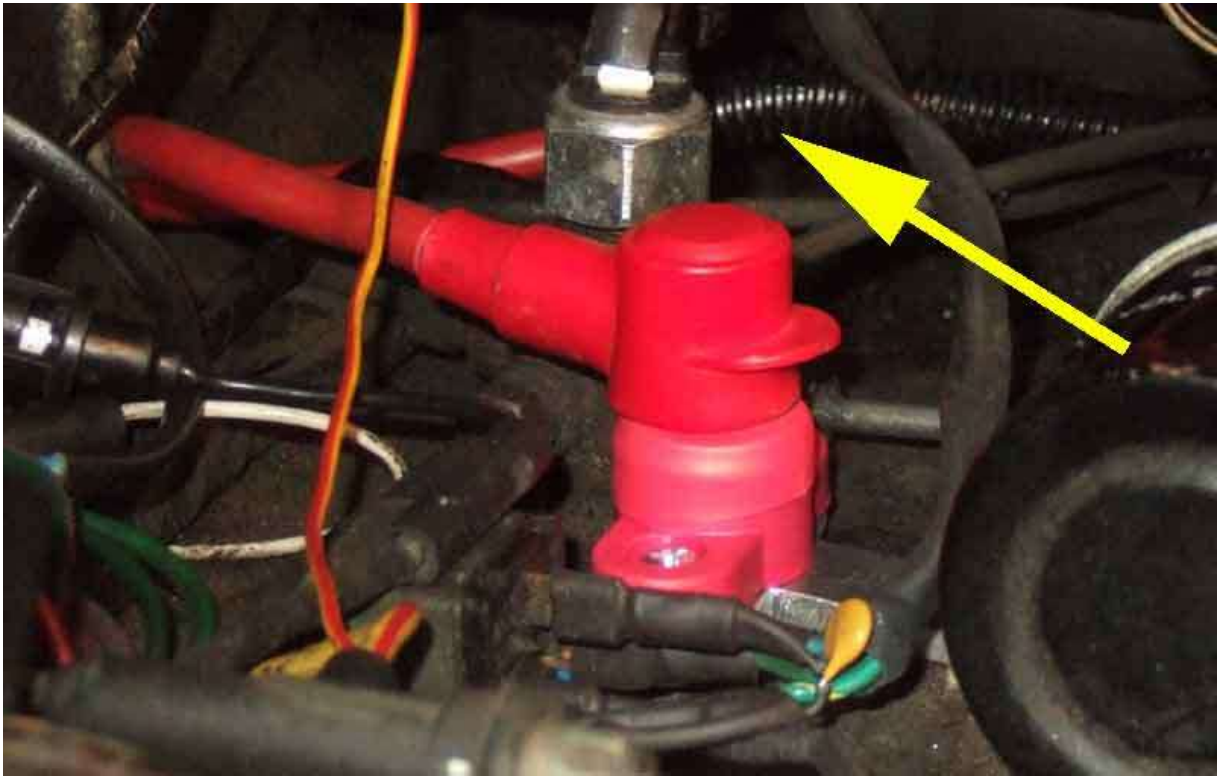
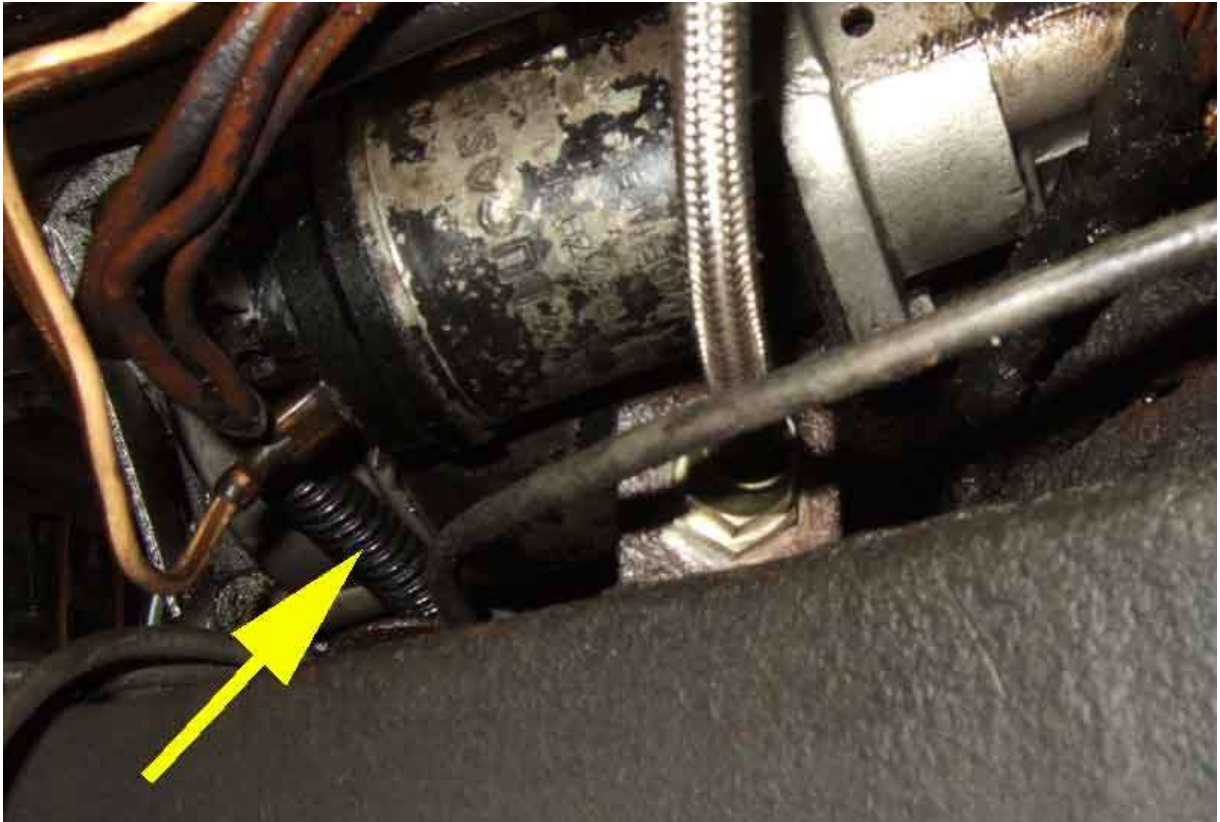
I also put split corrugated sheathing round the lower part of the cable where it passes between the engine and the chassis rail:

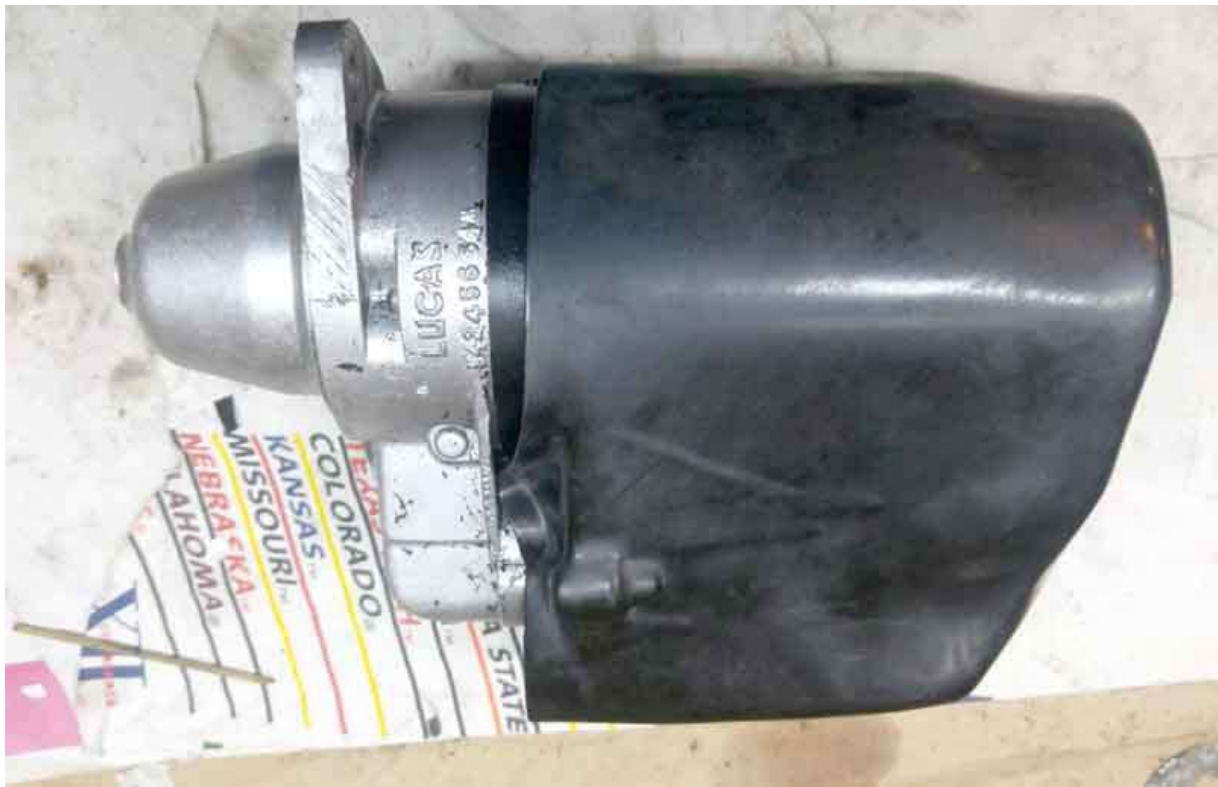
Rubber boot over the starter connections from May 72: (Ahmed EL Abasiry, Canada)

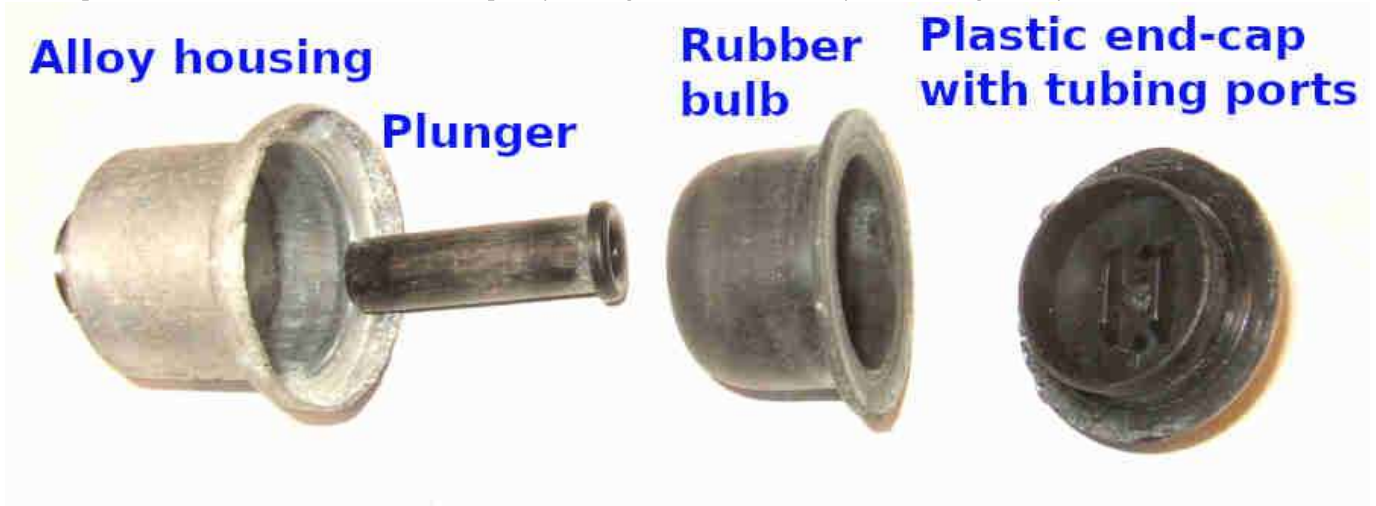
As simple as can be, and a testament to the quality of original rubber that they last as long as they have:

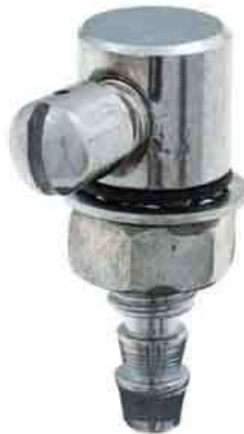
Two single nozzles on roadsters to 1977: ([Moss Europe](#))

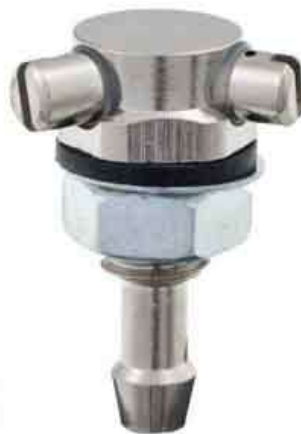
One dual nozzle on GTs to 1977: ([Moss Europe](#))

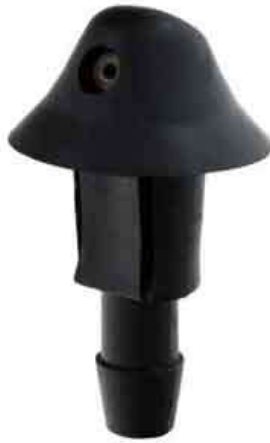
Two black plastic nozzles on all cars from 1978: ([Moss Europe](#))

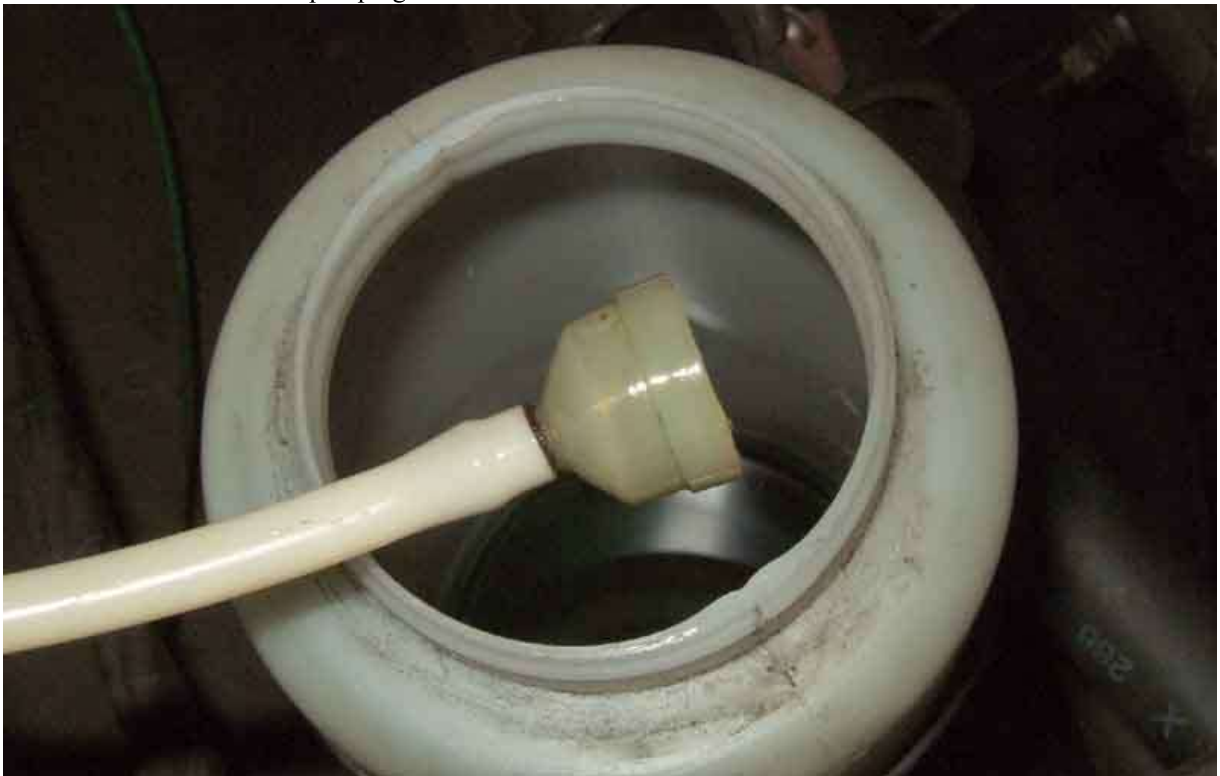
A one-way valve at the bottle is essential with the manual pump as otherwise the water runs back to the bottle as fast as you pump. Less so with the electric as pumping is continuous:

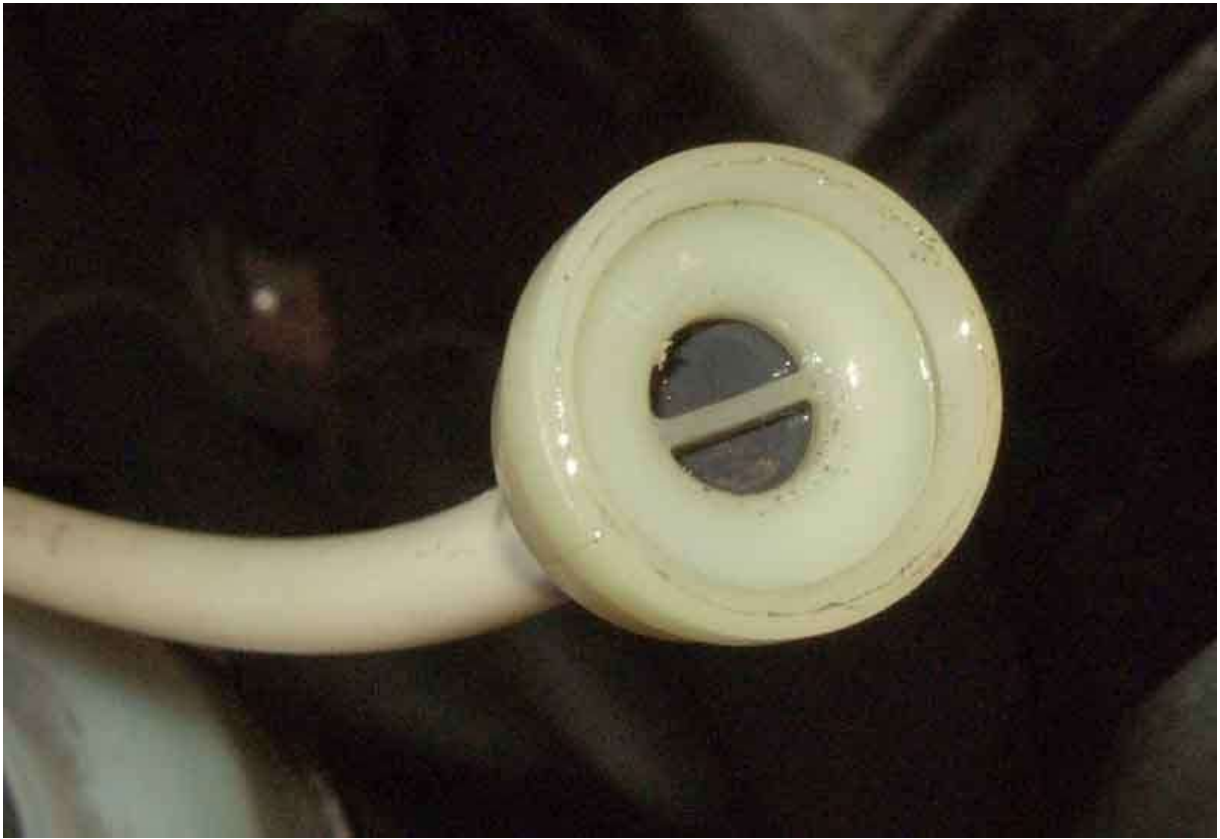
On Bee's bottle valve the valve flaps are visible so if there is a filter it must be behind those which would make no sense:

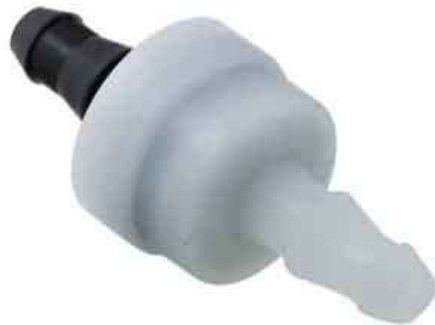
In-line valve. Parts Catalogue says "13H6501 (was BHA4610)" but does not indicate where it was used, [Moss Europe](#) says "GWW504 GT" and others indicate GT only, Brown & Gammons does not list it at all:

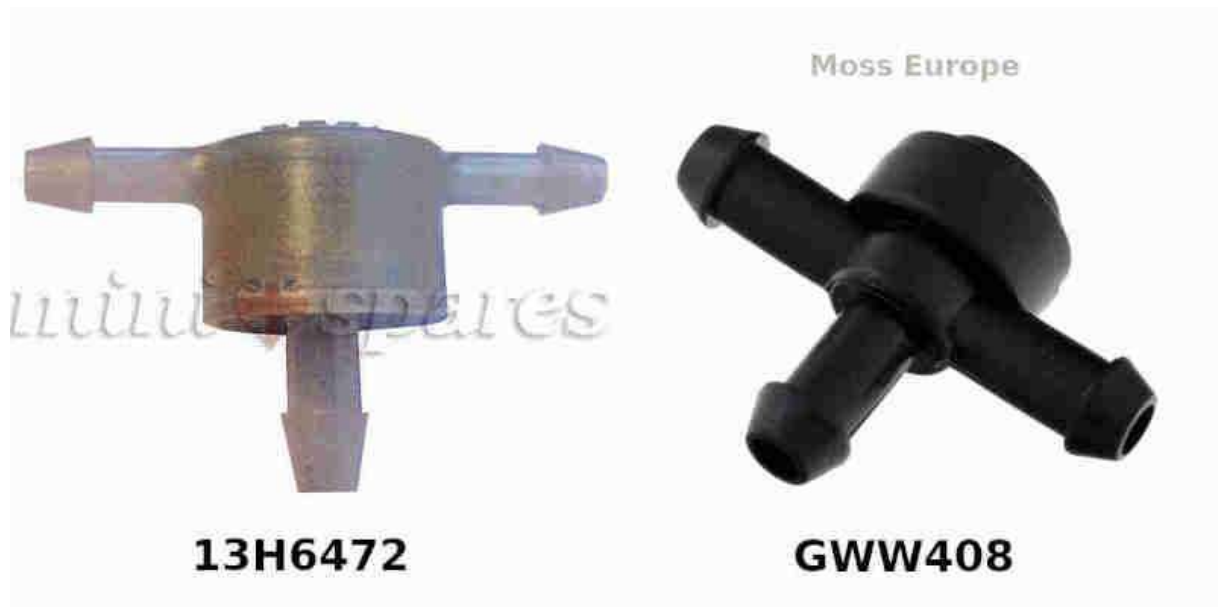
However roadsters prior to 1977 have dual nozzles with a tee linking them whereas GT have a single dual-port nozzle. So the roadsters need a tee, and that tee includes a valve. From 1977 both roadsters and GTs had that arrangement. The Parts Catalogues don't indicate by either the drawing or the description that this is the case, and the 77 and later catalogue seems to have a complete mis-match in item numbers between drawing and list, but one of the plain tees in the both catalogues depicted as 13H6472 includes the filter. GWW408 is a later number but few places seem to have either of them, some showing a separate tee and in-line valve with a short length of tubing to connect them:

Note that 13H6472 on the face of it needs larger bore tubing for the inlet port (and one supplier states that), whereas GWW408 ports seem to be the same (not known) size. The larger 13H6472 port is the same size as both pump ports, but one run of tubing connects the 4.7mm port on my bottle to the 5.7mm port on the manual pump.

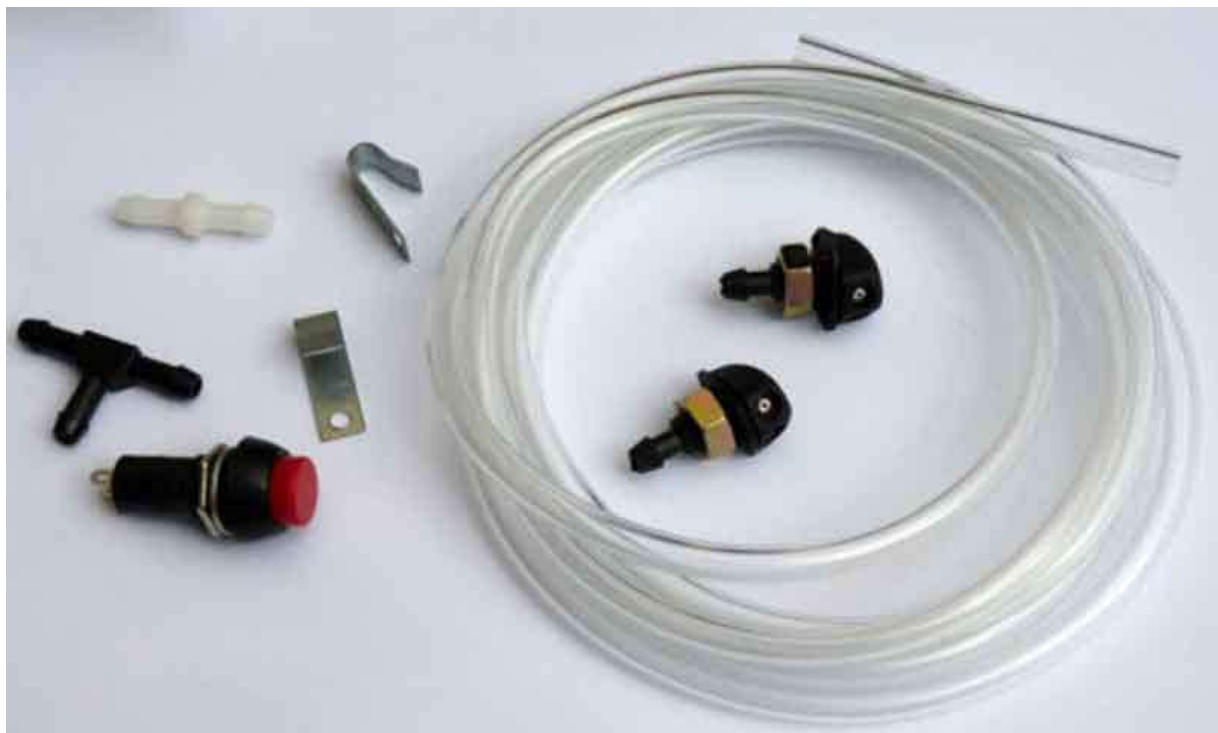
Dave Birkby: I tried to open the old pump to see if I could salvage it but I inevitably damaged the end doing so. Shame maybe because the problem was corrosion in the pump main bore that was simply jamming the plunger in the 'in' position. But as my plan was to fit an electric pump, I ordered a kit online which consisted of pipe, joiners, nozzle jets and a small momentary push switch, smaller diameter than the hole in the dash:

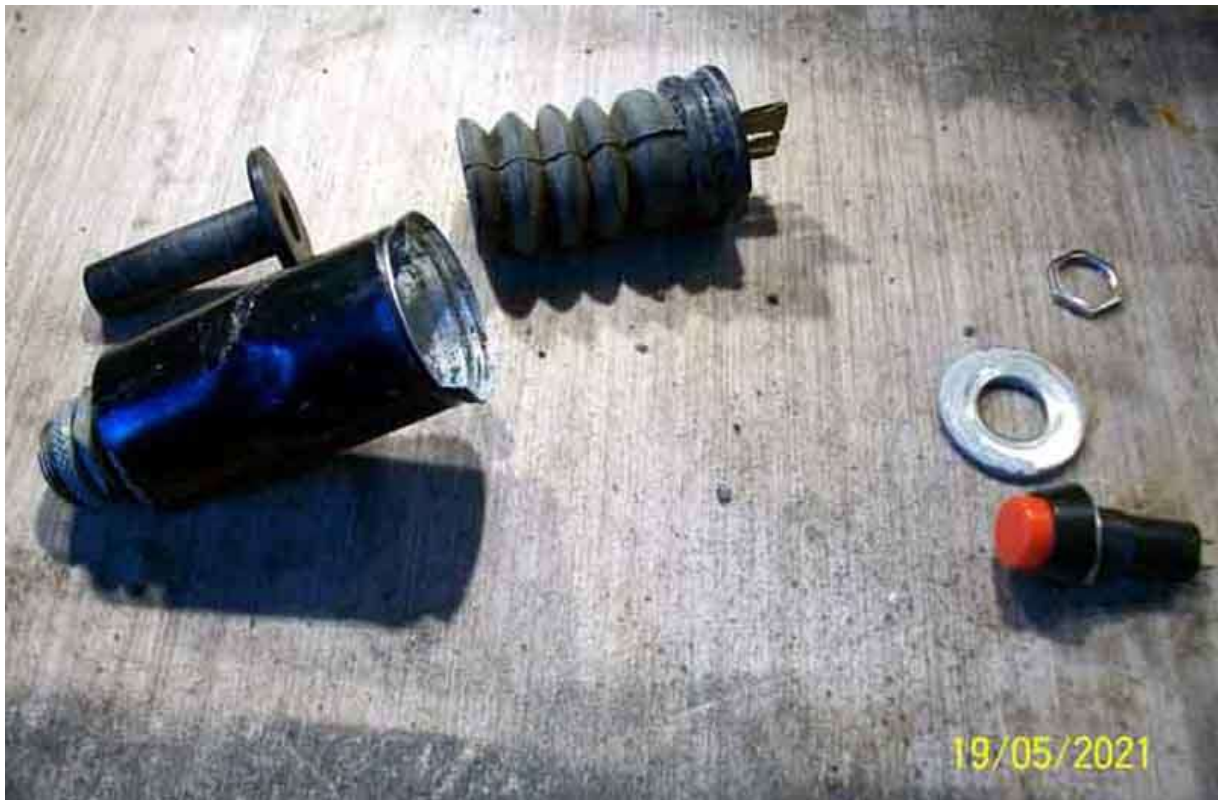
I found a washer in my tool box that had a 12mm inner hole (to take the switch) and 28mm diameter which fitted in the bore of the old pump:

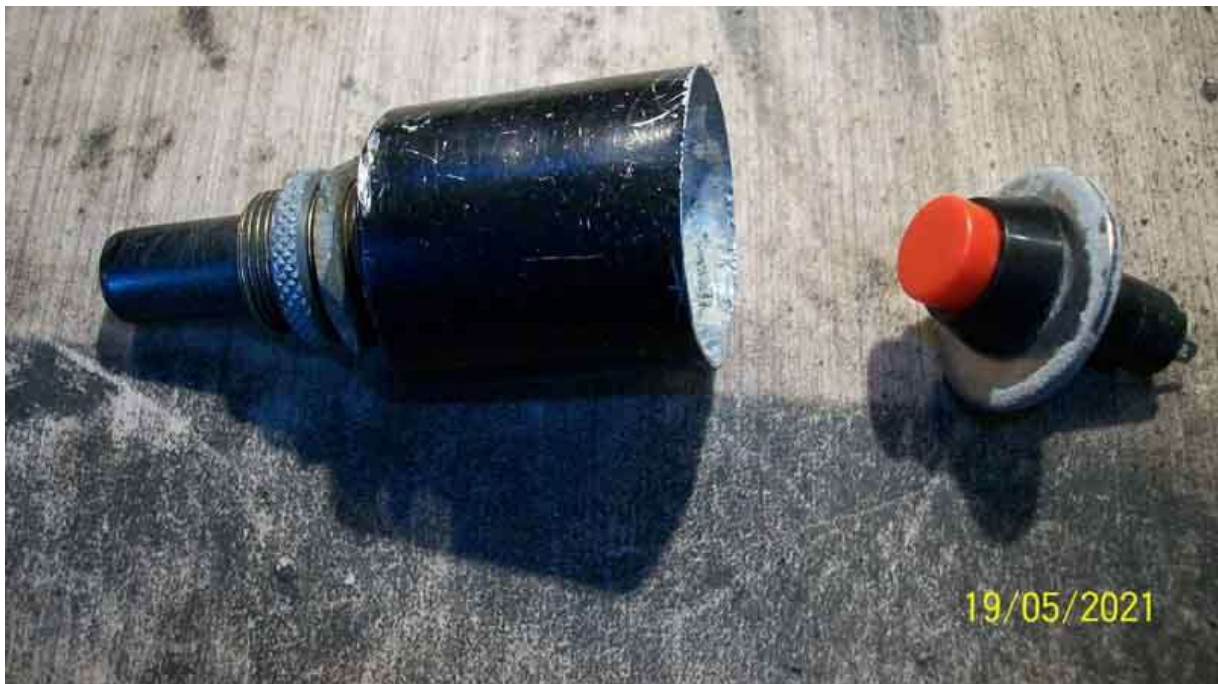
With the bore cleaned up I put the original plunger back in and dropped the new switch in behind it:

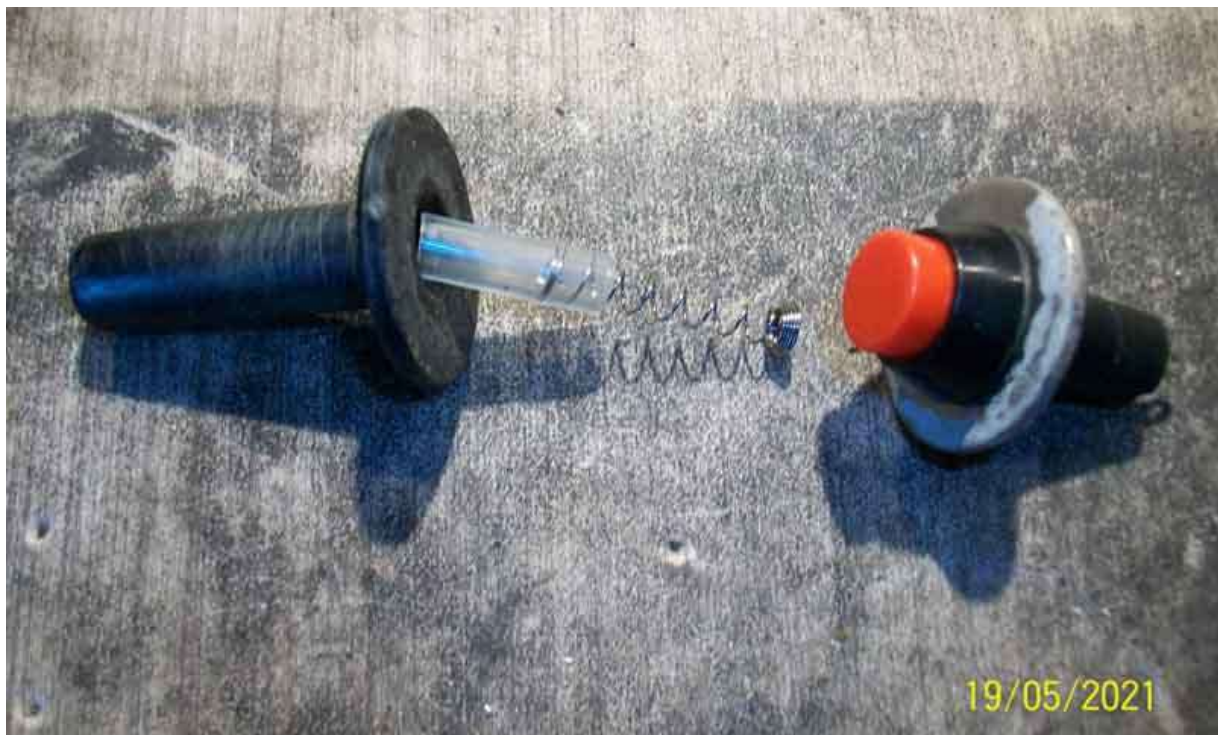
I didn't want any 'noticeable' feeling of a gap between the two switches so I put a small light spring to keep the plunger out but not operate the new switch:

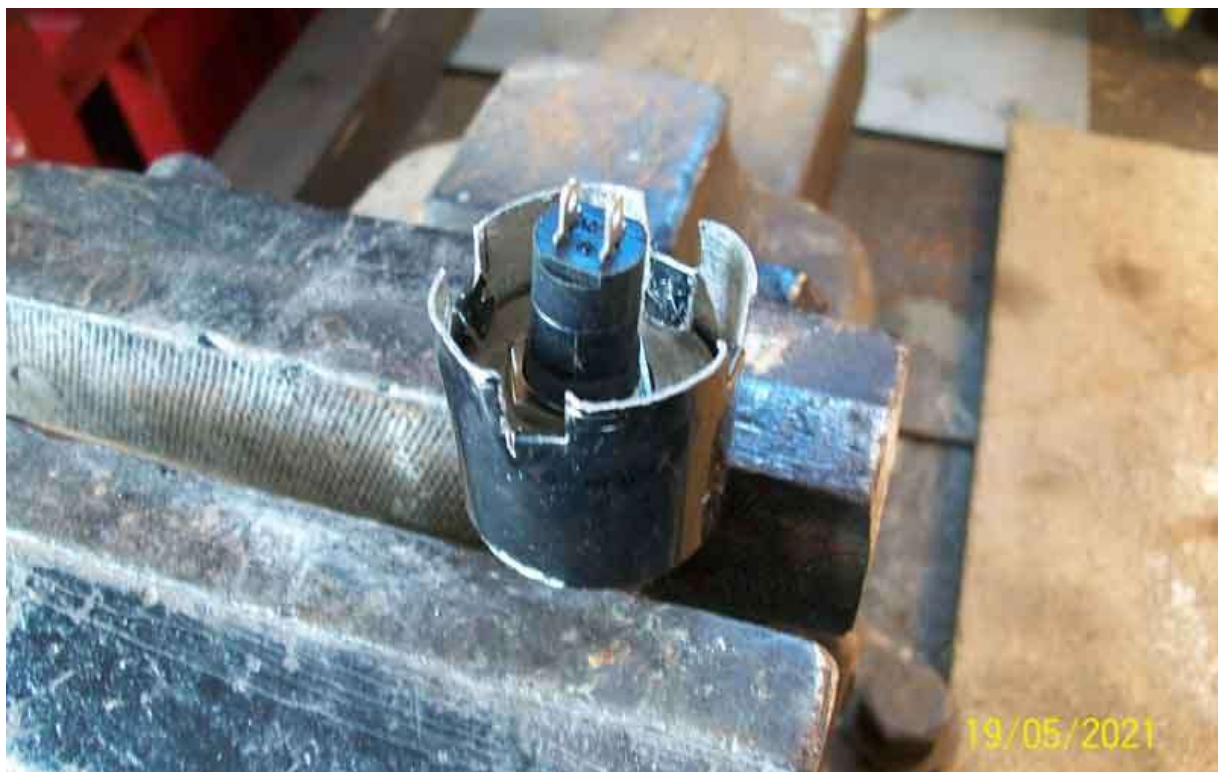
I cut the body down to within about 5mm of the steel washer and then cut tabs out of the body to hold the switch in. I bent the tabs over which worked well and I have since finished it off with a foam washer:

It feels decent to operate and touches the new one within about 5-6 mm of movement and returns nicely. And it looks like it did before.

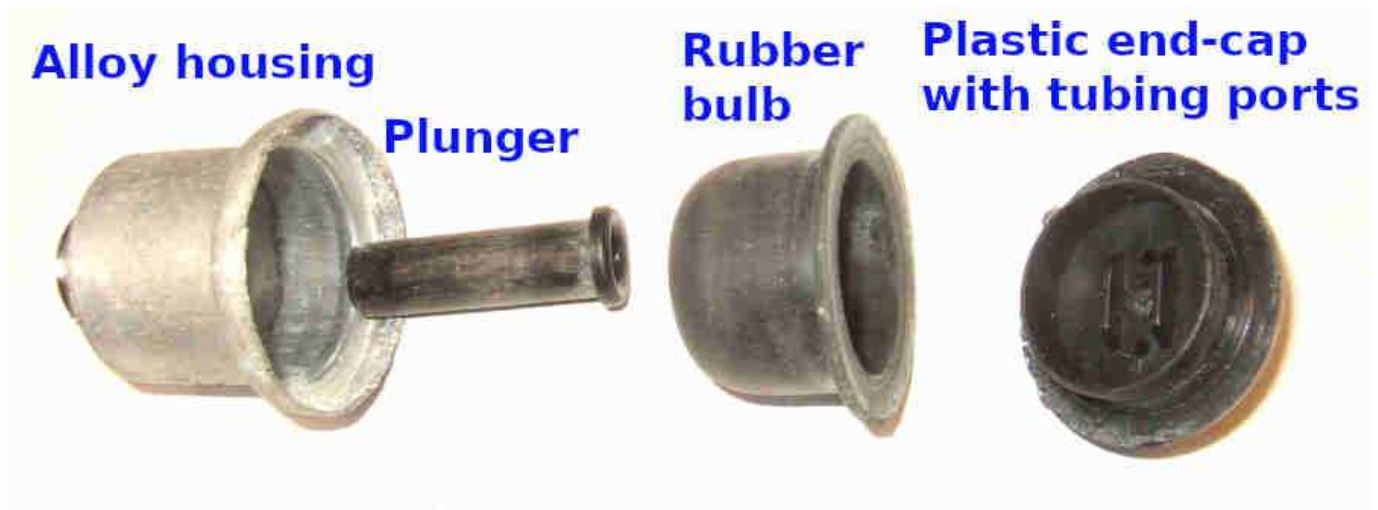
My pump looks shorter and fatter than Dave's, and with careful levering round the turned over edge of the alloy housing I released the plastic end-cap, and the rubber bulb and plunger fell out (incidentally unscrewing the slotted nut that holds it in the dash will also release the plunger on this type):

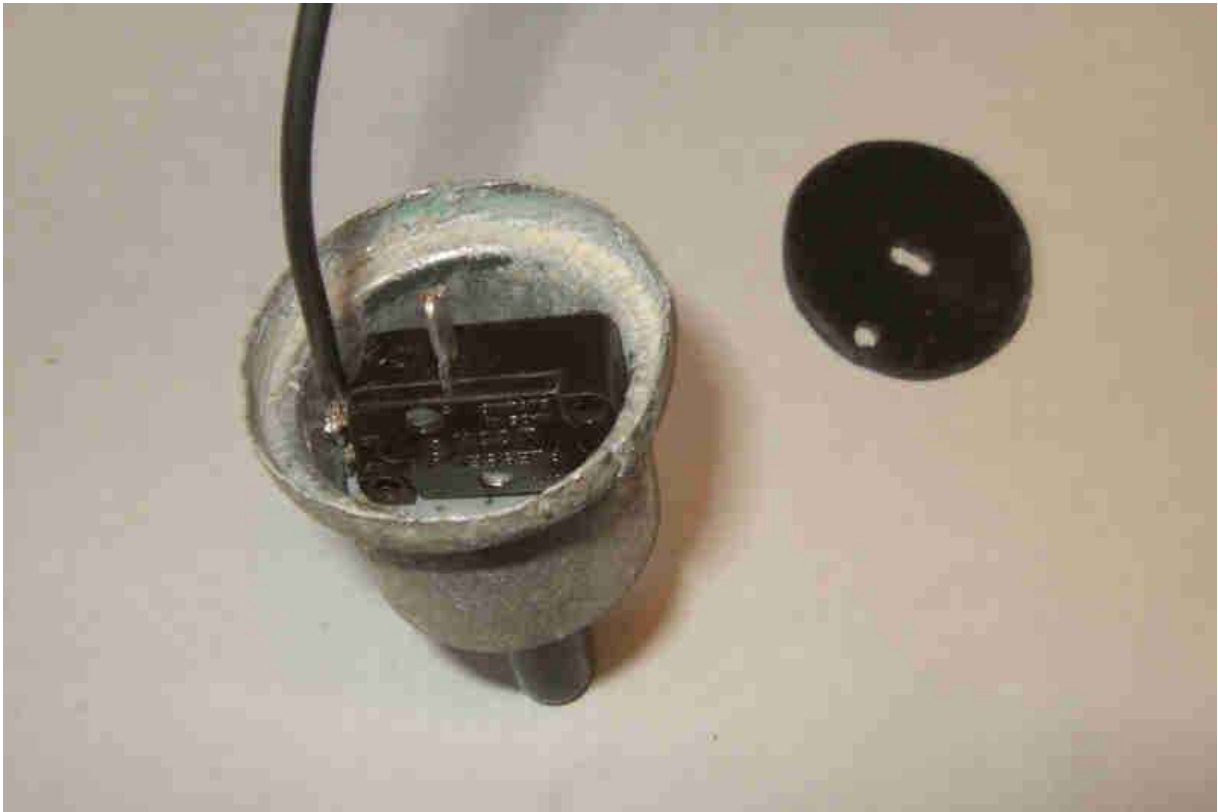
Thinking about mounting the switch I find there is just enough room inside the housing to push the switch all the way in, with another plastic disc on top to be held in place with the edges of the alloy housing turned back over again.

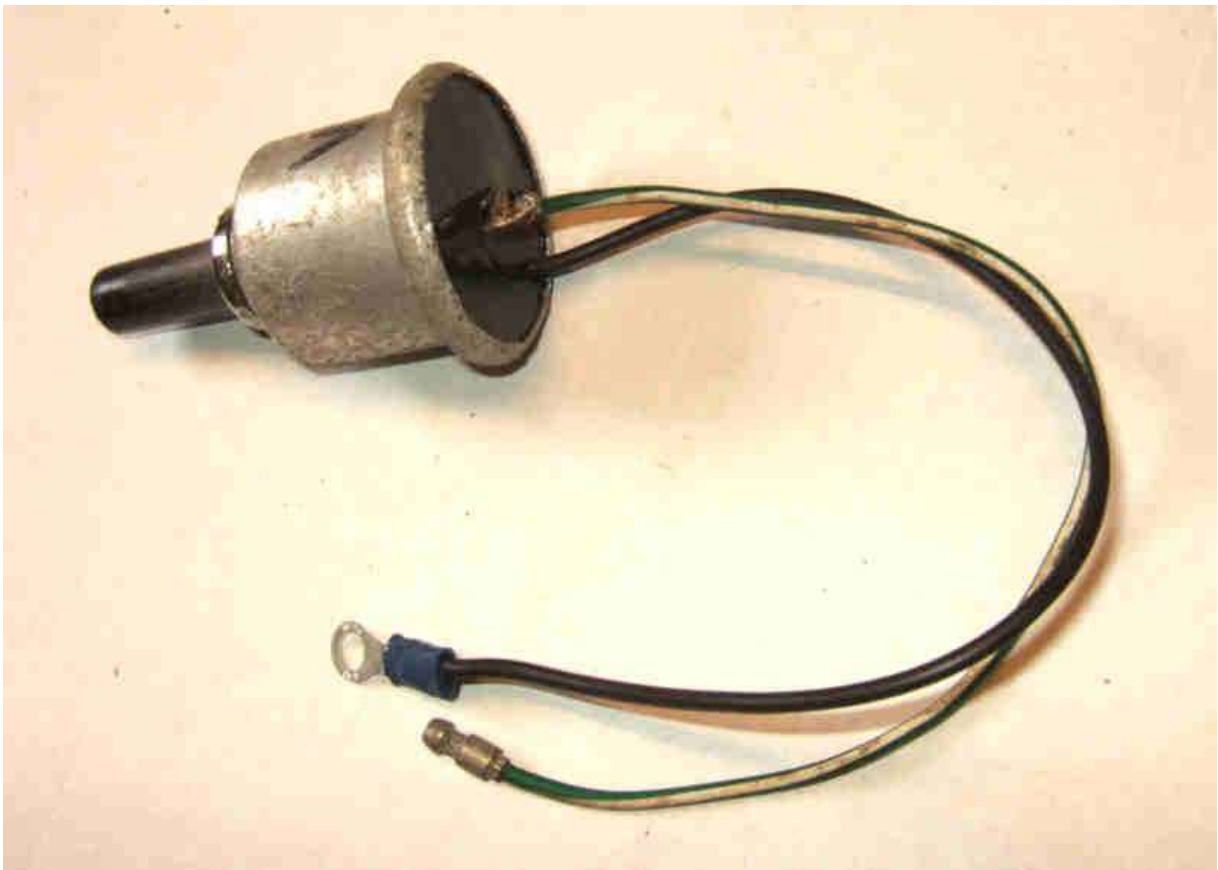
The pump plunger only moves about 3mm before the switch operates, which is less than I would like, but it does work and is really neat even though it won't be visible once installed!

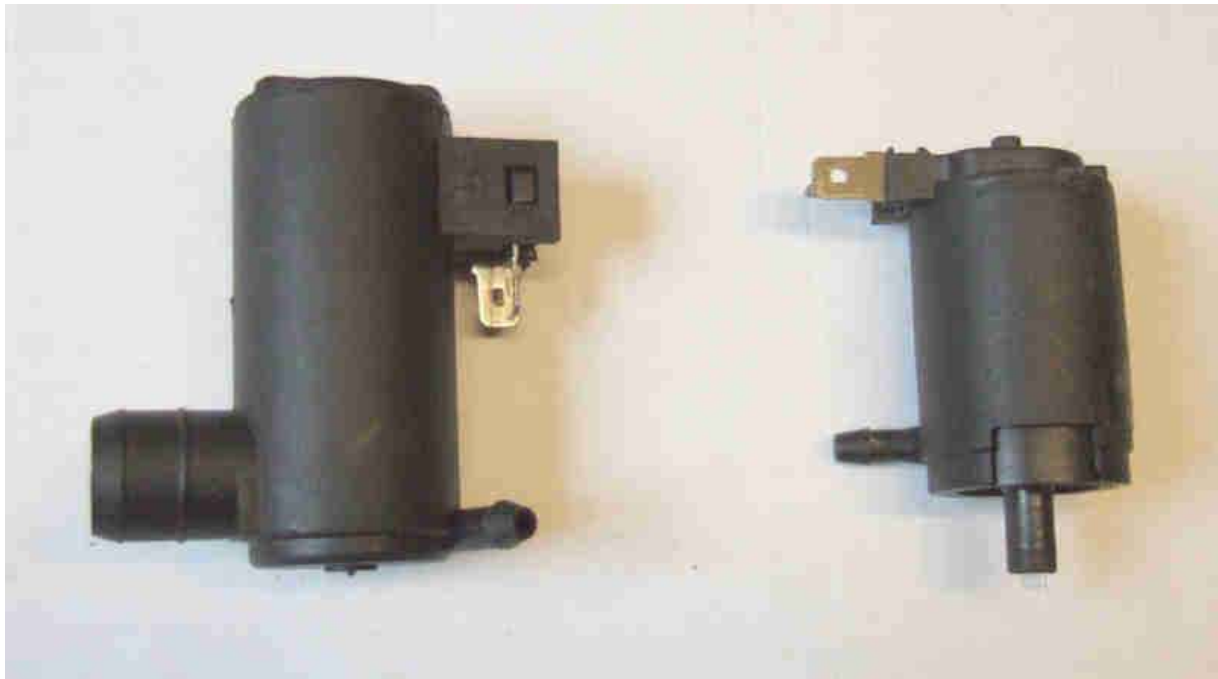
I Googled electric pumps and got a Peugeot item (left below) for under £4 which has a very large port which I assumed was the inlet that pushes into the bottom of the screenwash container, the other port being standard for tubing. The large port was going to be a bit of a fiddle to connect to tubing so I used it for another job (don't ask ...) and Googled again and this time found an Austin/Morris item with more conventional ports for less than £3! Testing that dry it's really noisy

compared to the Peugeot item so I use the AM pump for the other job, and since I had come up with a way of reducing the large port to accept tubing for that job can use the same on the car.

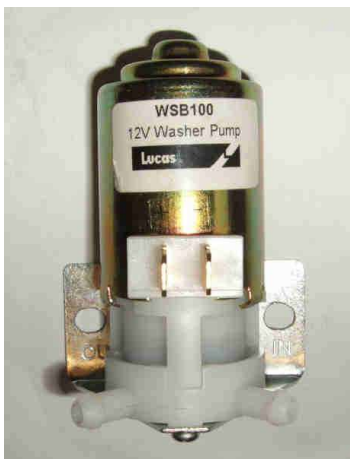
However neither pump sucks water up when fitted with tubing on both ports and tested in a bucket! I can sort of understand it for the Peugeot pump as that is designed to connect to the bottom of the bottle and so is kept full of screenwash. Less so the AM item as although the port at one end is slightly bigger than the side port and I'm assuming that is the intake, unless it pushes into a receptacle sticking out of the bottom of the bottle it's not going to be kept full of water. That one blew air out of either port (connected to tubing with the end in water) if the polarity was in the appropriate direction, so why it doesn't suck up with the polarity the other way round (it didn't blow then) I don't know. MGB pumps are mounted to one side of the bottle but the intake tubing goes up to the cap and down inside. So that must be able to suck water up without priming as Vees which was removed from the car and dry for many months during the engine rebuild and repaint worked straight away on re-installation. So, I'll just have to get one of those for a tenner (GWW125, WSB100), and suck that up.

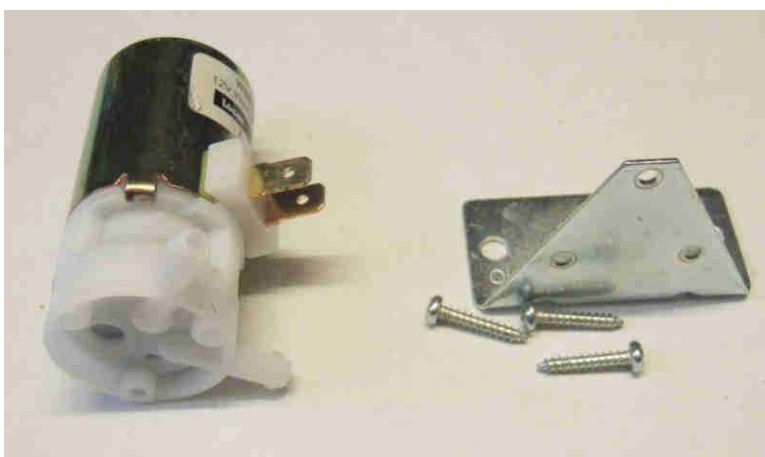
That arrived ... and didn't work! Some very weird and varying noises, a lot of sparking when testing on my battery charger, got hot very quickly as if it were partially seized, and no pumping. Message to [eBay vendor](#) and an immediate apology saying he would send another one out - good service. While waiting for that, and not returning the old unit I decided to have a look.

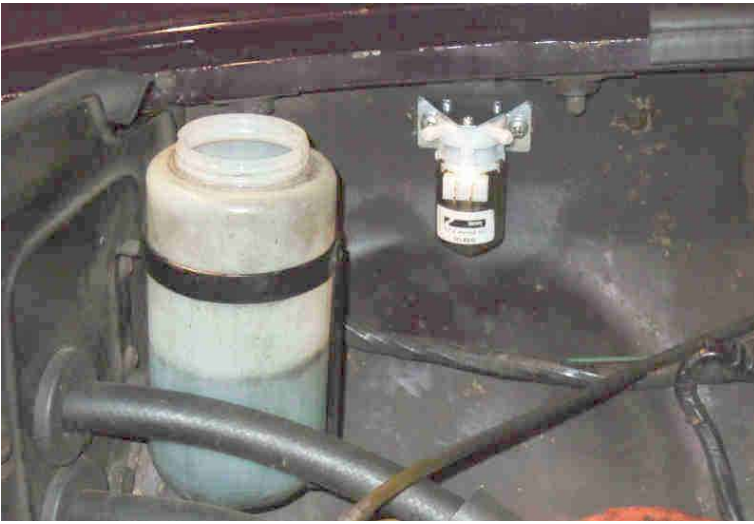
On to mounting. Amazingly there are three Posidrive screws in a row under the gutter just aft of my forward-mounted washer bottle, no clues in Clausager's pictures as to what they might be for, and two adjacent ones are close to the spacing of the holes in the pump bracket. It means mounting the pump upside down to fit directly as otherwise motor wouldn't allow the bonnet to shut, which might affect pumping, but to extend the bracket and put it the right way up puts the ports on the wrong sides. Solvable with longer tubing but initially at least I'll go for upside down. One of the screws comes out easily and the other after a bit of encouragement with penetrating spray and grips, then offering the bracket up shows its holes are just half a hole too widely spaced for the holes in the inner wing. But removing

the bracket for the pump to avoid damaging the pump it's just a couple of minutes work with a needle file and I can fit it to the inner wing.

The screws only just reach the ends of the nuts in the wheel-arch but amongst the many nuts, screws washers and bolts I accumulated during Vee's reassembly I have two 1" stainless which do the job. If the pump being inverted causes a problem I have some alloy strip exactly the same width as the pump bracket to use as an extender.

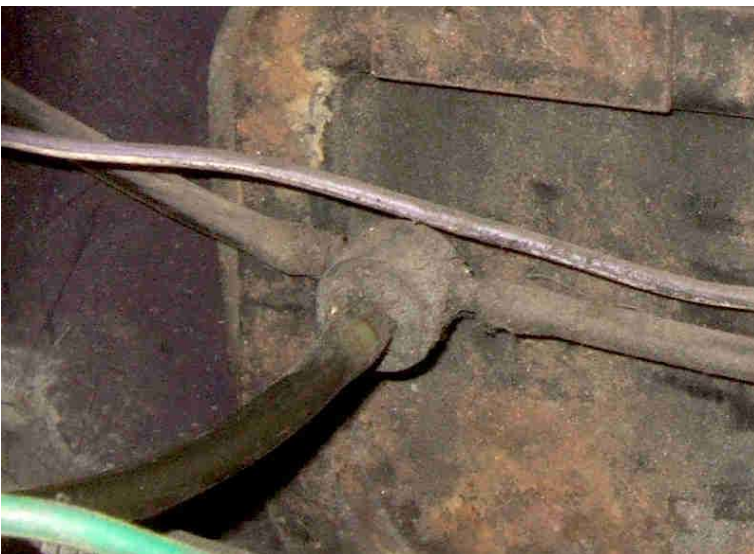
With the pump in position, the tubing on order (but annoyingly and rarely for eBay sellers no info as to despatch after two days) and the switch ready to install, it's time to get the old manual pump out and investigate what's behind that. Two separate jets so I'm expecting a tee, but when I first looked into the subject it was confusing ([subsequently resolved](#)) as to whether there is a one-way valve there or not as there doesn't seem to be one for roadsters unlike GTs. First get the dash vents out and moving the corrugated tubing from the air-box out of the way I can see the tubing and tee (green arrow), and also the separate purple/white wires going out to the courtesy light door switches (yellow arrows) from a 4-way bullet connector feeding the courtesy light as they are not in the harness on this era.

By now it's apparent that (as well as looking like it's been in a wheel arch for over 30 years instead of behind the dash!) the tee includes the valve (13H6472).
