Voltmeters

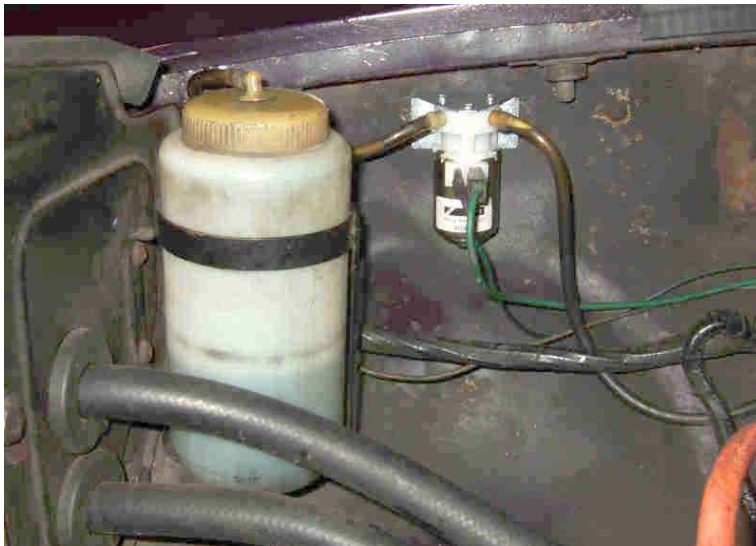
For the electrics I run a short length of green from a piggy-back connector on the green side of the fusebox to the +ve spade of the pump, and from the switch 'live' wire via a 2-way bullet connector a much longer length of green/black (don't have any green/blue to hand which is what the factory used on later cars) from the middle of the dash and through the main harness bulkhead grommet to the pump -ve. With the vents out there is clear access to a knurled nut on the back of the dual gauge for the earth wire from the switch. An unexpected benefit is that Bee's original manual pump nut looks like chromed plastic with some of the plastic having worn off to show white underneath, whereas the replacement is shiny bright! Only noticed from the pictures that the plunger is quite scratched though compared to Bee's, but it only took a couple of minutes to swap them

over.

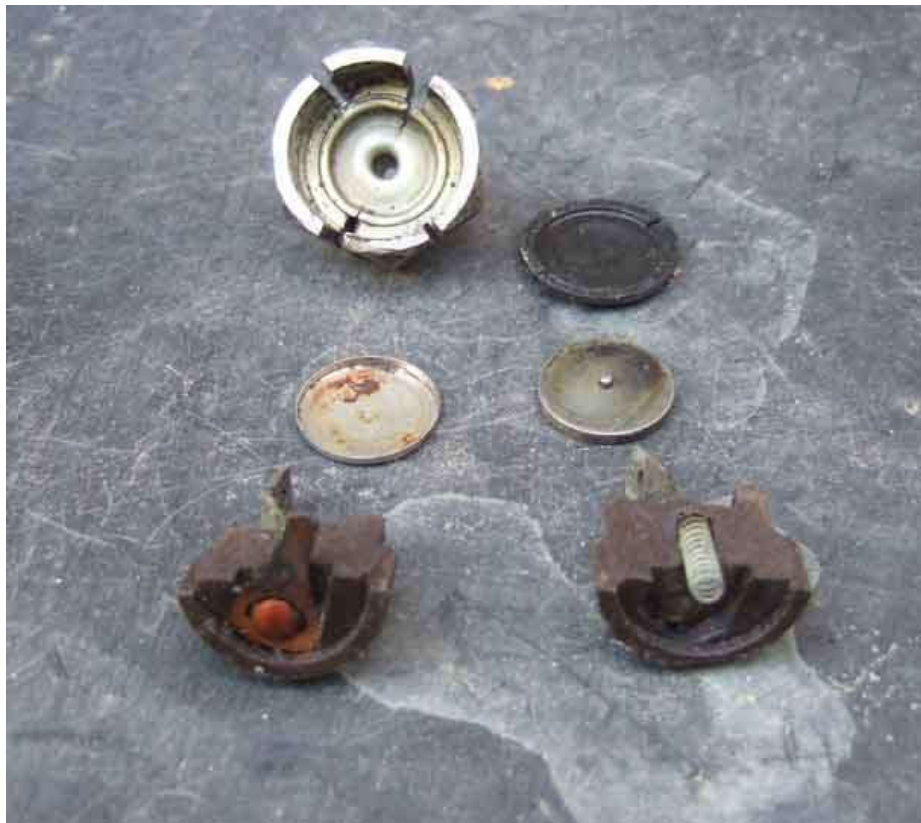
The old switch diced and sliced. I had cut off the ring at the top of the 'nut' which is what looked like was holding the plastic bit in, but it still wouldn't come out. Only later could I see that I would have had to cut a ring around the nut level with the point where each flat joins to get below the 'peened over' part.

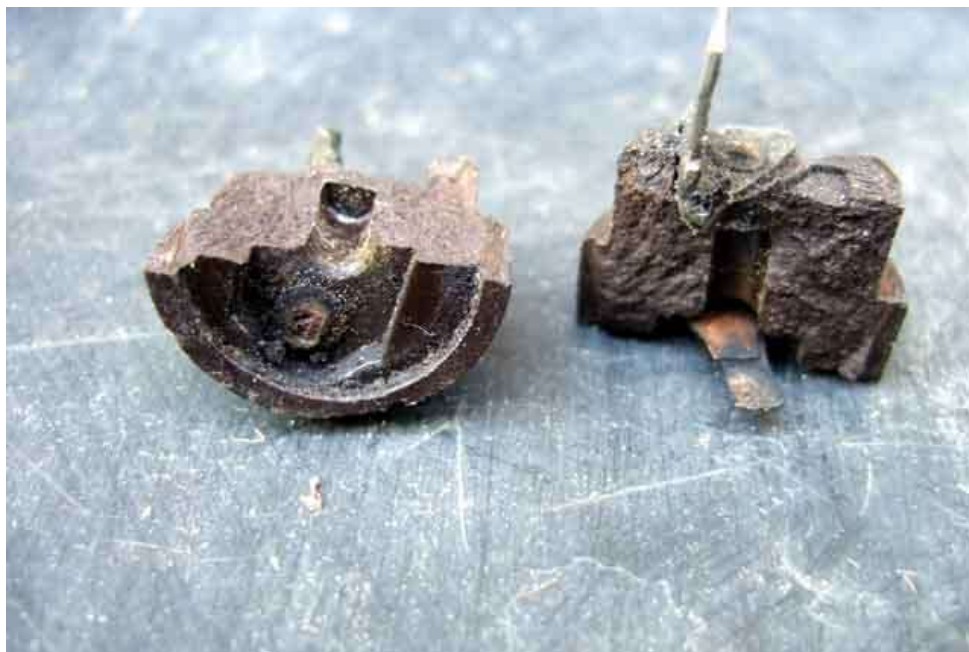
Surprising number of bits - rubber diaphragm in the bottom, then a metal disc with a pip on each side but a tin cover on the diaphragm side, then the plastic bit with the two contacts, a light spring holding the moving contact away from the fixed. Pressure on the diaphragm pushes the metal disc up against the moving contact, compressing the spring, and bringing the moving contact to the fixed, so completing the circuit. The design of this is such that as the moving contact is pressed against the fixed by the pip on the disc, it will flex, which imparts a rubbing action between the two contact surfaces, helping to keep them clean. Compare this with the simple 'bridge' connection on modern switches below.

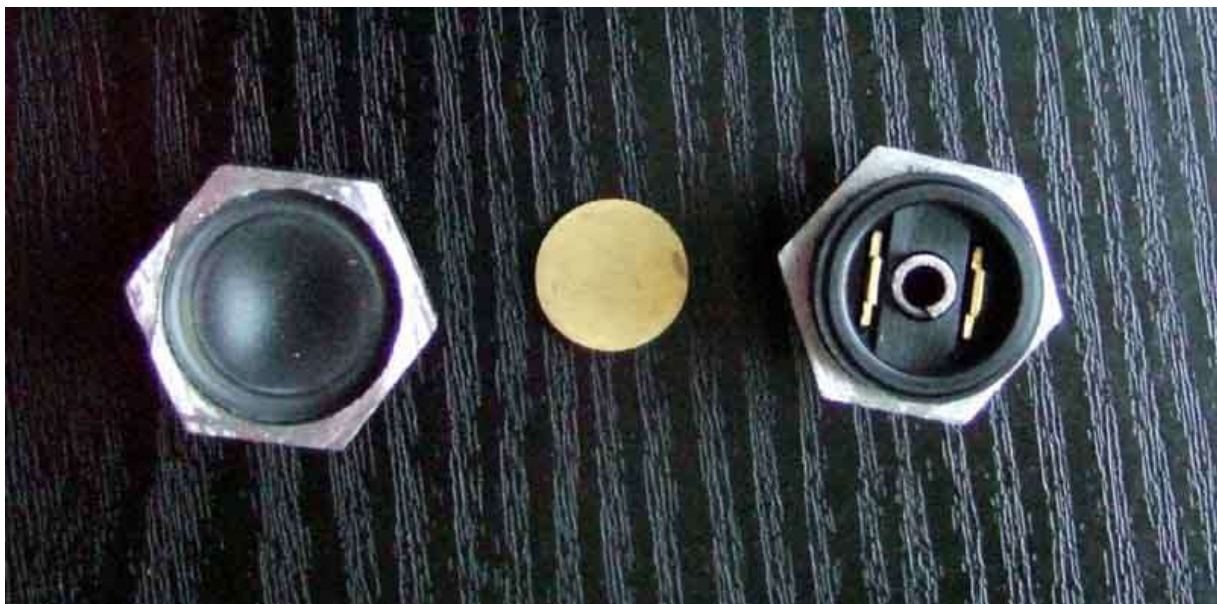
The LMS switch: (September 2017)

The same basic construction i.e. a disc pressed against the internal part of the spades, but with two possibly significant differences:

- Instead of the ends of the spades being bent over, these are left straight. This could well mean that sharp edges are better able to cut through any burning.
- The material of the spades and discs appears to be different. Instead of possibly soft alloy, these are more brass-like, so could be harder, which may well resist burning better in the first place.

Note also the single central spring as in the original, rather than the two springs in the failed switch.

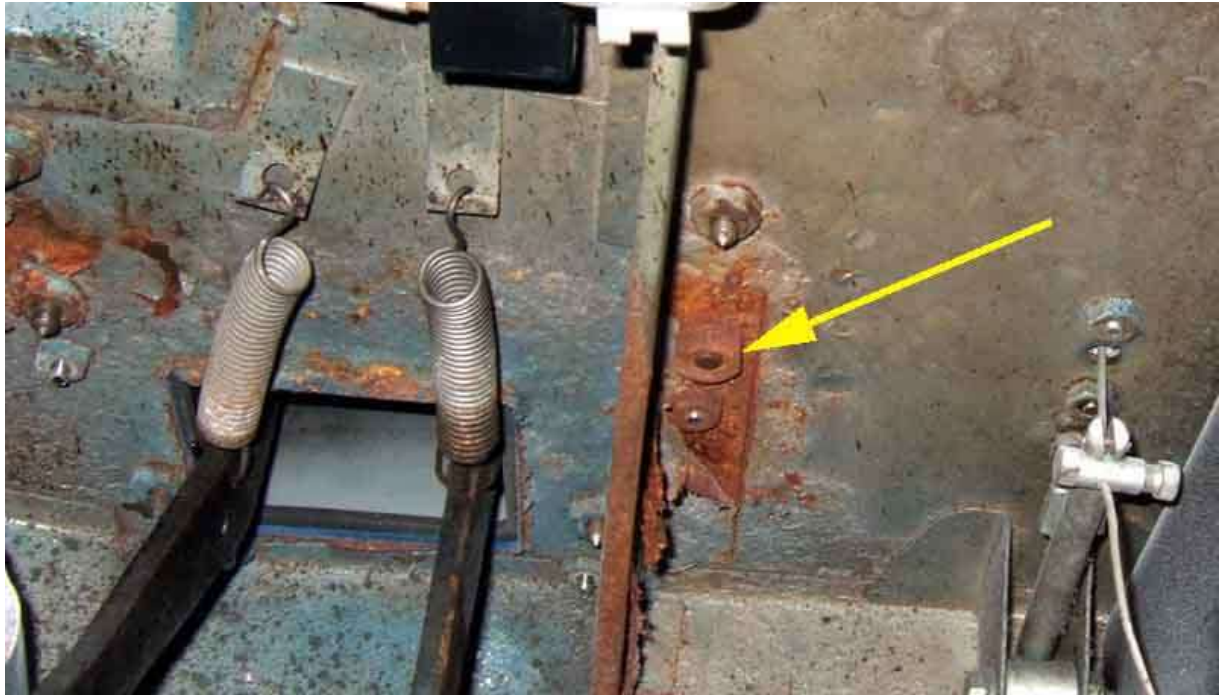
There is a handy stiffener bracket beside the brake pedal giving potential for mounting the switch, but I don't like drilling holes in my cars, and access would be tricky. I can visualise a bracket wrapping round that stiffener, clamping onto it somehow, but that seems a bit fiddly. Looking past that I espy the welded nuts for the bolts that attach the pedal-box to the heater shelf, and one is pretty-well in exactly the right place:

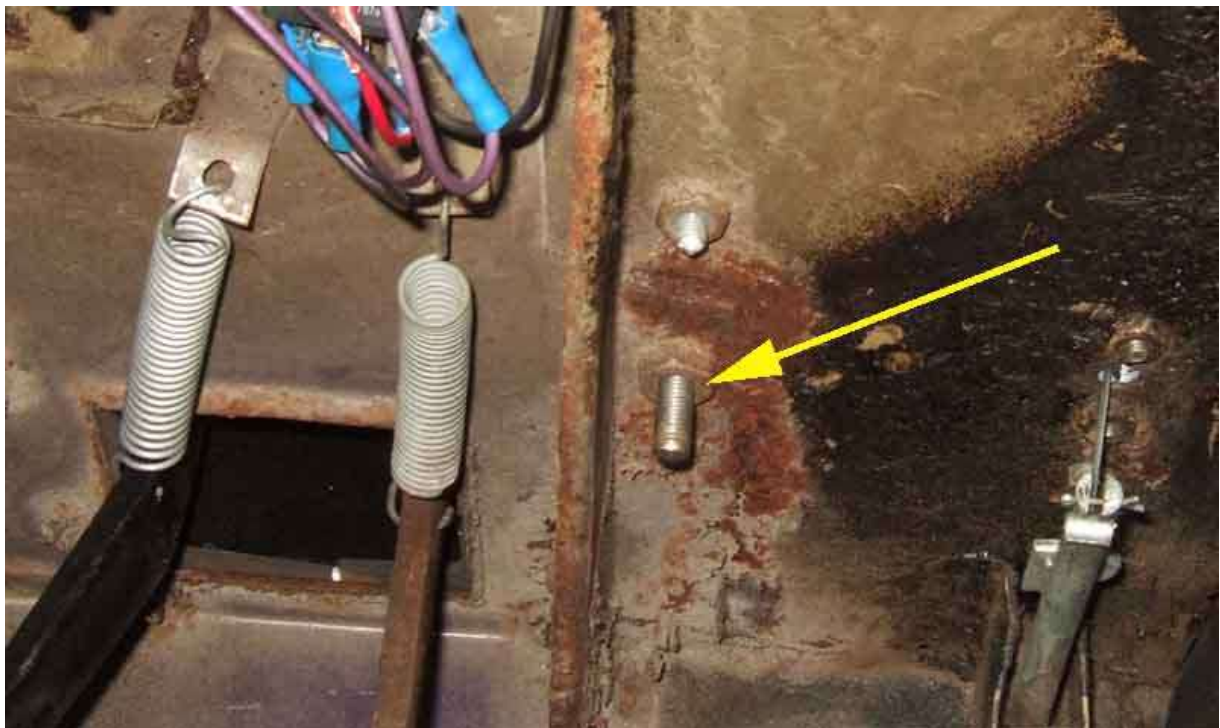
Fitting a longer screw would allow me to attach a bracket using a nut and washers, but while looking at it I realise that the one I'm intending to use is bigger than the other five! Wondering if it is an oddity on the roadster I check the V8 and that is the same. The odd one is 5/16" UNF with a 1/2" head, the others are 1/4" with 7/16" heads. [More info on that here:](#)

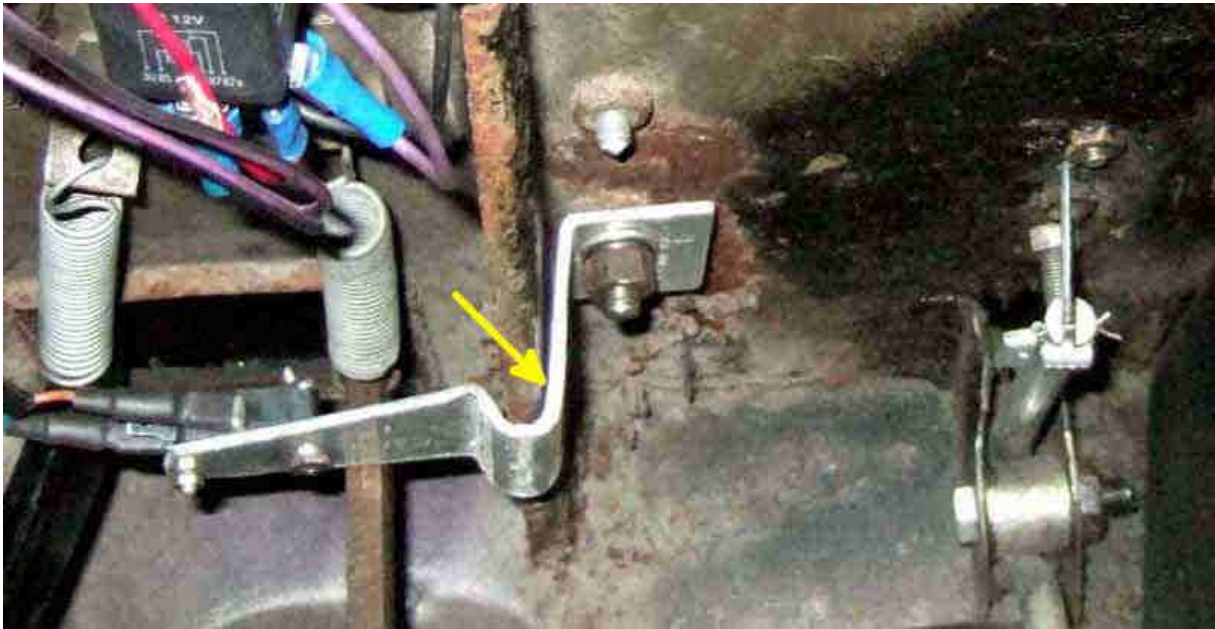
Installed. Initially my thinking was that with the bracket being curled round the flange on the stiffener, it would resist any tendency to pivot away from the pedal which could result in the lights remaining on. Subsequently I realised that a simple 90-degree bend under the stiffener would still be well out of the way of feet in normal use, and by making the bend for the horizontal section that goes on the pedal-box screw a little less than 90 degrees, when tightening the nut the vertical part of the bracket would be pressed hard up against the side of the stiffener (arrowed), having the same effect:

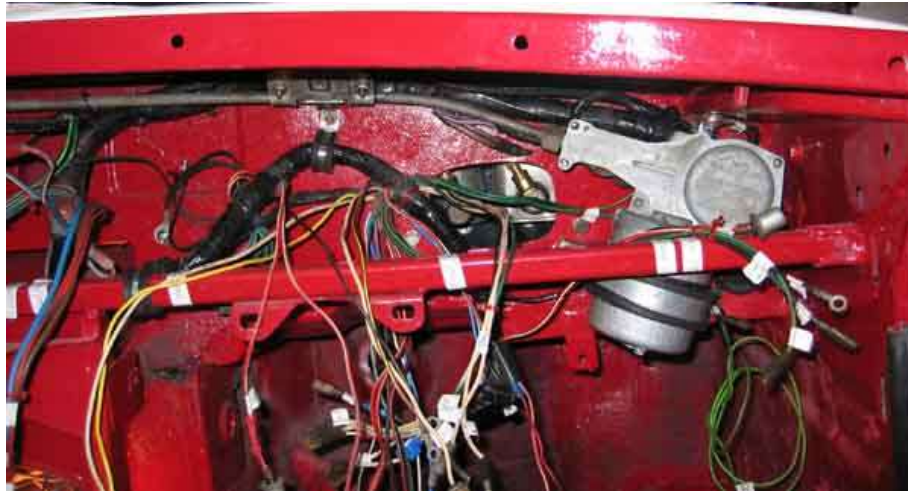
Showing the main harness coming across the firewall behind the wiper motor, before looping back down and through a clip mounted below the motor for RHD. Basically the same harness was used for LHD but going across the firewall to the other side:
(Richard Coombs)

Note that the wiper rack goes through the wheelboxes under the spindles, not above.

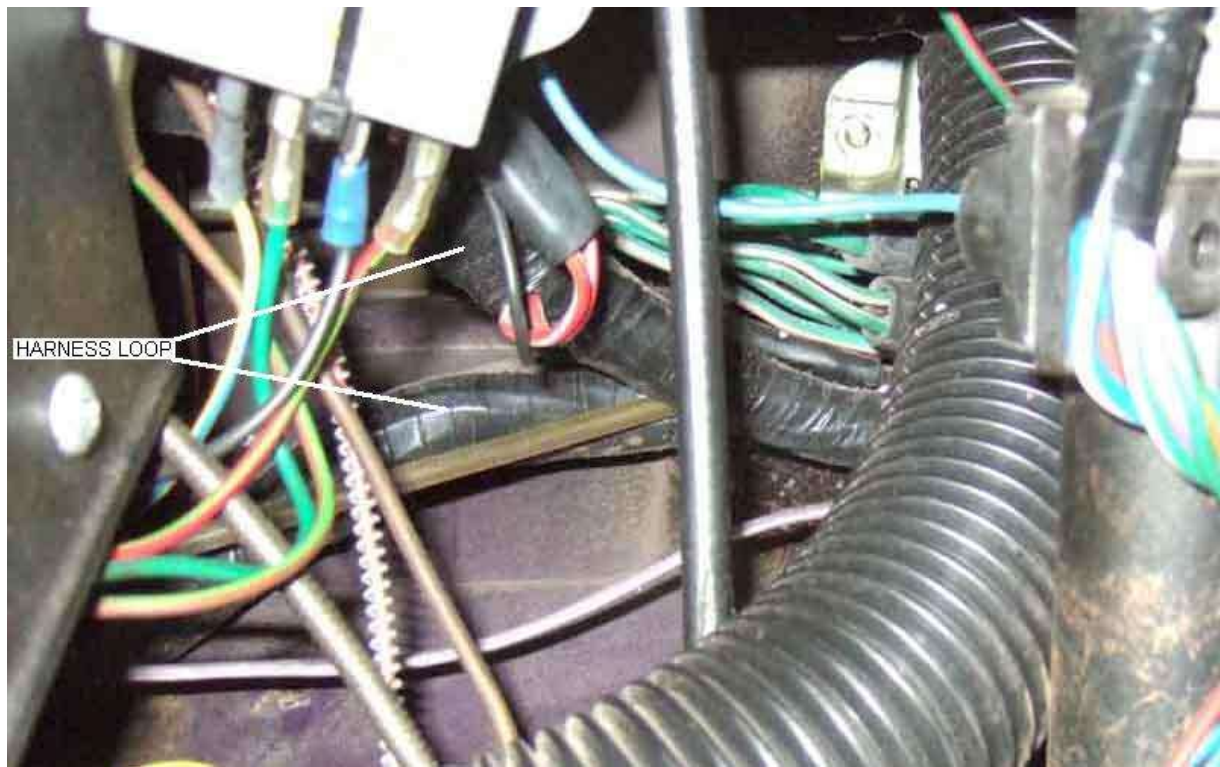
Whilst I had the dash off when I repainted the car I'm pretty sure I didn't disturb the routing of the main harness:

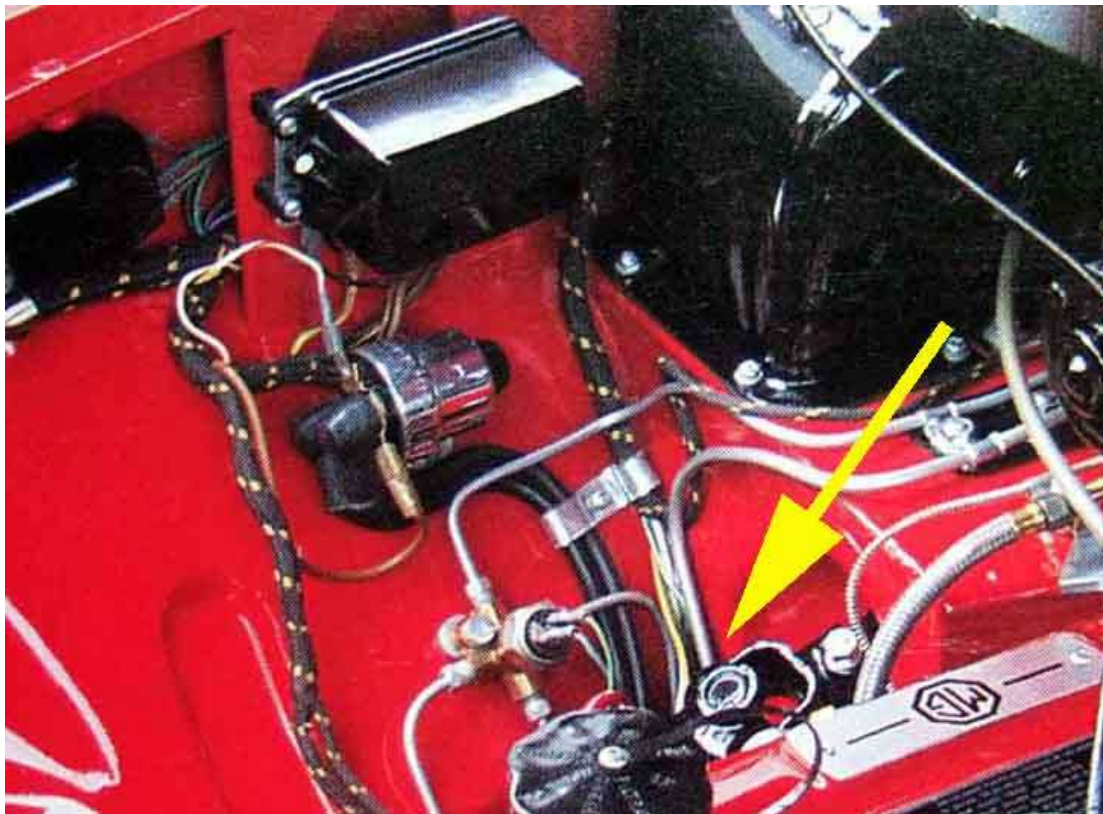
Main, rear and gearbox harness interconnection: In these images from Clausager this 1965 looks like it has a long tail on the main harness with connections close to the steering column UJ:

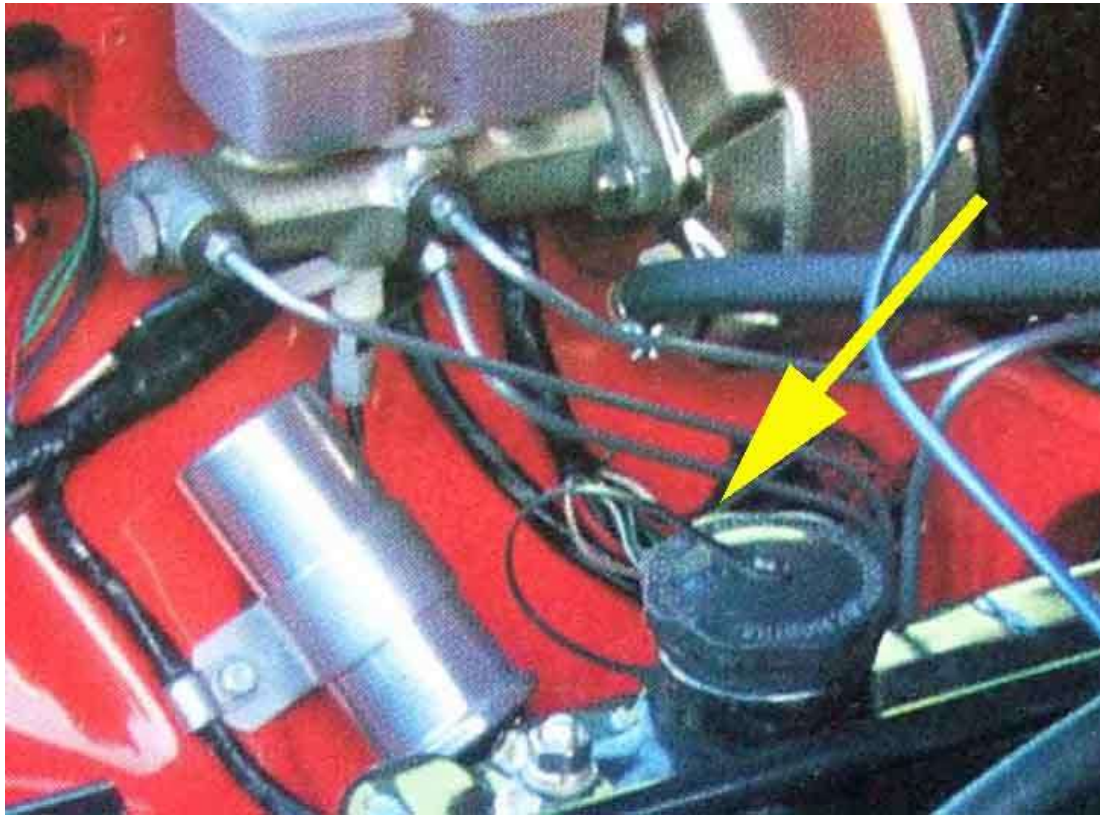
Until for 1977 with the longer brake master and servo assembly again there is a long tail with connections close to the steering column UJ:

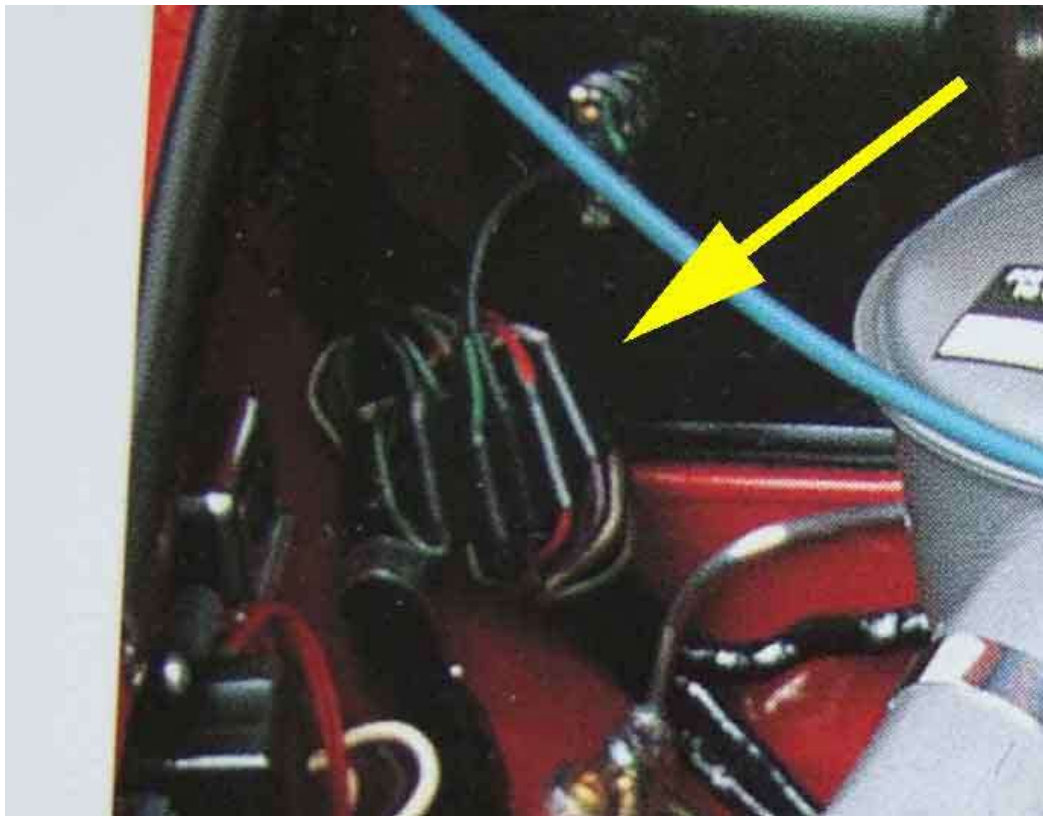
The V8 also had them my the main harness:

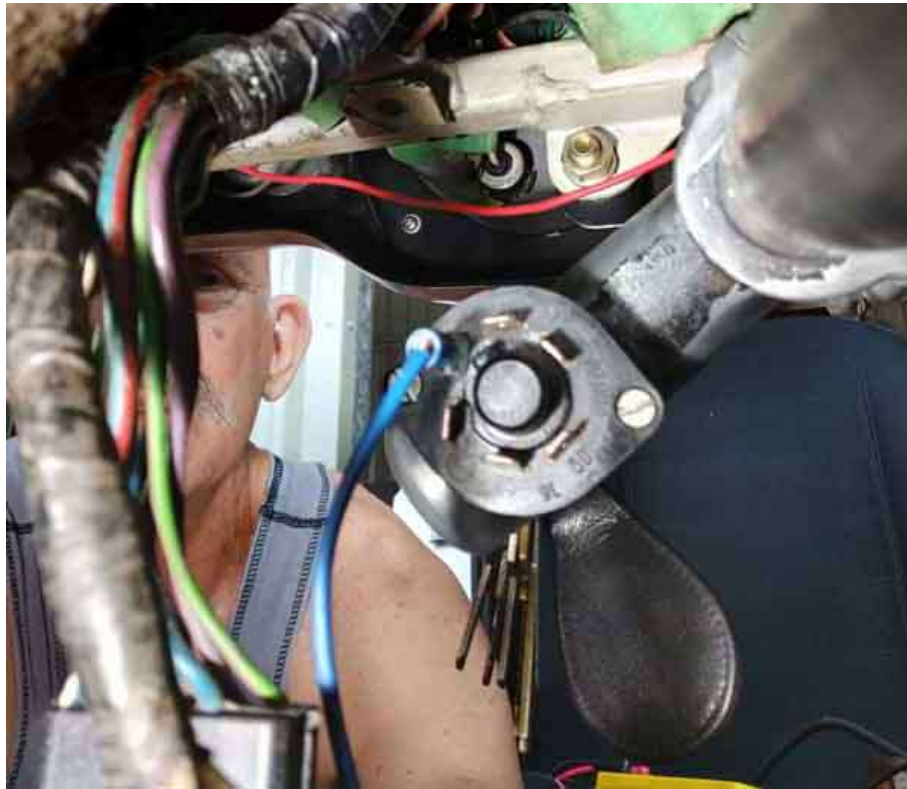
Info from the Parts Catalogue and Clausager indicates that a different type of lock and 'eared' switch was fitted from February 72 to the end of CB production, as in this case on John Hall's 1973 MGB in Queensland Australia:

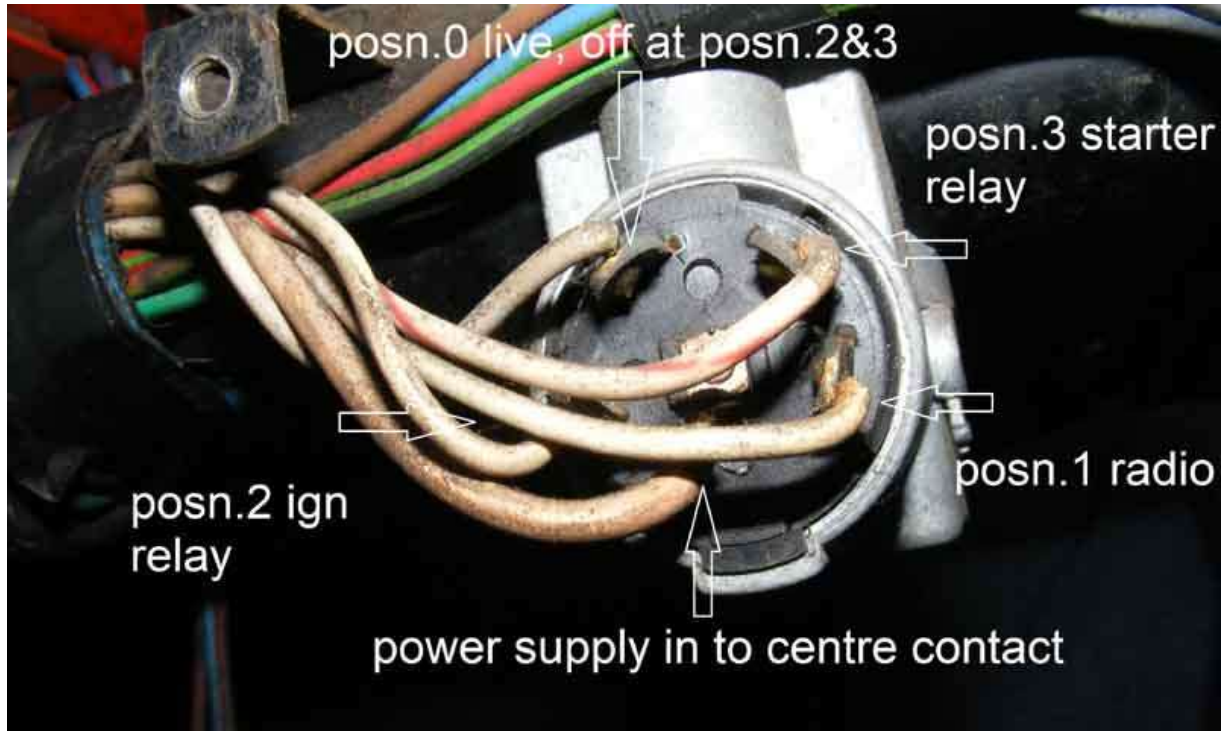
Image from Crispin Allen showing the North American slate/grey anti-runon valve wire at 'posn.0' on a UK 1977:

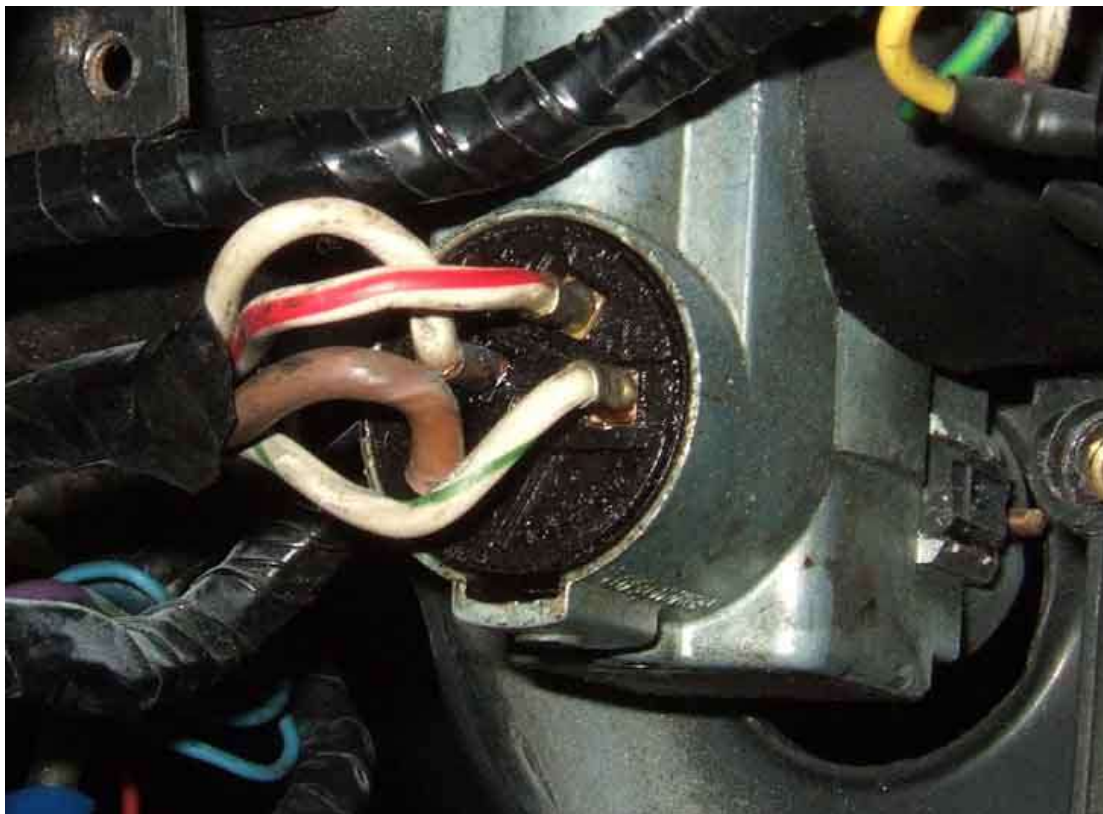
As you can see this switch comes with a short sub-harness and bullet connections to connect to the main harness:

With the key inserted and turned to the first position (accessories) the brown (12v) and white/green (accessories) wires should be connected together. When turned to the 2nd position (ignition) the brown, white/green and white (ignition) wires should be connected together. When turned to the 3rd position (start) the brown, white and white/red (starter) wires should be connected together and the white/green wire should be isolated. With the key turned fully left or out of the lock all of the terminals are isolated.

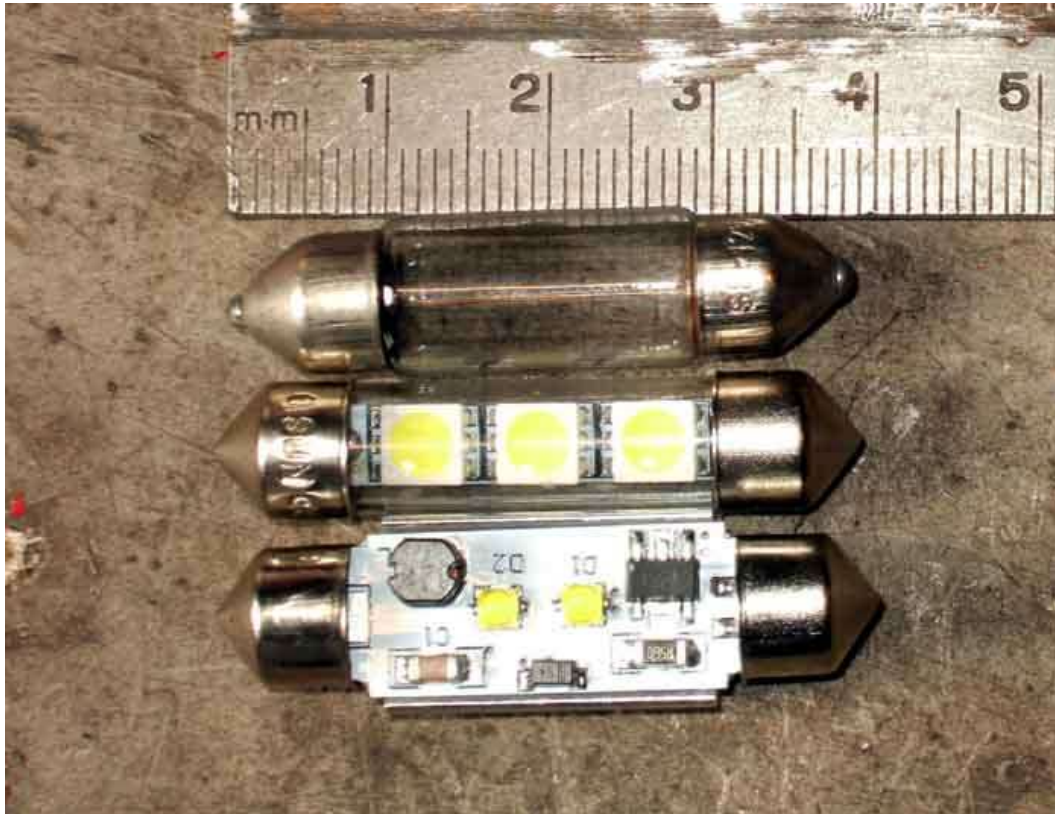
From top to bottom an original 6w type; commonly available '5050'-type; less commonly available Cree type. There are several different lengths of festoon available (reverse light festoons are 44mm for example), whilst the holders can be 'adjusted' for a range of sizes opt for the standard 39mm for courtesy lights.

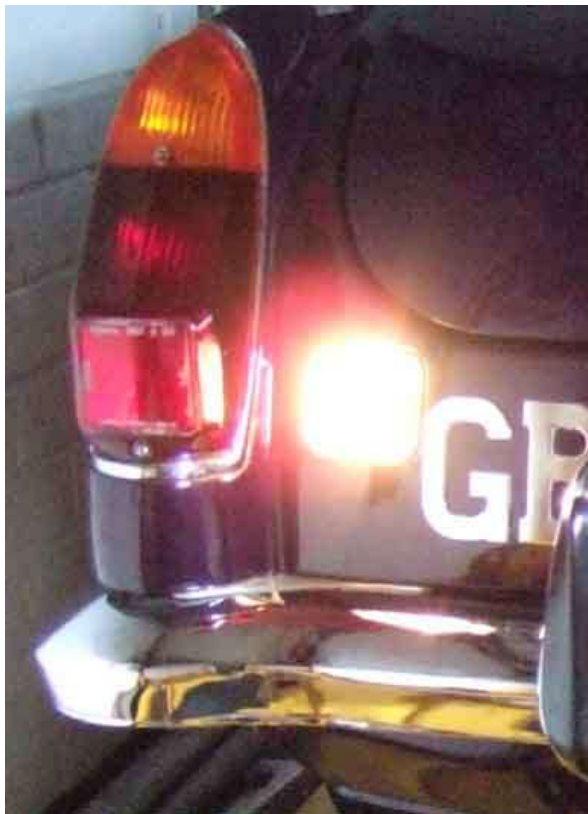
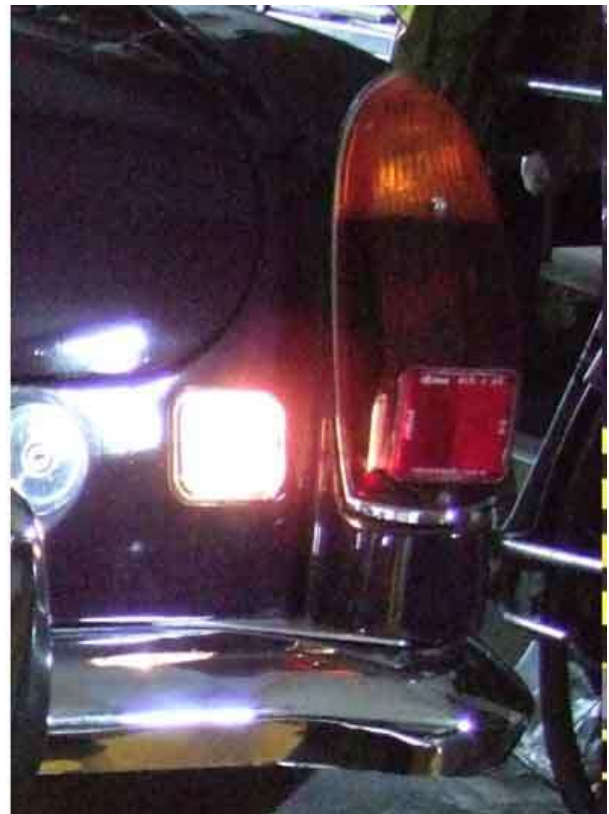
In the reversing lights for comparison - both sides taken in the same picture then edited together for convenience. Standard 18w festoons on both sides, despite the one on the left appearing brighter, possibly a newer bulb with less blackening inside the glass.

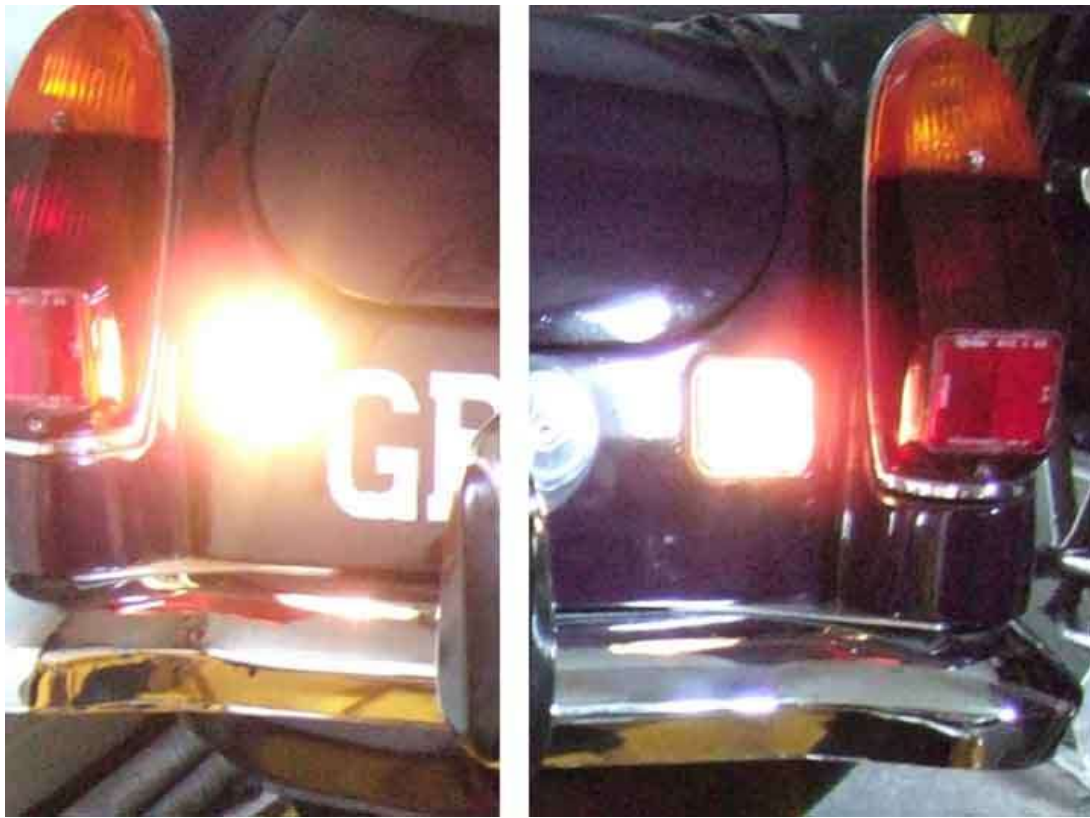
Standard 18w festoon on the left, noticeably brighter than the 6w on the right

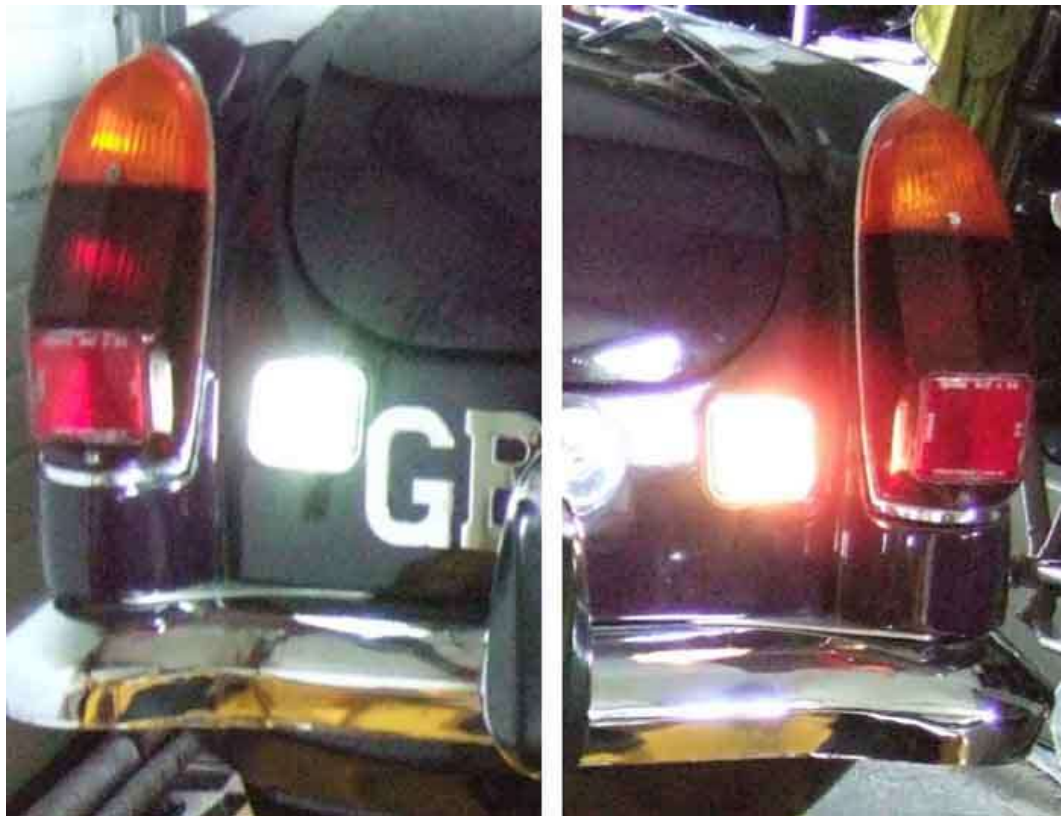
5050-type on the left, 6w festoon on the right - not obviously brighter, just whiter

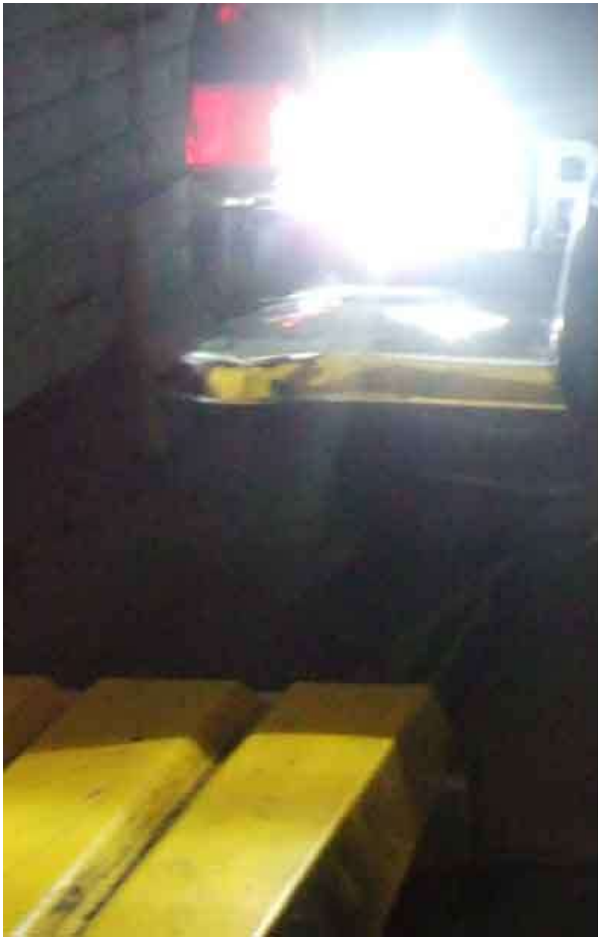
Cree-type on the left - very much brighter than the standard 18w festoon on the right

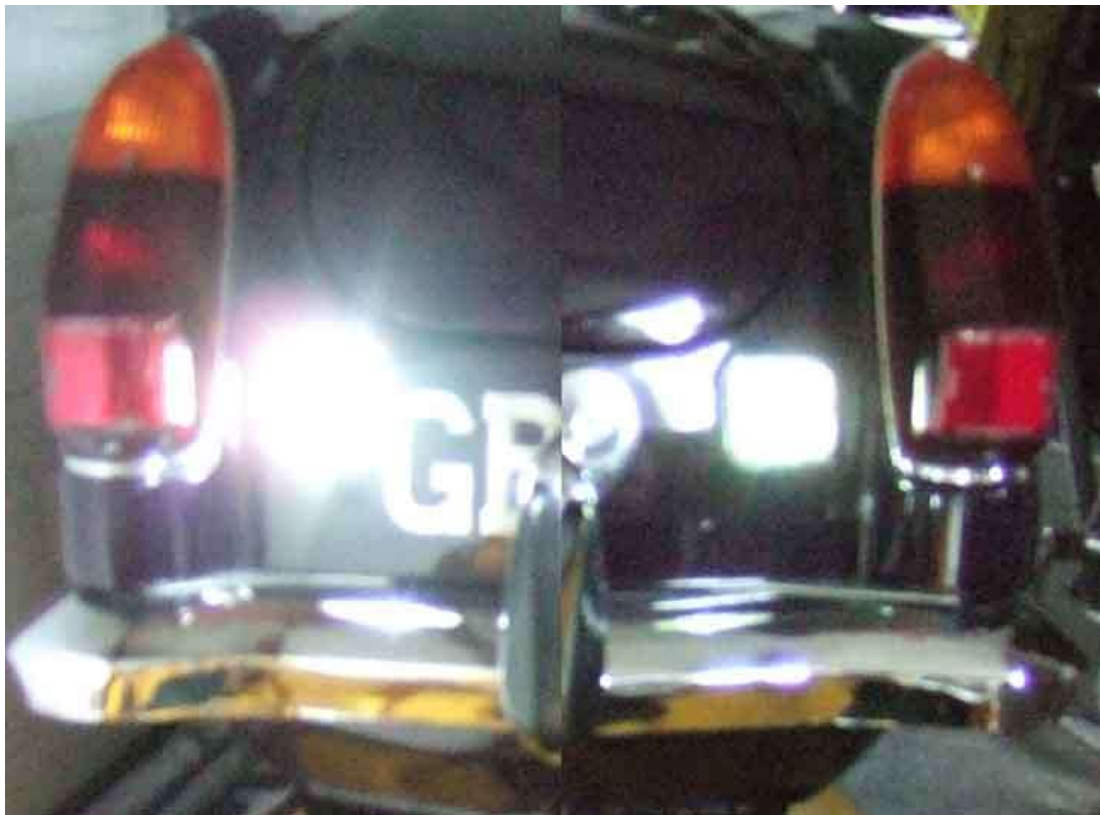
Finally Cree-type on the left - again much brighter than the 5050-type on the right

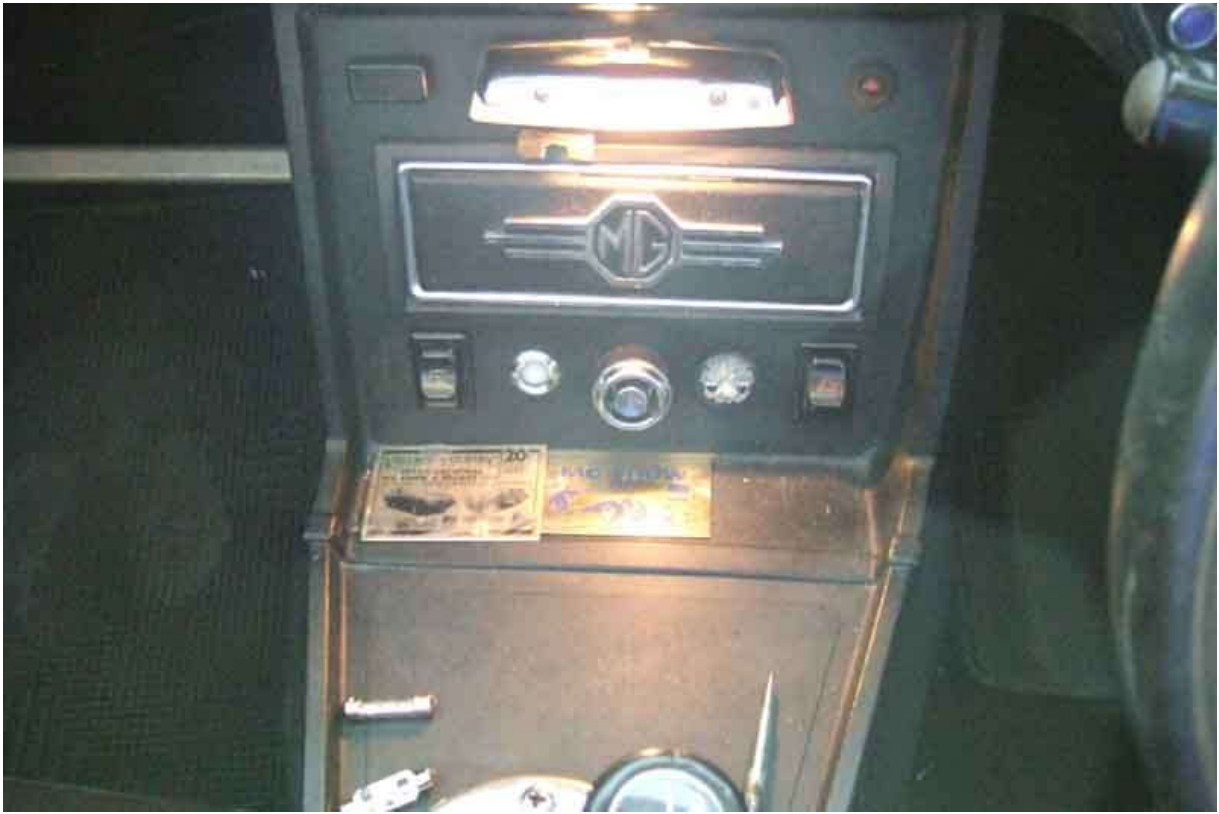
More difficult to compare the three in the interior light fitting as I can only take one at a time - standard 6w festoon.

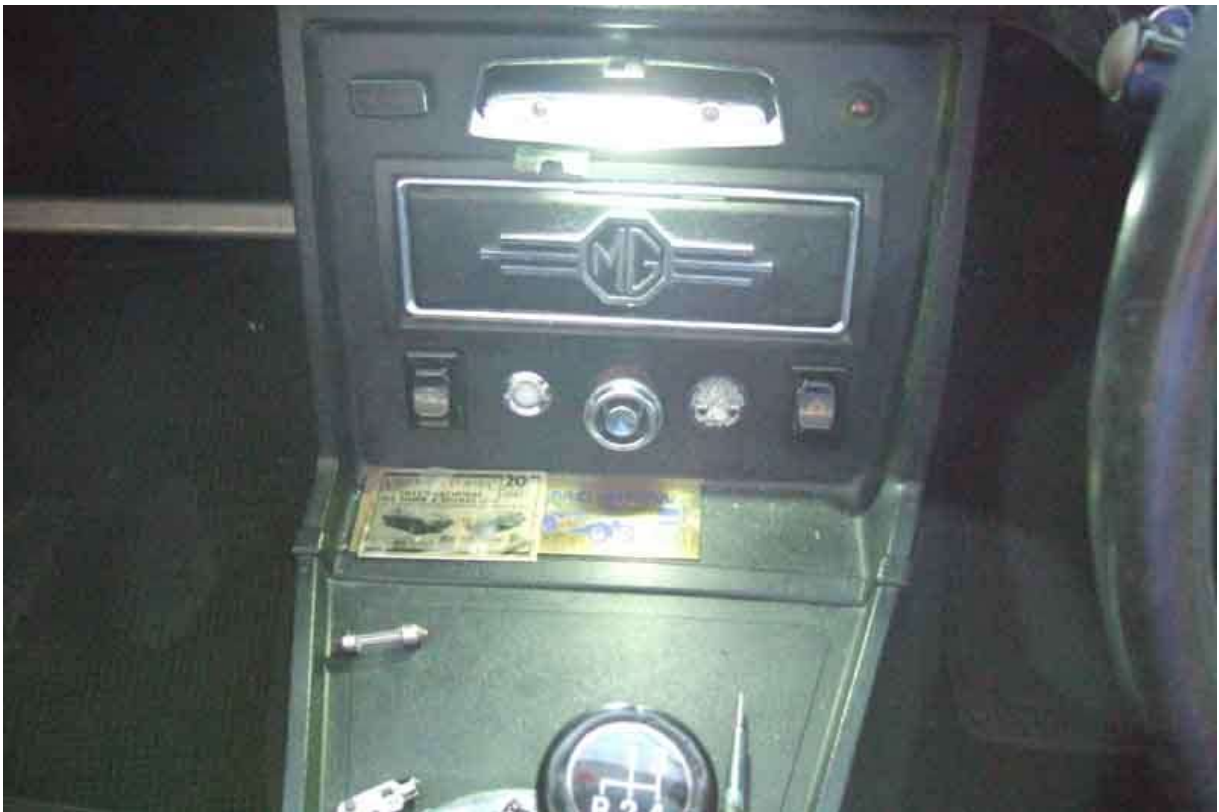
5050-type - almost identical exposure as shown by the foot brace and floor mat patterning in the passenger footwell, hence equivalent brightness, albeit whiter of course.

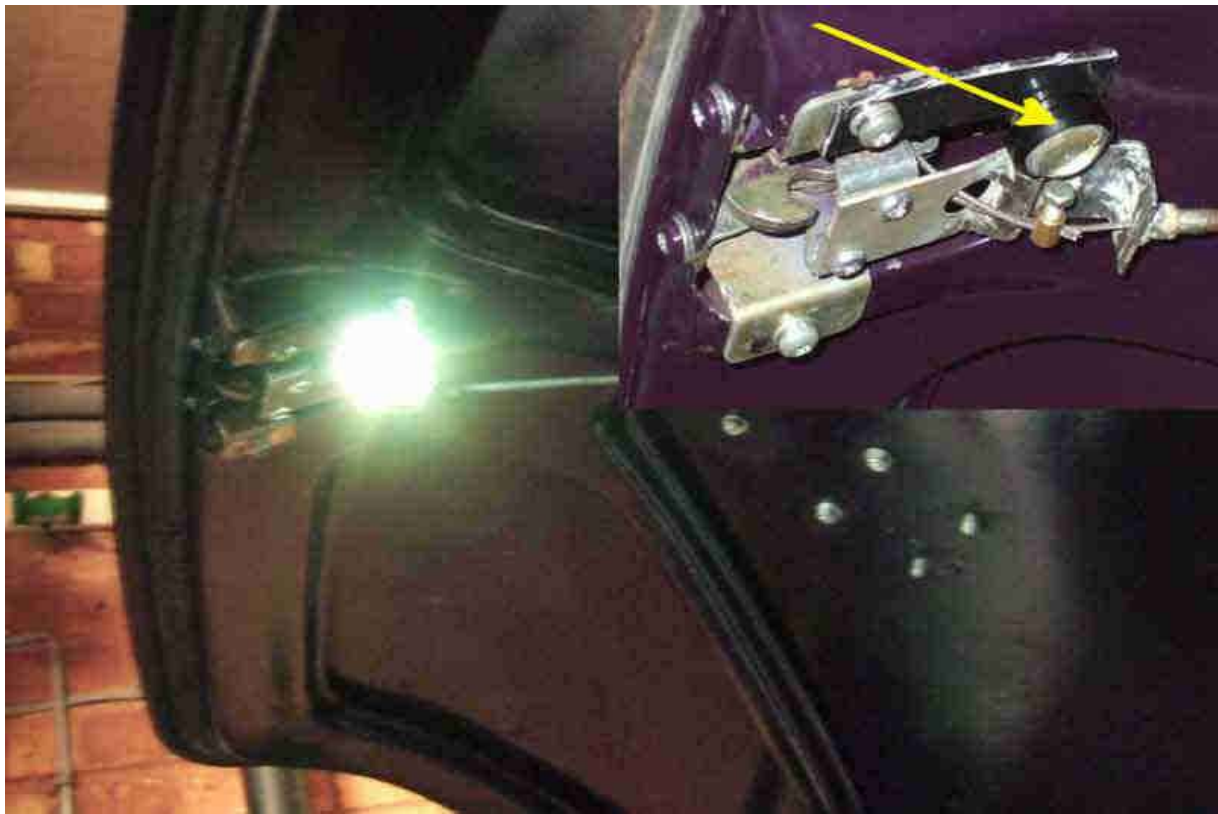
The LED positioned in the cut-out for the latch release, on the right-hand side so as not to interfere with the release mechanism in either the locked or unlocked positions. Attached using a strip of plastic (from an offcut of square black guttering downpipe - very useful stuff) under one of the latch fixing screws. It could be attached using a screw or double-sided sticky pad to the underside of the latch, but I have my emergency boot release mechanism already there.

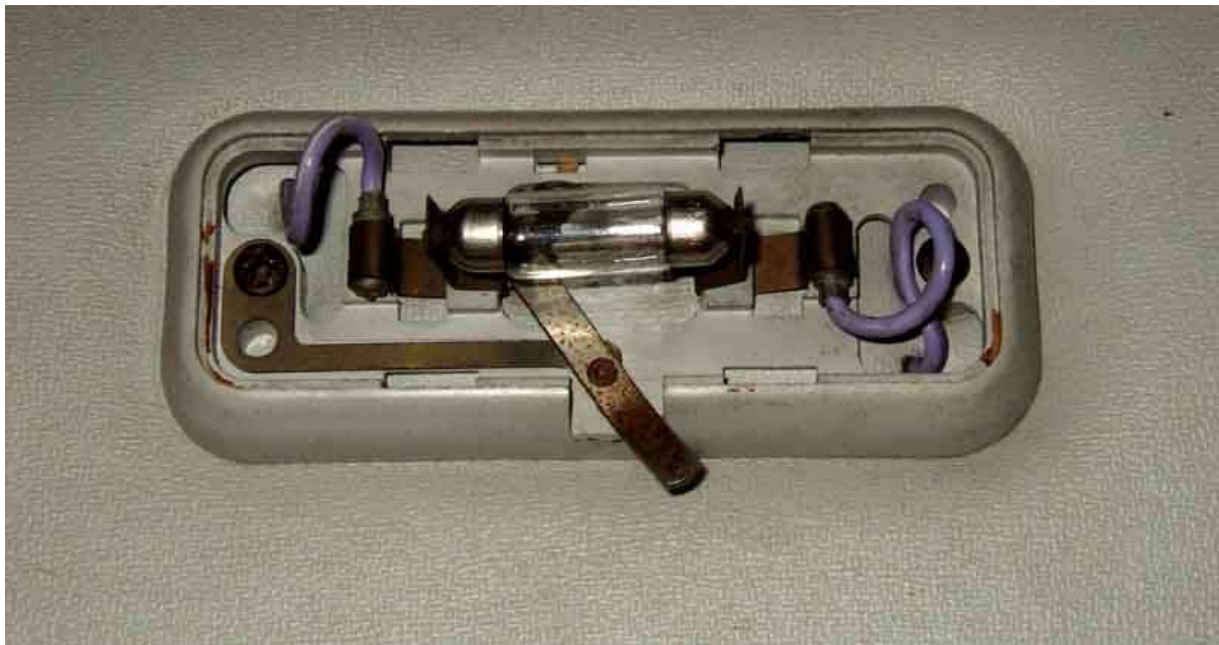
Manual switch operated, simply touches the left-hand (in this image, right-hand on the car) bulb contact. The purple/white wire from the hatch switch must go to this end of the courtesy light and the purple 12v supply to the other end. Getting them the wrong way round will blow the fuse:
