Voltmeters

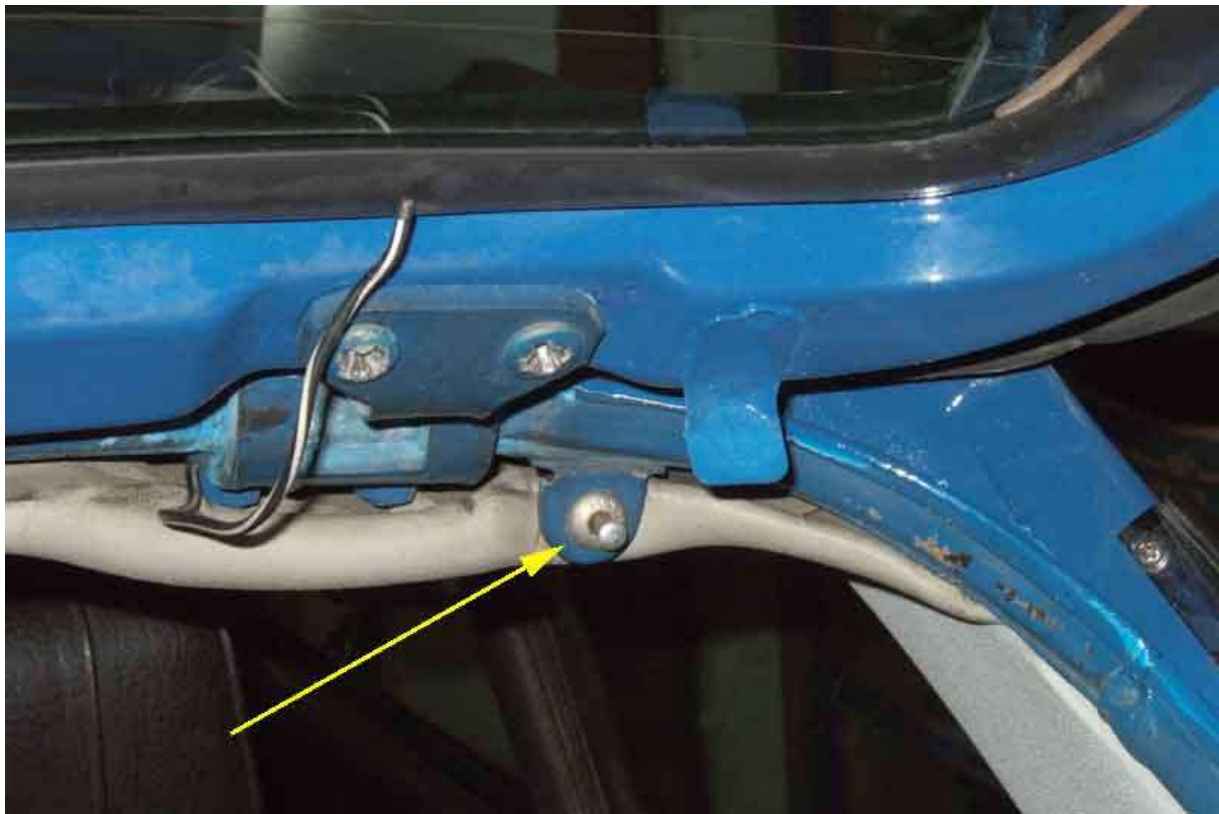
The manual switch (arrowed), depressed by the tab on the hatch to turn the light off.

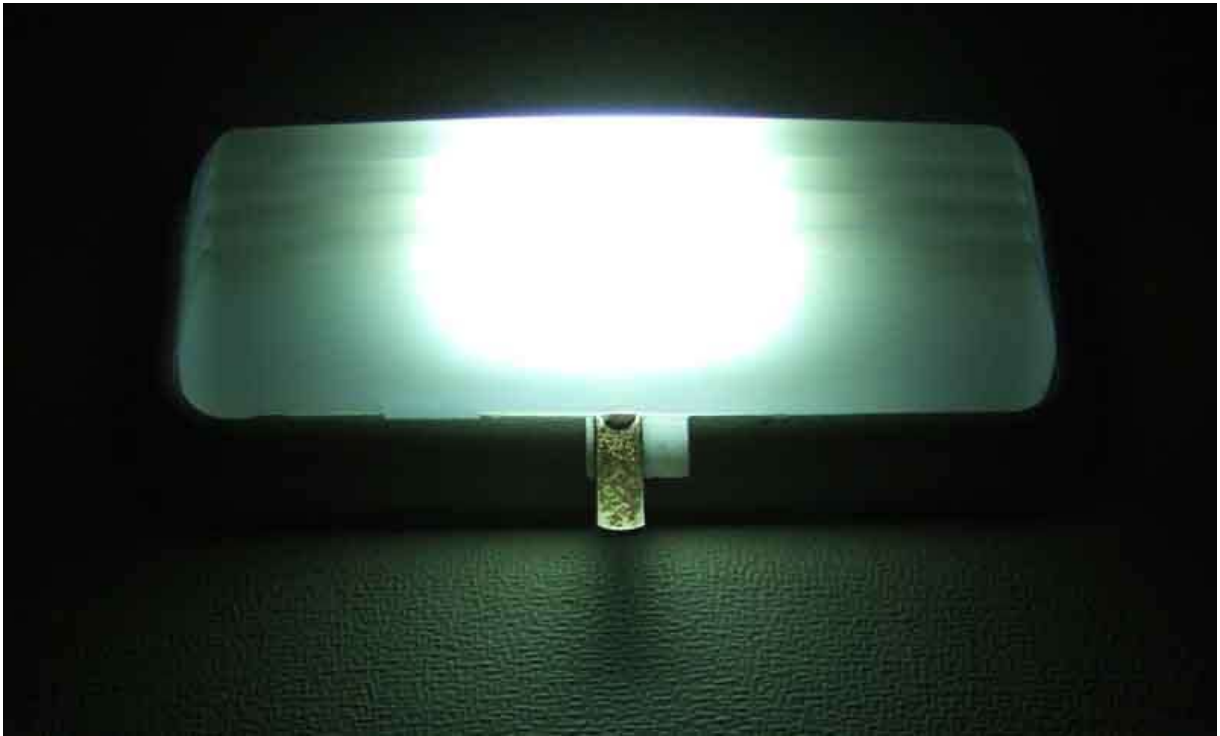
With new cover and an LED, it's the big increase in brightness that has reduced the exposure.

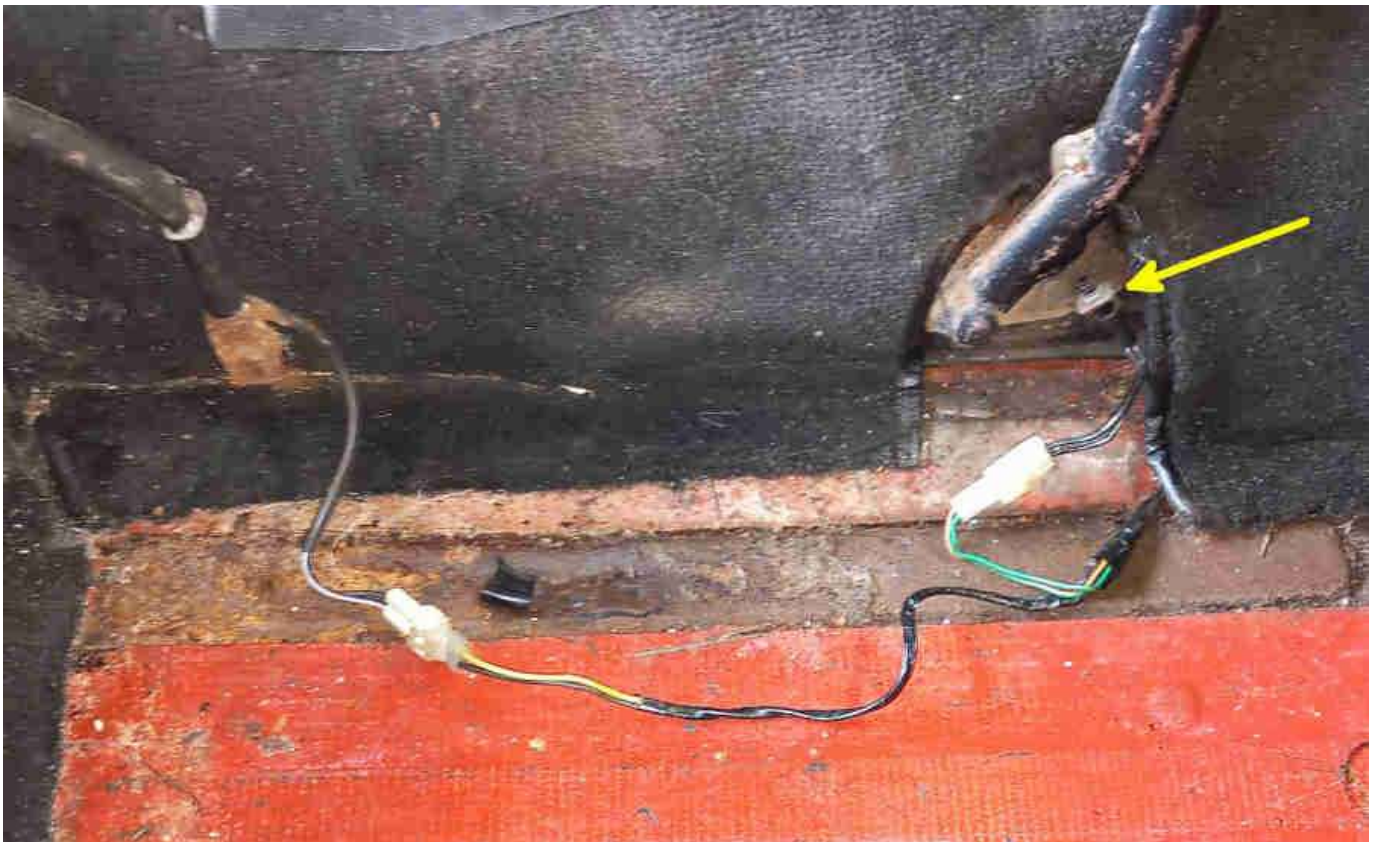
The UK seat-belt and handbrake switch wiring:

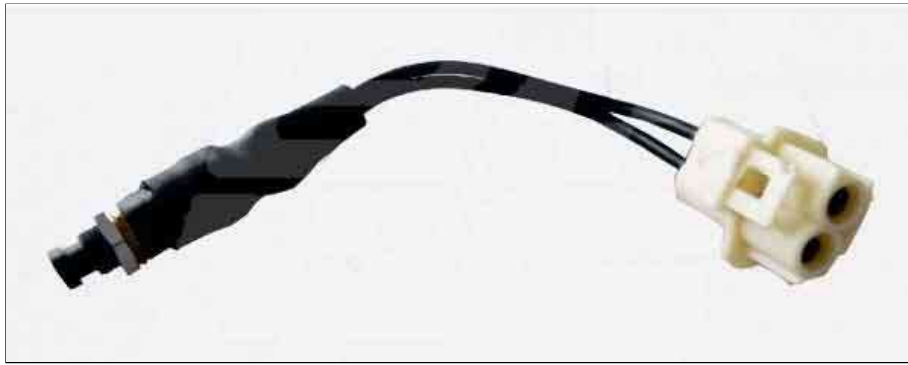
The handbrake switch used is AAU2492: (*Brown & Gammons*)

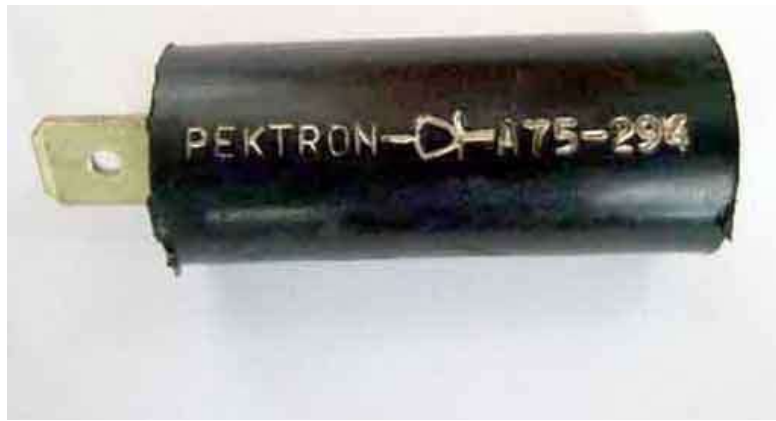
Warning light test diode showing the male connector for the white/red wire ...

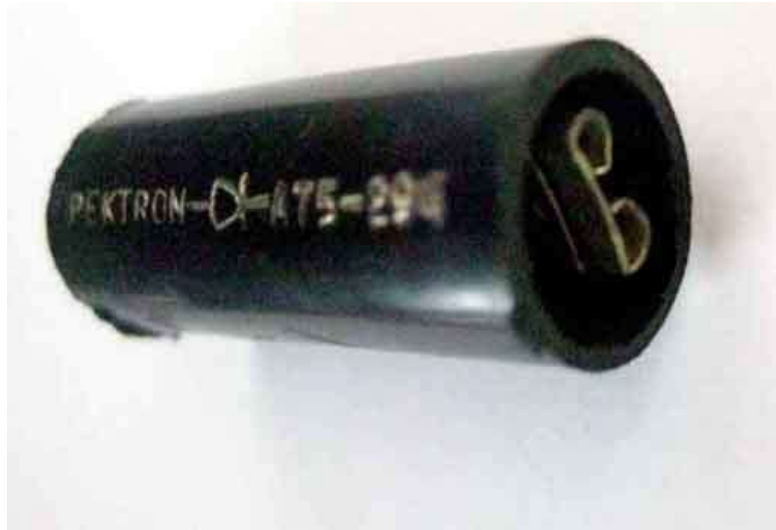
... and the recessed female connector for the green/orange wires:
