Mk1 or Mk2?

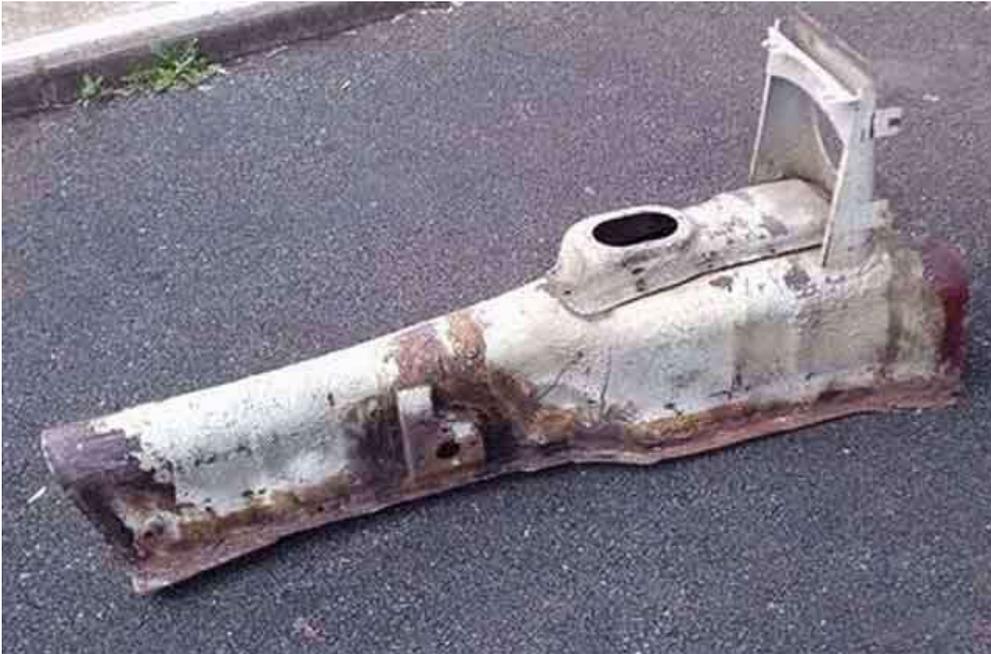
Mk1 tunnel with a pronounced hump on top of the tunnel in a large removable panel round the gear lever: ([MGBs Made in Australia](#))

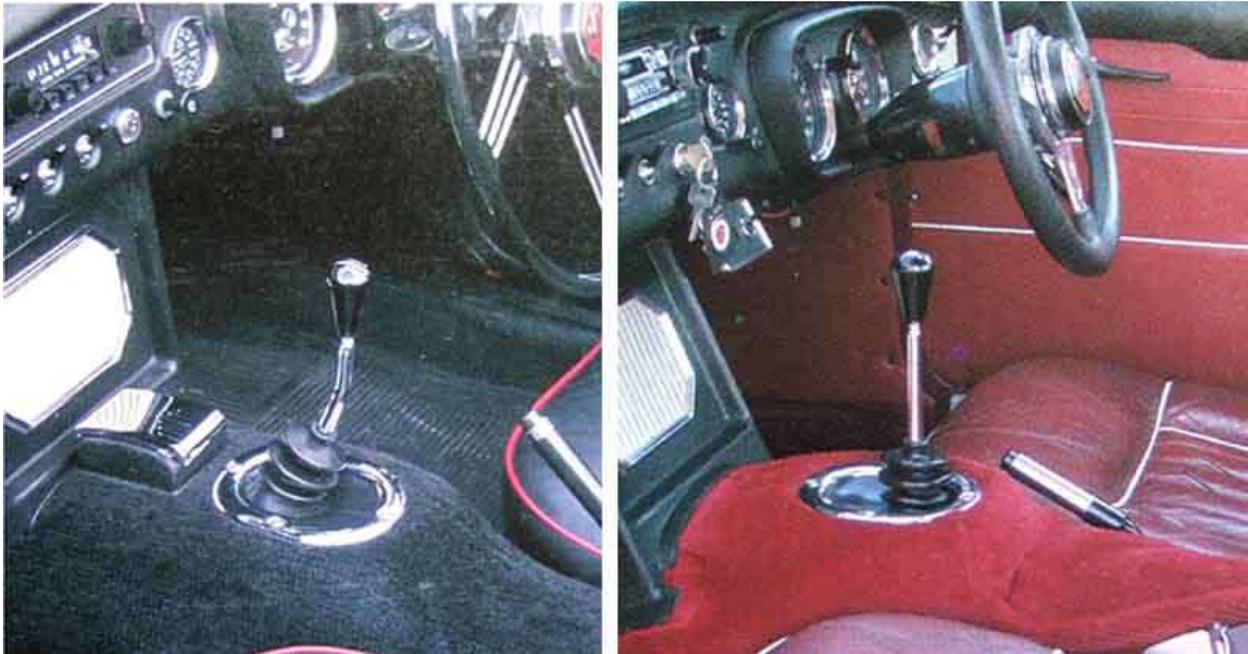
Non-OD on the left with the lever at the front of the oval rim ring, OD on the right with the lever at the rear of the trim ring: ([Clausager](#))

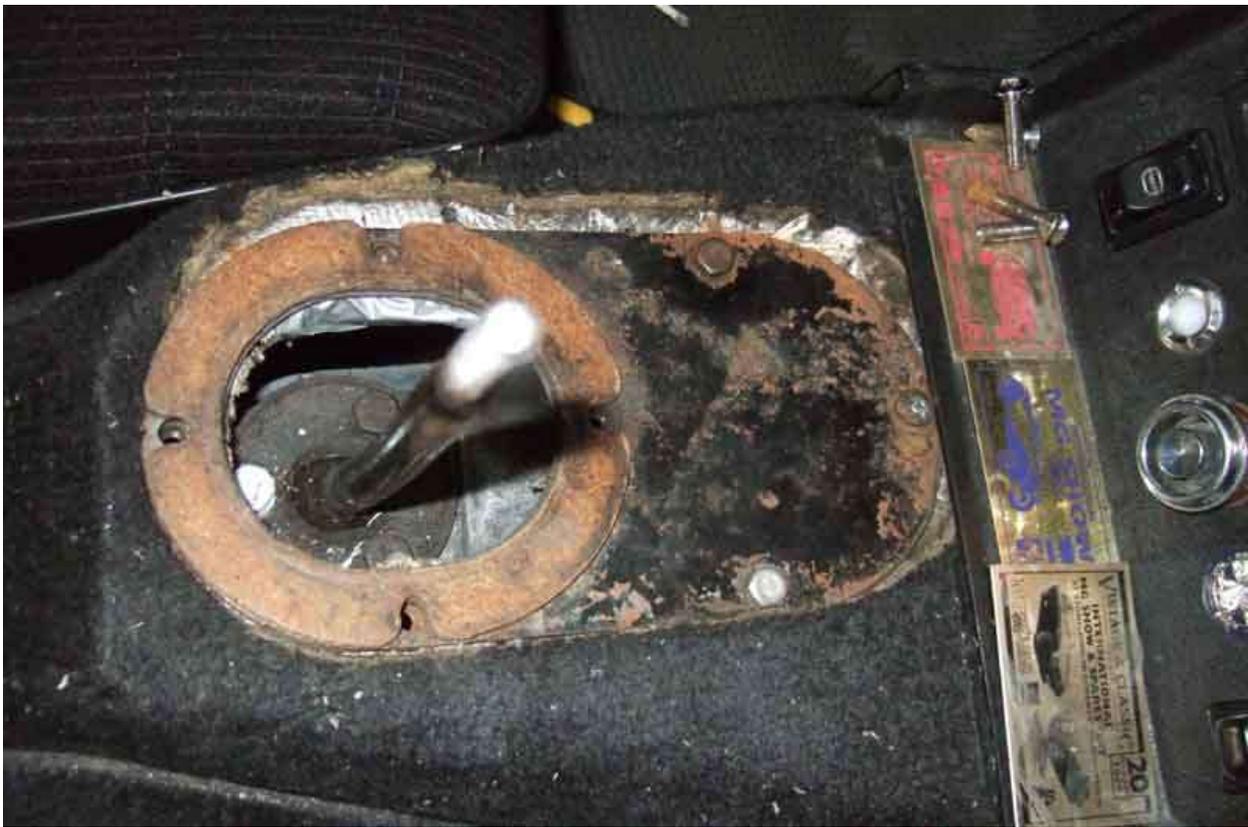
Mk2 tunnel is wider with a flat top, with the lever in the same position on both OD and non-OD. There is a small removable panel HZA1431 screwed to the tunnel:

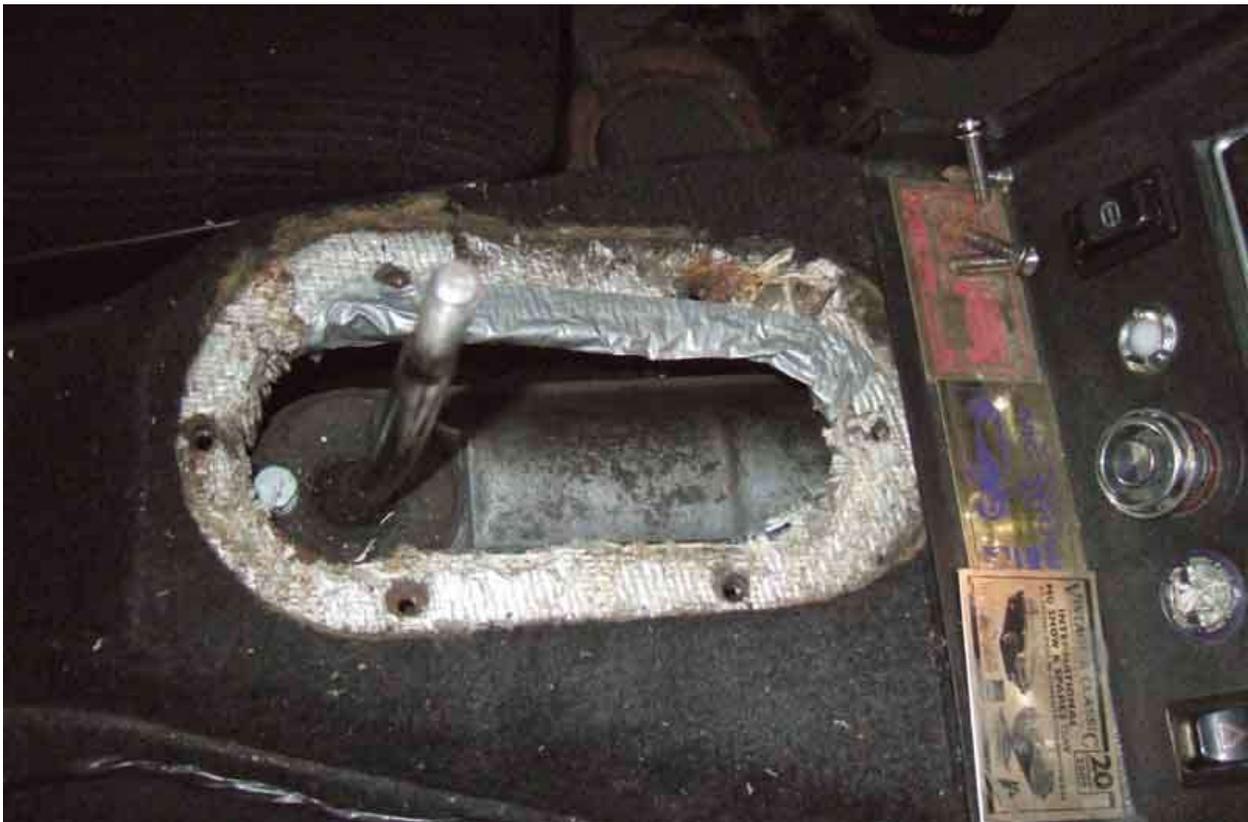
Removed - suppliers show gasket AHC188 under it and I did find that on a 78 sitting on the metal tunnel but both Bee and Vee have thick insulation there which makes the gasket pointless:

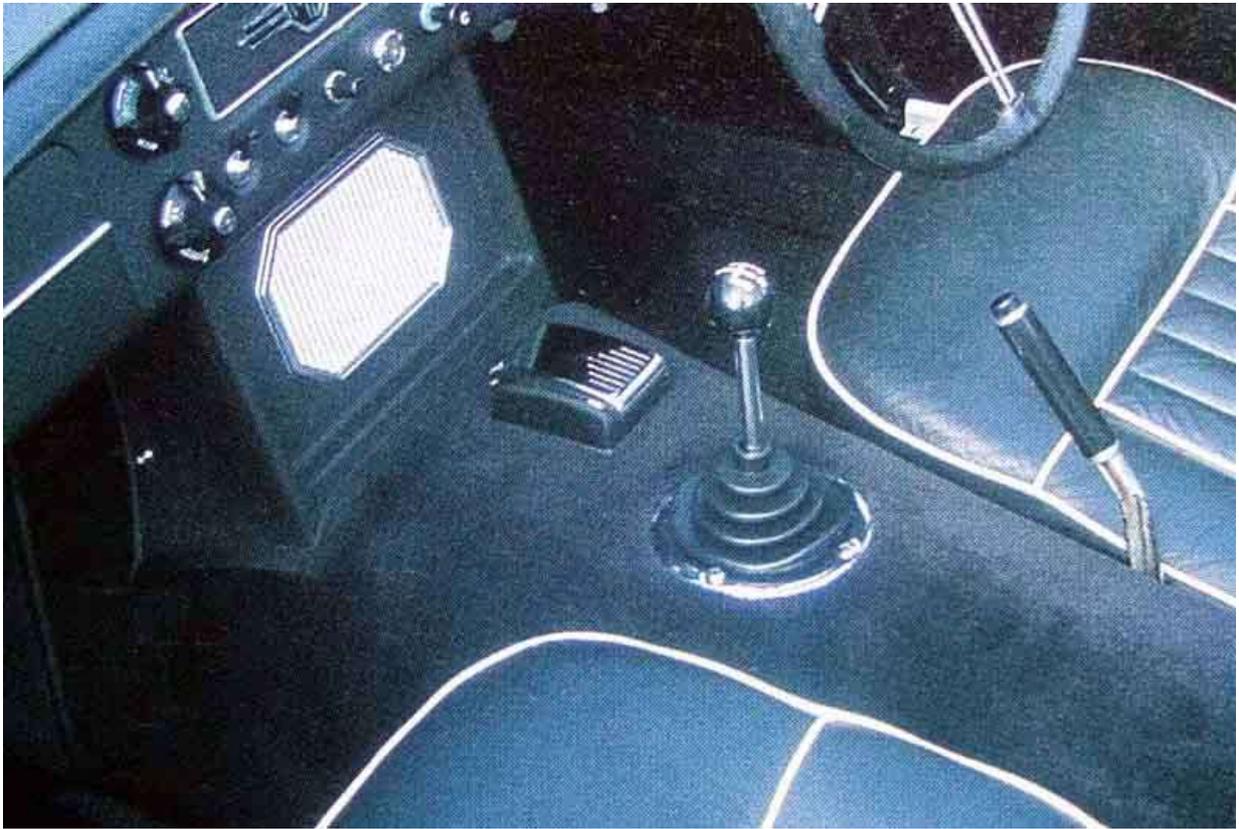
Mk2 with the 72 and later centre console. What the rubber bit at the top of the gaiter is I have no idea, it came with the car - possibly hiding a bit of rattyness at the top of the gaiter, but like steering wheel and the gear knob it seems churlish to replace that part of the car's 'character':

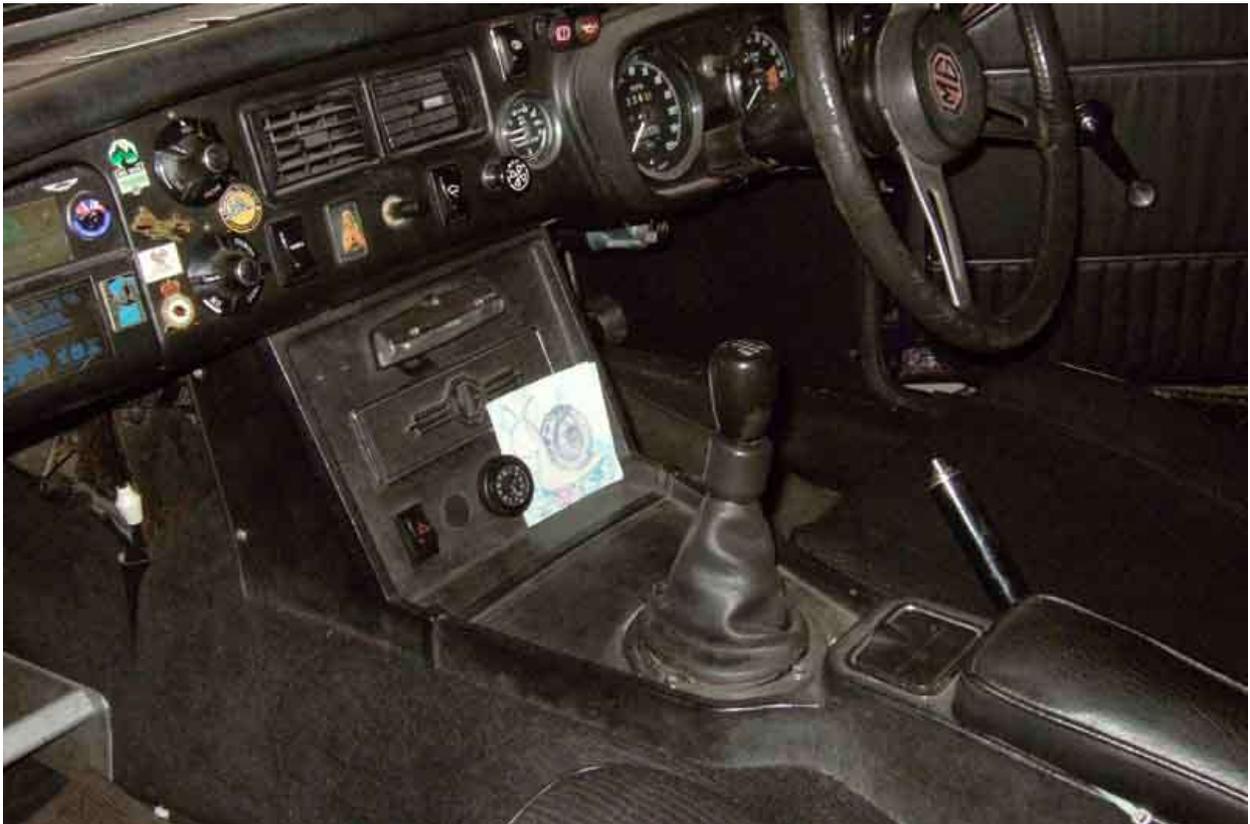
With the 72 and centre arm-rest the tunnel carpet can be cut to allow removal of the small access panel without pulling the carpet back, saving a section of carpet to drop back on top for noise insulation:

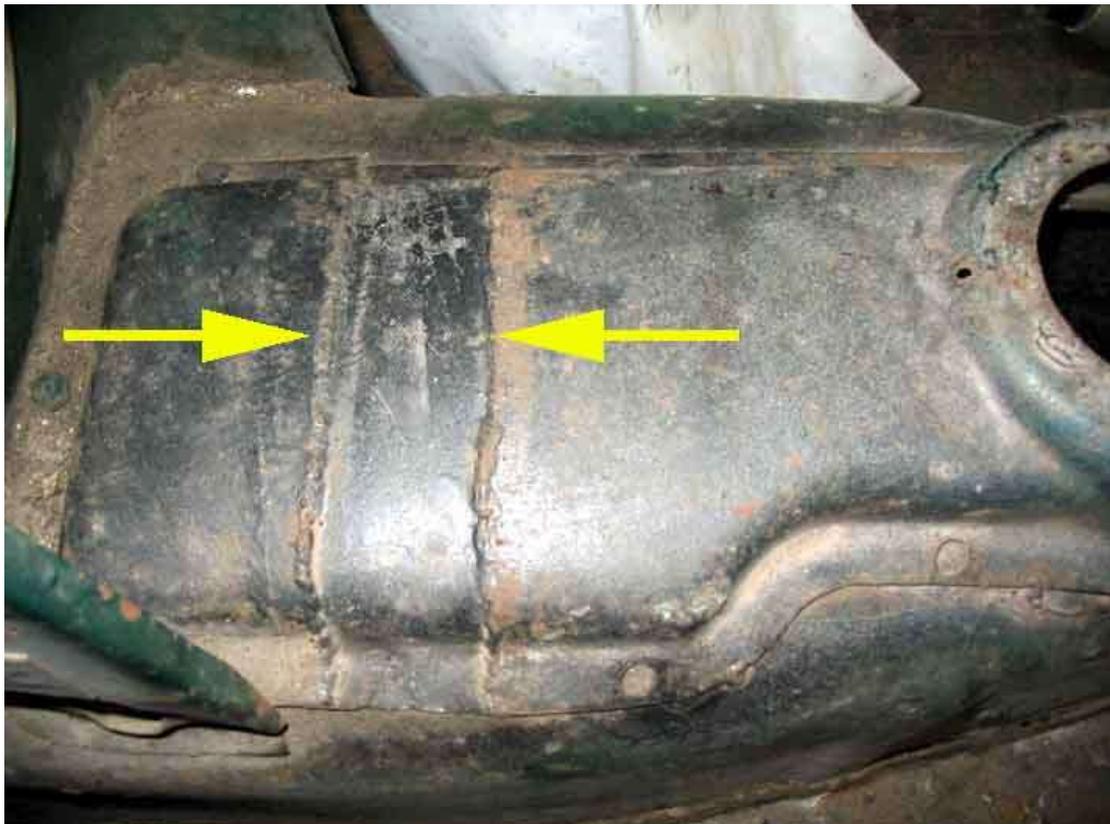
A 4-synch gearbox can be installed in a Mk1 car but the large removable panel on top of the tunnel needs a section inserted to move the hole back for the 4-synch gear lever, as indicated by the arrows:

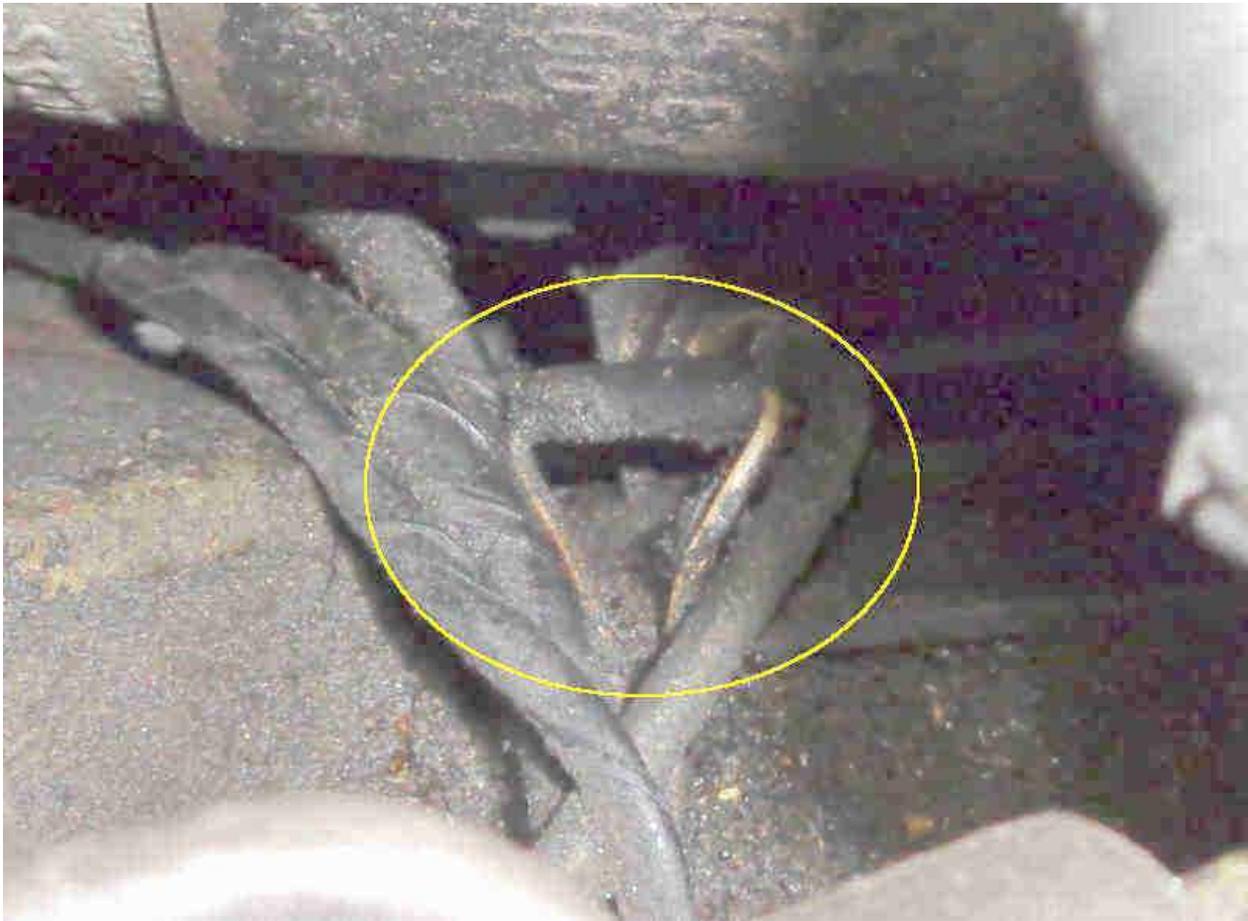
Note 2: There is a bullet connector in the white/red between the ignition switch and the starter solenoid (68 and 69 models) or the relay (70 and later) on **all** Mk2 CB cars, which is where the transmission safety switch/starter inhibitor wires are connected when the automatic gearbox is fitted. Arrowed below, just above the bracket for the clutch pipe and hose, in the tail that leads down to the starter:

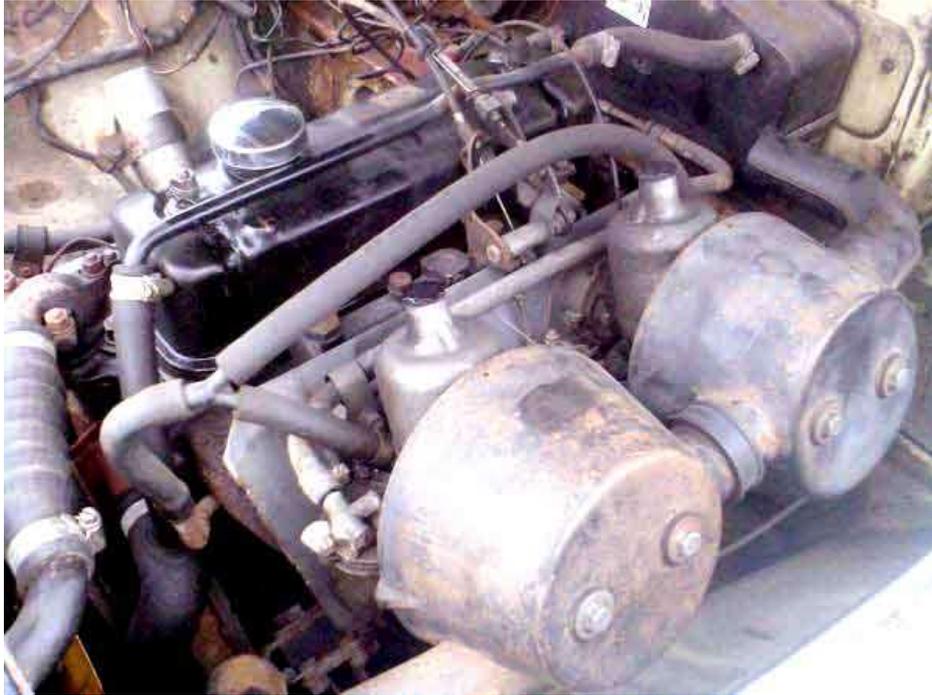
What's that kink in the heater return pipe for?

To give clearance for the kick-down cable on automatics:

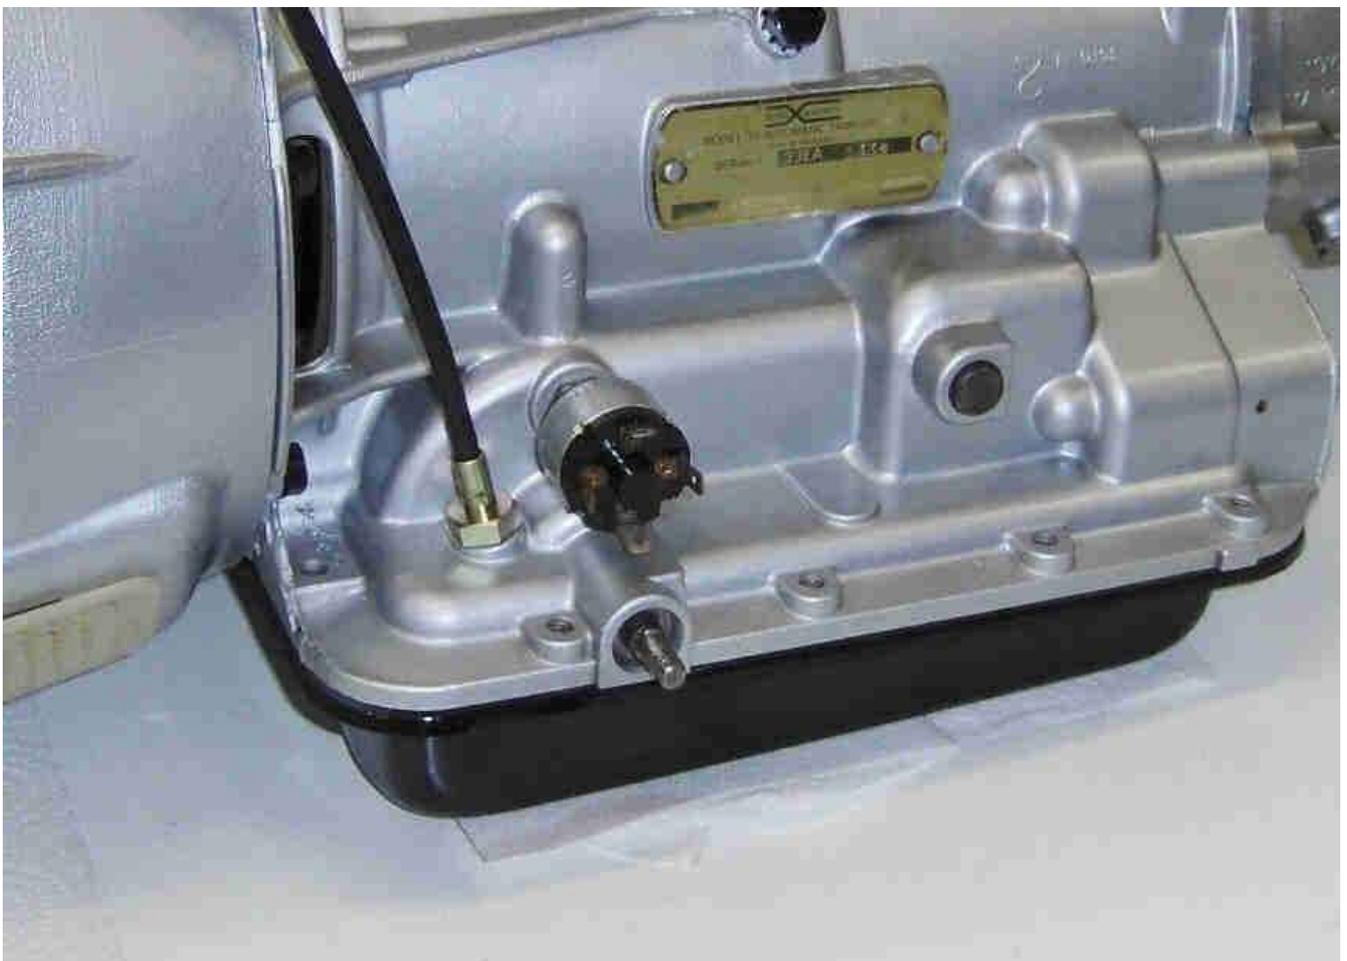
Kick-down cable and starter inhibitor/reversing light switch on a BW35 auto:

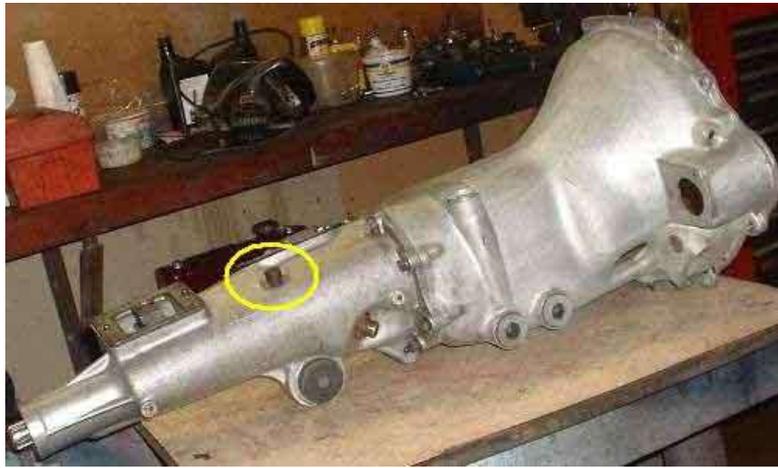
3-synch non-OD: ([Chicagoland MG Club](#))

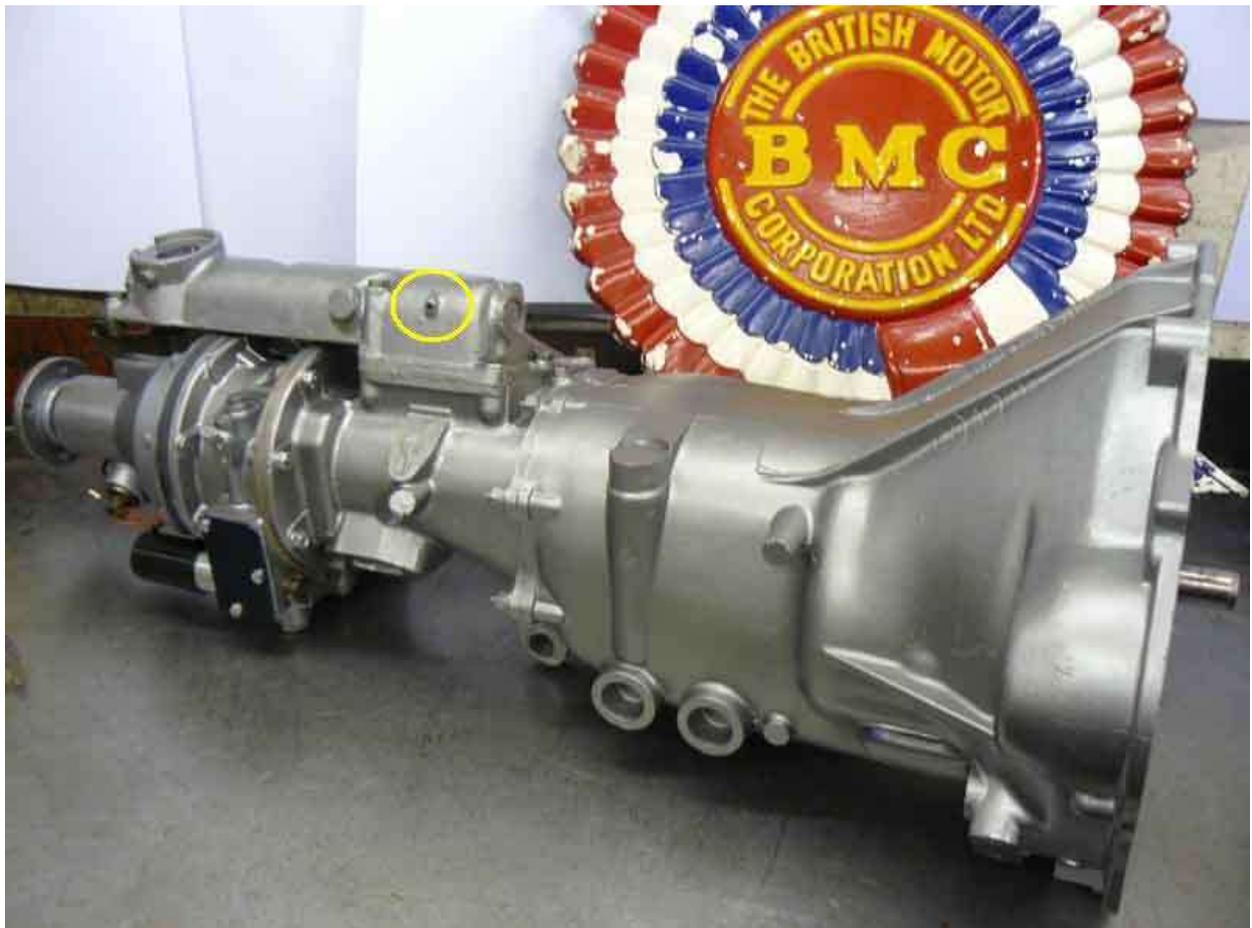
However despite one being listed in the Parts Catalogue there are several indications in the wild that 3-synch OD don't have one, just a hole in the side of the remote change unit:

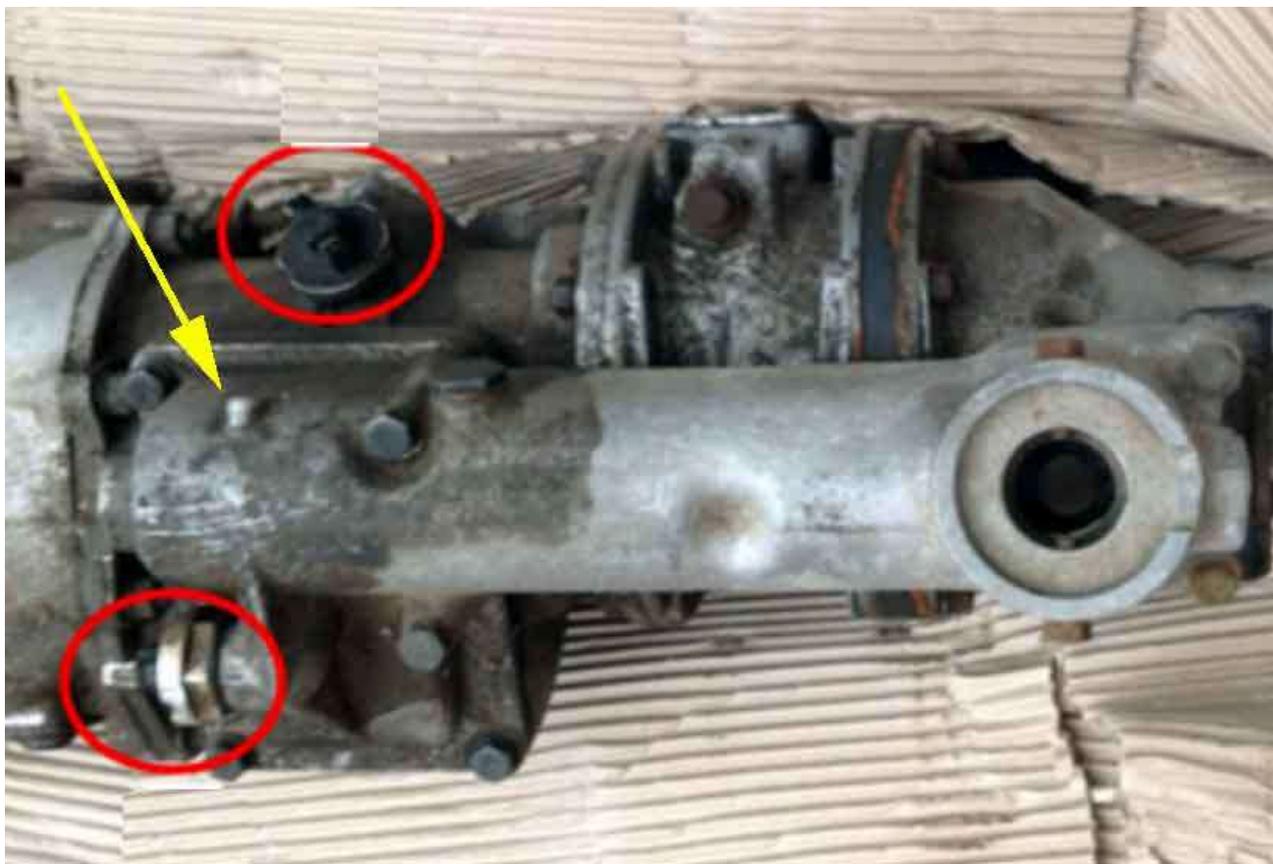
Cap removed. The cap seals the end of the tube, and the holes in the sides (one each side) allow for the breathing. Martin Roberts pointed out that they can be used with a small screwdriver or thin bar through the holes to fit it - or to remove one that hasn't already broken off. The cap should shroud the holes to hopefully prevent flood water going in, but it's a bit hit and miss. ([Dave O'Neil on MG-Cars.net](http://DaveO'NeilonMG-Cars.net)). I suspect this is the earlier breather as a new 21H6060 in 2017 is quite different:

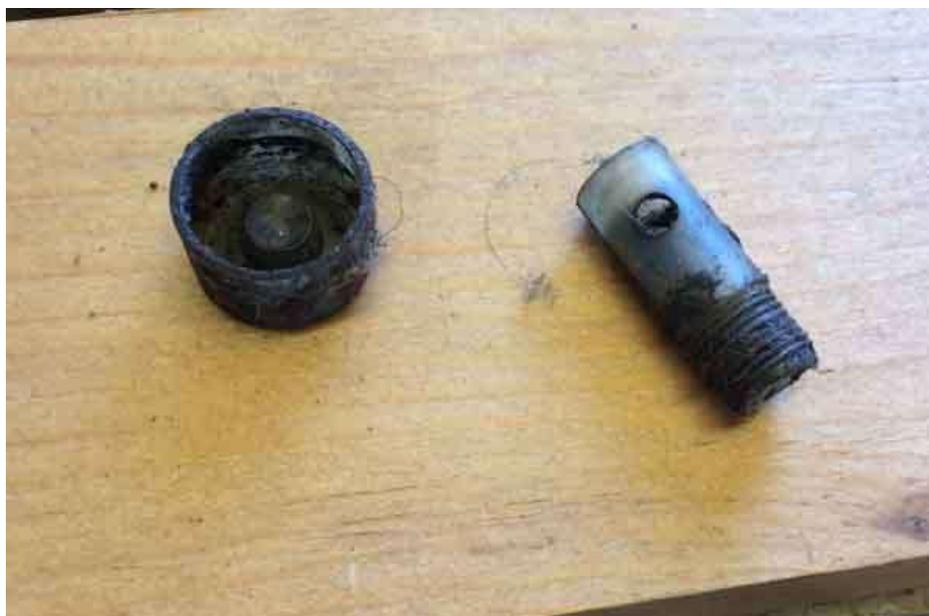
A new 12H6060/V8 breather, comprising a body (A), insert (B), and cap (C). It can be seen that the main part of the body and hence the cap are significantly bigger than the original items above:

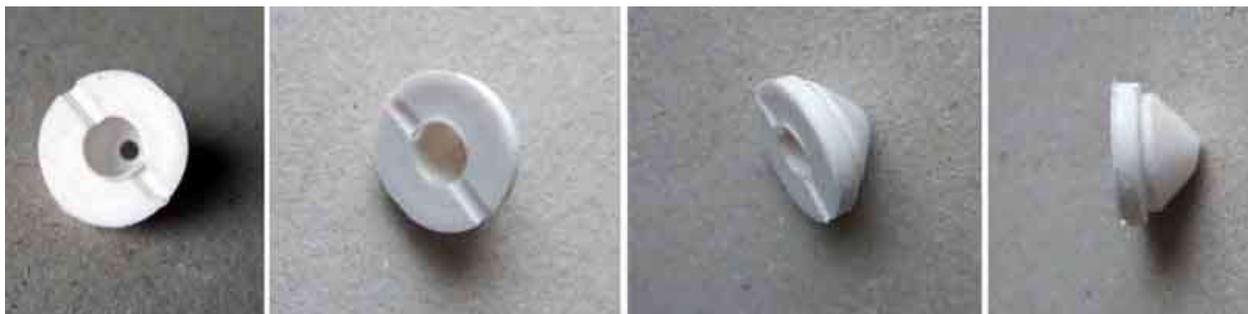
The insert. The small hole visible in the first image is actually too small to allow water that might be sitting in the insert to run through to the axle. Of course, if the axle is hot, and has run through water, any sitting there will be sucked in as the axle cools. The slots across the top allow air to pass between the insert and the cap:

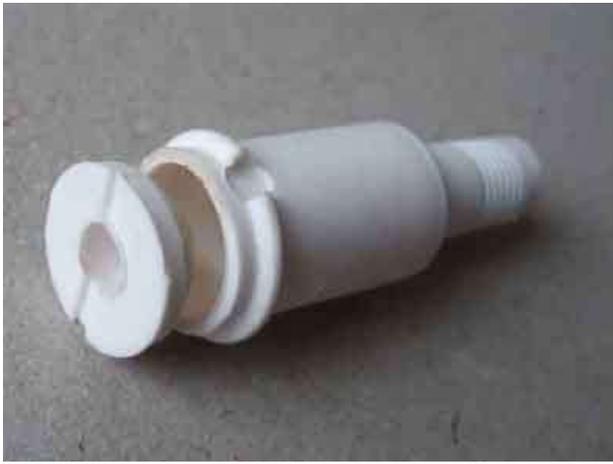
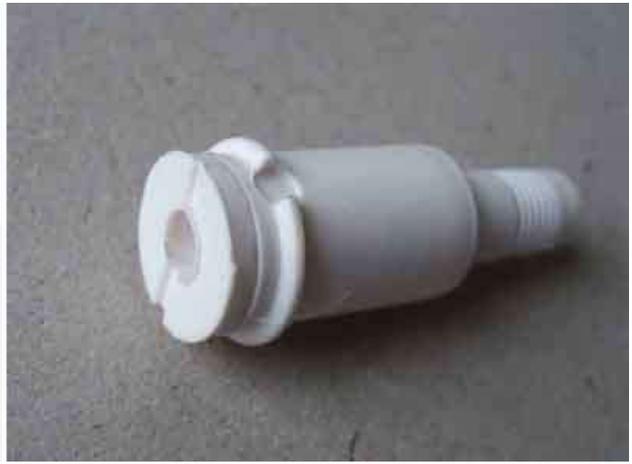
The insert fitted to the body ...

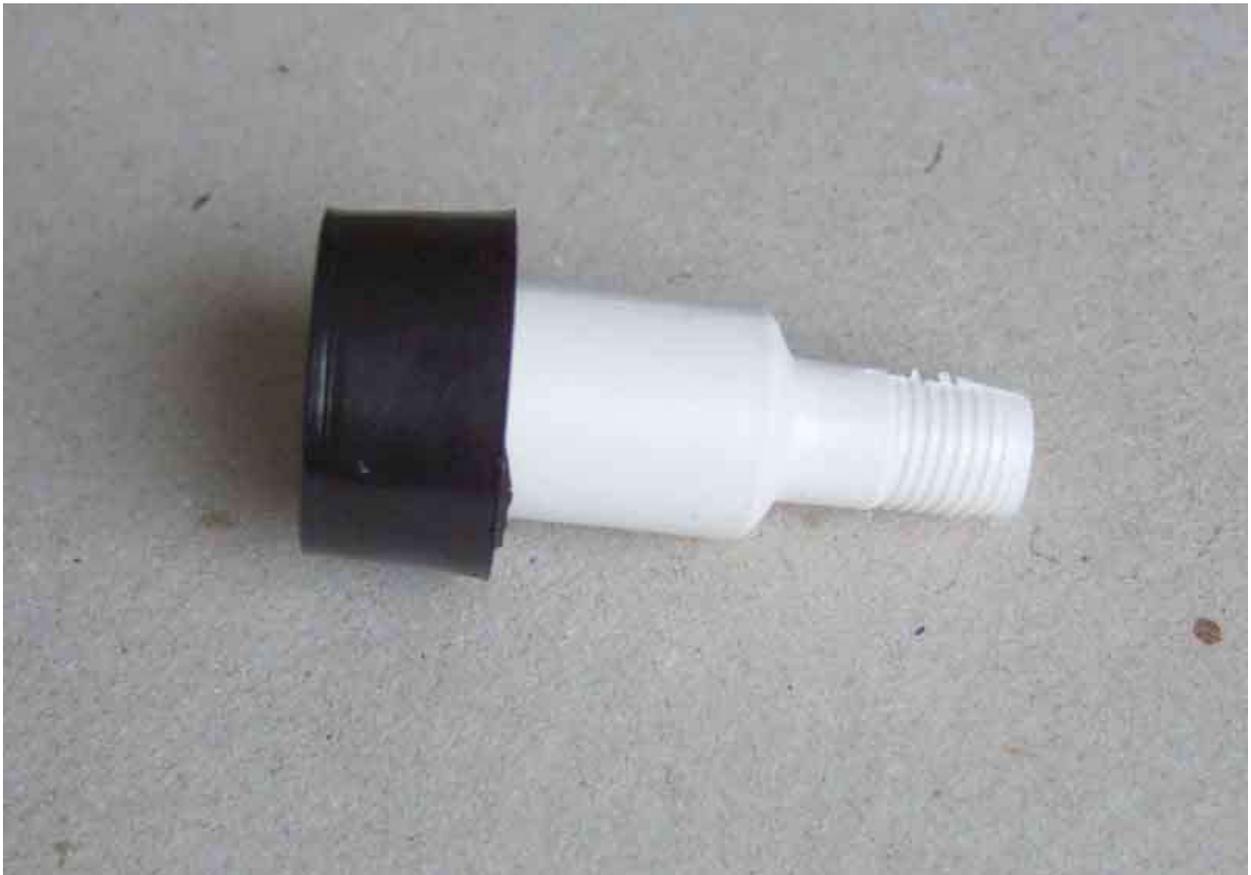
A lot of worrying crud, probably friction material, on top of the filter, which is what led to the replacement of the OD

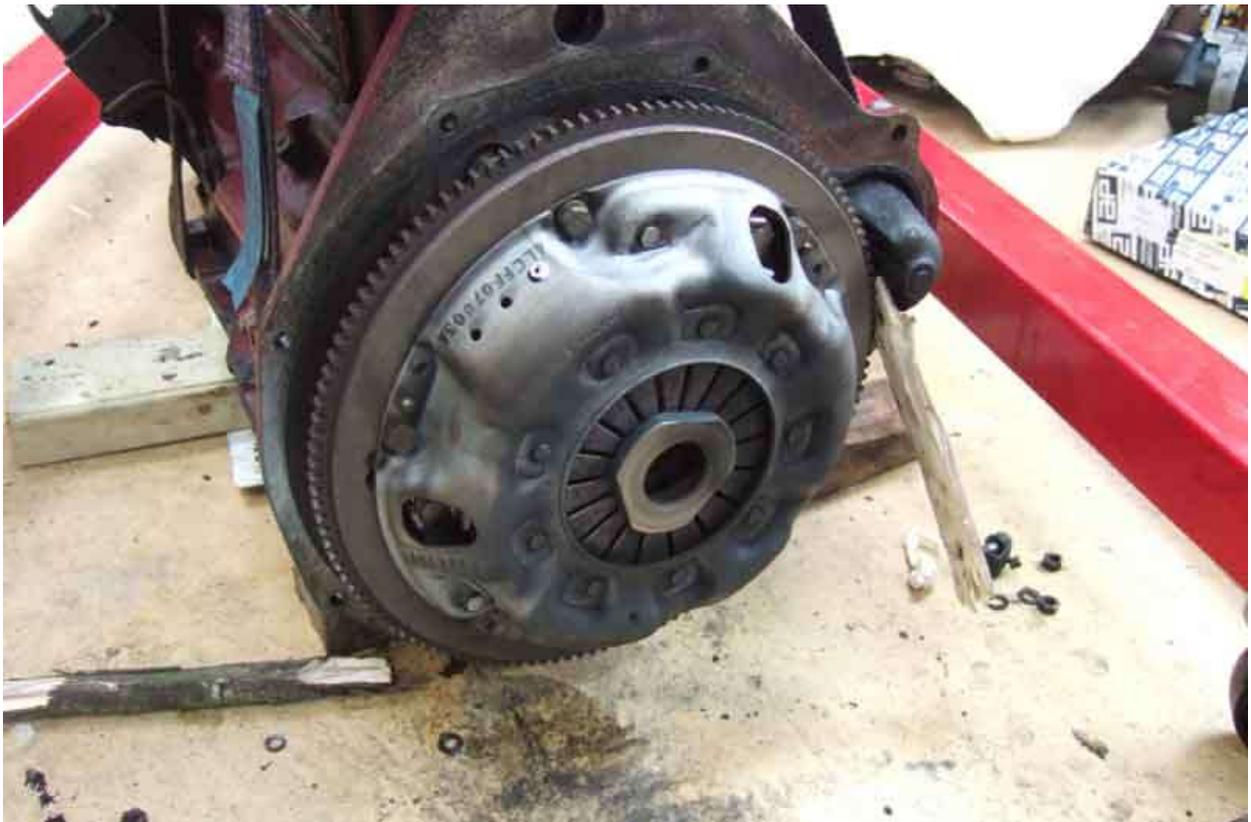
Gearbox separated from engine, bit of wood wedged between ring-gear and starter pinion prior to undoing the clutch cover plate bolts to replace the clutch at the same time.

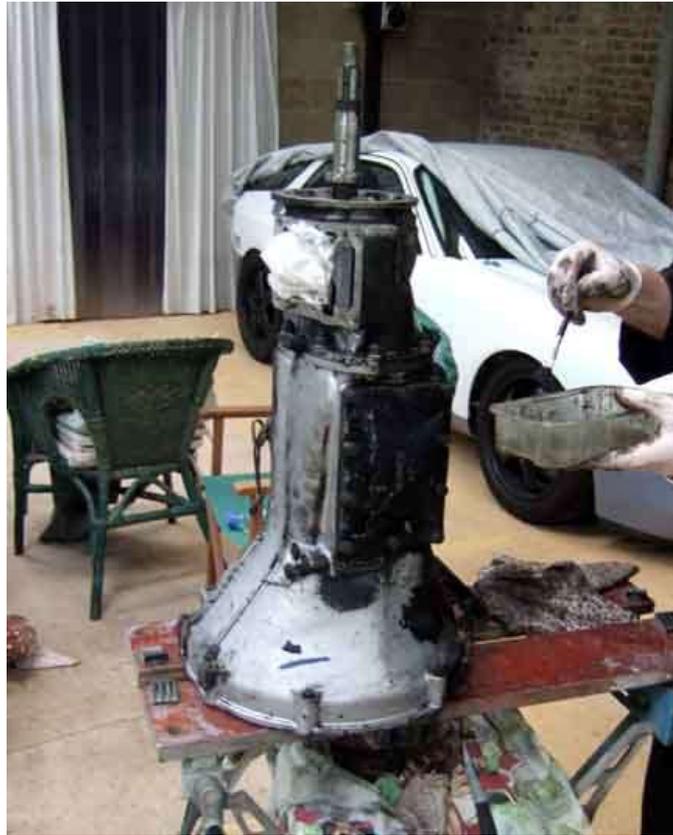
Gearbox on Workmate preparatory to fitting OD

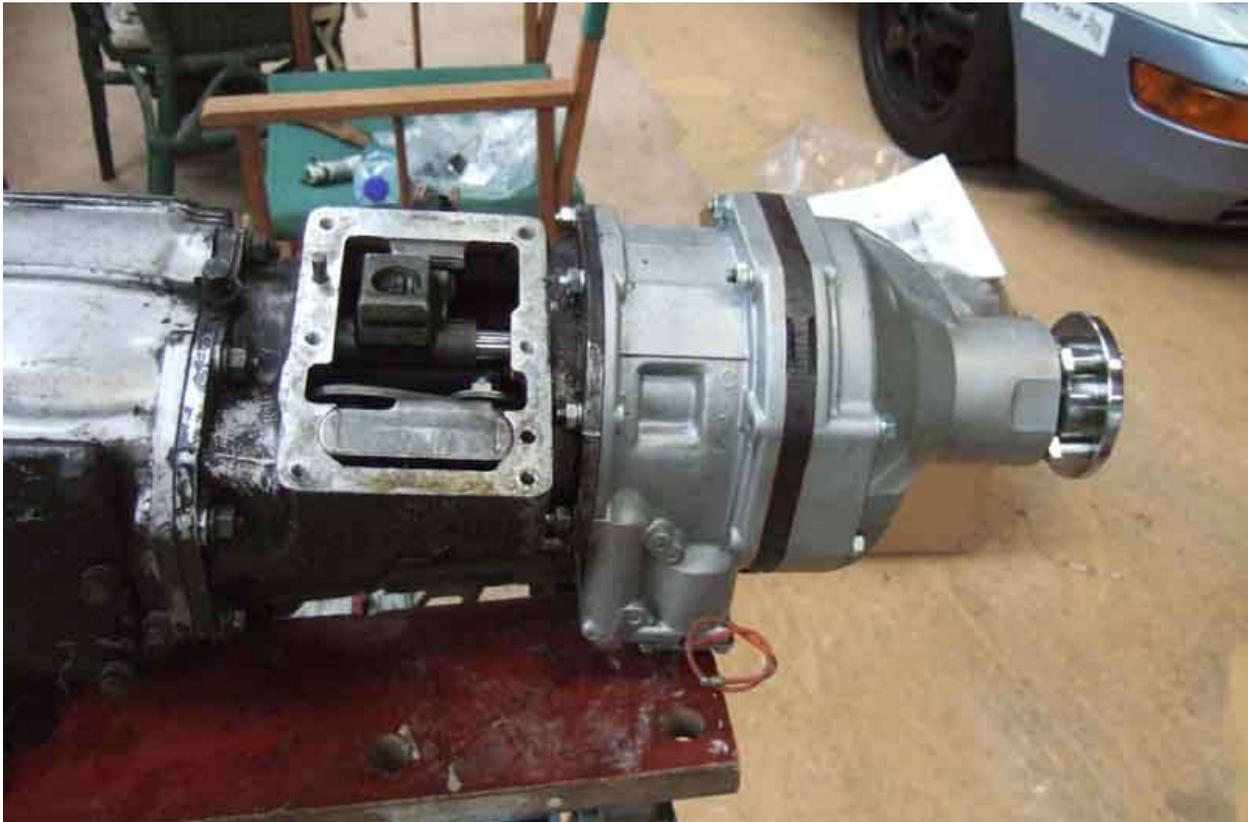
OD fitted, time for a celebratory bacon sarnie!

IMPORTANT! The LH overdrive is attached to the gearbox with the solenoid and the manufactures info plate on the bottom. Unlike the D-type where they are basically on the side.

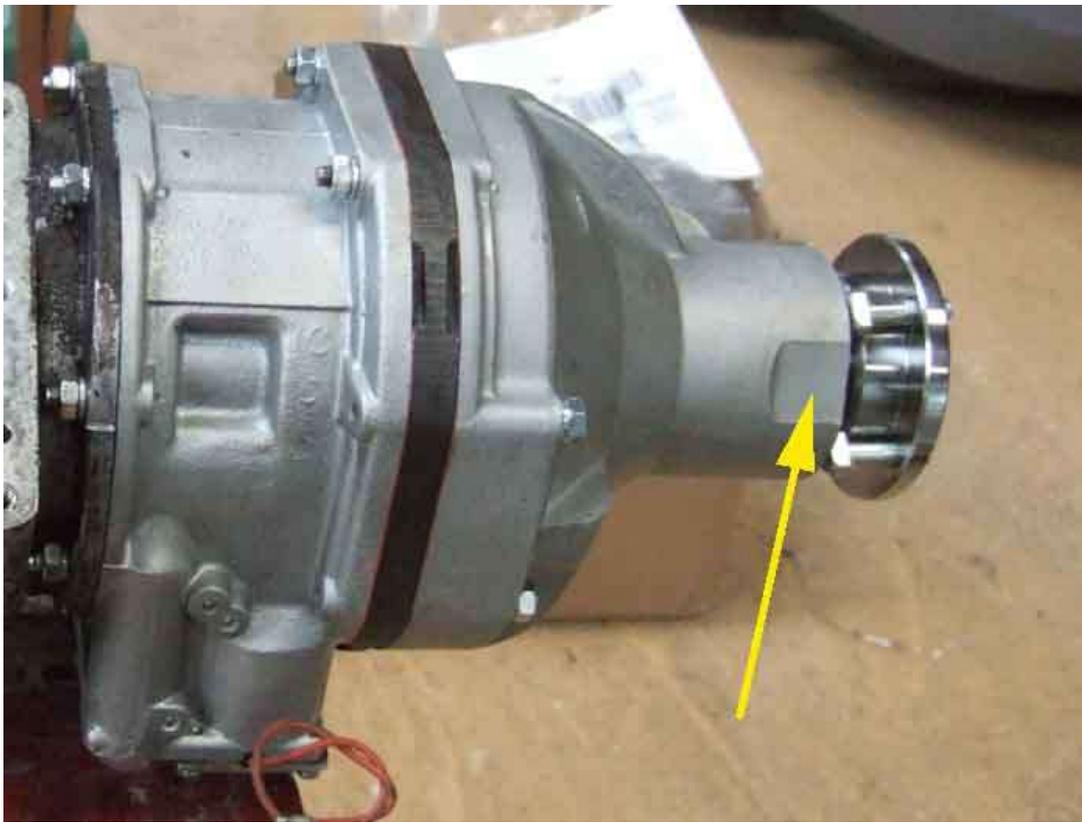
Arrowed is the flat on the casing that allows the removal of the V8 propshaft bolts while the flange is still fitted to the output shaft. Not possible with this 4-cylinder flange, which is smaller.

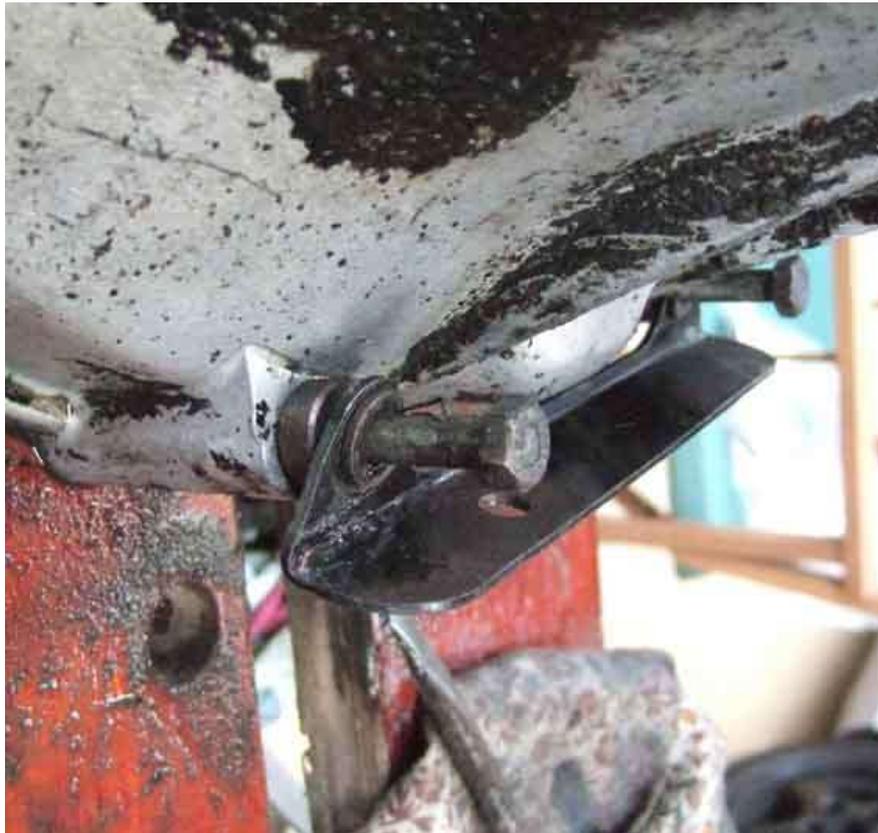
The disposition of the bottom two bell-housing bolts and exhaust mounting bracket

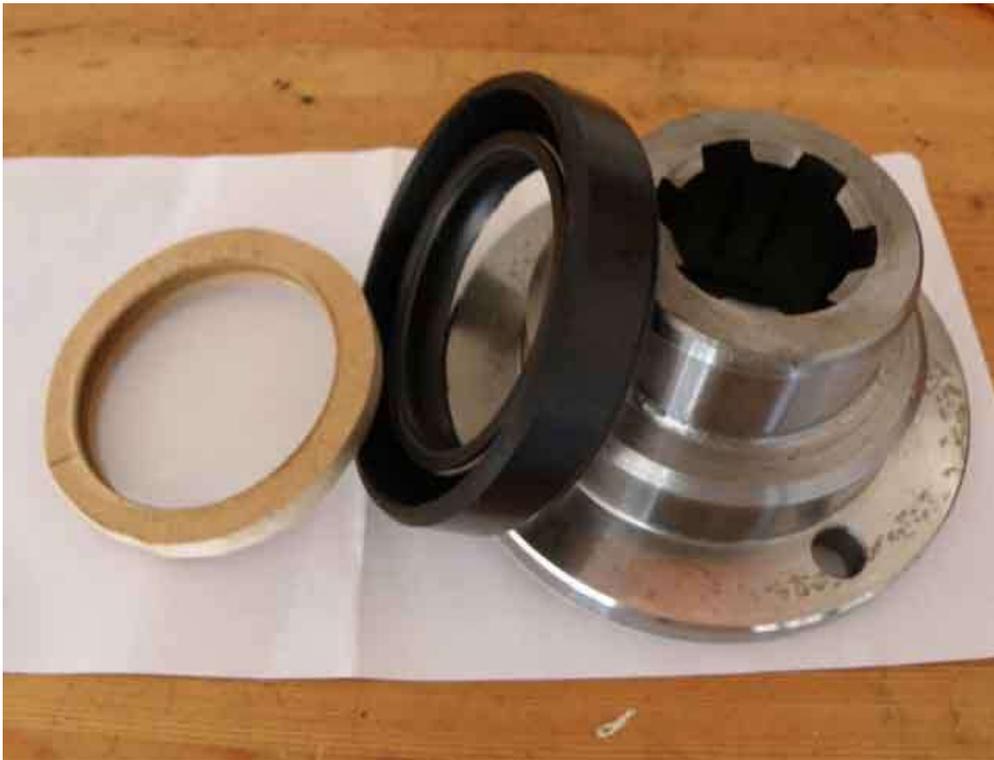
New flange and seal, together with a wooden ring originally intended to be used to drift the new seal into position but not used

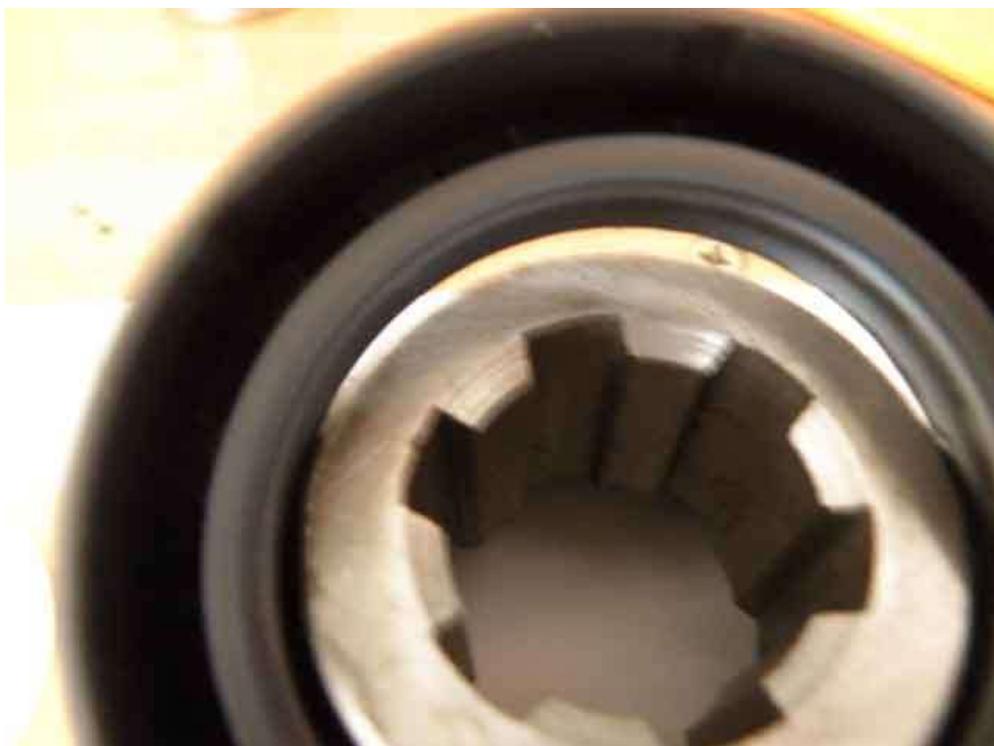
The seal fitted over the flange
