Mk1 or Mk2?

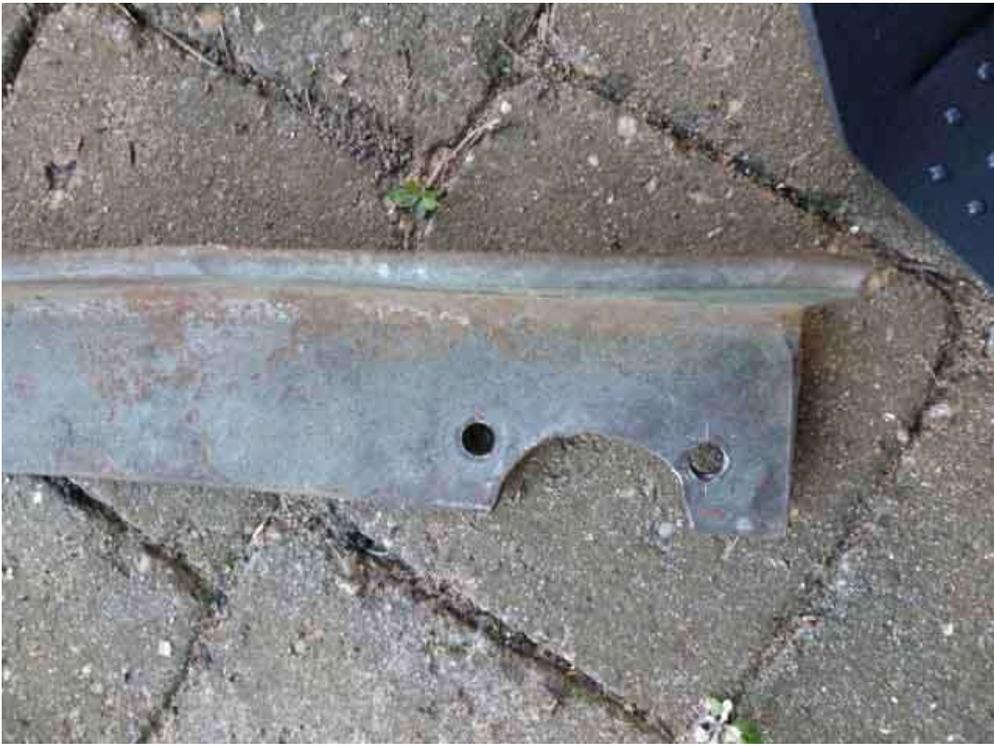
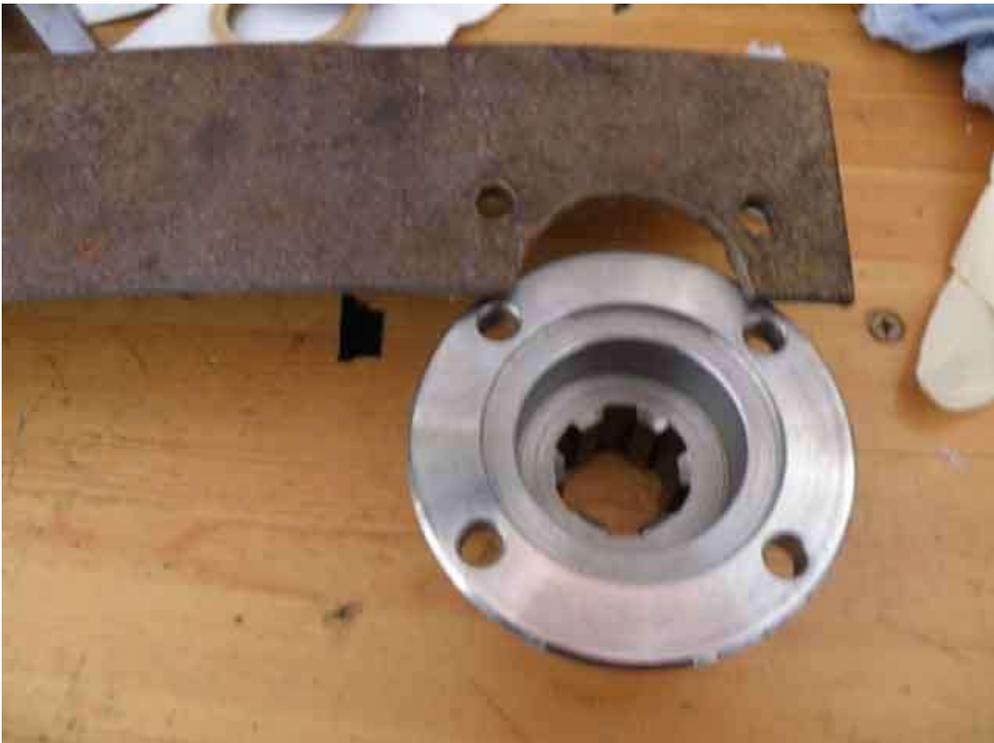
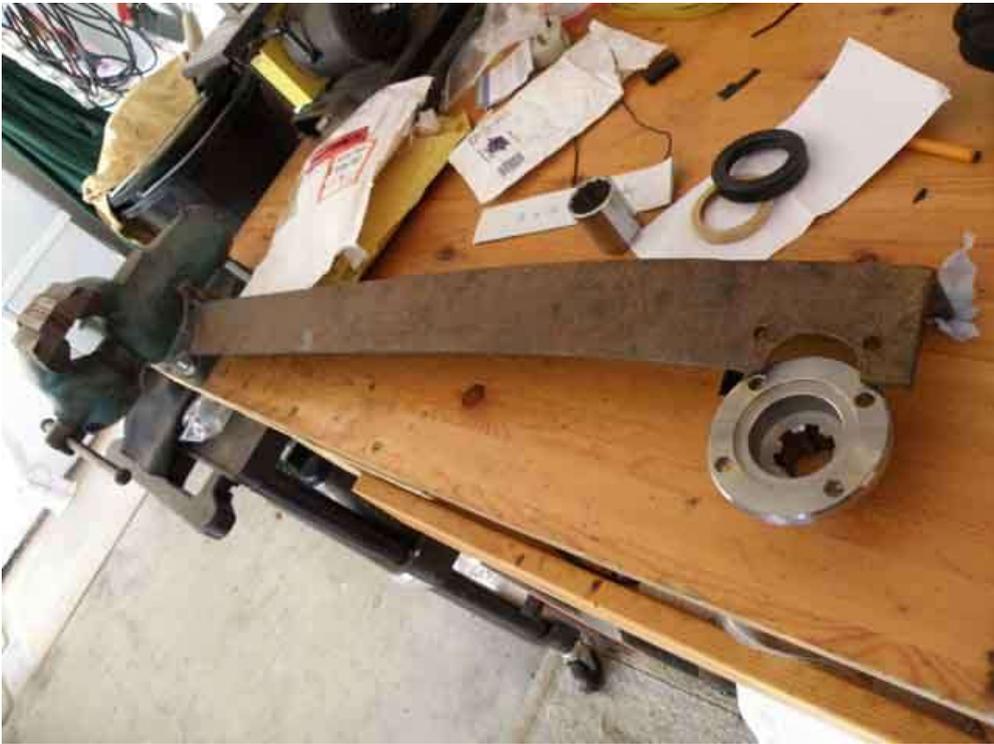
The 'tool' used to hold the drive flange steady while the central nut was undone - a piece of 2 1/2" angle iron, with a curved section cut out and 2 holes. The flange nut is 1 1/8" AF, same as the front hub nuts.

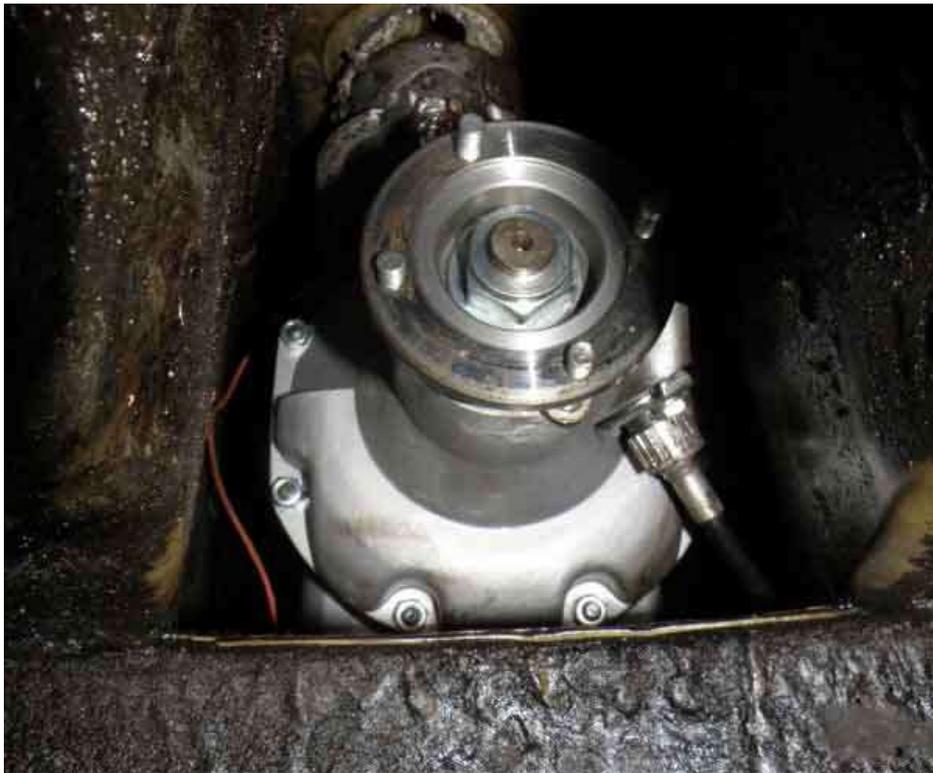
Prop-shaft removed

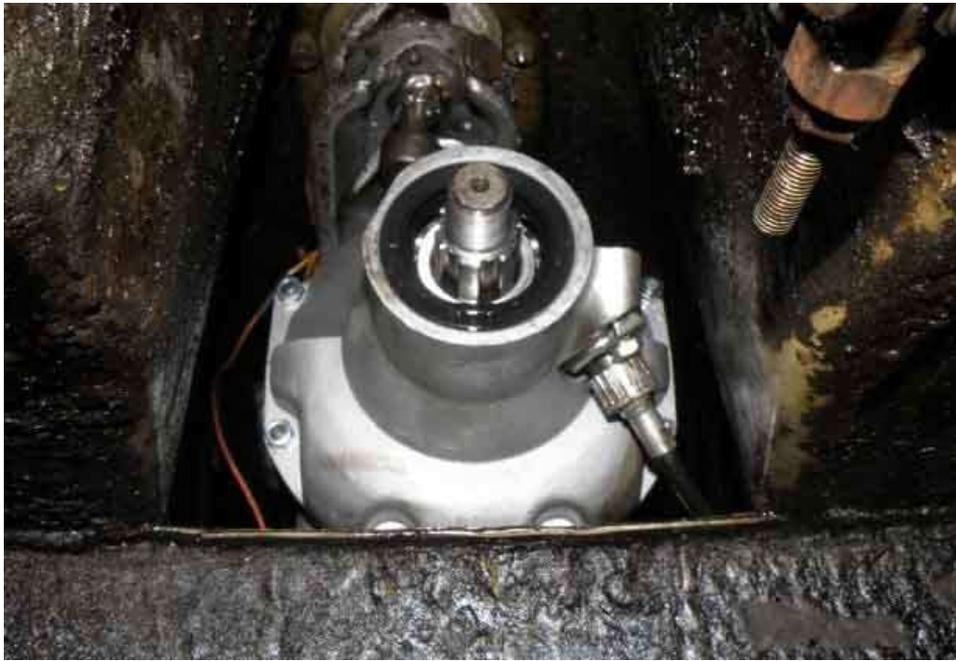
Flange removed

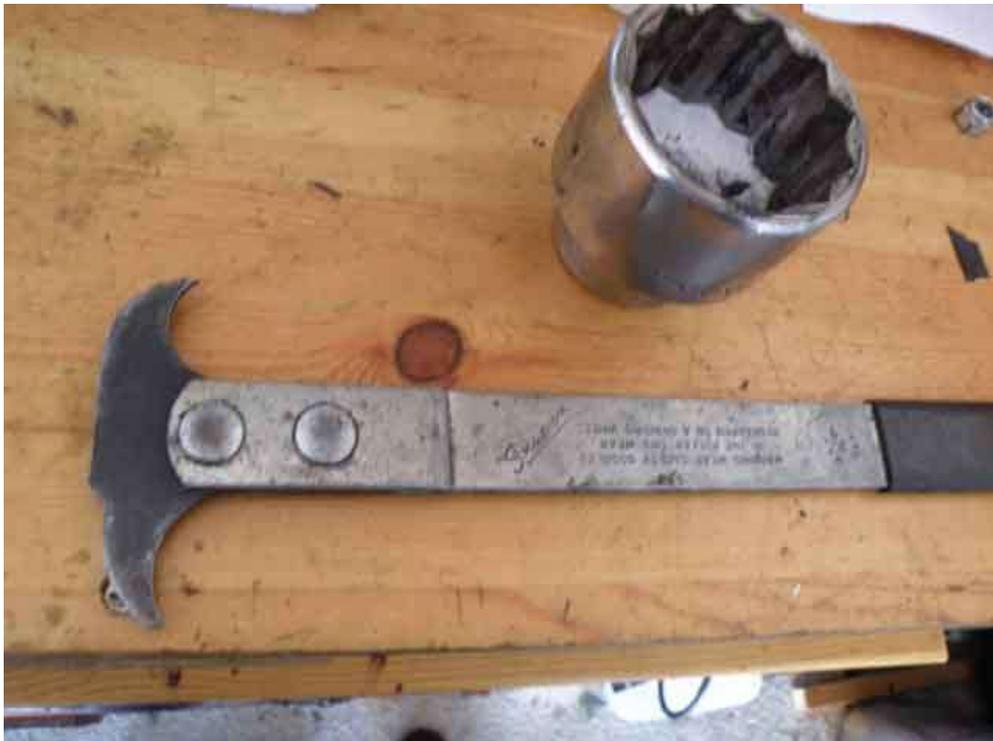
The 'ice pick', and the large socket that was used to drift the new seal into position

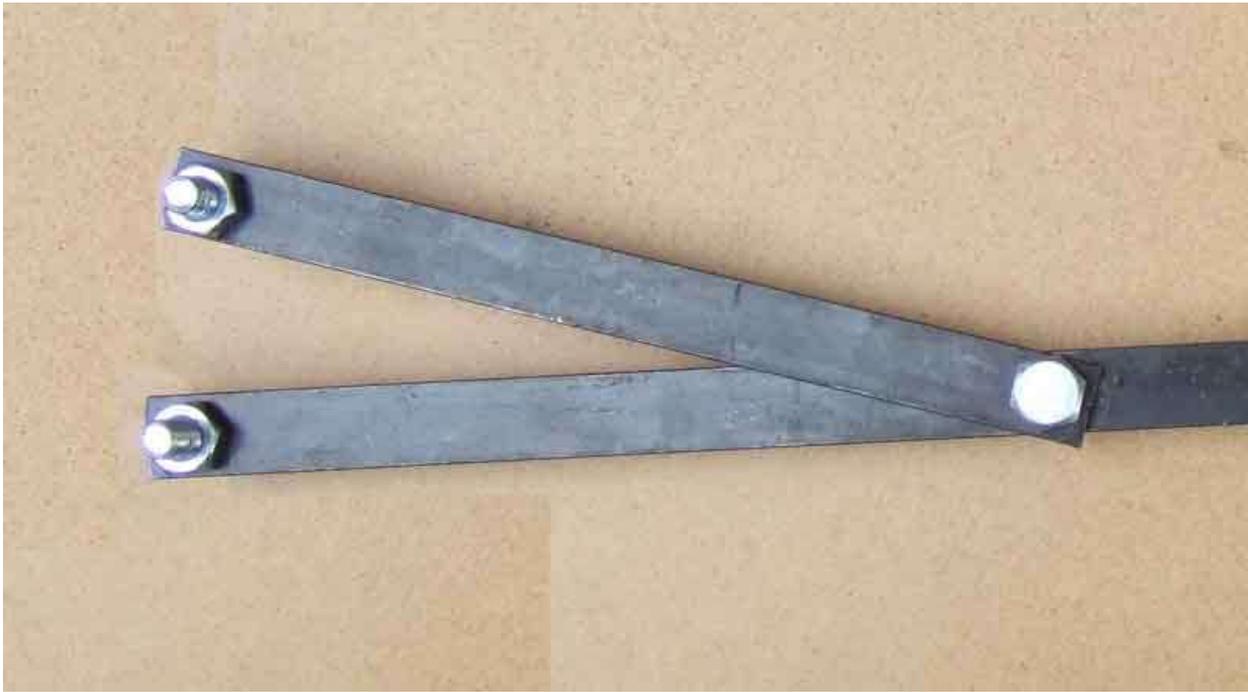
The forked tool. About 8" cut off the flat strip and a set of 10mm (shank) bolts and nuts for the pivot and 'pegs' to engage with the slots in the sprocket. After the other pieces had been cut off the tool ended up being about 2 ft long overall.

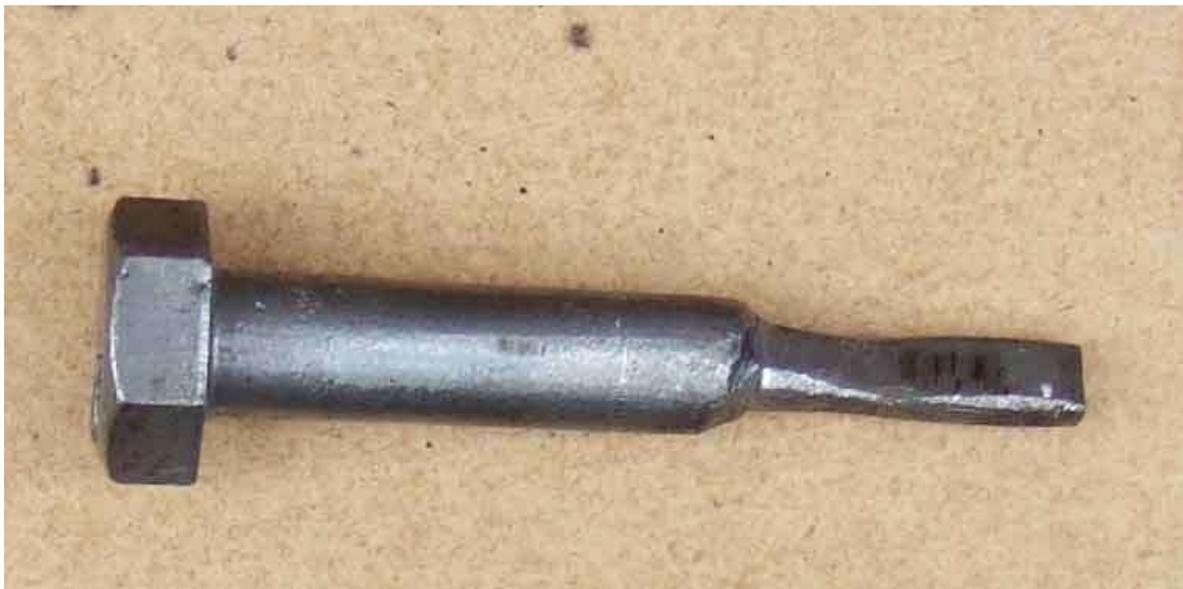
Flywheel locking pin cut down from a 10mm (shank) bolt. I put the threaded end in a drill chuck, then used that as a kind of lathe to 'turn down' 36mm from the head to 9.7mm, then a further 12mm to 7.4mm, then cut off after that. That was before I butchered it trying to get it into the wrong hole!

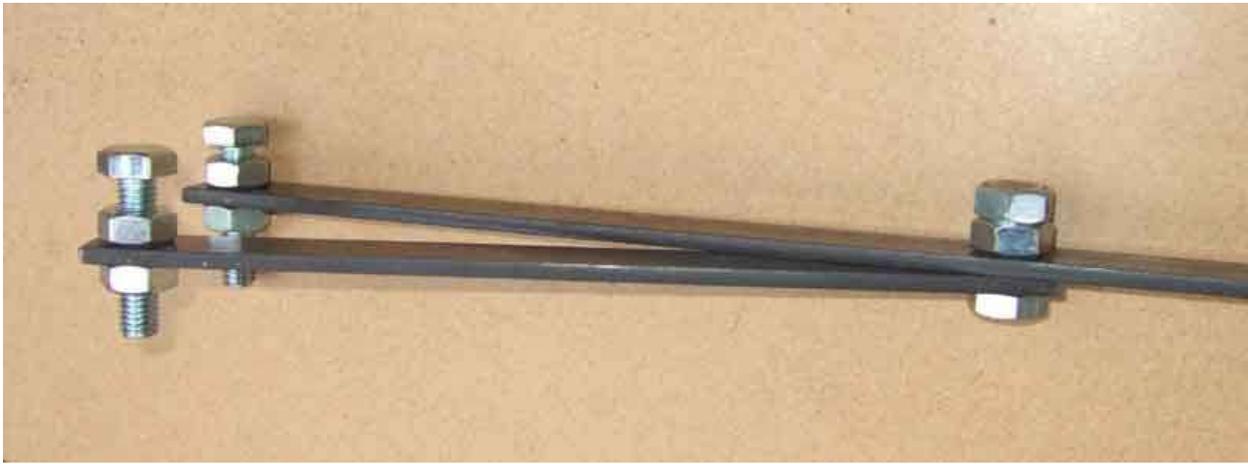
Note the bolts are screwed into the fixed and pivoting arms by different amounts so they engage the cut-outs in the sprocket equally.

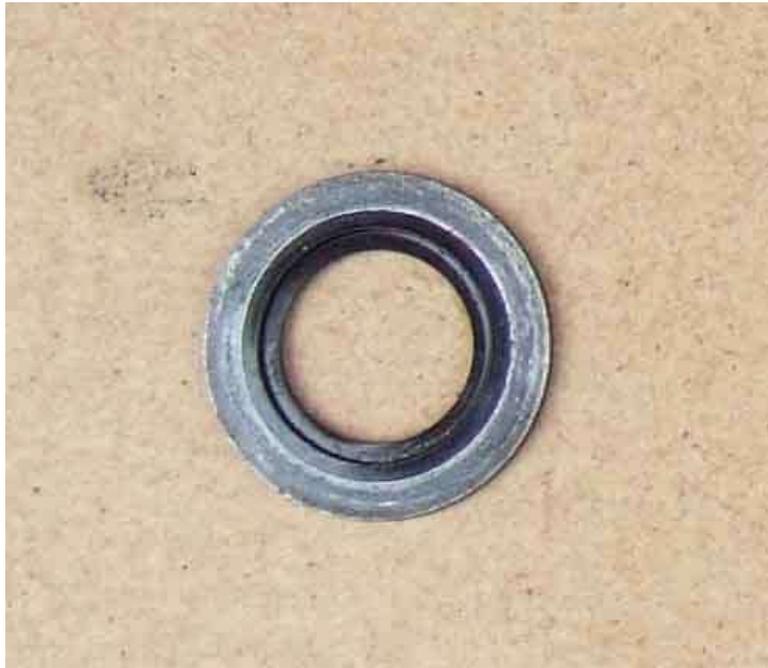
The curious sump washer with the rubber insert (now known to be a 'Dowty' washer). Looking in Halfords for solid aluminium ones I noticed this type specified for Ford (yuk).

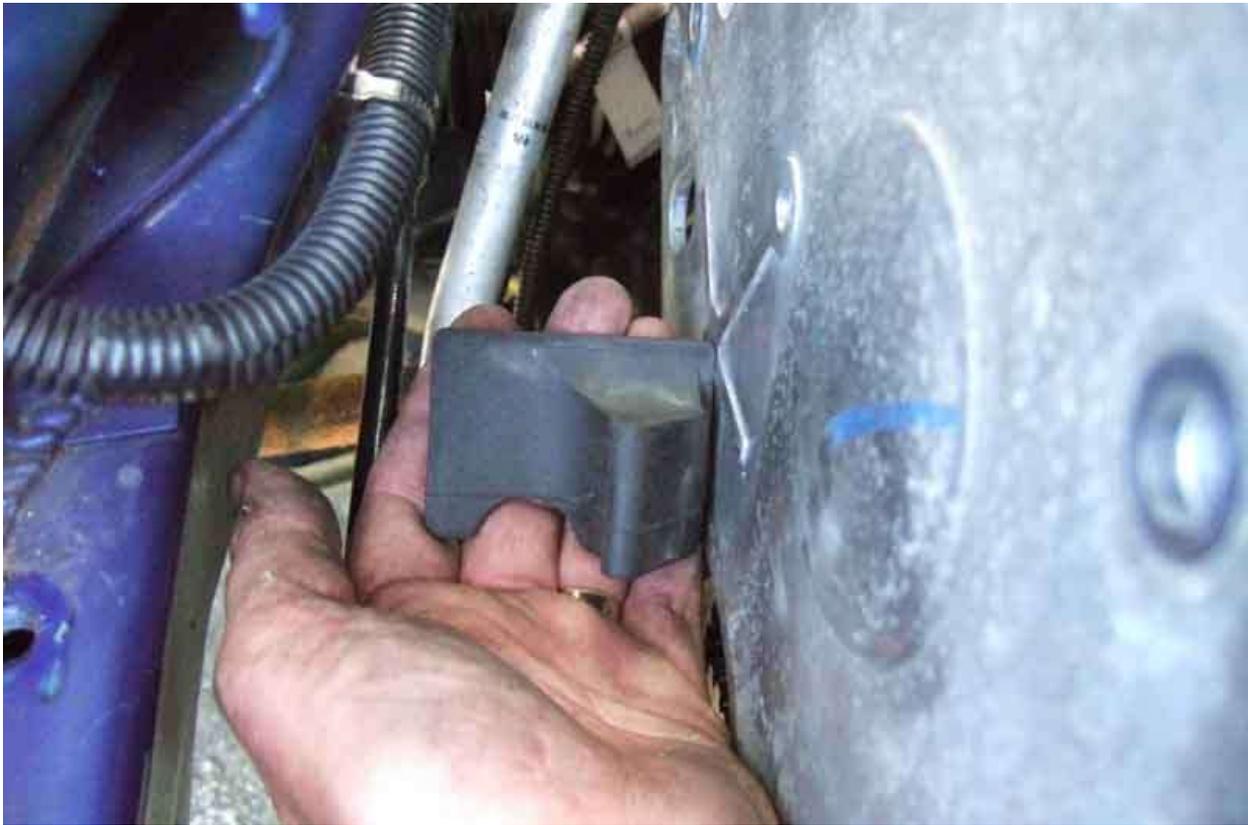
Orientation of the tension rubber cover. This is held beside the position it fits in the lower rear part of the front cover.

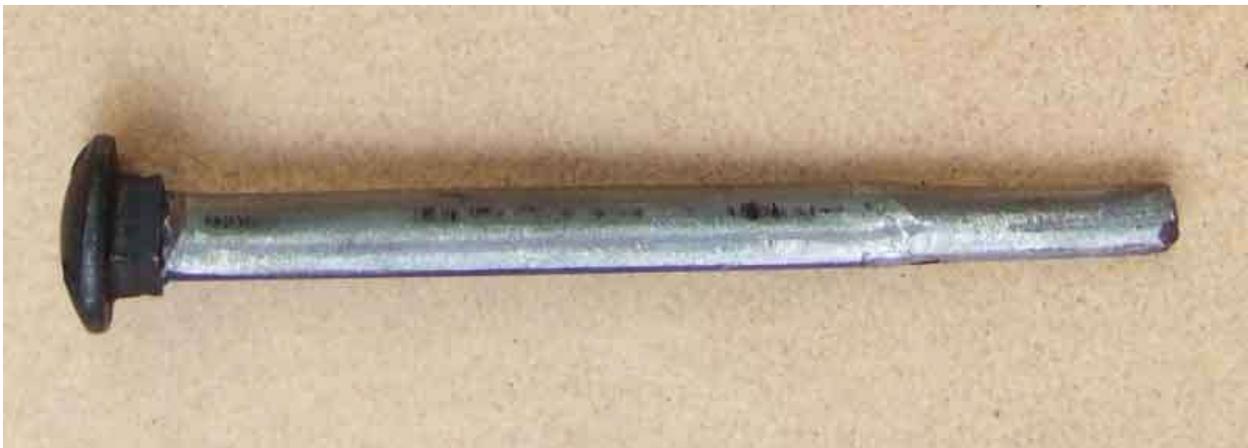
One of two unnecessary tools. Haynes calls for a tapered pin to help locate the sprocket over the hole to enable insertion of the bolt. This seems to be based on the two tapered pins used in the pukka MG Rover kit when **both** sprockets are removed and slid back on as an assembly with the belt. I couldn't see how that would help with the Haynes method, so made this pin which is actually eccentric rather than tapered, so that as the bolt was turned it would move the sprocket outwards and so locate it over its keyway. Not required, the bolt fitted right in, then turning it pulled the exhaust sprocket back into alignment and tightening the inlet bolt simply pulled it onto its keyway.

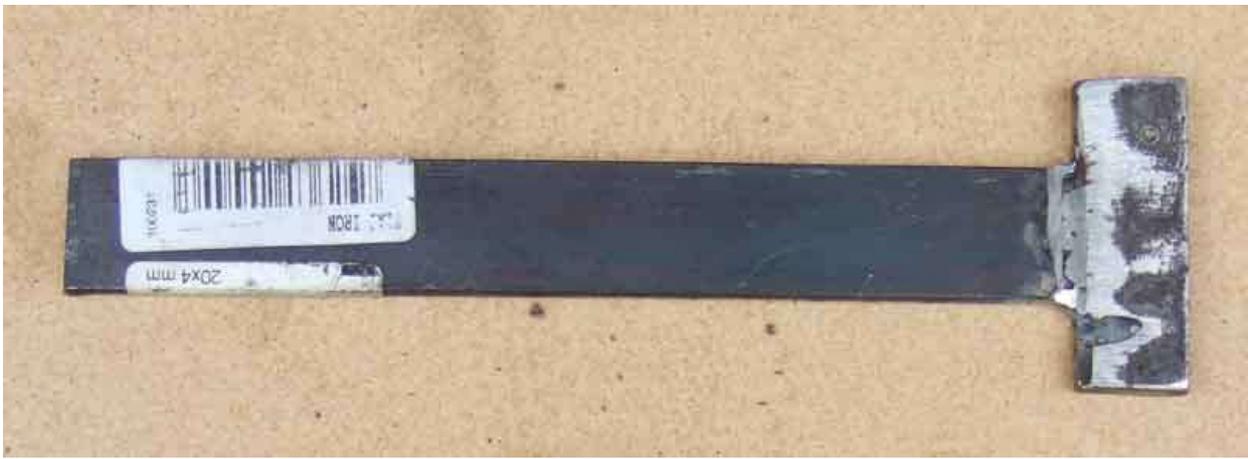
The other unnecessary 'flat bar tool' made from a few inches of offcut from a 1 metre length of 20mm x 4mm flat bar, with another 48mm length welded crosswise. In the event it wasn't needed, it kept slipping out of the shallow notches in the end of the sprocket. It might have been of more use if the crosswise piece were T-shaped to fit inside the sprocket as well as engage the slots.

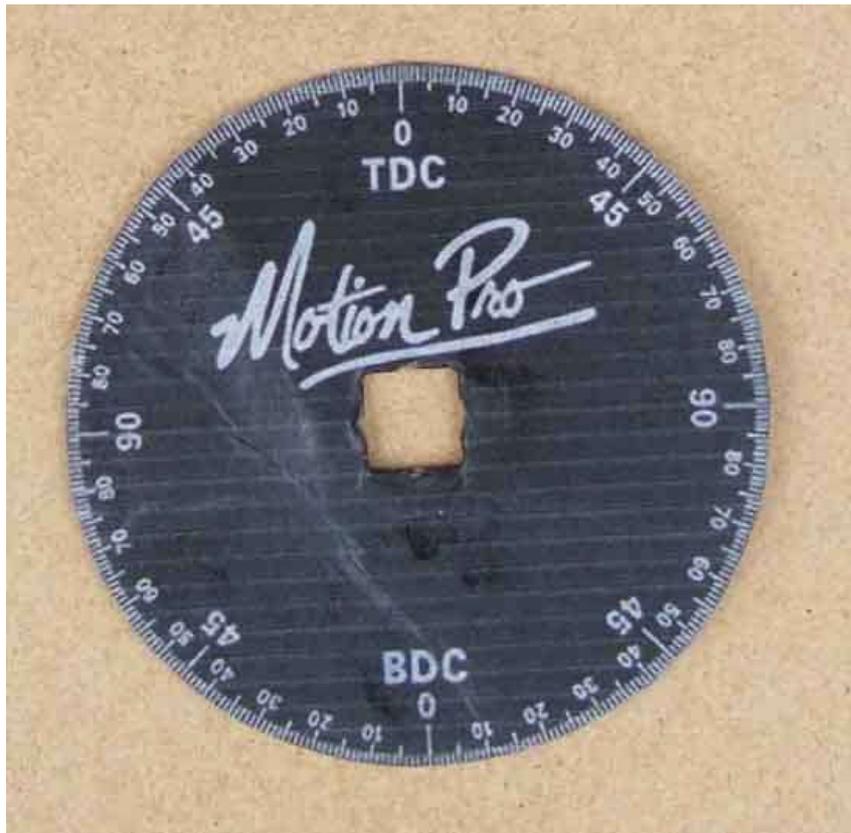
Homemade degree-wheel. What more could anyone want for a one-off job?

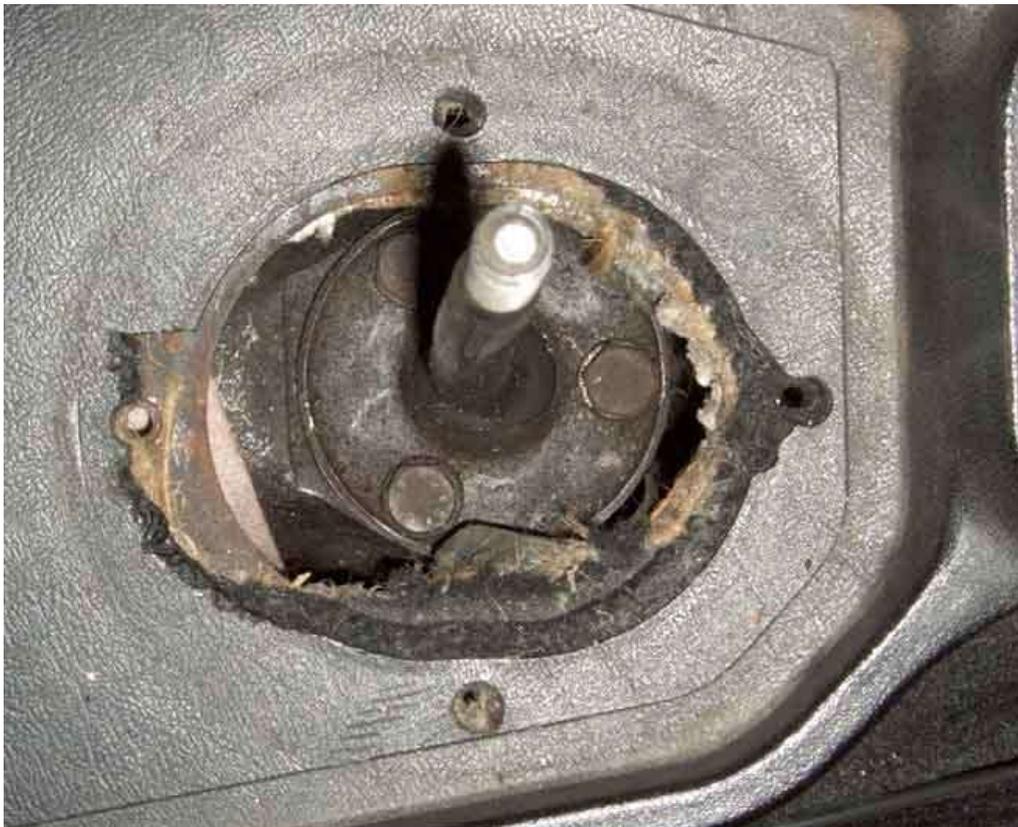
4-synch gearbox - the retaining plate is secured with three special bolts and Thackery washers into the remote control housing:

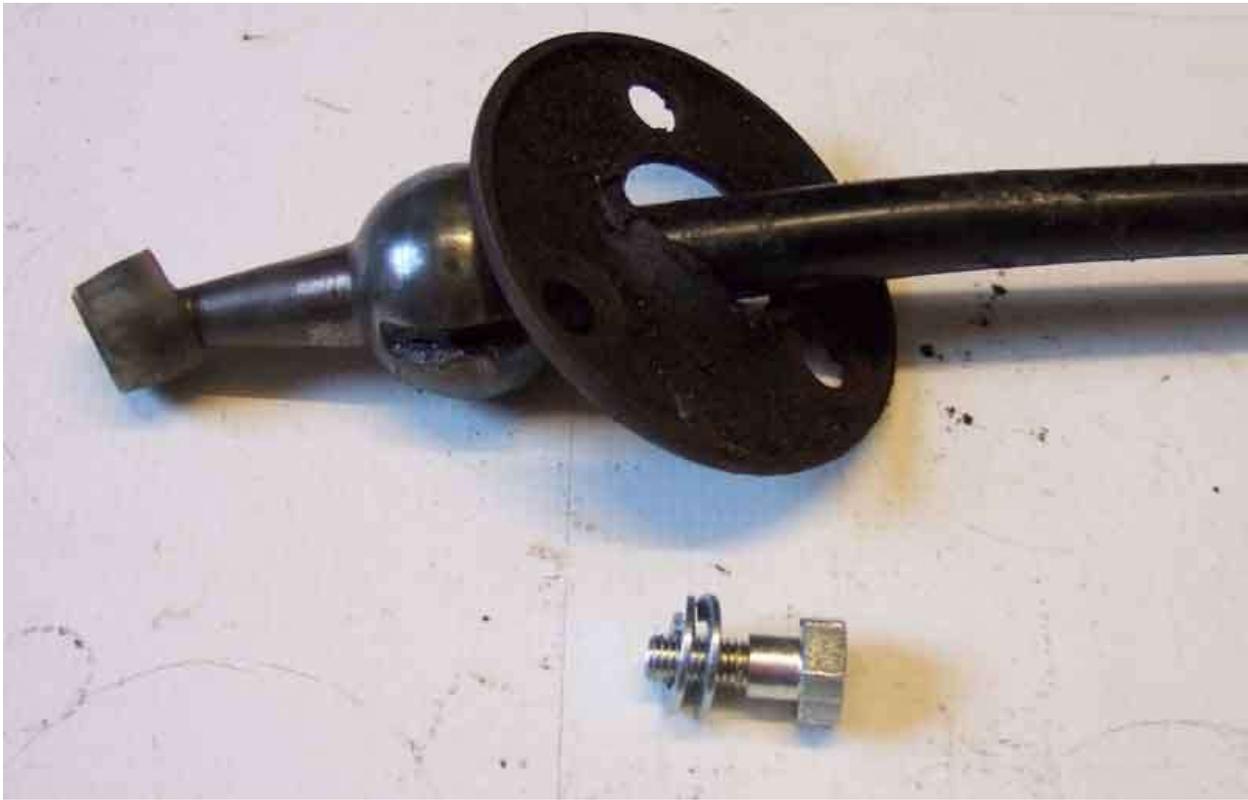
Shouldered bolt and Thackery washer. The bolt tightens through the retaining plate and washer onto the gearbox casing, compressing the spring of the washer, which presses the retaining plate down onto the large ball of the gear-lever, pressing it into the socket in the casing:

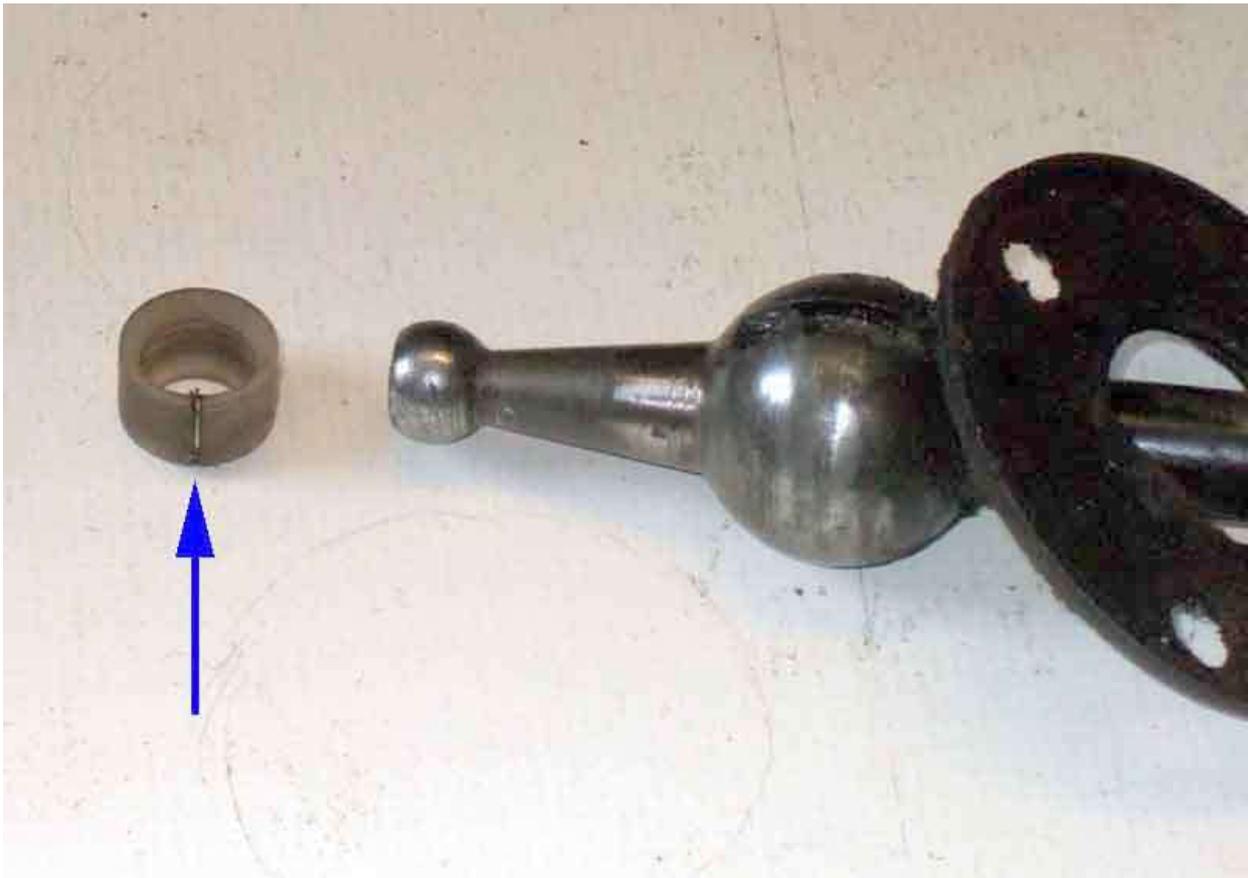
An original bush on the left with a significant chamfer to aid insertion into the gearbox shaft socket, once the bush has been fitted to the ball-end of the cabin lever. The bush on the right is a replacement with virtually no chamfer and was impossible to fit, until I cut more of a chamfer. I tried fitting this to the gearbox first but when fitting the lever it just pushed it straight out, fortunately to fall on the floor and be retrieved. However [Bill Etter was able to fit the bush to the gearbox before fitting the lever](#):

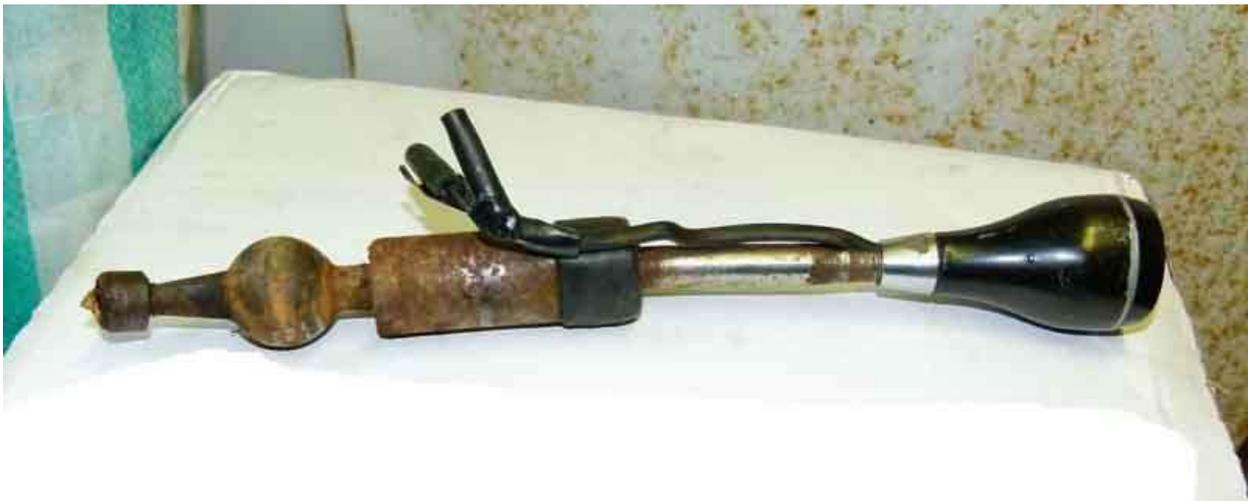
Lever with thickened section, said to be a harmonic damper, but there are still complaints that this knob buzzes. Guide pin slot on one side only (not visible here) so the lever can only be installed in the correct position. It may be that this is a 'steel-rubber-steel' sandwich so there may be the risk of twisting the upper part of the lever relative to the lower part if you apply too much force to the knob nuts:

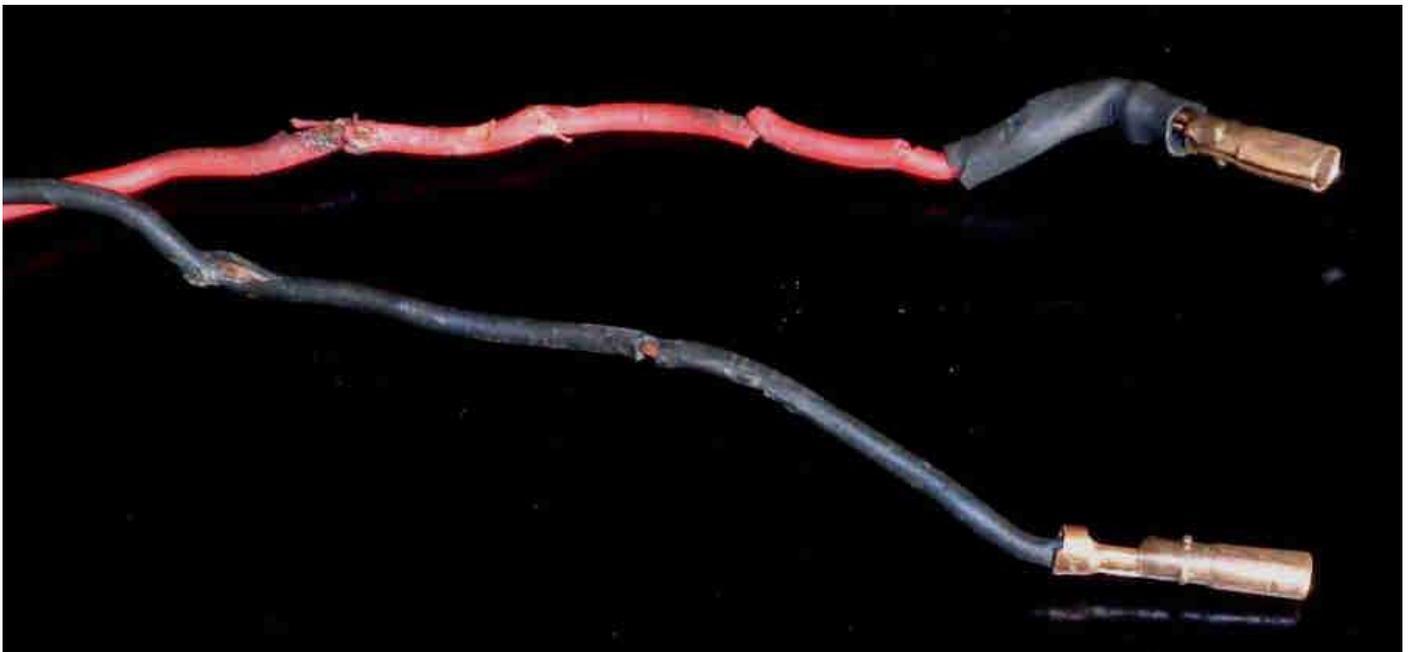
Gear-lever sub-harness 153726 with bullets to connect to the gearbox sub-harness and 'sleeve' connections to the switch. [Get one like this with a 'loose' sleeve](#) that can be slid towards the switch connections so protecting the wires where they are in the slot in the gear-lever, not one with a tight sleeve (like 2-wire lighting cable):

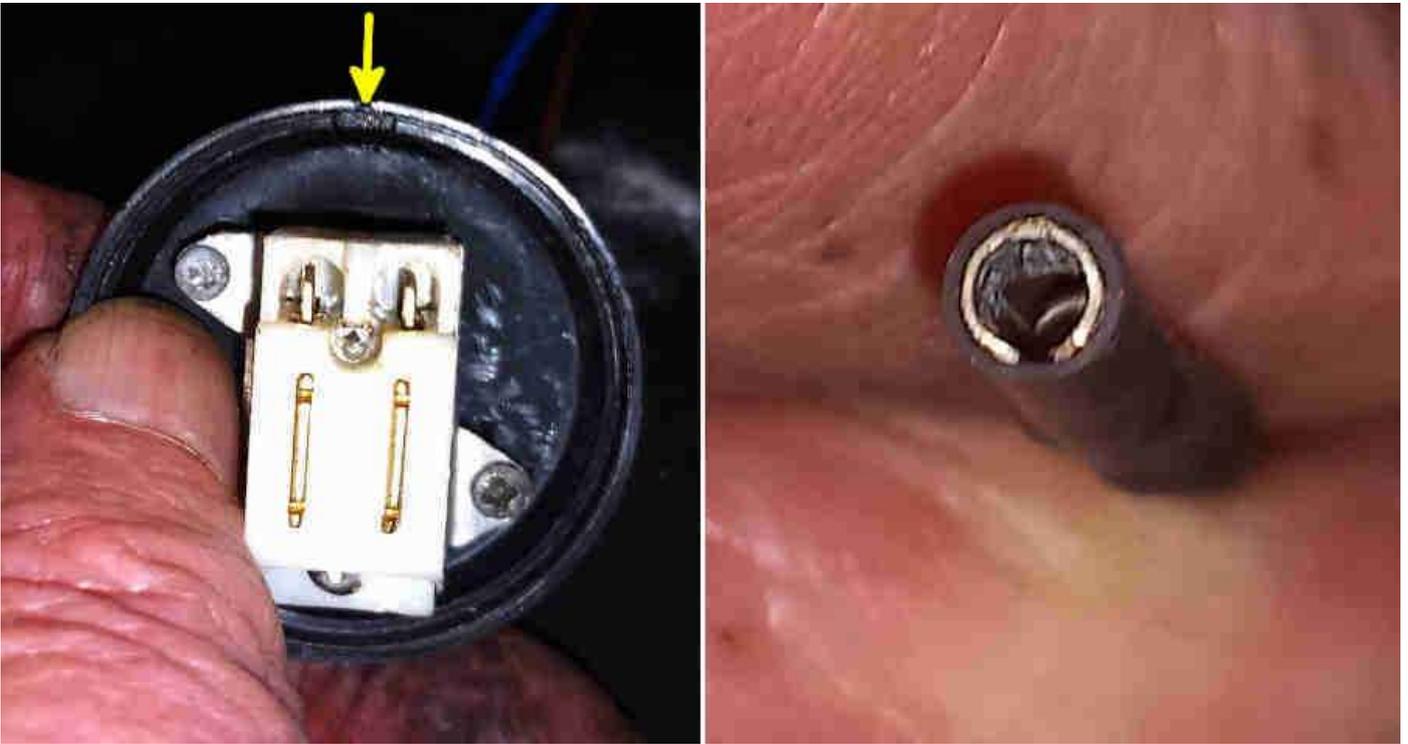
Ring-nut C30623 goes inside the knob and chrome nut C30505A goes under the knob to secure it. The ring-nut can be lightly screwed on with a suitable implement then the chrome nut tightened with a 5/8" spanner (it has flats) from below to secure the knob: ([Moss Europe](#))

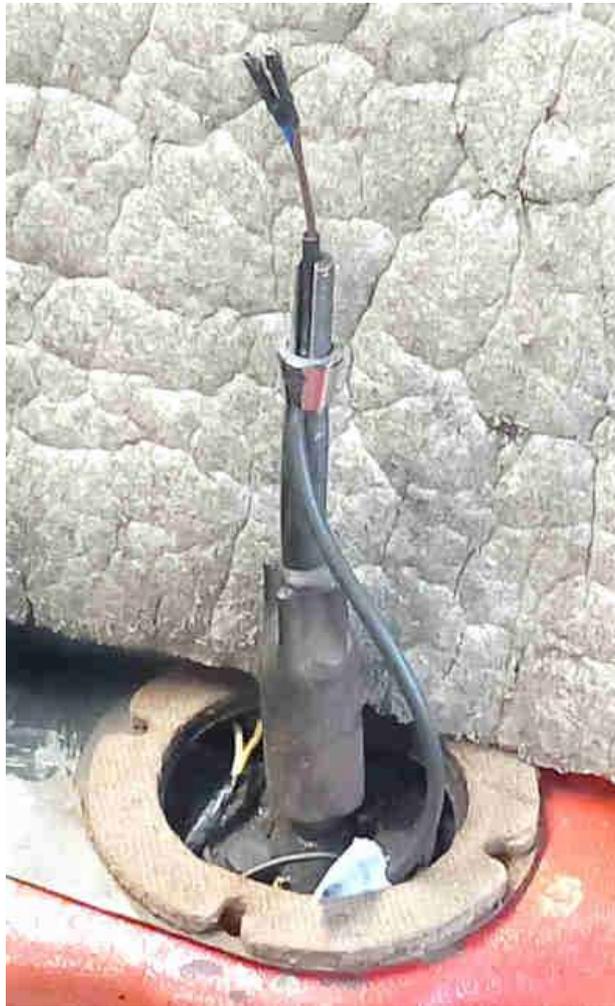
Gear lever with chrome nut screwed on and sub-harness passing up the slot, sleeving extending up above the slot:

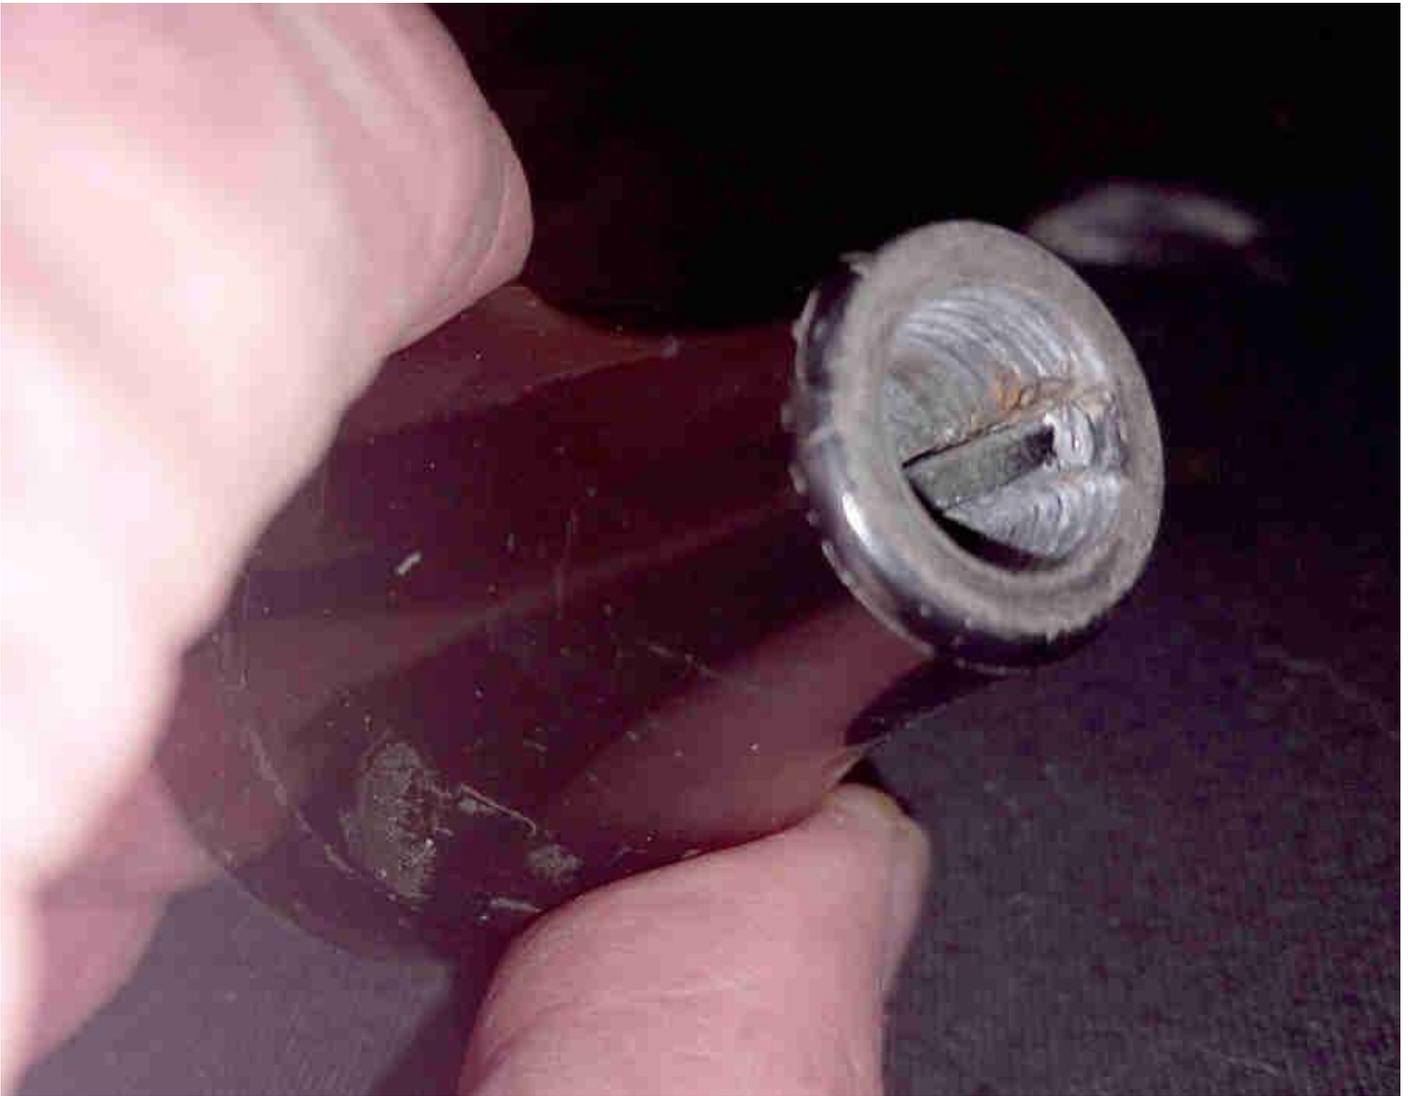
The knob has a 'key' that fits in the lever slot so the knob can only fit in one orientation and not twist round:

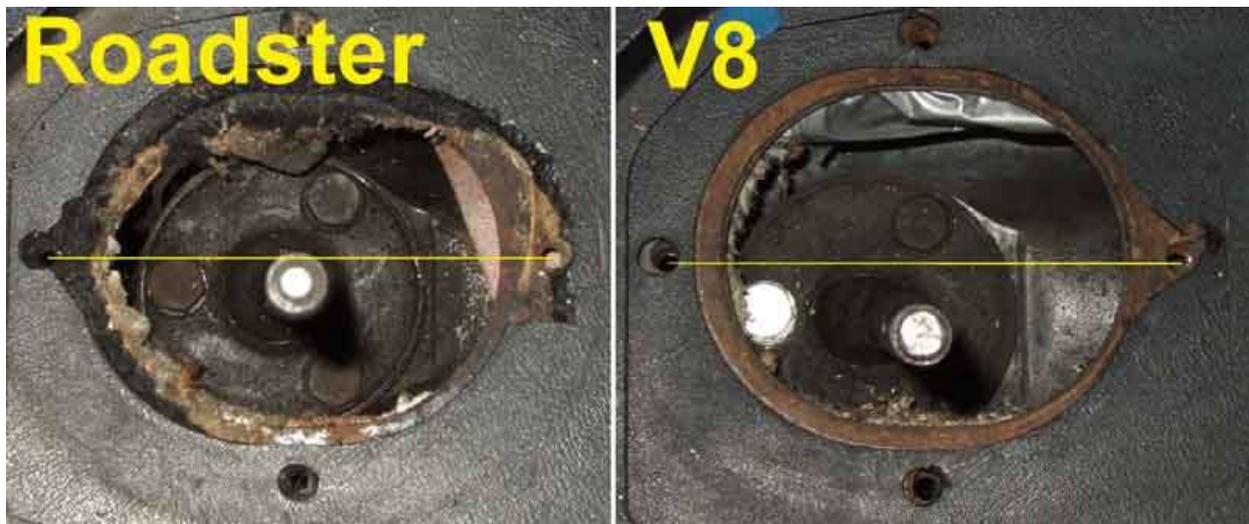
Showing the additional offset towards the driver of Vee's gearbox compared to Bee, which exacerbates the problem with the gaiter:

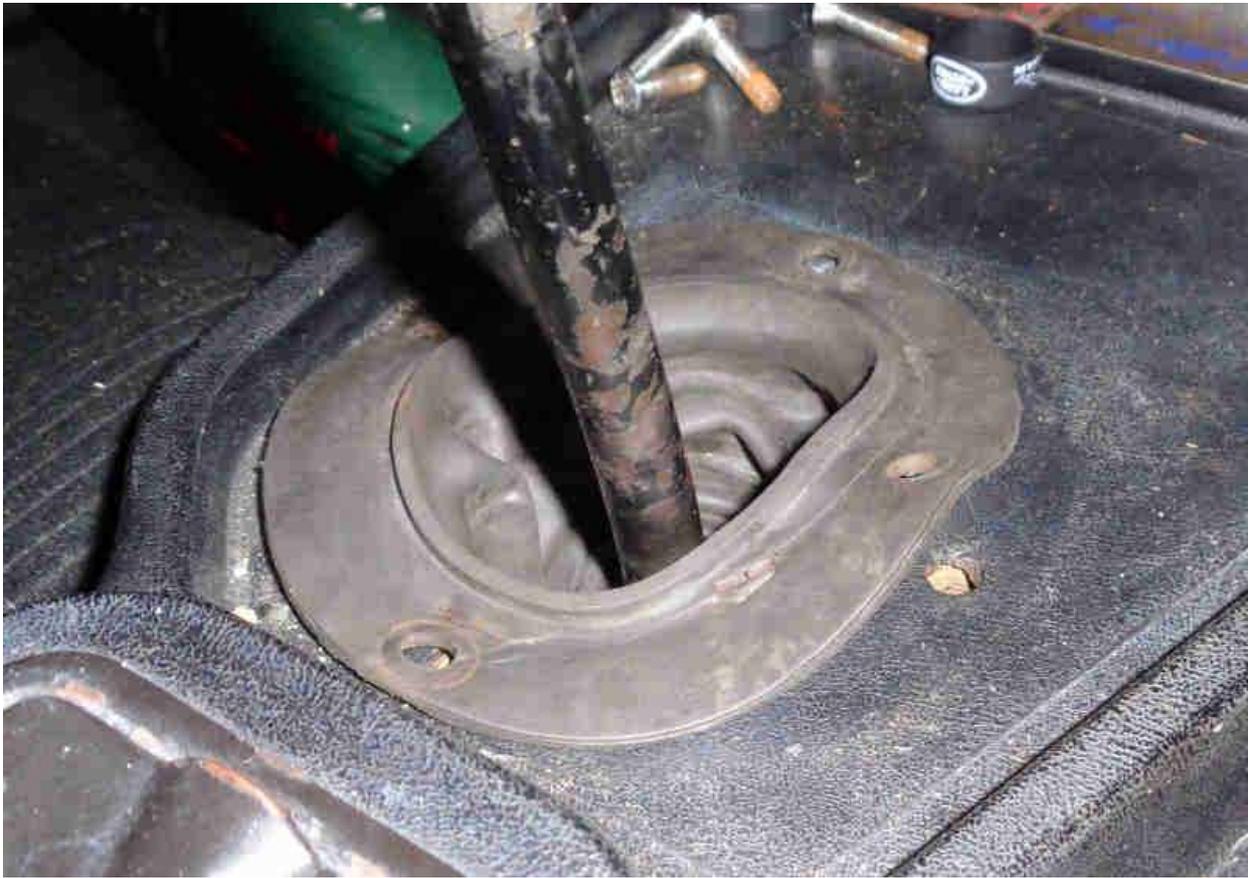
Rubber gaiter inverted, before re-stapling the leather gaiter. The driver's side edge sticks up a bit as with the gearbox offset to that side a bit there is less space for the corrugations:

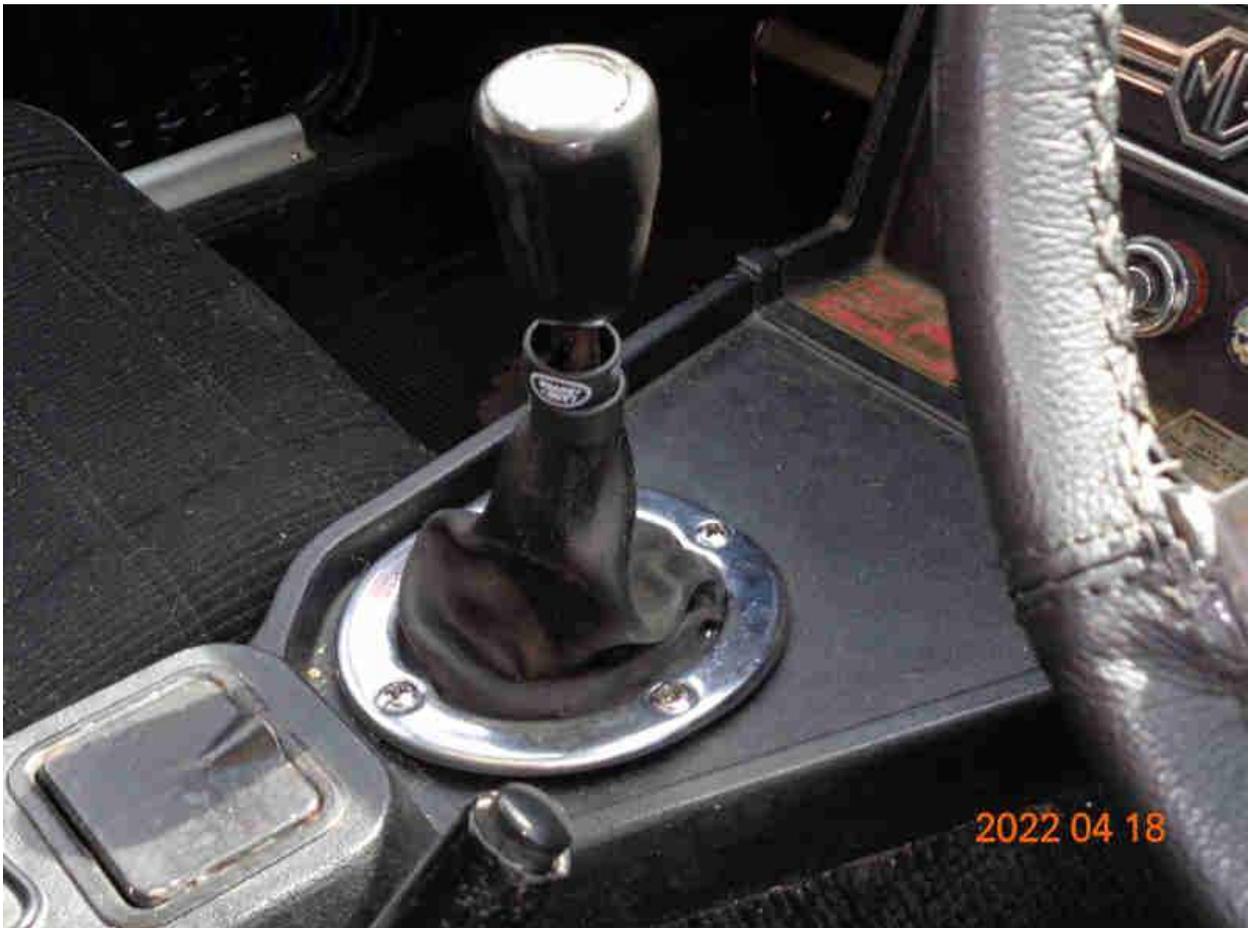
Fitted, different but not unattractive:

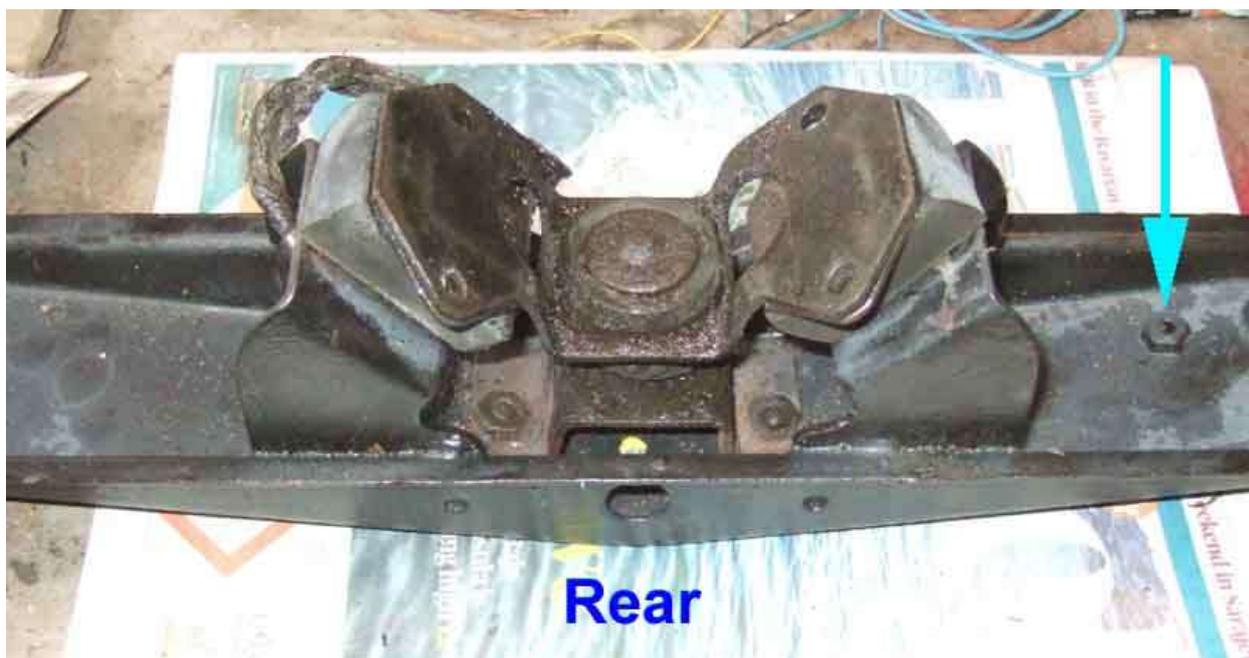
Note that the gearbox earth strap (rubber bumper cars) is fitted to the left-hand side here, the manuals show it fitted to the right-hand side i.e. the same side as the speedo cable clamp welded nut:
