Mk1 or Mk2?

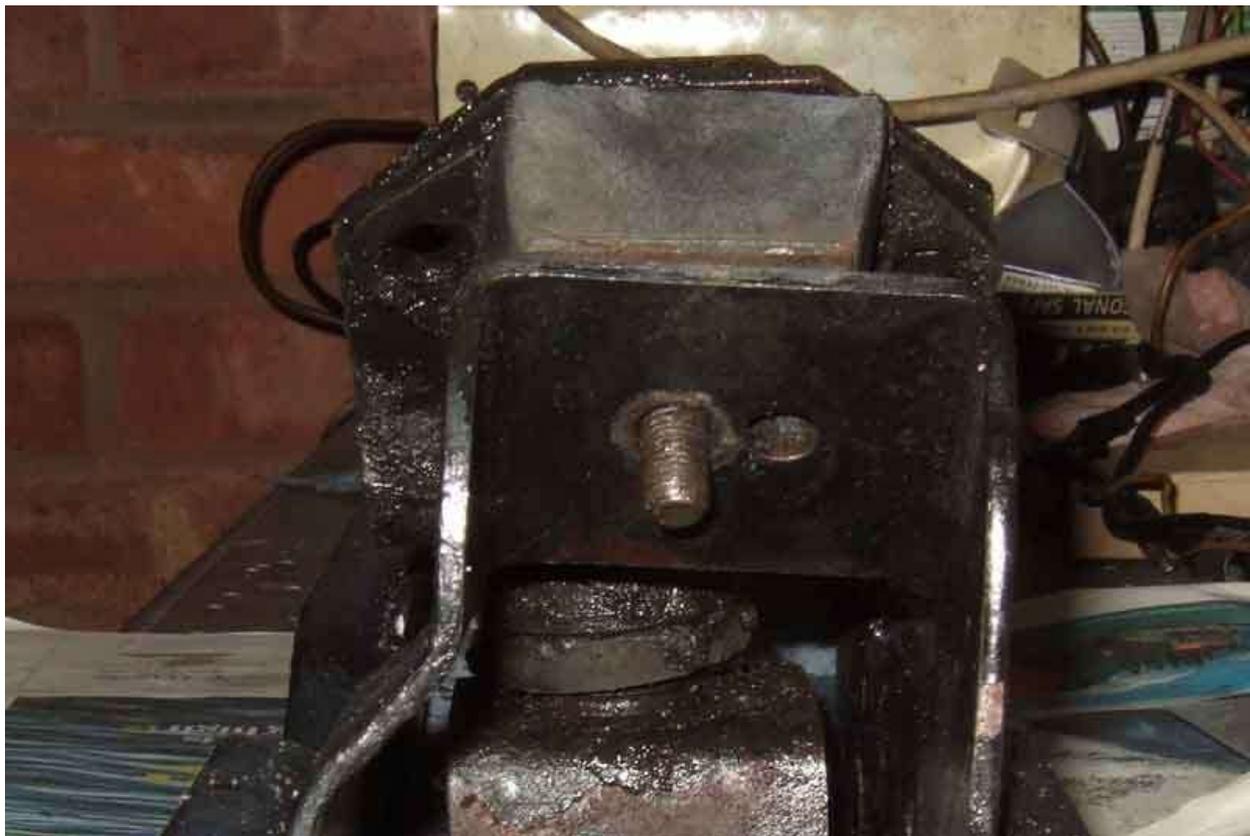
The mount stud goes through the front-most of the two holes in the bracket:

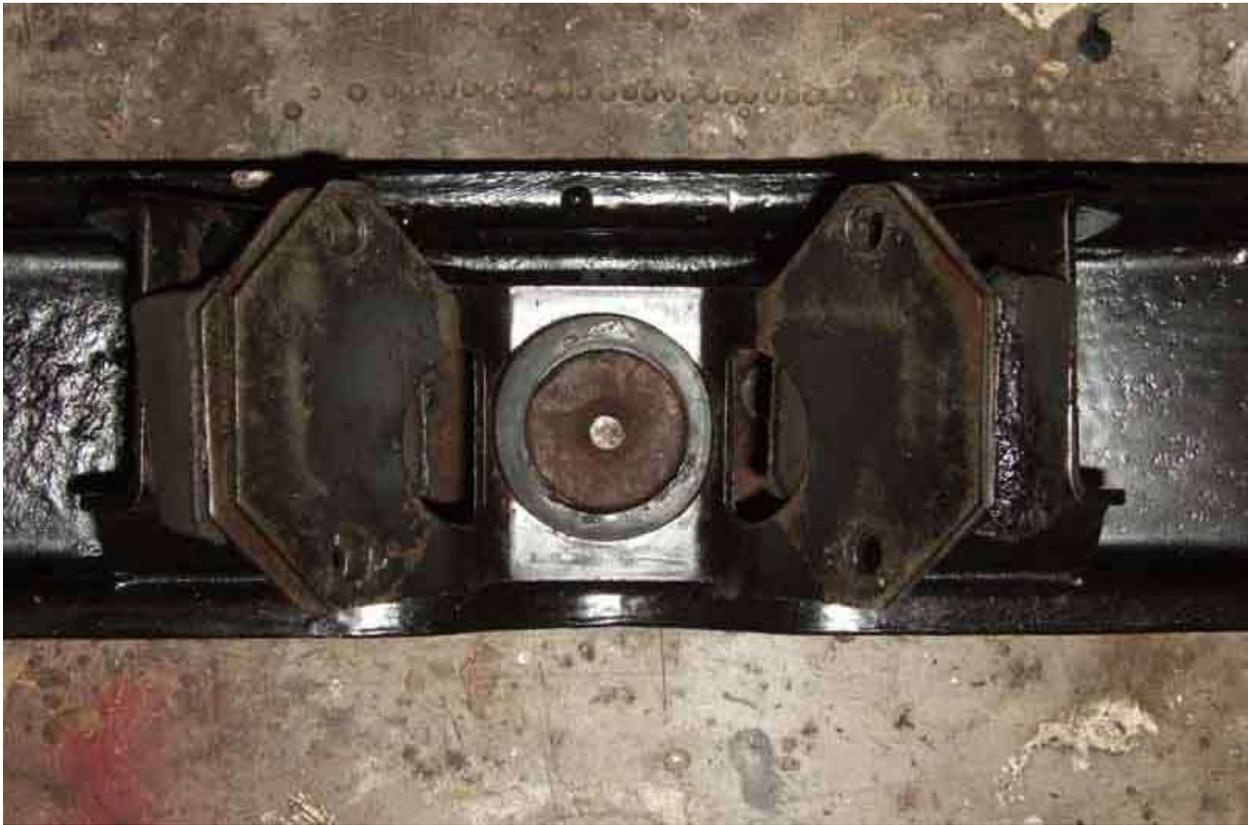
The upshot is that the rubbers are positioned centrally across the crossmember, and the lower yoke welded nuts line up with the holes in the crossmember:

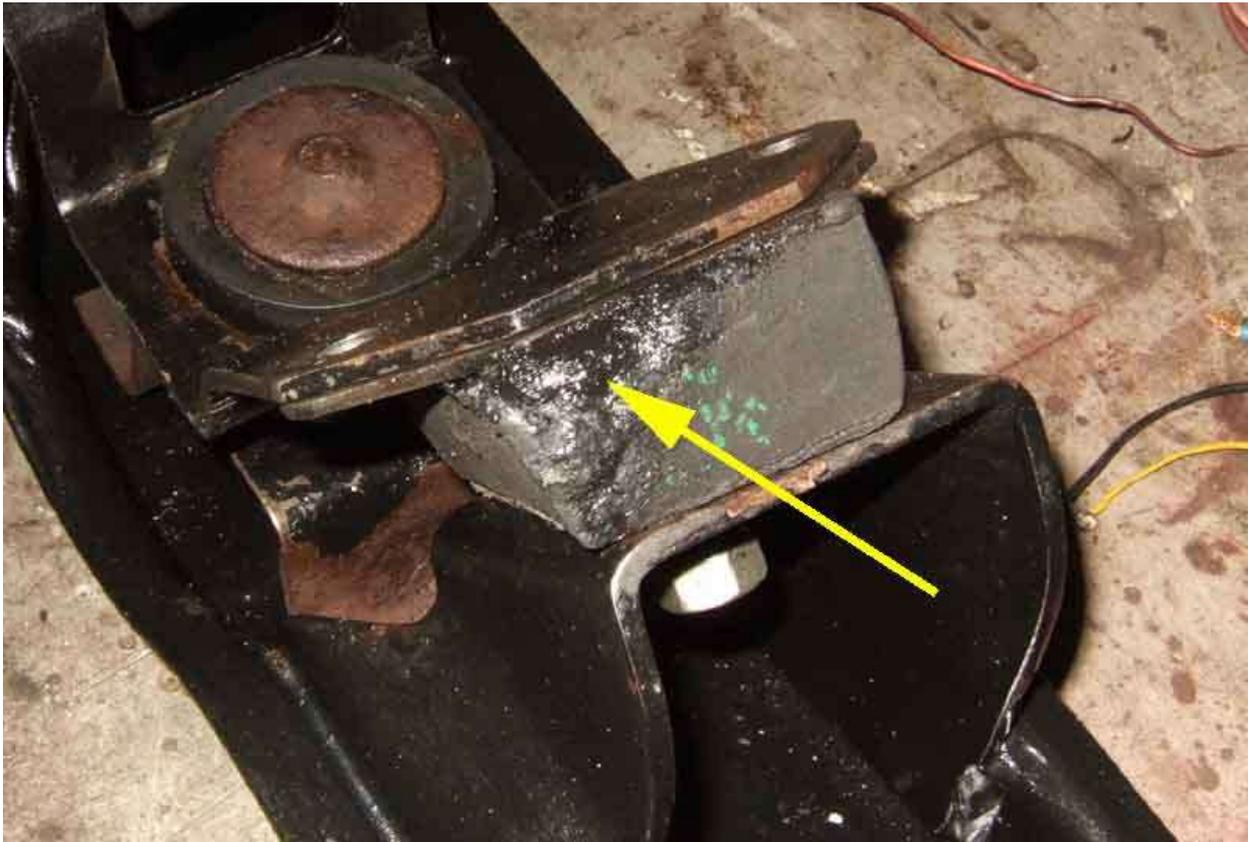
Perished mount rubbers:

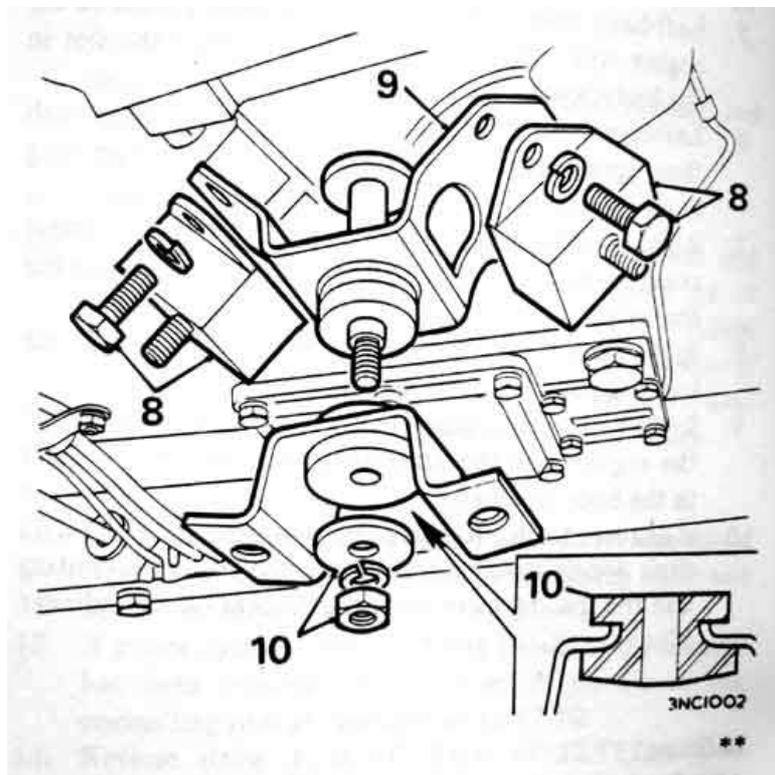
Showing the earthing strap (8) on rubber bumper cars and V8s, one end under the head of a bolt securing the mount to the gearbox casing, the other under the nut on the mount stud. Shown on the left-hand side front here (as I found it), the manuals show it fitted to the right-hand side front:

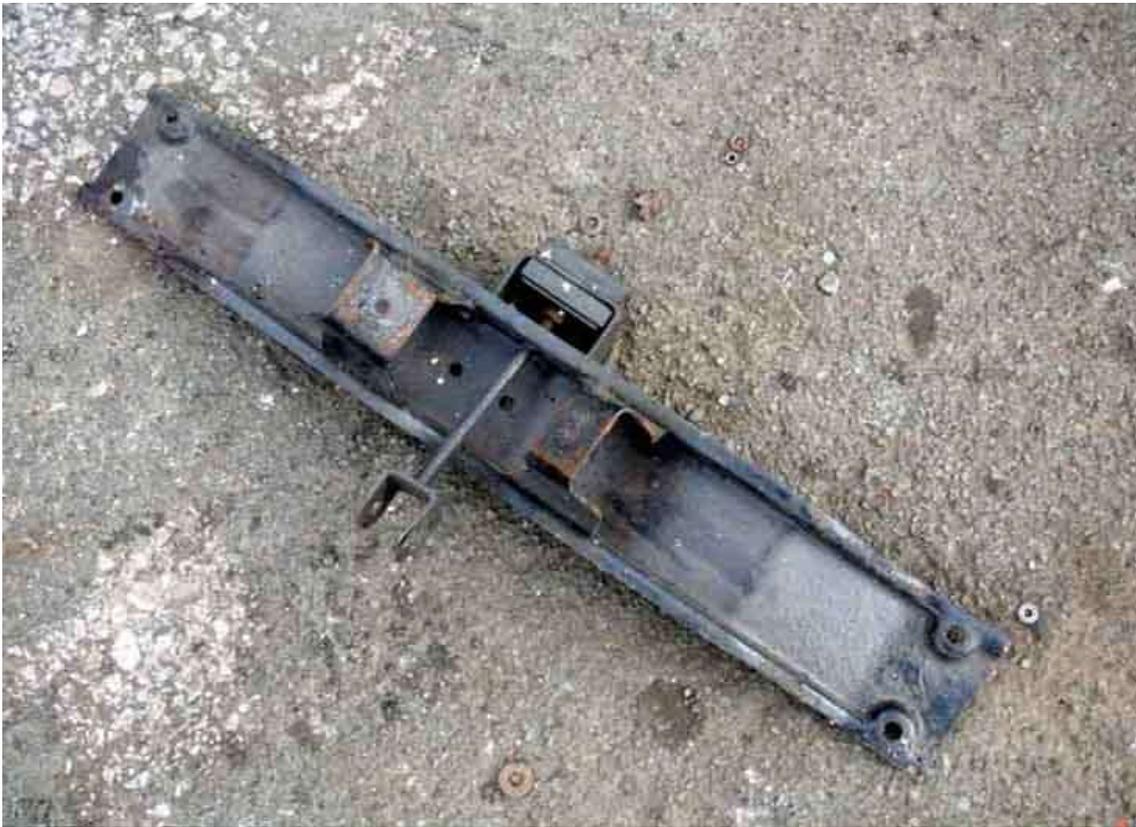
Restraint Rods: Mk 1/3-synch cars had a crossmember with just a single hole for each gearbox mount stud. Roadsters had welded nuts on the rear face for a restraint rod bracket. A short rod passed through the crossmember and bracket and was retained by a nut. The front of the rod has a 'U'-bracket that goes around a protrusion on the bottom of the gearbox casting close to the crossmember, and a special pin goes through the bracket and protrusion with rubber bushes between them. They don't appear to have the yokes, bushes and pin at this stage: ([MG Centre Wrexham](#))

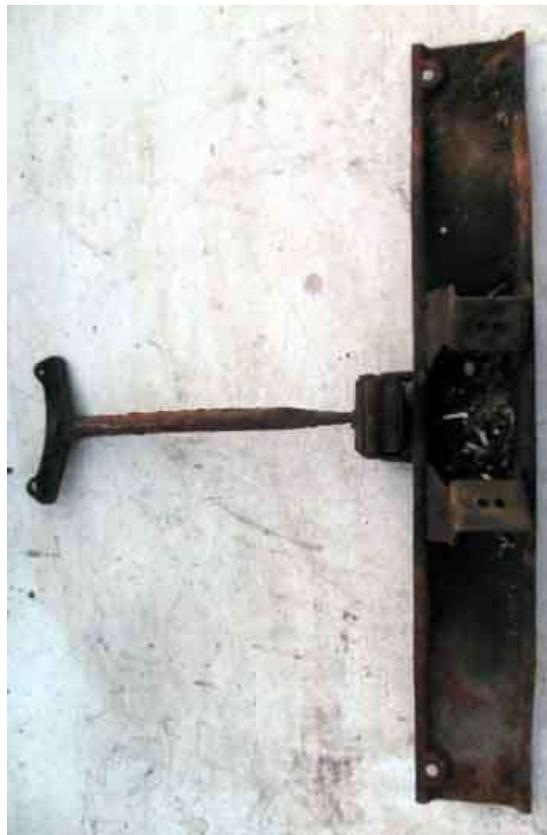
In Feb 74 (still chrome bumper) a new restraint rod was added to North American cars. This used a welded bracket on the front face of the crossmember, and a longer rod going all the way to a bracket that attaches to the two bottom bolts that secure the bell-housing to the engine. Other markets got this arrangement at the start of rubber bumpers, but despite this very positive restraint being used again, and the yokes, pin and bushes, the front mount control brackets were also apparently still provided (making no less than three restraint systems!), 2 for North America, 1 elsewhere as before, until the engine mounts changed from rectangular to round at the start of rubber bumper production in September 1974, which prevented the use of the front control brackets. The crossmember brackets again have two holes for the stud on the rubber mounts.

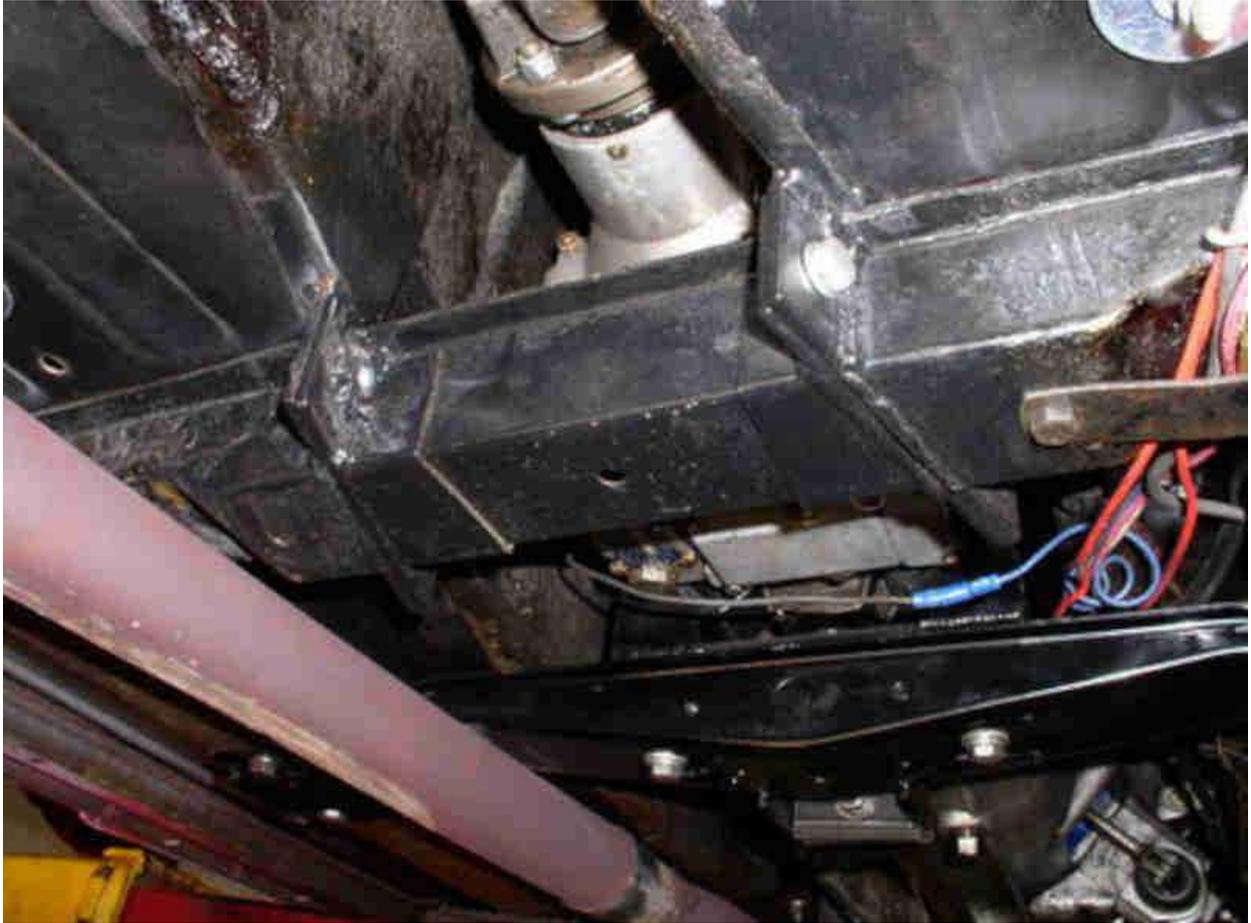
Quite a neat installation: ([The MG Experience](#))

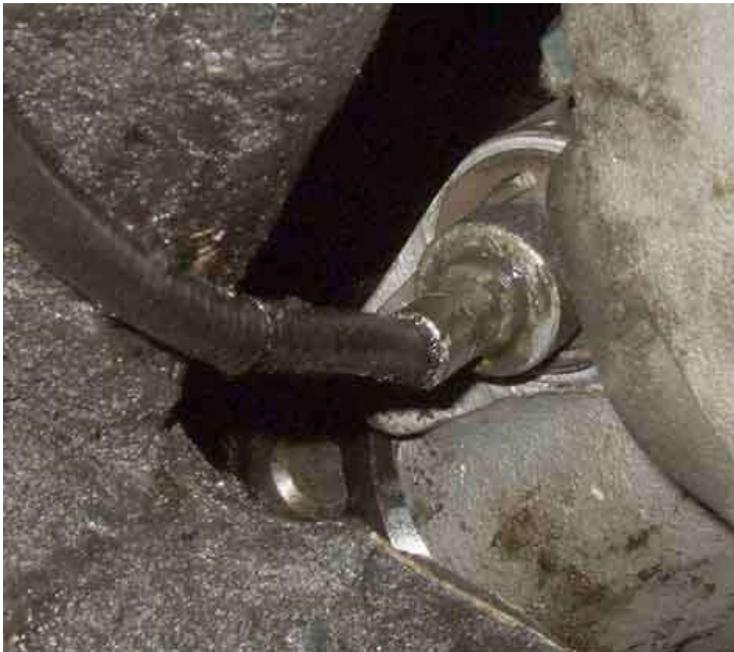
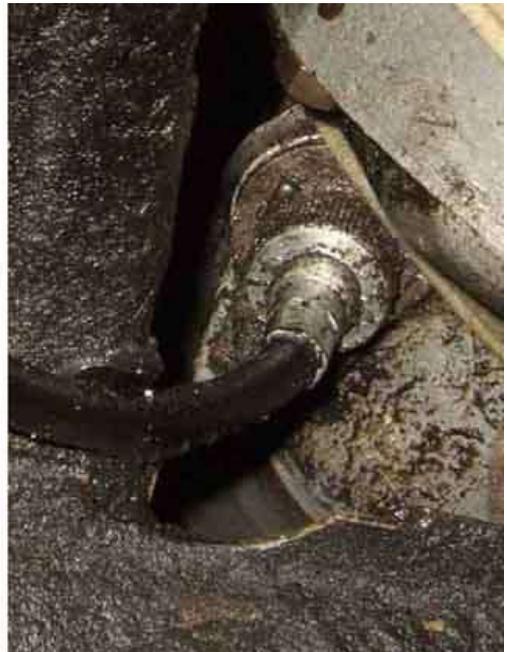
I do wonder how it affects speedo cable routing though:

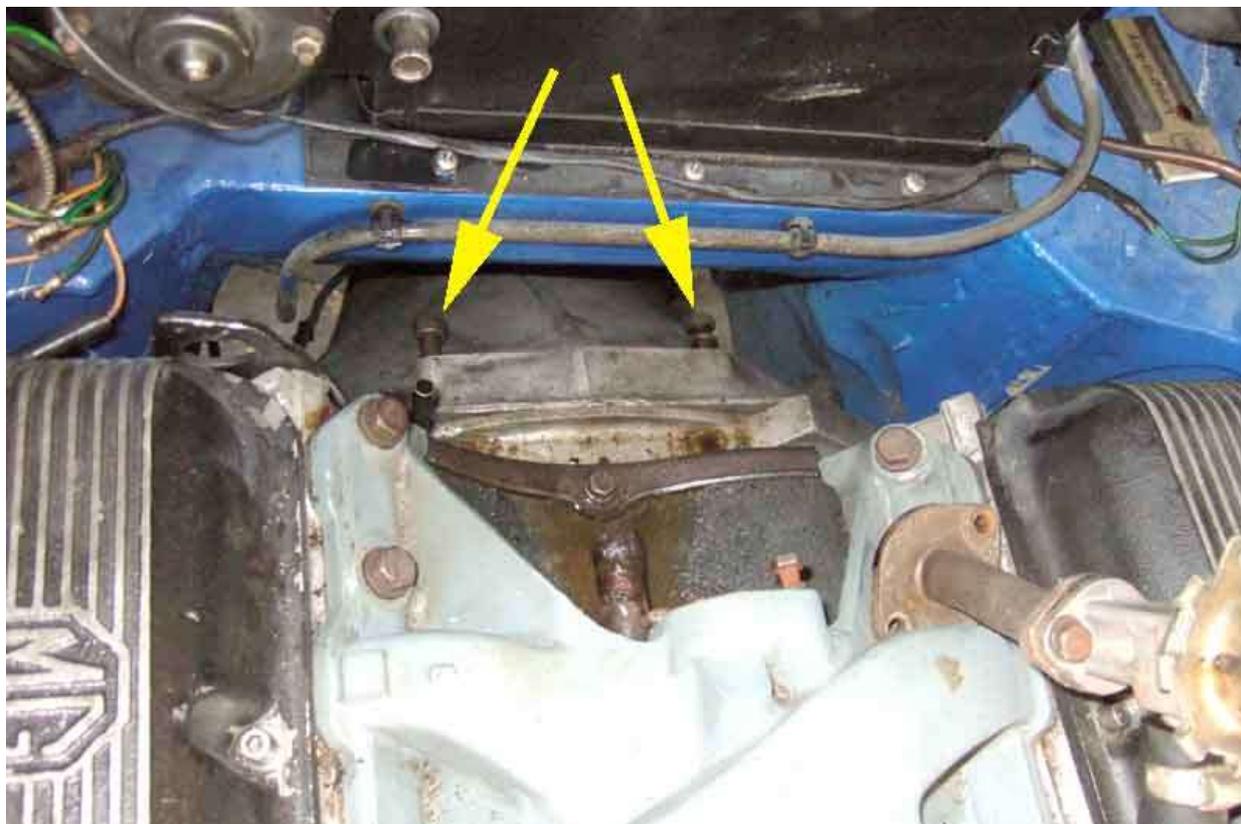
However looking ahead to getting the gearbox looked at, one of my contacts came up with a local chap, and he said it is possible to get the V8 engine out on its own. You have to remove the engine mounts and mounting plates, and exhaust manifolds, and that allows the engine to sit a good 2" or more lower in the chassis. Then with the carb assembly off and heater hoses and heat valve out of the way you have more access to the top two bell-housing bolts. To get the off-side exhaust manifold off the rack needs to be removed, and removing the manifolds gives more access to the engine mounts, so quite a bit of work needs to be done to get to the point where you know you will be able to access all the bell-housing bolts. The engine has to be lifted right up so the mount studs are clear of the chassis slots so they and the mounting plates can be removed, so prior to that I disconnected the oil cooler and gauge hoses to avoid stressing them, removed the distributor cap and leads and fitted an old cap to protect the distributor innards. As I can only borrow the hoist for the final extraction I'm having to raise the engine by jacking under the sump with a wood block, and squeezing in and out between that and the wheel ramps first one side then the other is hard work. With the mounts and plate off and the engine lowered onto the chassis rails, and the carb assembly removed, there is a lot more access to the top two bolts as shown below, even though in this picture the engine is sitting on thin wood blocks in place of the mounts and is not quite as low as it can go.

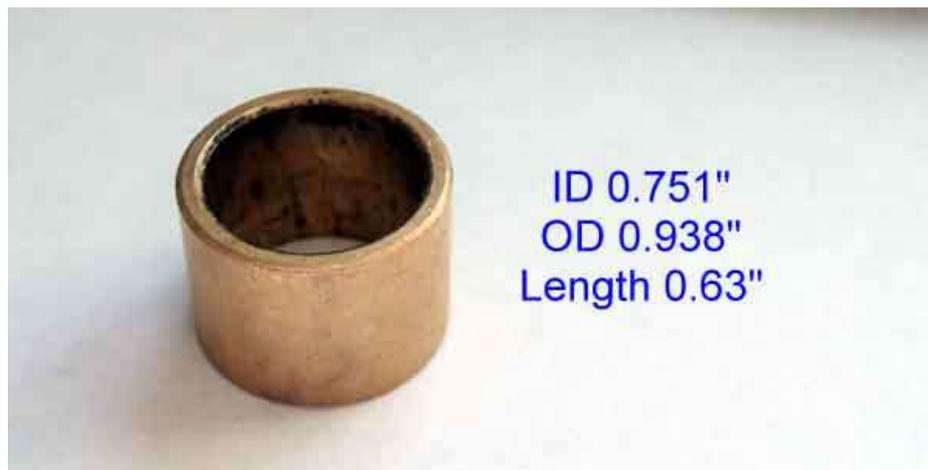
Then the first thing I did was test-fit the MGB GT V8 crankshaft pilot bush MGB549911 that I'd bought to the gearbox shaft to make sure it fitted, as I was going to use that bush to check the rebuilt gearbox had the correct shaft when I went to collect it.

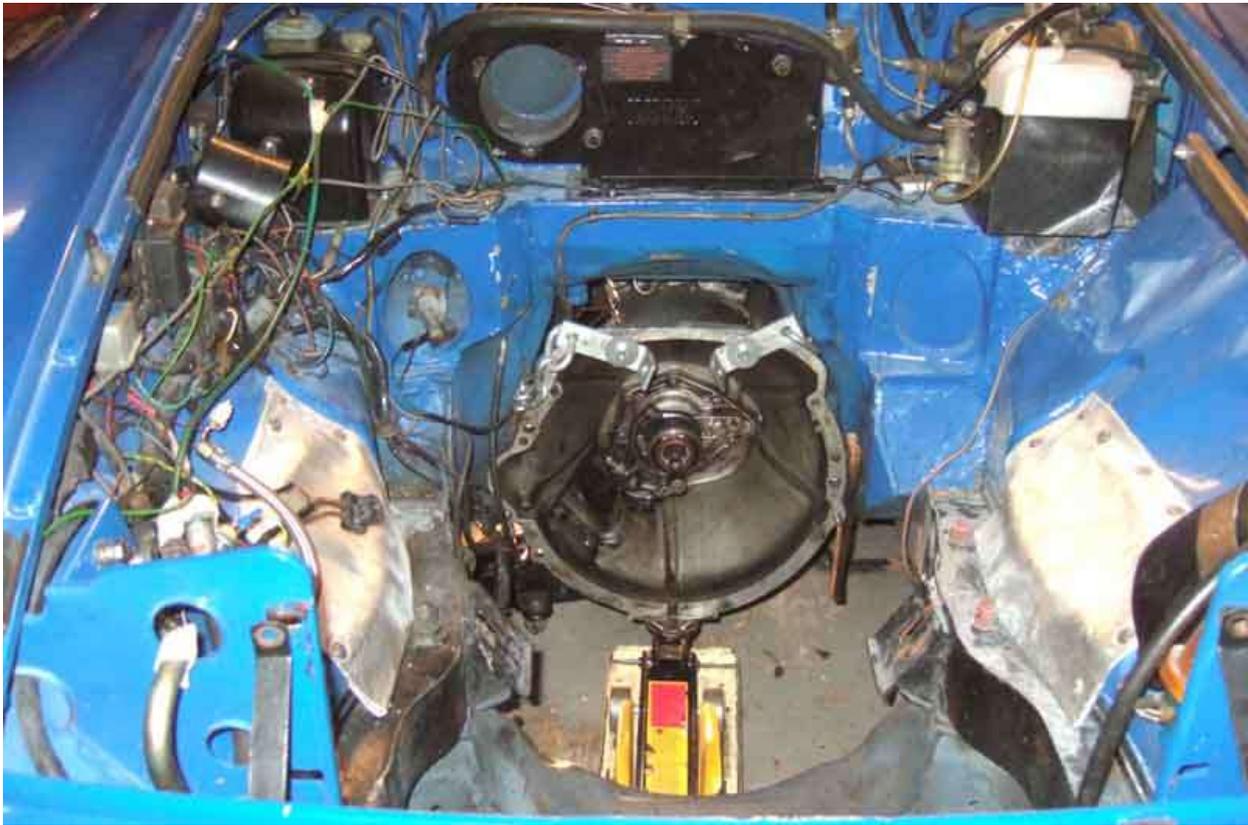
Now for the gearbox - hoist chains attached to the bell-housing in preparation for the initial pull forwards to bring the OD clear of the fixed cross-member before lowering it, as with the rear cross-member disconnected I didn't want to risk it toppling off the trolley jack.

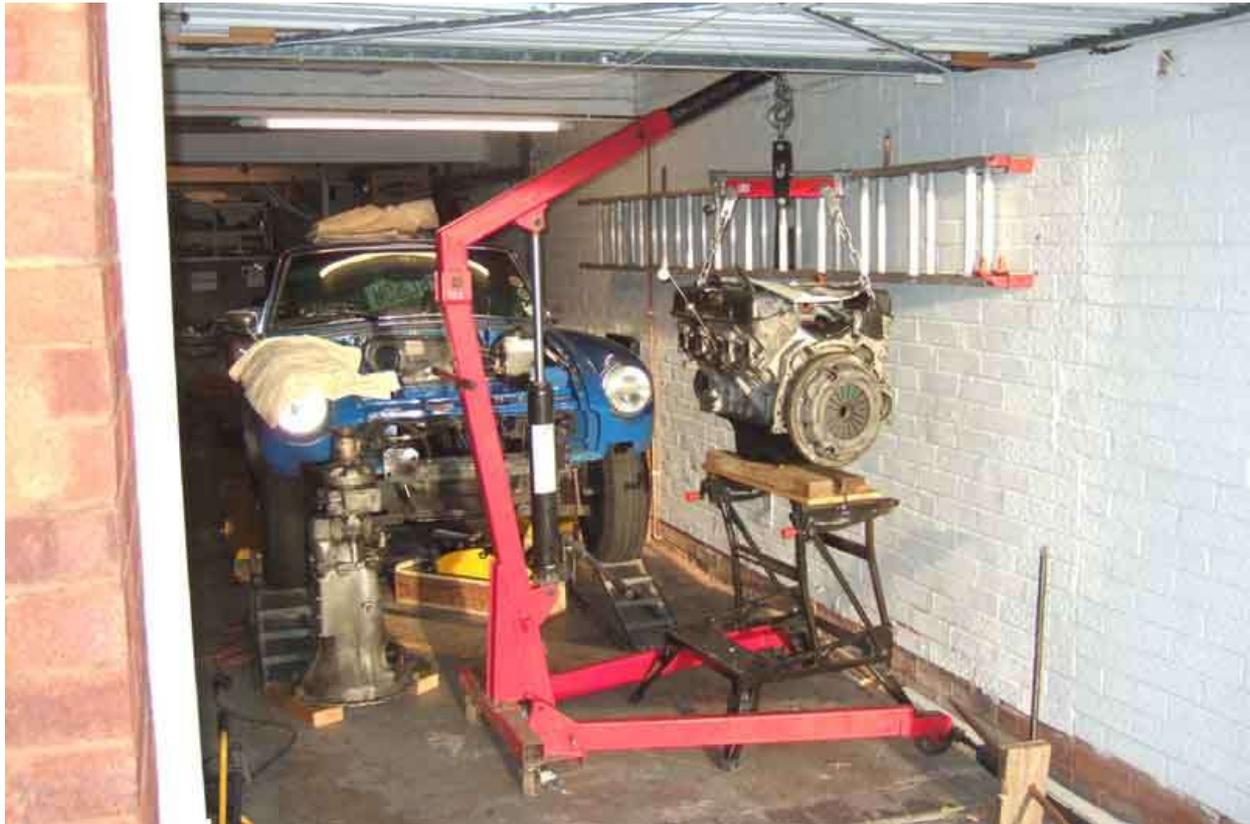
Stand the gearbox on wood blocks to keep the first-motion shaft clear of the floor, ready to remove the cross-member and mounts, sub-harness, reverse light switch. I decide to remove the tower as well to investigate the [OD switch actuation mechanism further](#), with a view to converting it to 3rd and 4th to overcome the coming out of OD on the over-run. Drain the

gearbox first while in-situ, then after standing like this for a while lay it level and drain it again, and about another pint comes out:

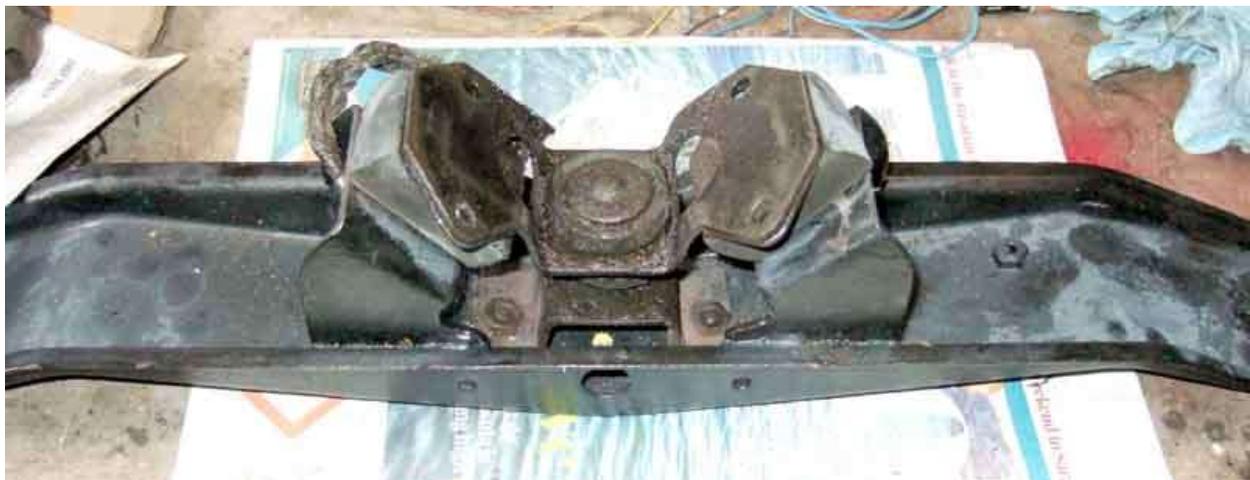
I'd been advised not to replace the mount rubbers unless absolutely necessary as new ones are so much harder, but these are definitely perished even having gone shiny and 'melted' in one area, so I will replace them. The central bracket circular rubbers can stay as there is no sign of damage and they only restrain the gearbox against excessive forward movement in the event of a severe frontal impact:

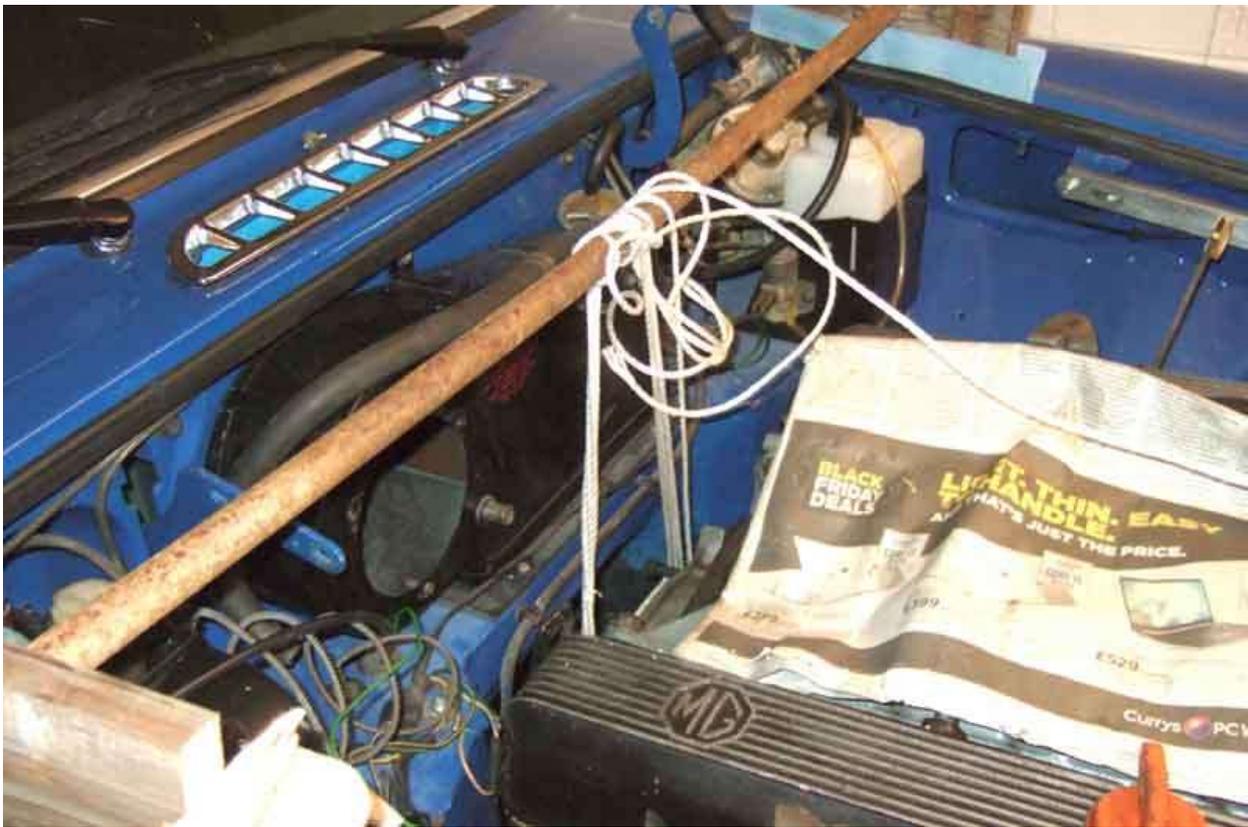
Getting the engine back in is easy, and to support the rear I come up with a steel bar slid through holes in two pieces of planking, sitting edge-wise in the rain channels of the wings, on cloths to protect the paint. First I have to support the engine under the sump so I can get the hoist out of the way, and with the two top bell-housing bolts replaced I wrap several turns of nylon rope under the bolts and round the bar and tie it off. Tentatively lower the jack, the suspension sinks as expected, but it all seems secure. With everything out of the way from behind where the bumper, air dam, and sundry mechanical parts have been stored up to now I chock a rear wheel to stop it rolling forwards, lower the jack under the sump all the way, and roll her back. I'm not leaving the engine supported solely on the steel bar so fiddle about under the full-length ramps to get the jack back in, and taking some of the load. From time to time I'll check the jack to make sure it isn't sagging.

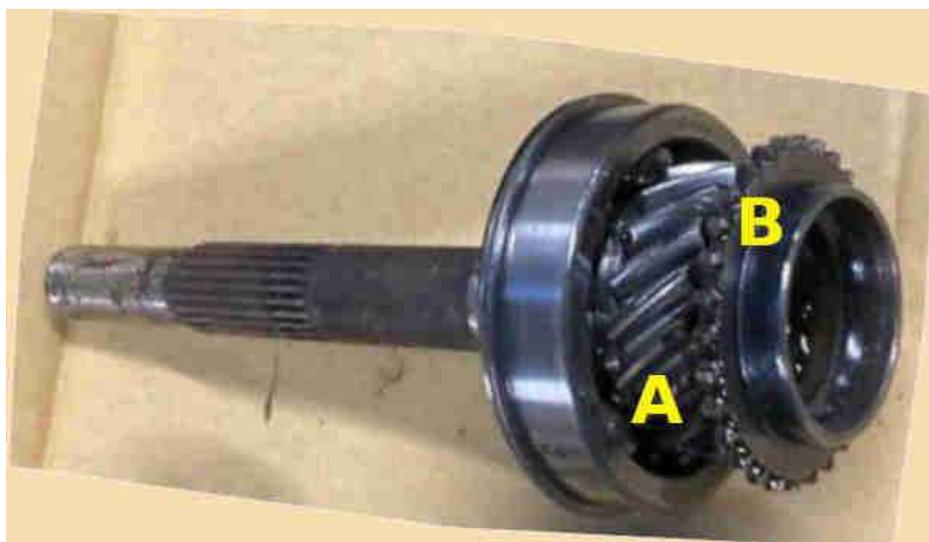
1st-motion shaft containing the gear 'A' to drive the laygear and dog teeth 'B' that the 4th gear synchroniser assembly engages with to select 4th gear:

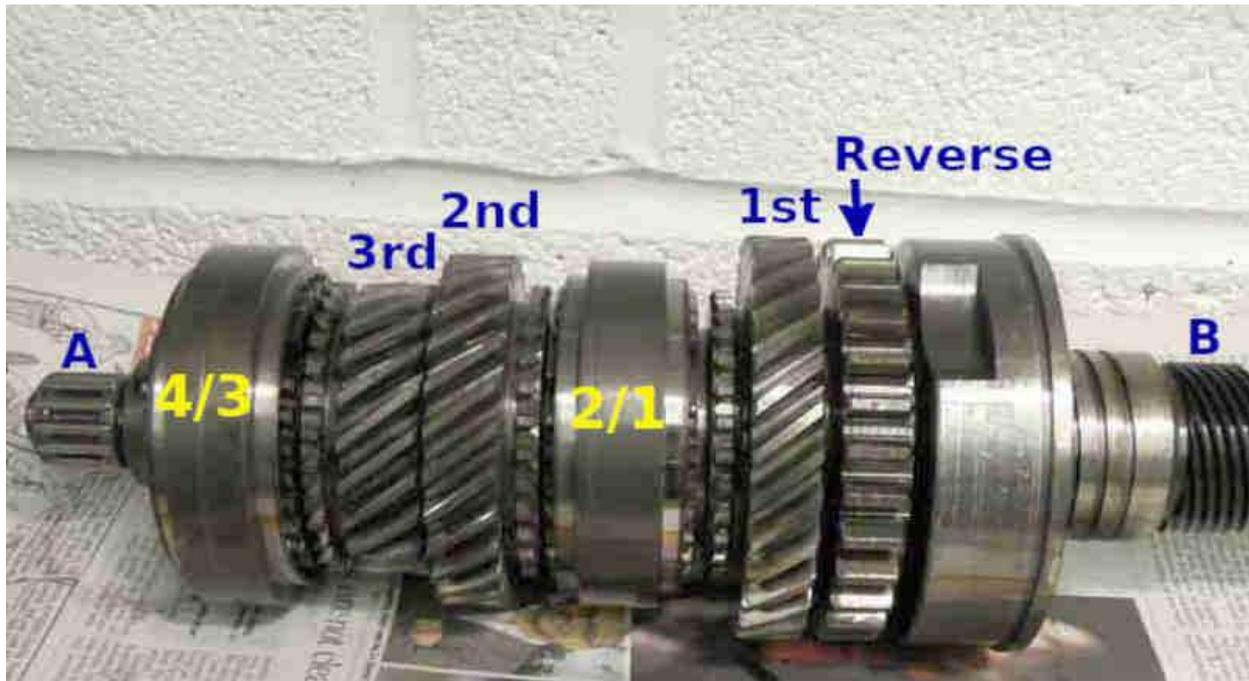
Output/mainshaft with the '4/3' synchro assembly moving left for 4th and right for 3rd, ditto the '2/1' assembly, and near-equal 1st and reverse gears. 'A' is the needle roller that engages in the end of the 1st-motion shaft to support that end of the mainshaft, 'B' is the worm gear for the speedo drive:

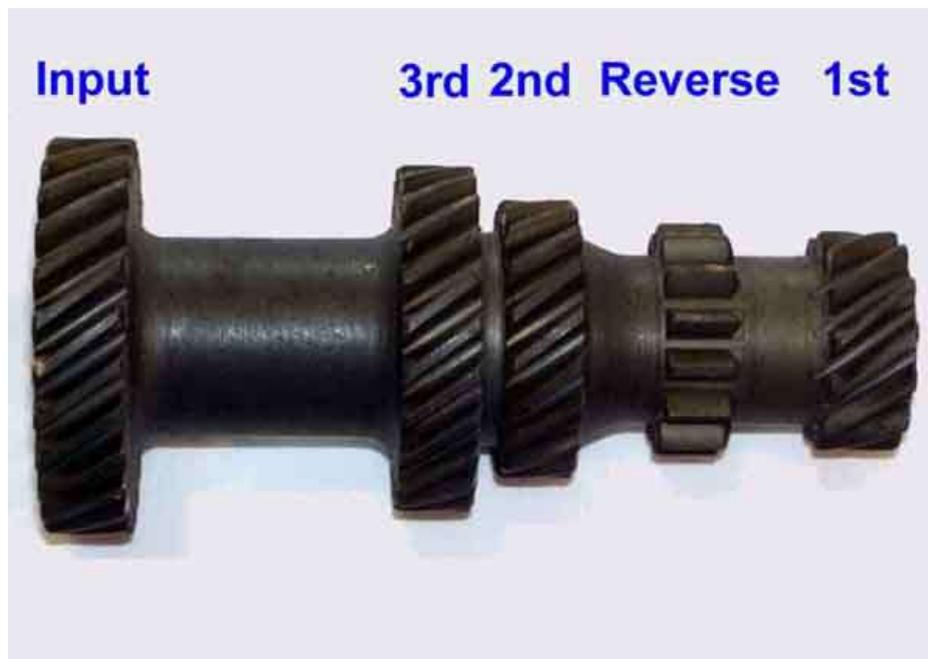
The laygear has 1st and reverse about the same size on the laygear - this is the 4-synch where 1st is 3.44:1 and reverse is 3.095:1 i.e. reverse has a lower ratio/higher gear than 1st. The 3-synch has 1st at 3.64:1 and reverse at 4.76:1 i.e. the other way round with reverse being a higher ratio/lower gear than 1st. This fits in with old-school advice when a very steep hill defeats 1st, which is to try reverse:

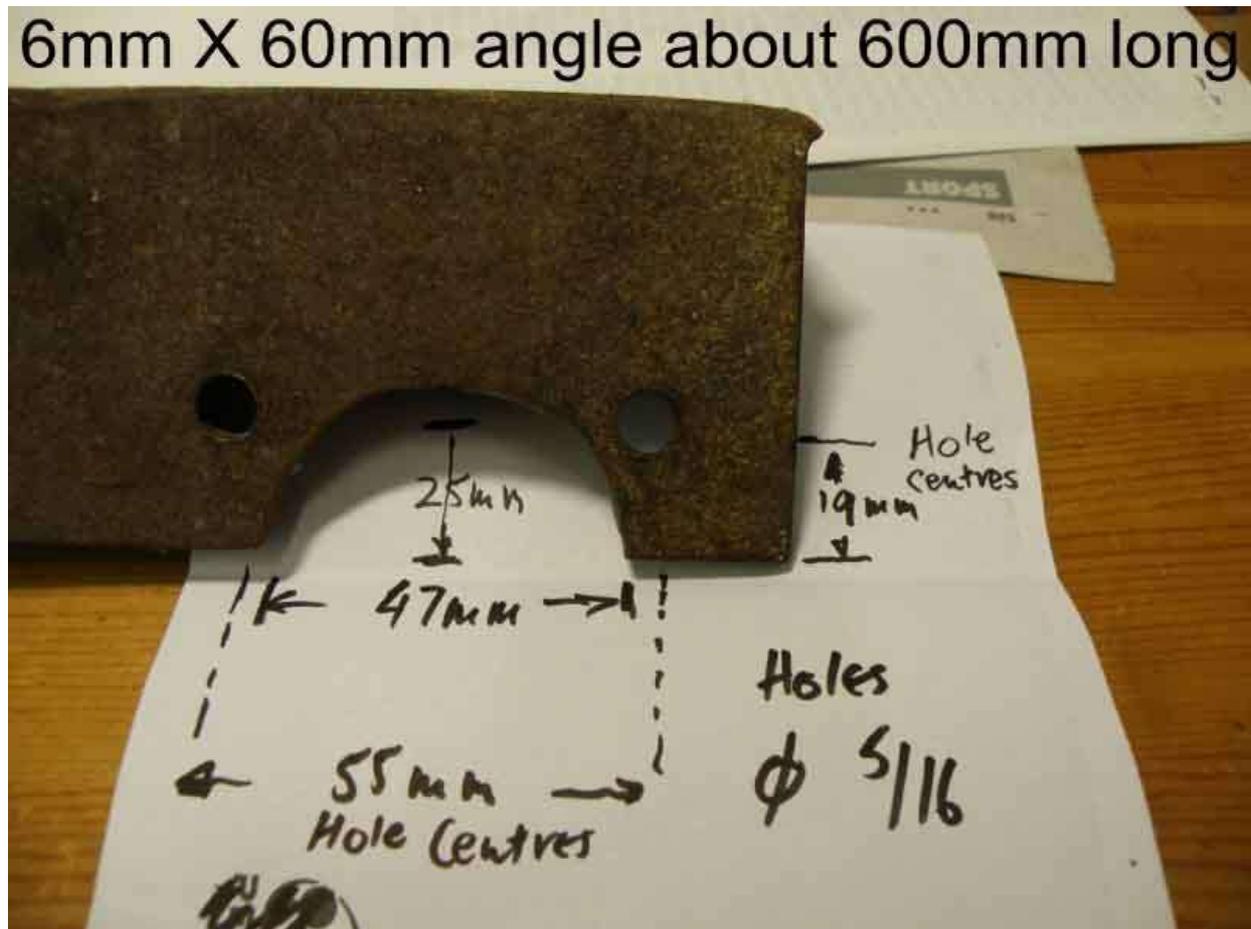
You need a piece of 6mm angle iron, about 2 foot long, with a suitable sized "bite" out of one end and two holes. The bite is large enough to fit the 1 5/16" AF socket and the holes line up with 2 adjacent bolts on the flange. I was lucky in that when bolted up, the angle iron rested against the leg of the bench, so I tied it to the leg and used a 2 ft breaker bar to undo the nut. It might be easier to leave the gearbox on the floor to allow it's own weight to help with undoing the nut.

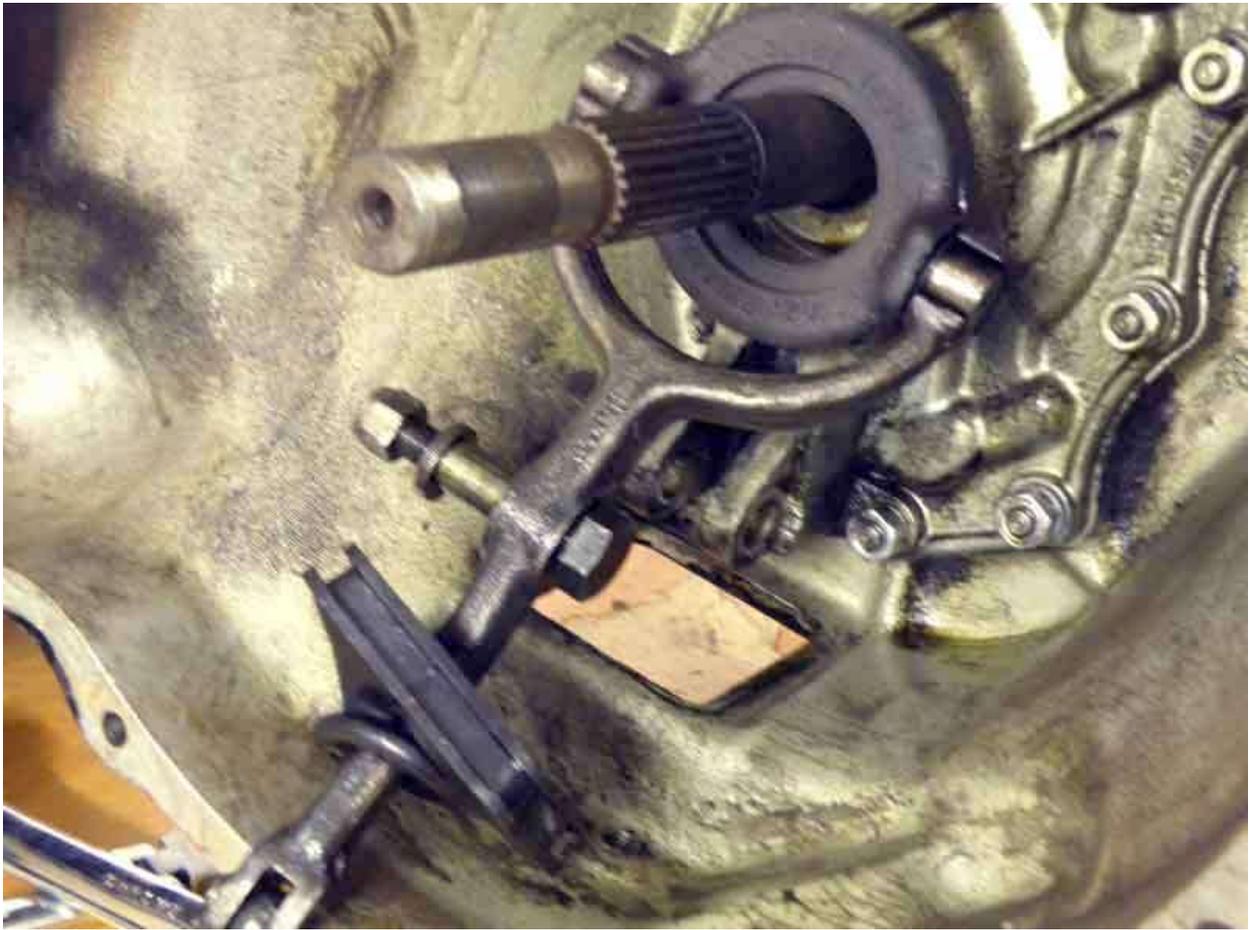
Gearbox input shaft - release bearing inadvertently rotated through 180 degrees.

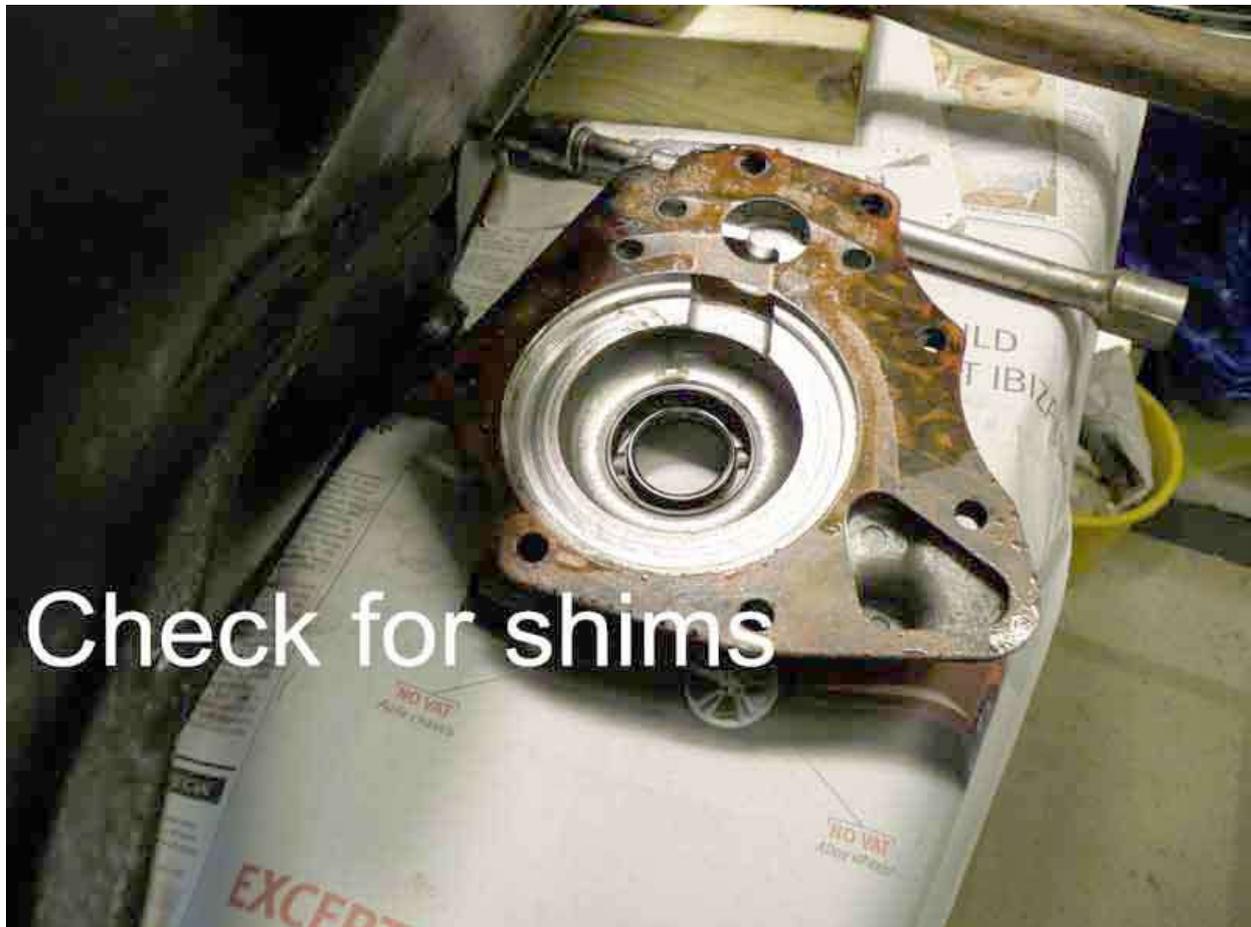
Check for shims in front plate.

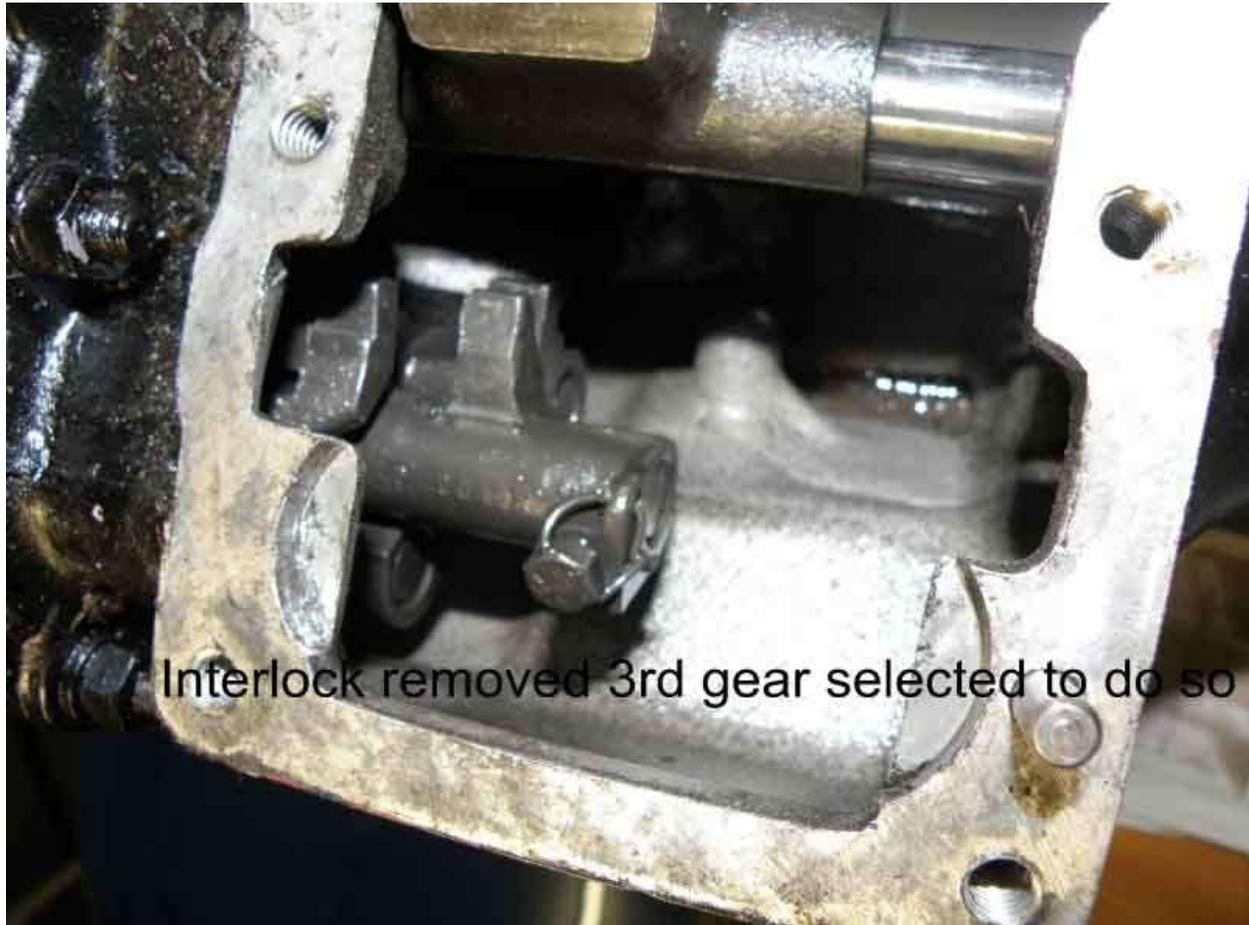
I found removing the interlock plate impossible until I moved the gear selector lever out of the way by selecting third (I think) gear.

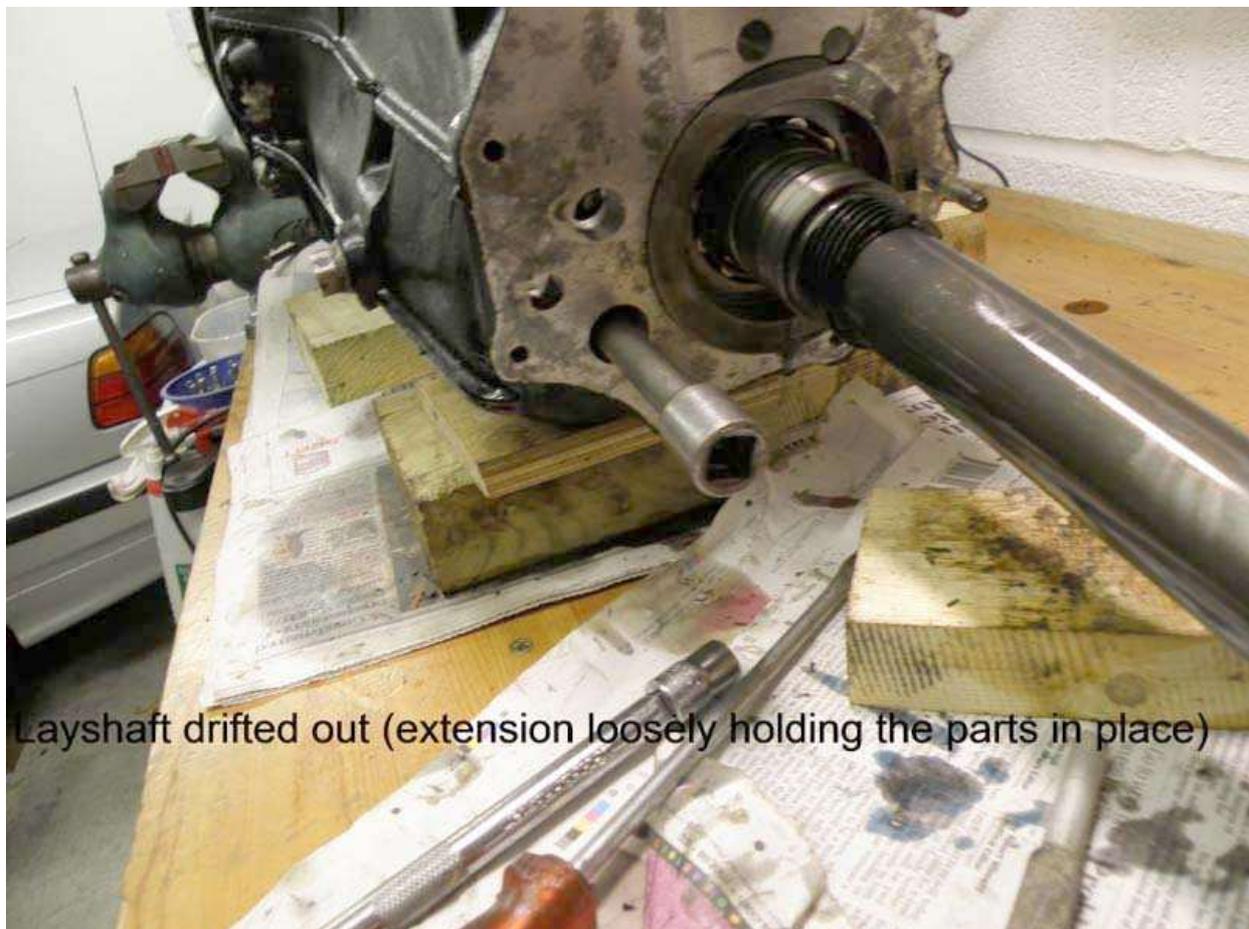
Next to drift the layshaft out. You need a long drift and a piece of coat-hanger wire. As you drift out the shaft push the wire (not shown) down the centre to keep the thrust washers roughly in place. Allow/assist the laygears to move to the bottom of the casing.

Layshaft drifted out (extension loosely holding the parts in place)

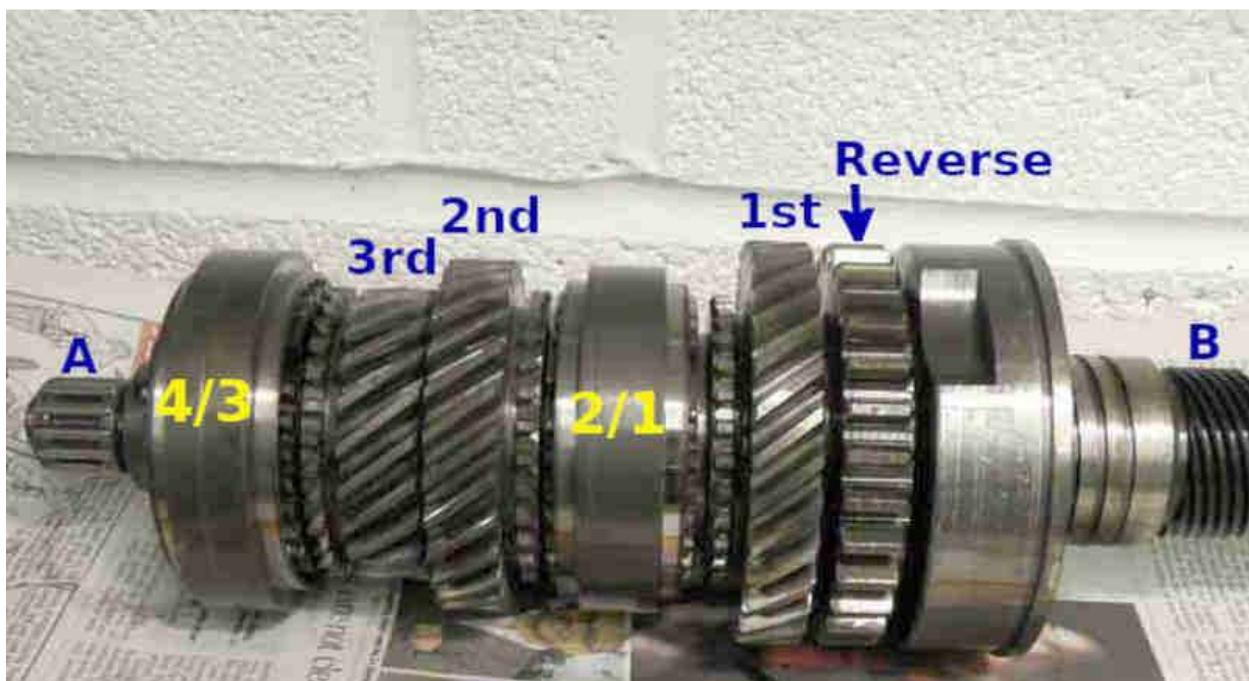
Output/mainshaft with the '4/3' synchro assembly moving left for 4th and right for 3rd, ditto the '2/1' assembly, and near-equal 1st and reverse gears. 'A' is the needle roller that engages in the end of the 1st-motion shaft to support that end of the mainshaft, 'B' is the worm gear for the speedo drive:
