Mk1 or Mk2?

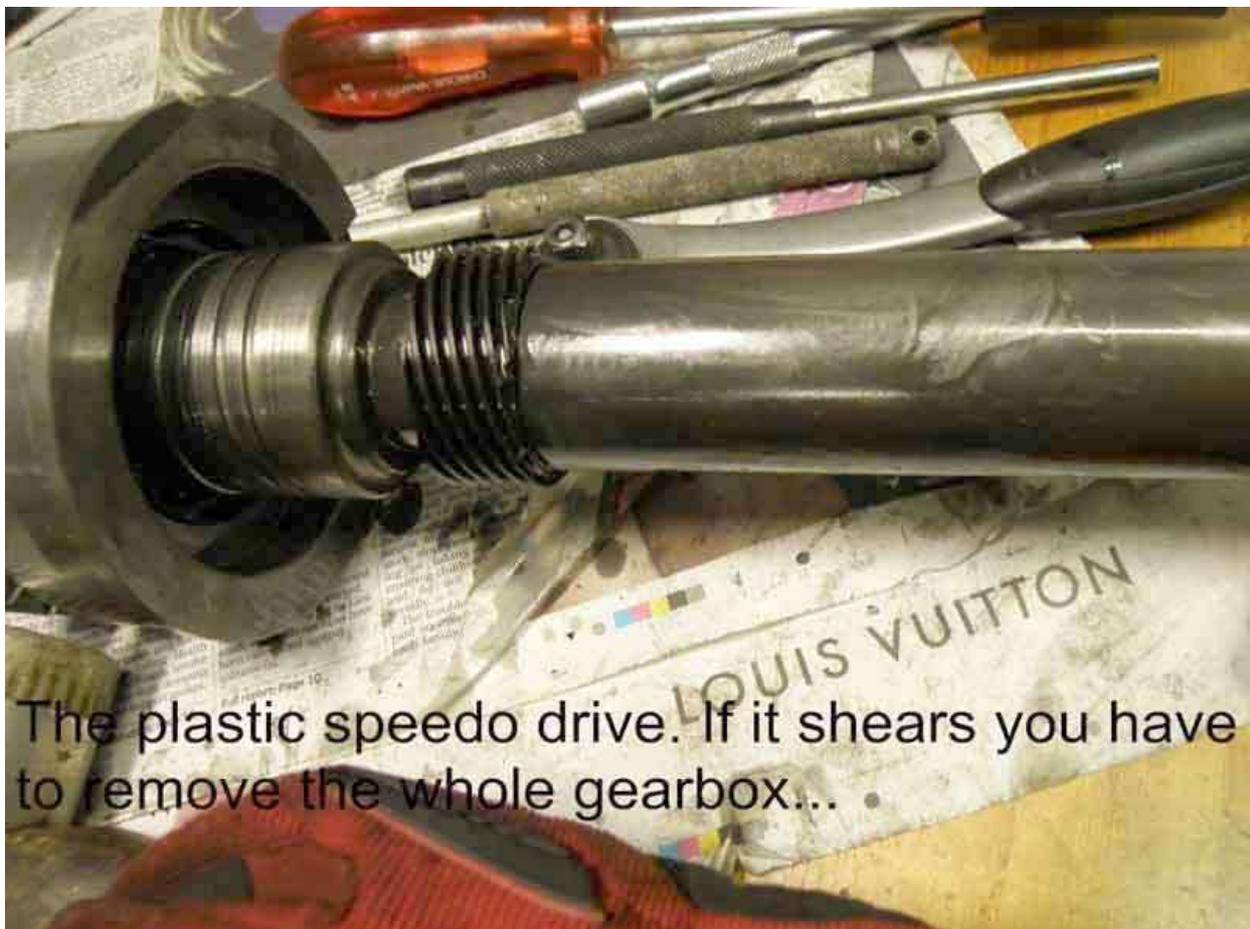
Take care not to damage the plastic speedo gear.

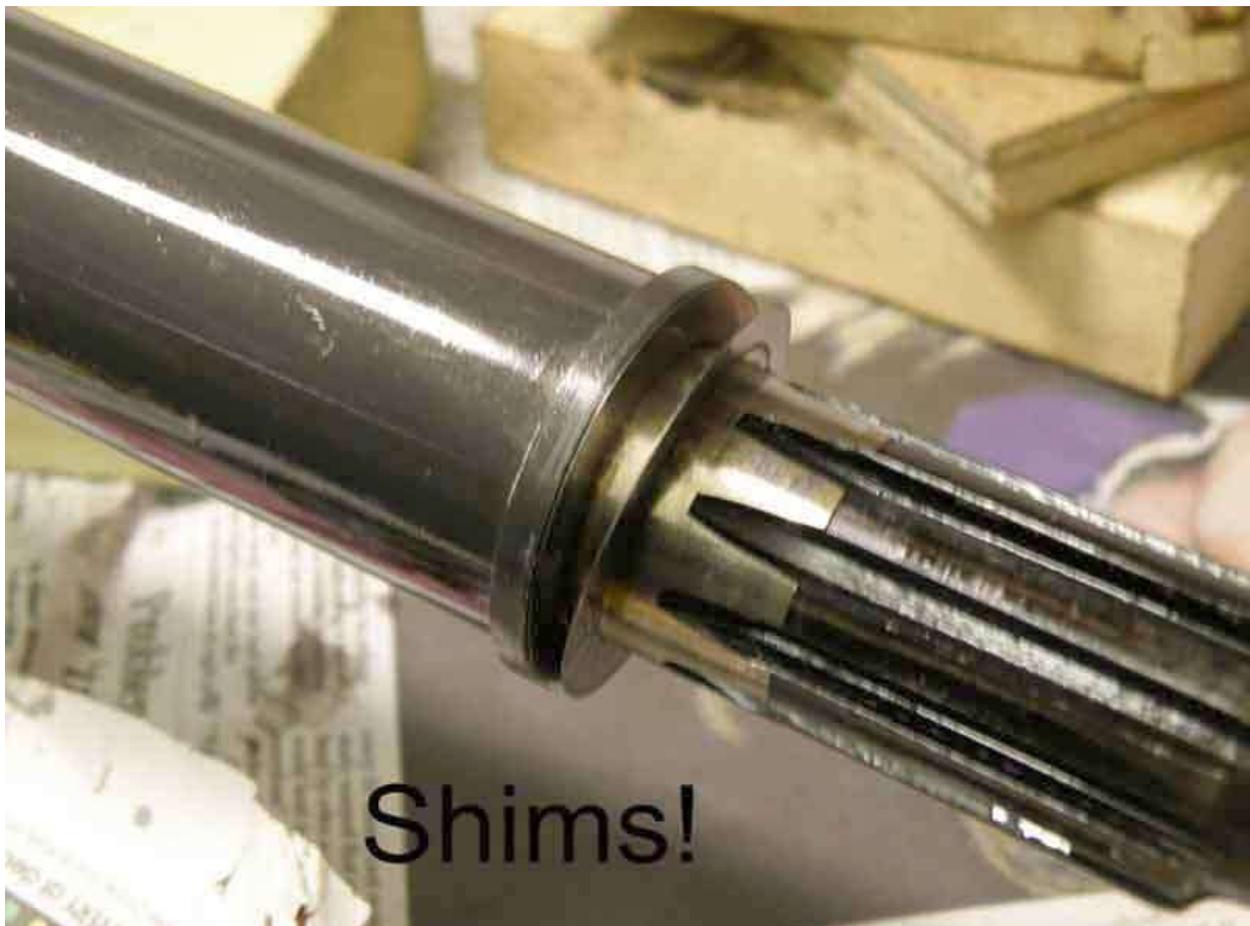
More shims on the mainshaft.

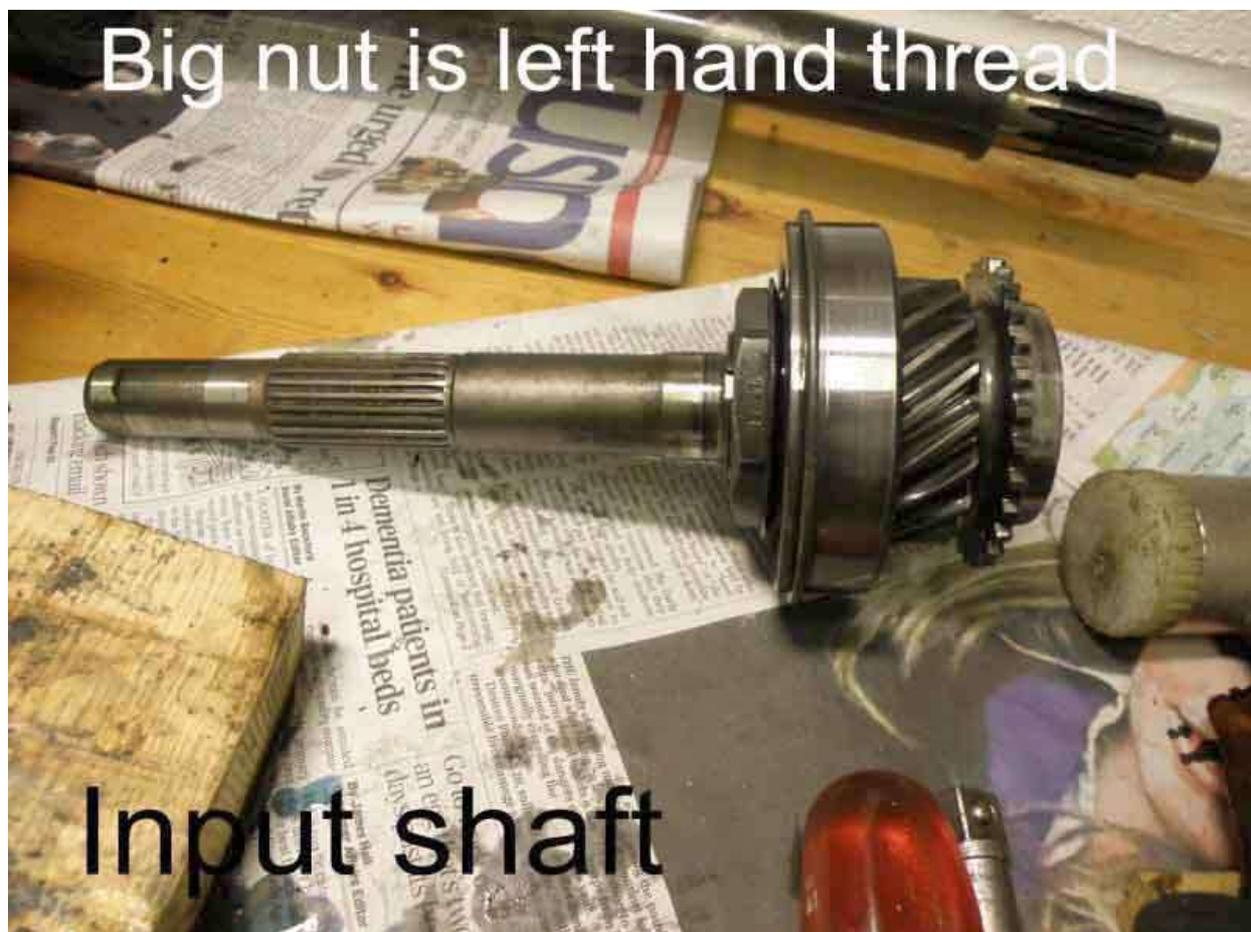
To remove the input shaft you need to use a (softish) drift on the outer bearing face from inside the box. It takes time and patience as the angle is not easy!

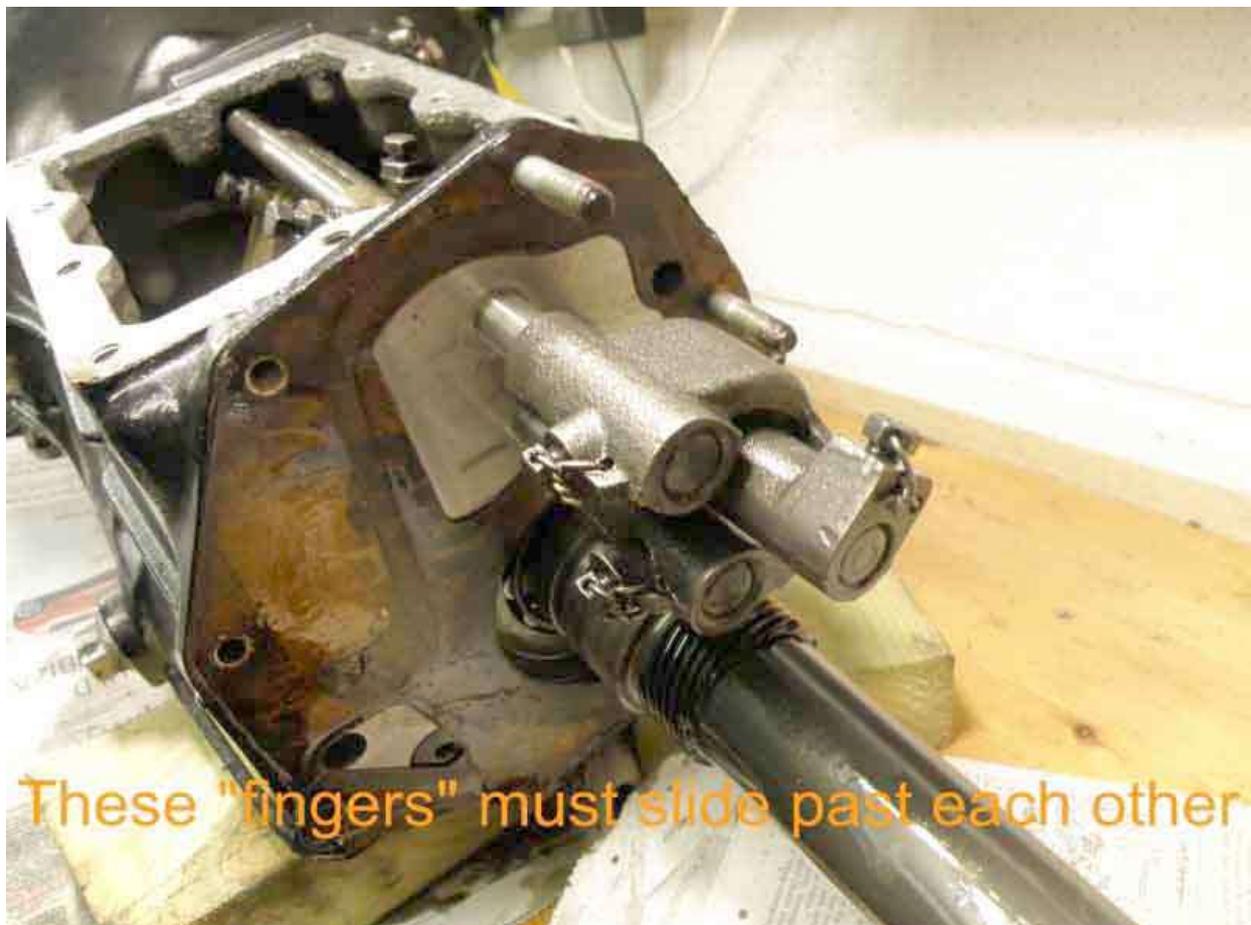
Slide the selector rods in through the forks. Note that the rods have holes in which the bolts bolt into. A delicate touch whilst finger tightening these bolts and moving the rod very slightly will ensure the bolts are in the right place. I got it wrong and caused the "fingers" (that protrude out of the tail) to jam.

Once I rotated the shaft a tad the bolt in the fork engaged properly and the "fingers" slid past each other. Now slide the tail on having first replaced the gasket, and bolt up. Engage 3rd (I think) gear to allow the interlock to be inserted. Feed it in rounded end (not the finger end) first as far as possible in a diagonal direction. Then rotate it and move it slightly left to allow the flat plate to sit in the recesses. Again a fiddle-at first it seems impossible and when it finally slips in, you wonder how you did it! Bolt the remote casing back on, squirt some oil on the cogs, bearings, and replace the side, and front covers. I was storing mine so just used enough to keep moisture at bay. If replacing in the car I would add more to allow for initial lubrication.

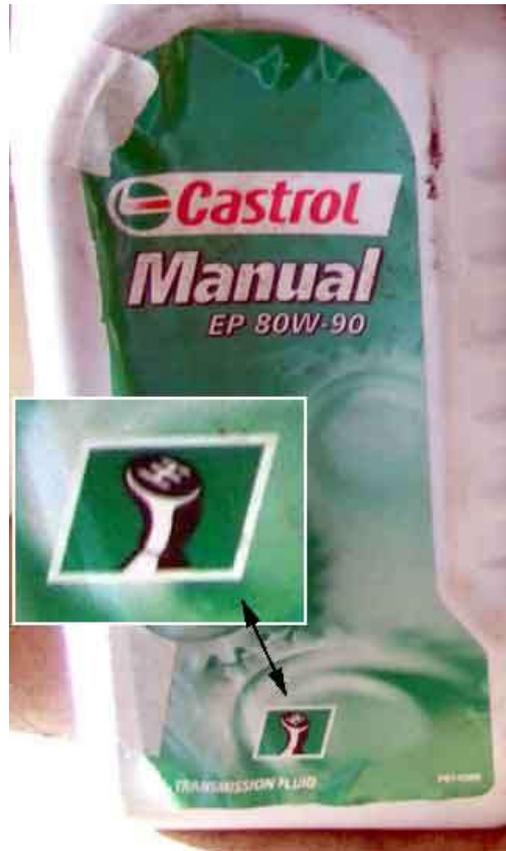
Castrol V8 gearbox oil showing 'MANUAL' and a picture of a gear lever on the front ...

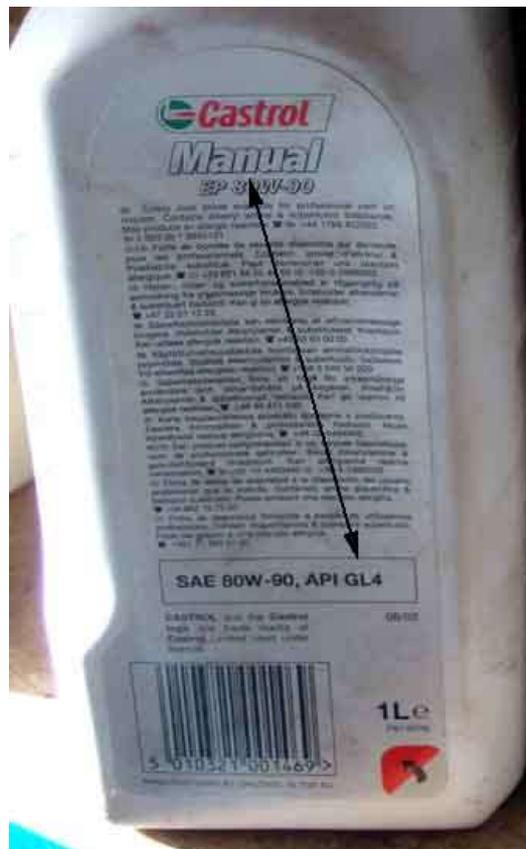
... and 'MANUAL' and 'GL4' on the back.

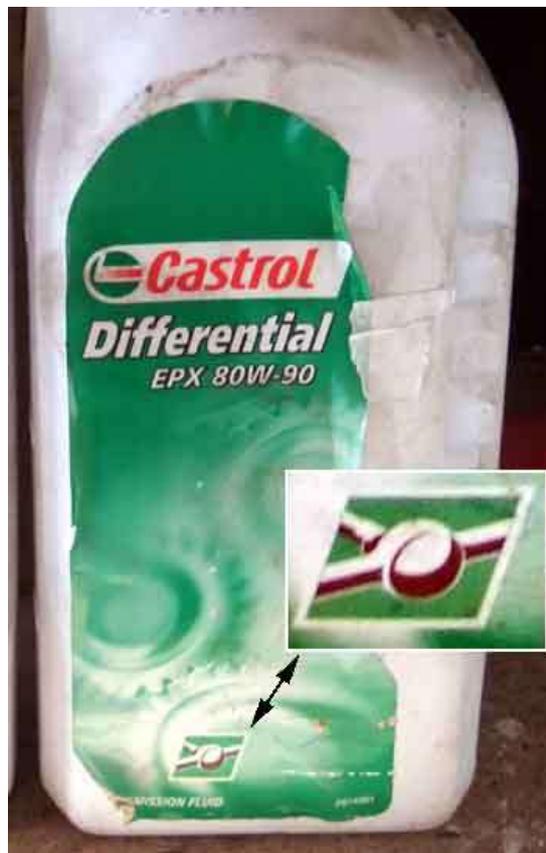
Castrol rear axle (and steering rack) oil for all MGBs showing 'DIFFERENTIAL' and a picture of an axle on the front ...

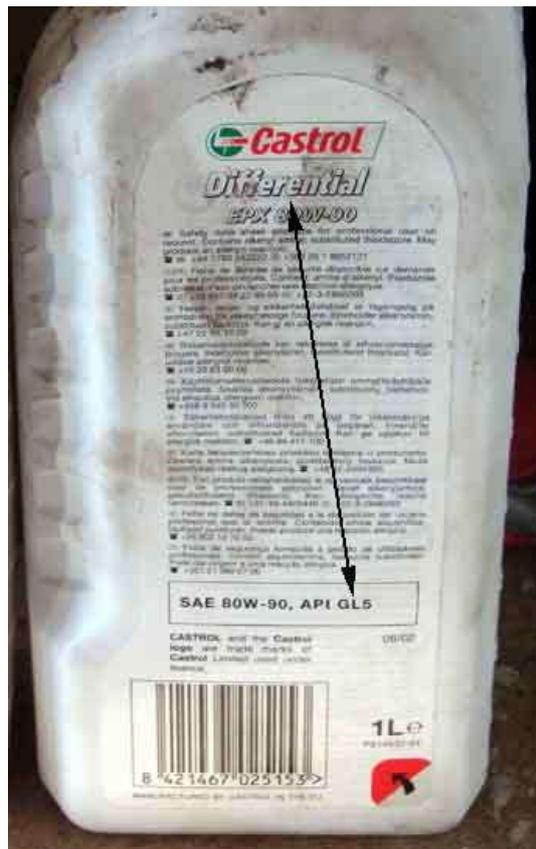
... and 'DIFFERENTIAL' and 'GL5' on the back.

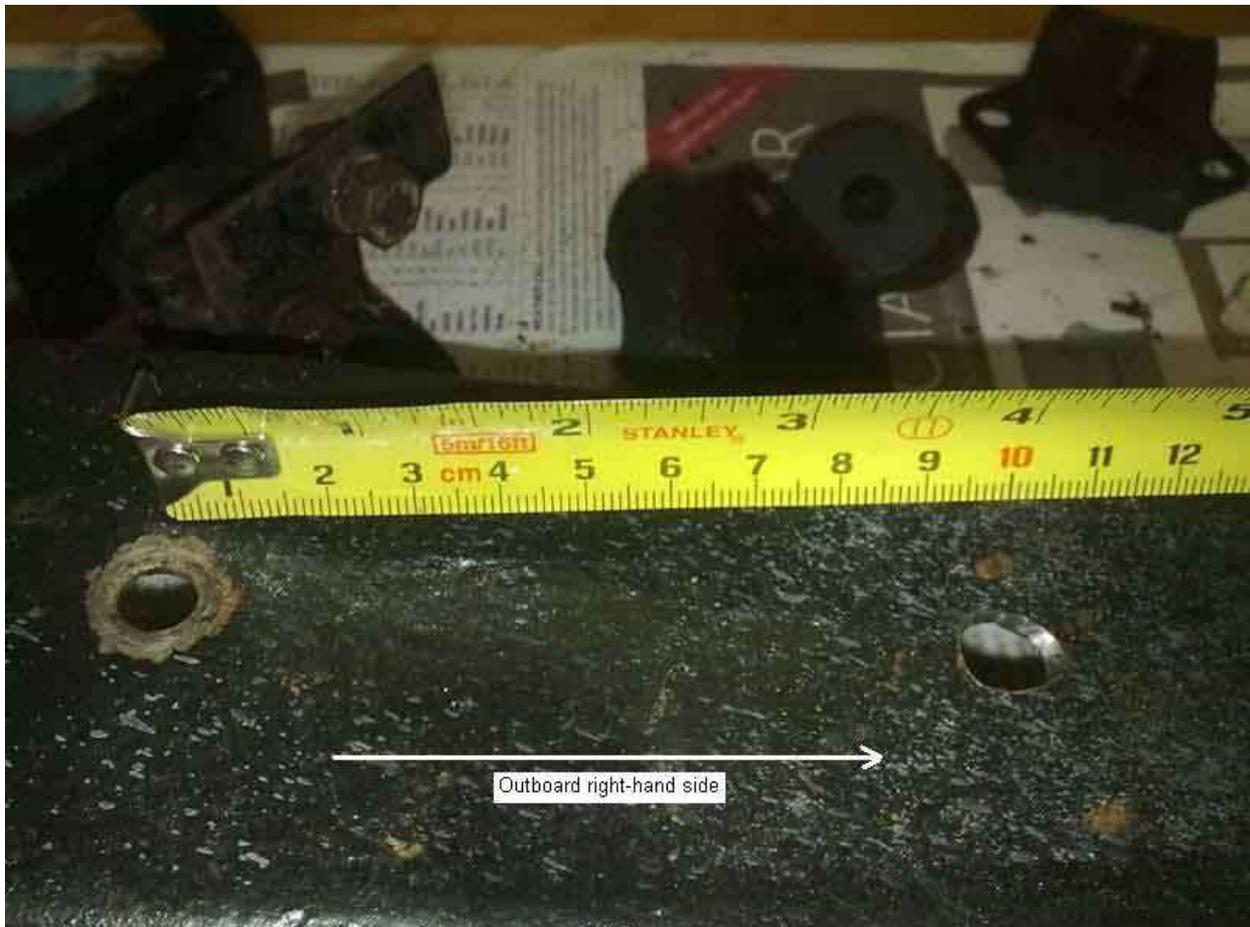
Measure and mark a point 100mm from the centre of the bolts that hold the yoke to the cross-member outwards. Drill respective pilot holes. The exhaust starts to get in the way on the left-hand side.

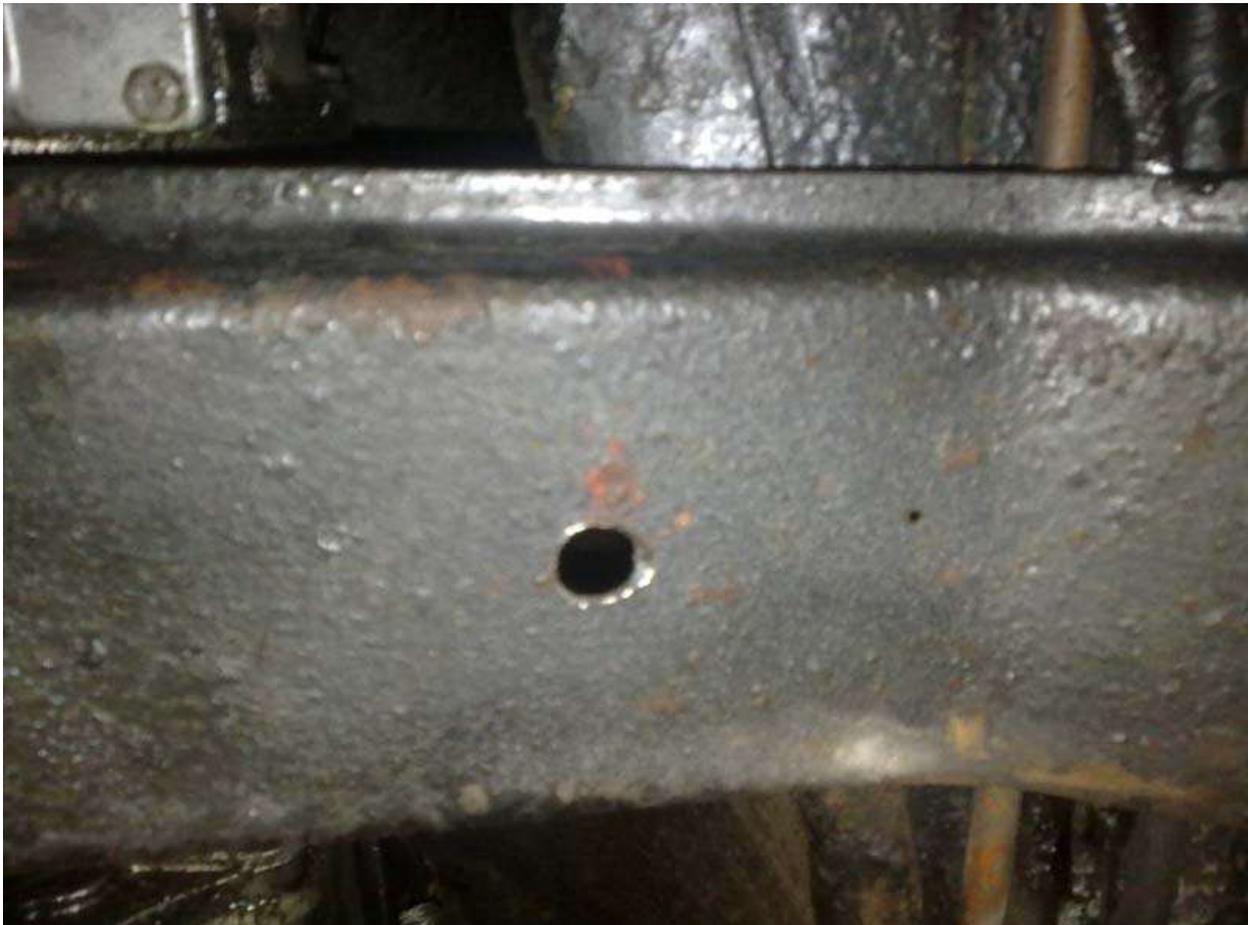
On the right-hand side enlarge the hole to 10mm, and then elongate it to about 18mm. The 18mm dimension is “across” the car, the 10mm front to back of the car.

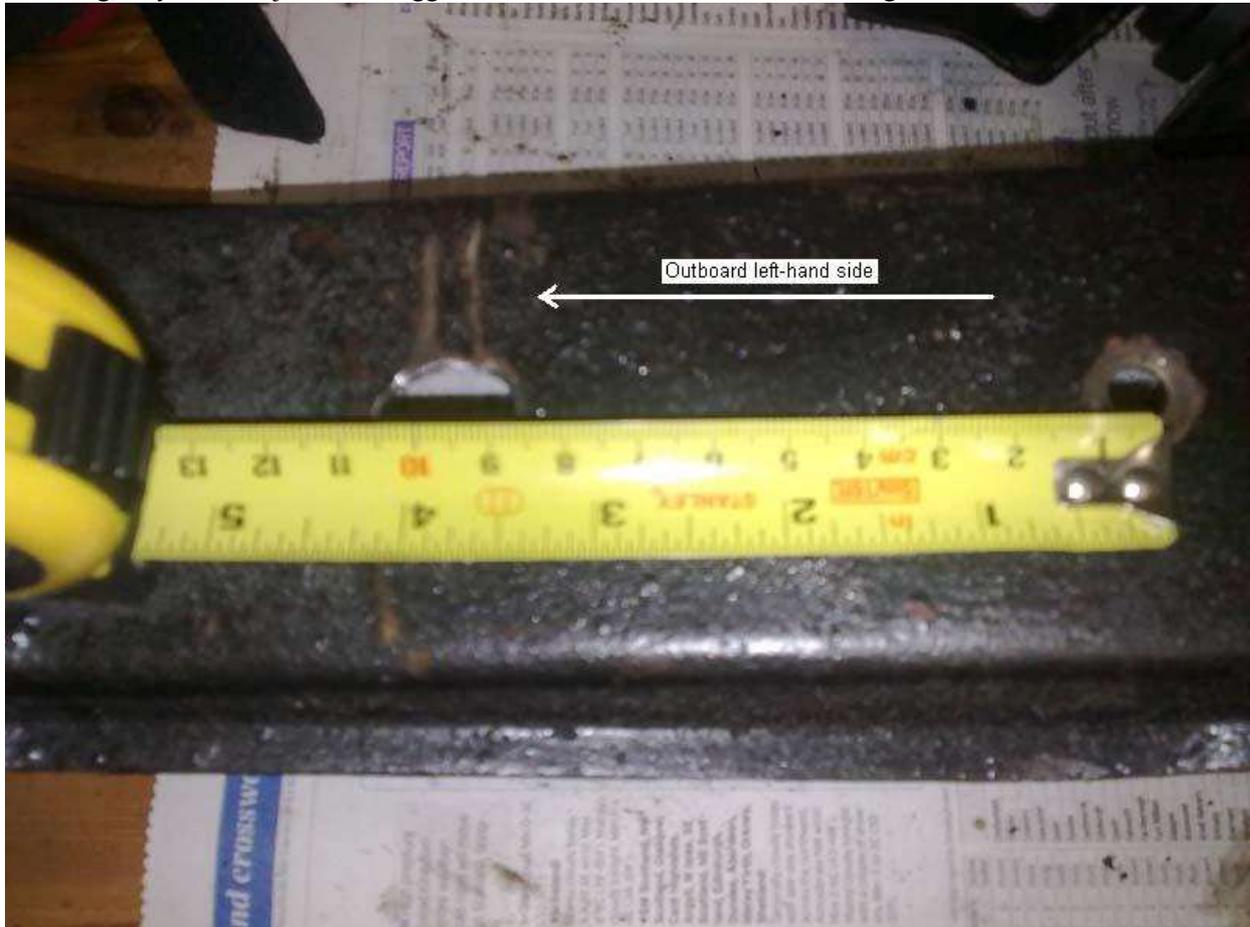
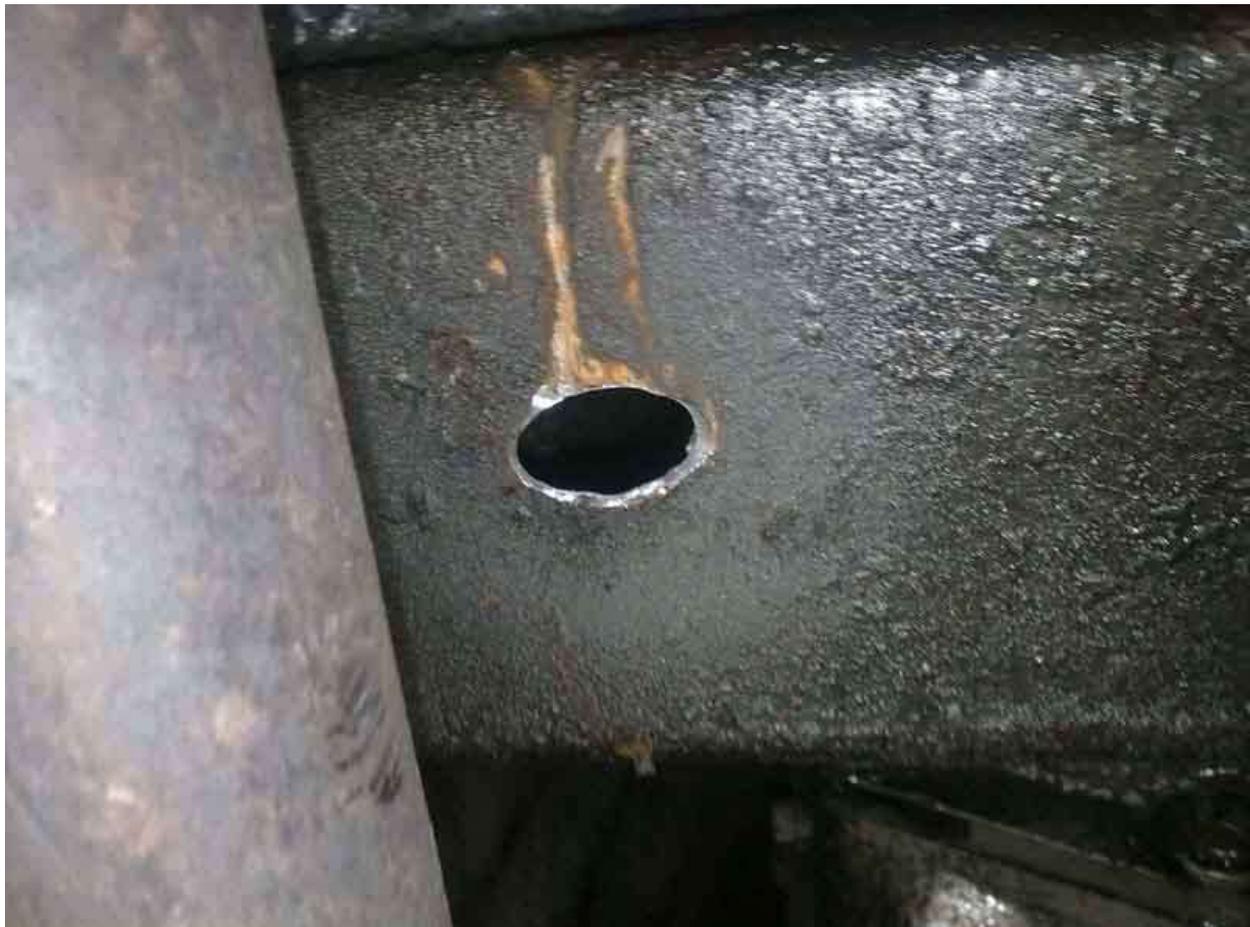
Repeat for the left-hand side but enlarge to about 22mm “across” and 18mm front to back. This is not critical-the cross-

member is strong, so you could just make bigger round holes. I used a Dremel to enlarge them.

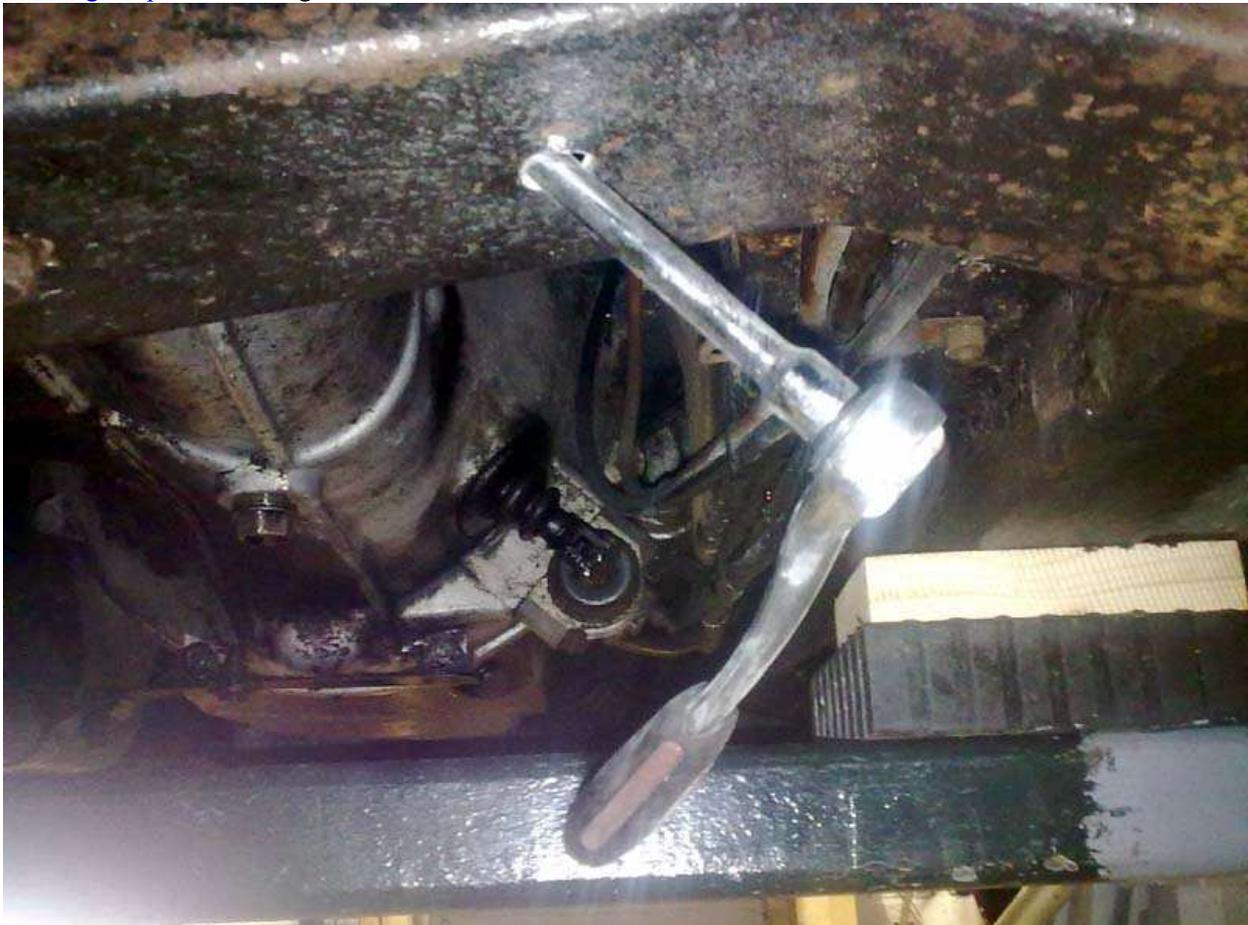
It should be possible using a 250mm $\frac{1}{4}$ " extension and a $\frac{1}{2}$ " socket to reach the nut on the rubber mount on the right-hand side. Fit the socket after you have fed the extension bar through the hole. Note that rubber bumper cars and all V8s should have an [earthing strap](#) round the right-hand mount.

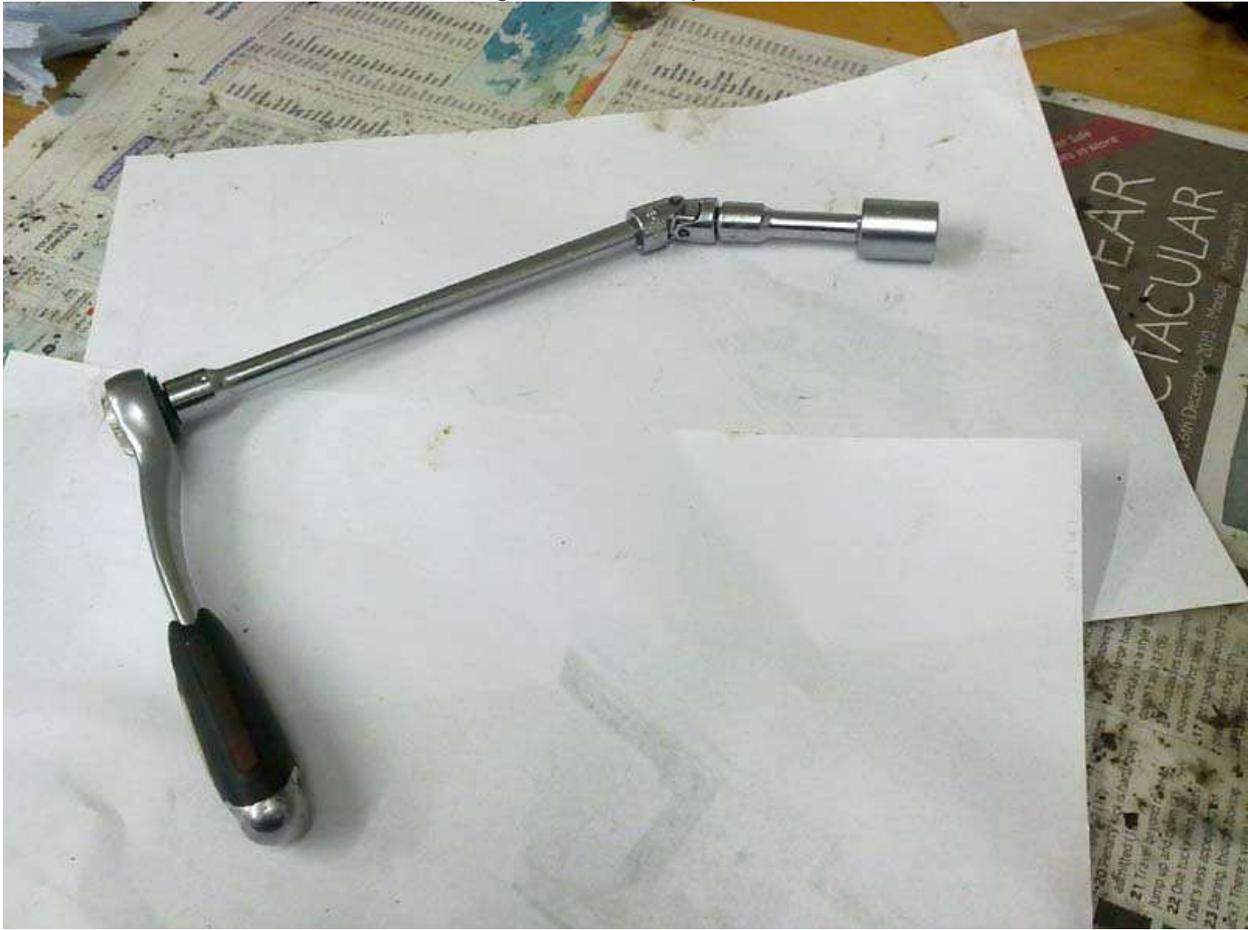
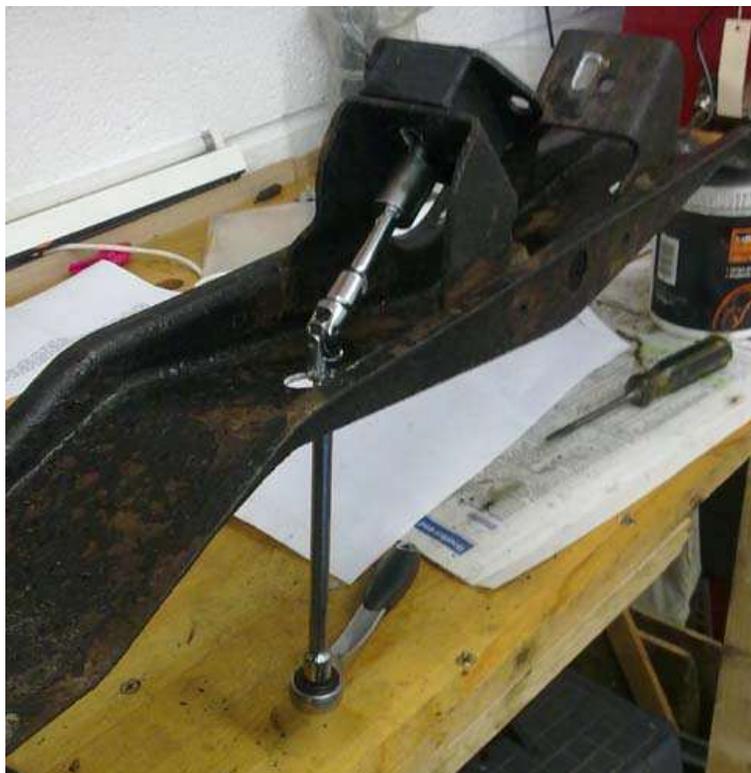
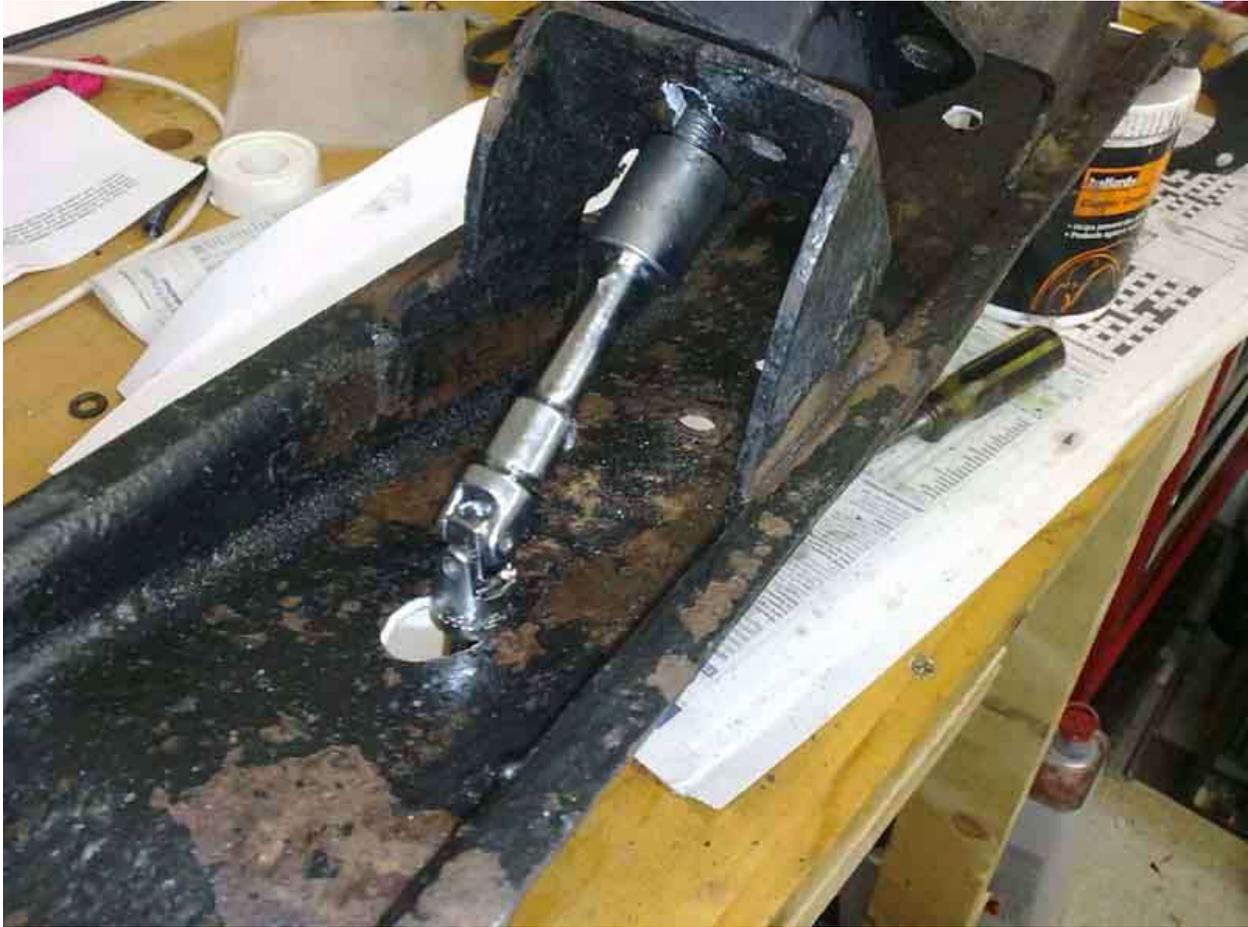
If the nut won't shift or you only have a $\frac{3}{8}$ " drive set-make the hole bigger. For the left-hand side, the socket fits on to a

75mm extension, then a universal joint, then a 150mm extension. This allows you to work inboard of the exhaust pipe. The whole lot does move about a bit, as the U/J is turning in the hole that you drilled.

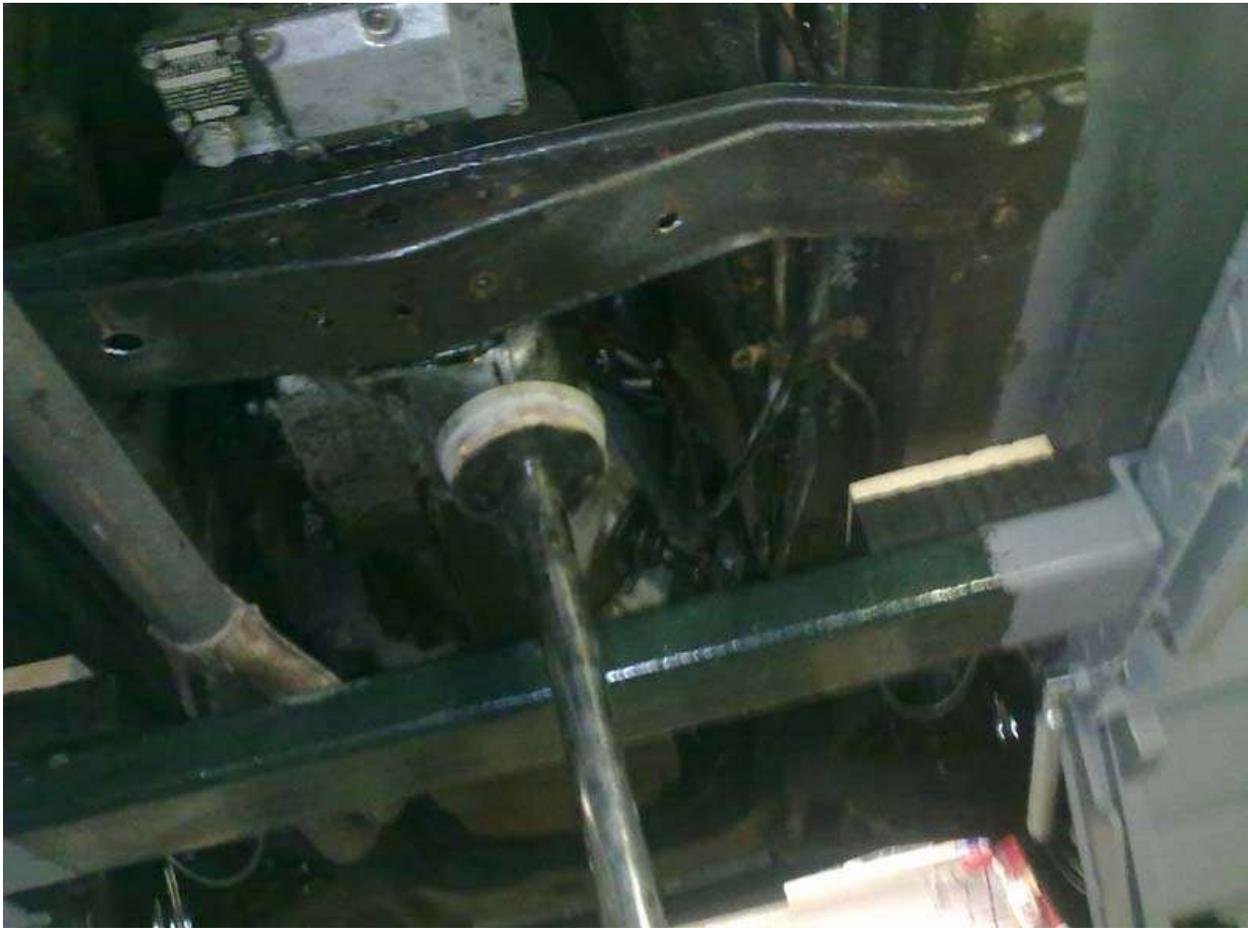
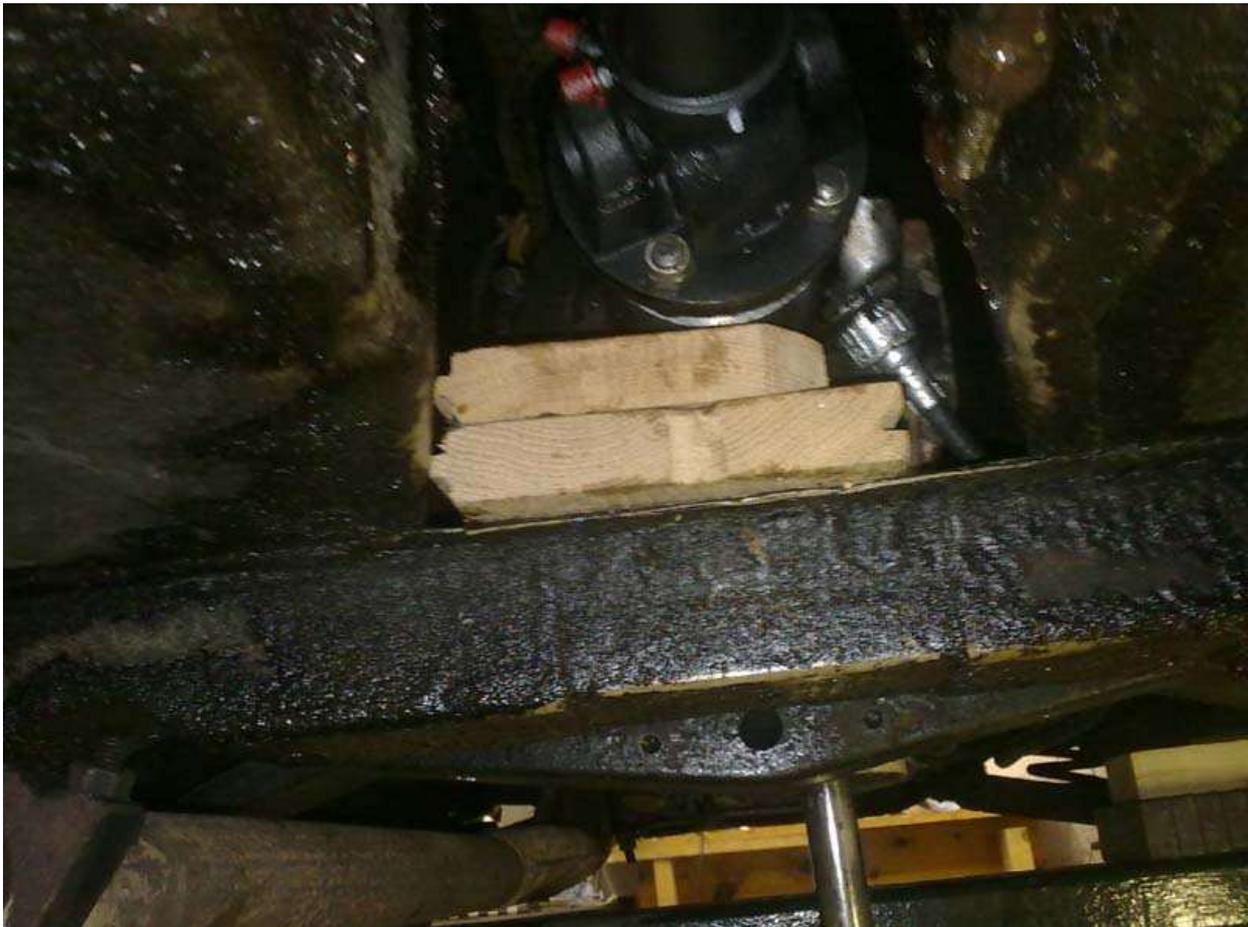
Support the gear box back end. If O/D style, blocks of wood allow you to rest the tail of the O/D on the fixed cross-member. I lifted the tail slightly to compensate for the collapsed mounts. Remember that the whole engine is now tilting slightly, so for c/b cars the clearance between front crankshaft pulley and steering rack could (but shouldn't) become an issue. (Mine is 10mm clearance)

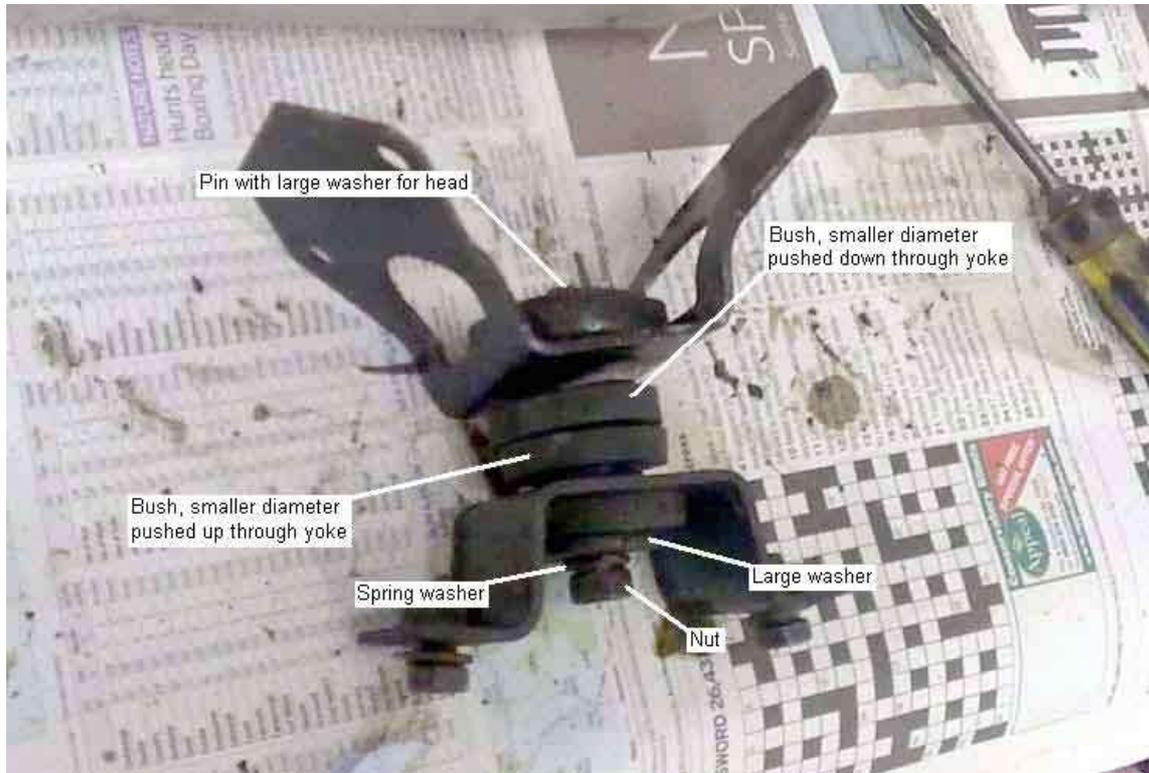
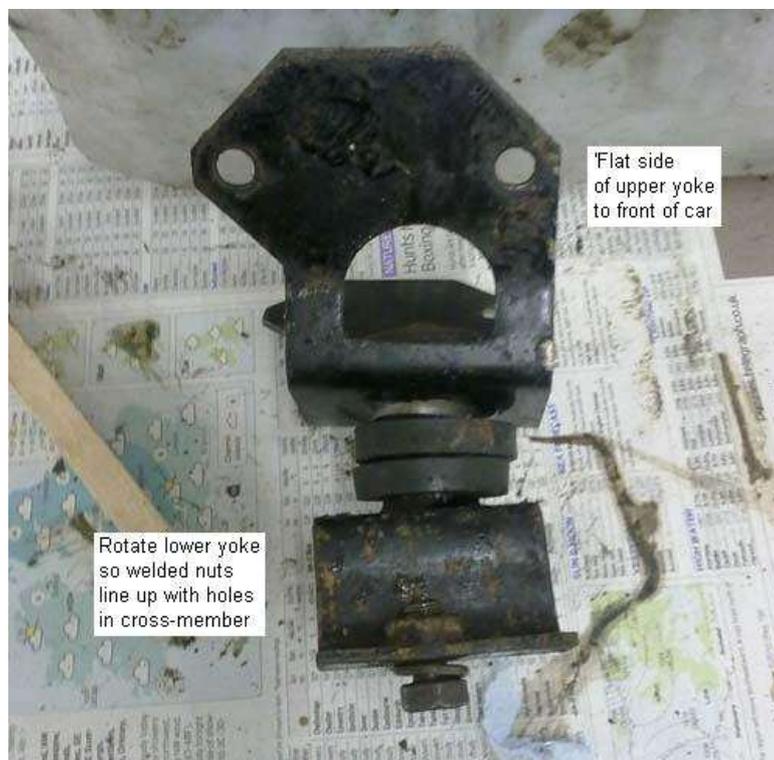
You should now have the cross-member free and the rubber mounts, upper and lower yokes bolted to the gearbox. The rubber mounts almost certainly have “spread” preventing easy access to the bolt heads. Cut away the excess rubber! Remove the two bolts on either side and remove the upper and lower yokes (bolted together) and the two rubber mounts.

Note which way round everything goes-again!

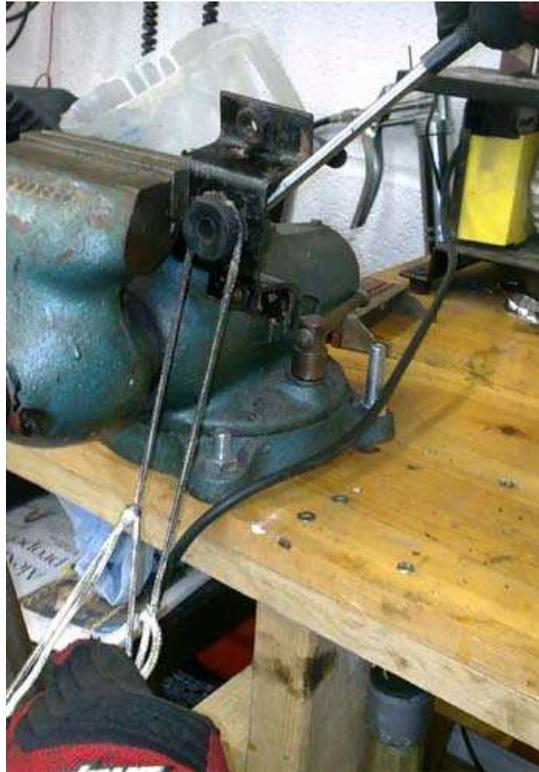
To dismantle the yokes, use a mole grip on the top “disc” to allow removal of the nut and washer at the bottom. With so much apart it is pointless not to renew the rubber “bobbins” that are a feature of the two yokes. These are a pig! I reduced the diameter of the smaller of the two “discs” from 32mm to 28 mm using a belt sander whilst rotating the bobbin. The technique is to heat the bobbins, and use Vaseline on both it, and the metal yoke. Put the yoke in a vice, and put a loop of nylon cord around the waist of the bobbin (check which way up they go –see parts diagram) with the ends passed through the hole in the

metal yoke. Pull downwards so the lower edge of the smaller diameter “disc” of the bobbin goes through the hole and use a blunt pusher (6mm punch) to push the rest in – working round the disc. Note that it makes sense for the narrower diameter of each bush to be pushed through from the side that **doesn't** have the lip round the edge of the hole.

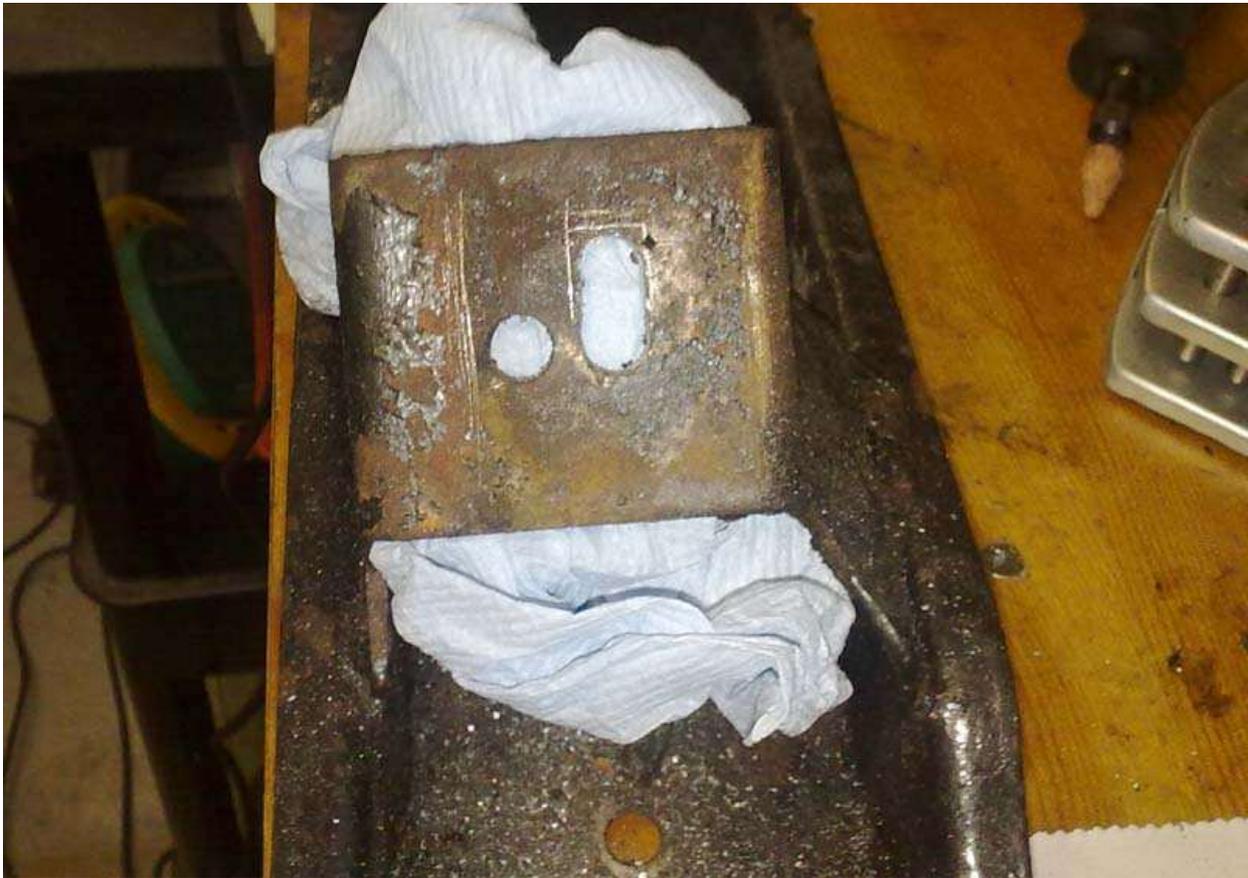
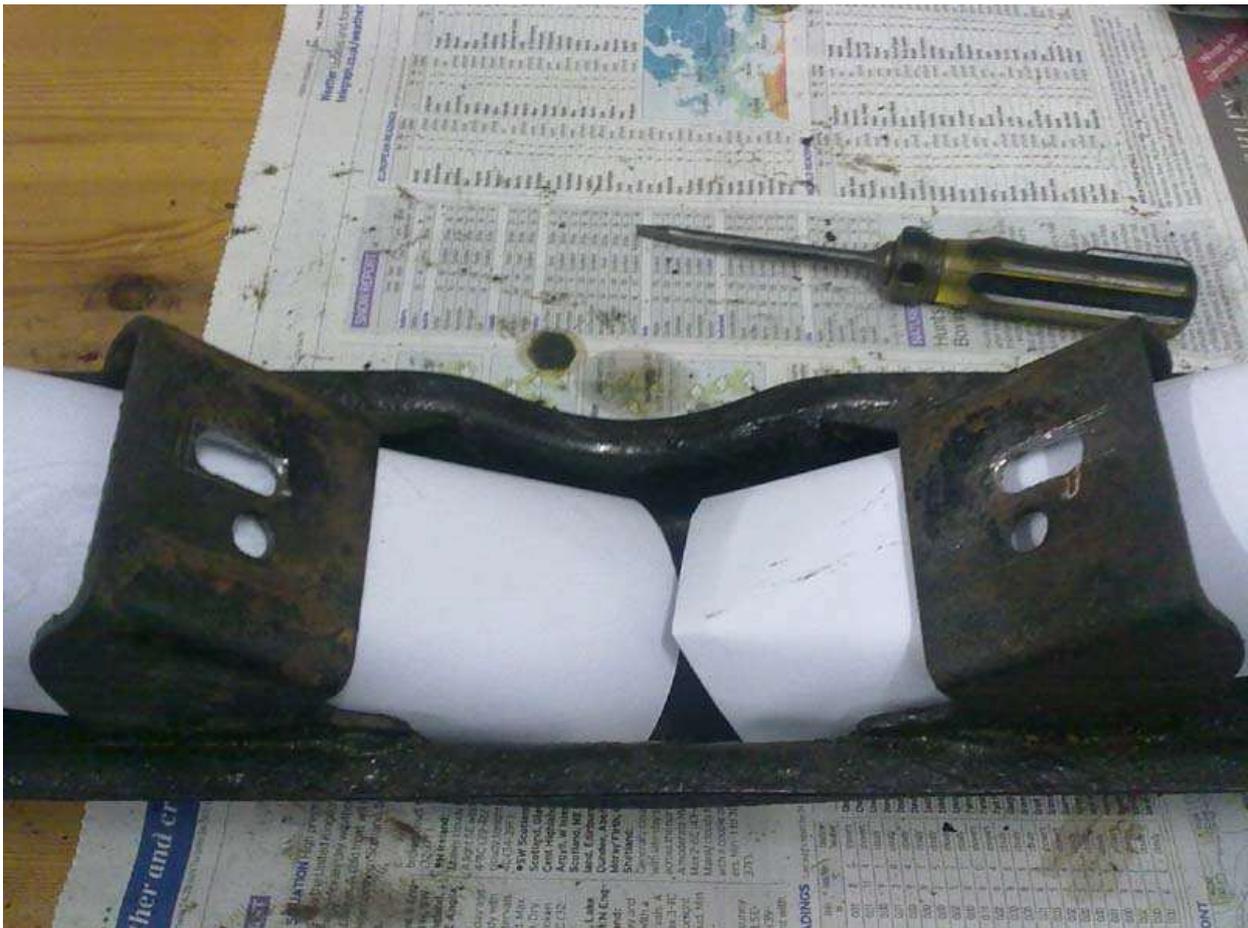
Now back to the cross member. The new rubber mounts are likely to have far less give in them, so it will be more difficult to lever the cross-member on than removing it-and it has to be in the right place! Elongate the fitting holes to about 15-18mm-upwards. This should allow the cross-member to be lifted and located easily(!) on the protruding studs of first one and then the other mount. Clean the cross-member mounting bolts –or replace- and put Coppaslip on these. I also slightly enlarged the holes in the cross-member through which the bolts go to hold the lower yoke, to aid reassembly. Note John Twists's video (and also this [very wordy alternative](#)) shows one of these holes elongated so neatly that it seems 'factory', however this cross-member didn't have that.
