Mk1 or Mk2?

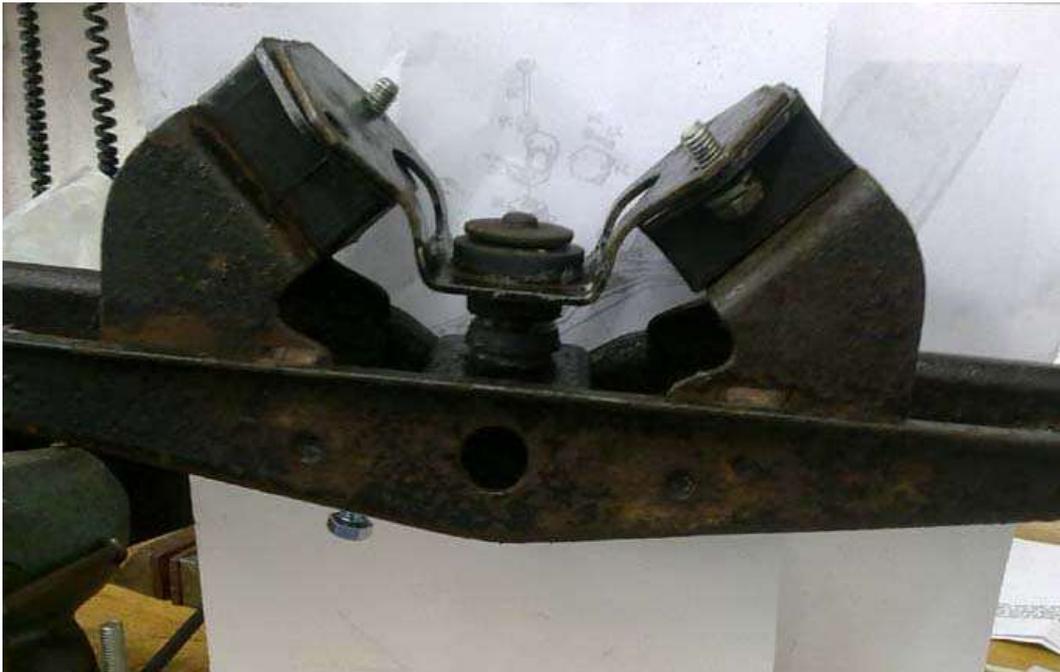
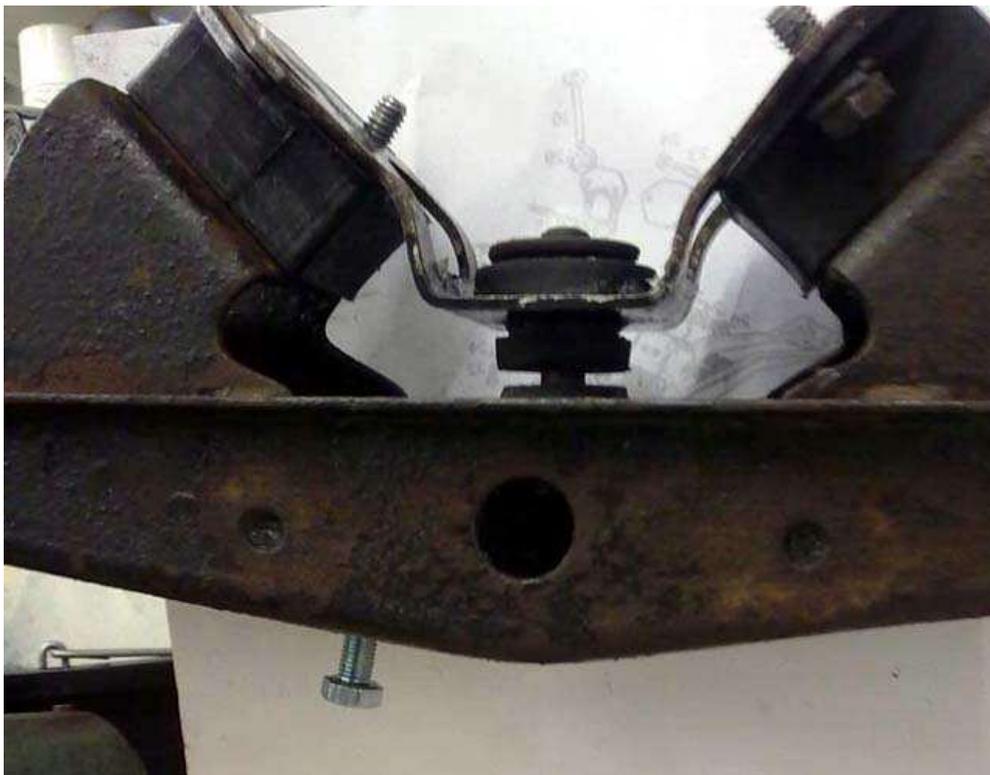
Using longer bolts with a filed point to aid location would be easier than refitting the short original ones, and allows for some wiggle room on re-assembly. Once the assembly was tightened (but before bolting up the cross member) I removed these long bolts one at a time and replaced with short ones. You could leave the long ones in, but the protruding thread will corrode make disassembly more difficult next time!

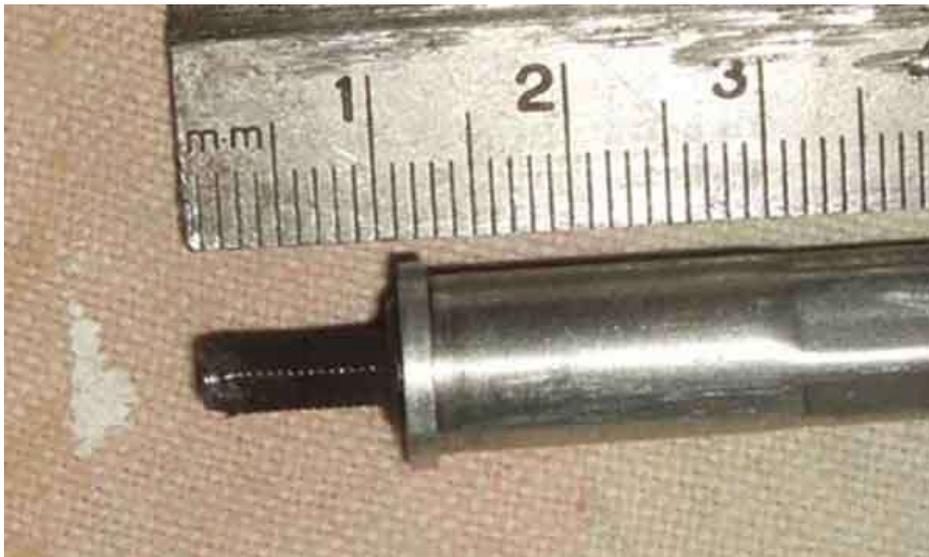
Prior to the 77 model year the inner projects about 10mm and the ferrule sits against the end of the outer flange:

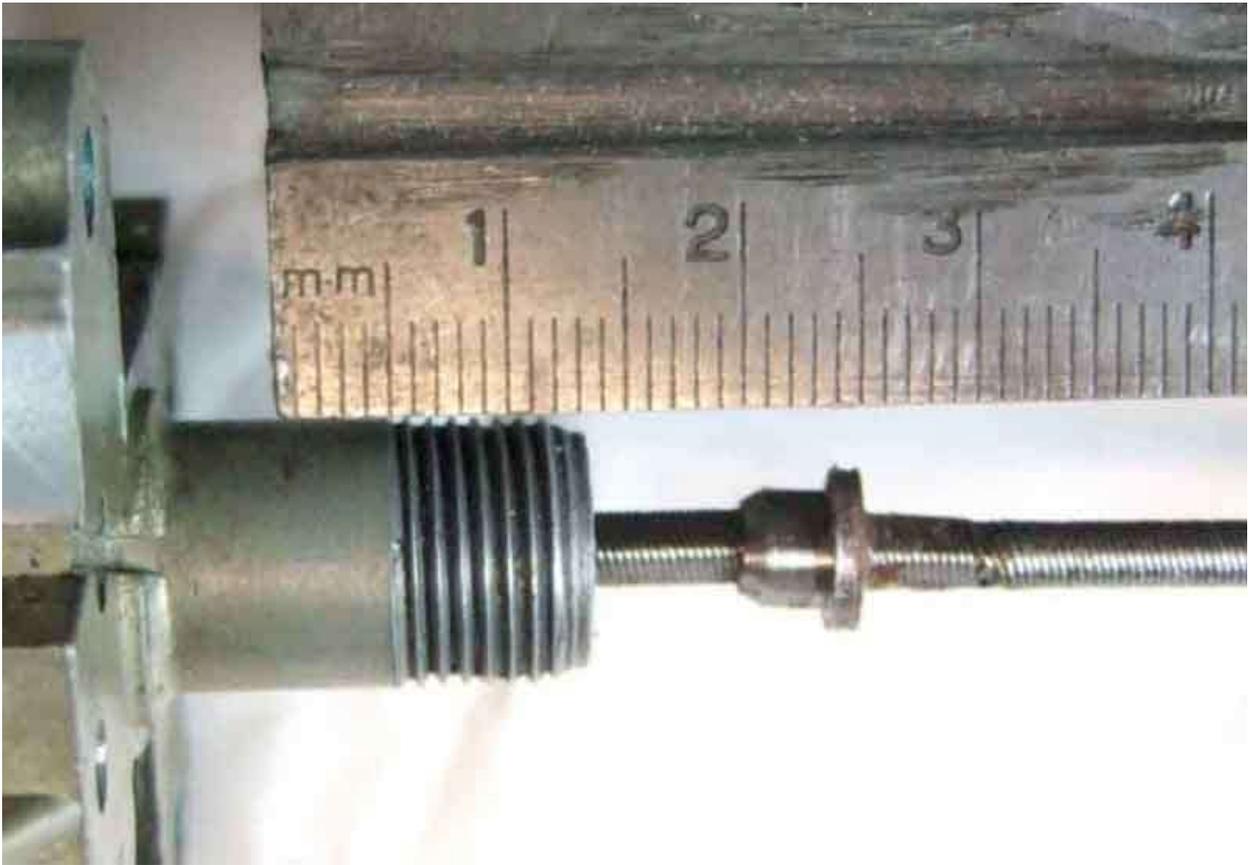
Using the longer 77 and later inner as a 'depth gauge' in a pre-77 speedo you can see that there is about 13mm of depth available inside the speedo fitting. If the inner projects further than that - for example using a 77 and latter inner on an earlier speedo, the inner would be pushing the input shaft into the speedo with some force as the knurled nut on the outer

was tightened, which would almost certainly affect speedo operation. That would be an extreme case, but if slackening the knurled nut cures the problem it would be worth checking the amount of engagement:

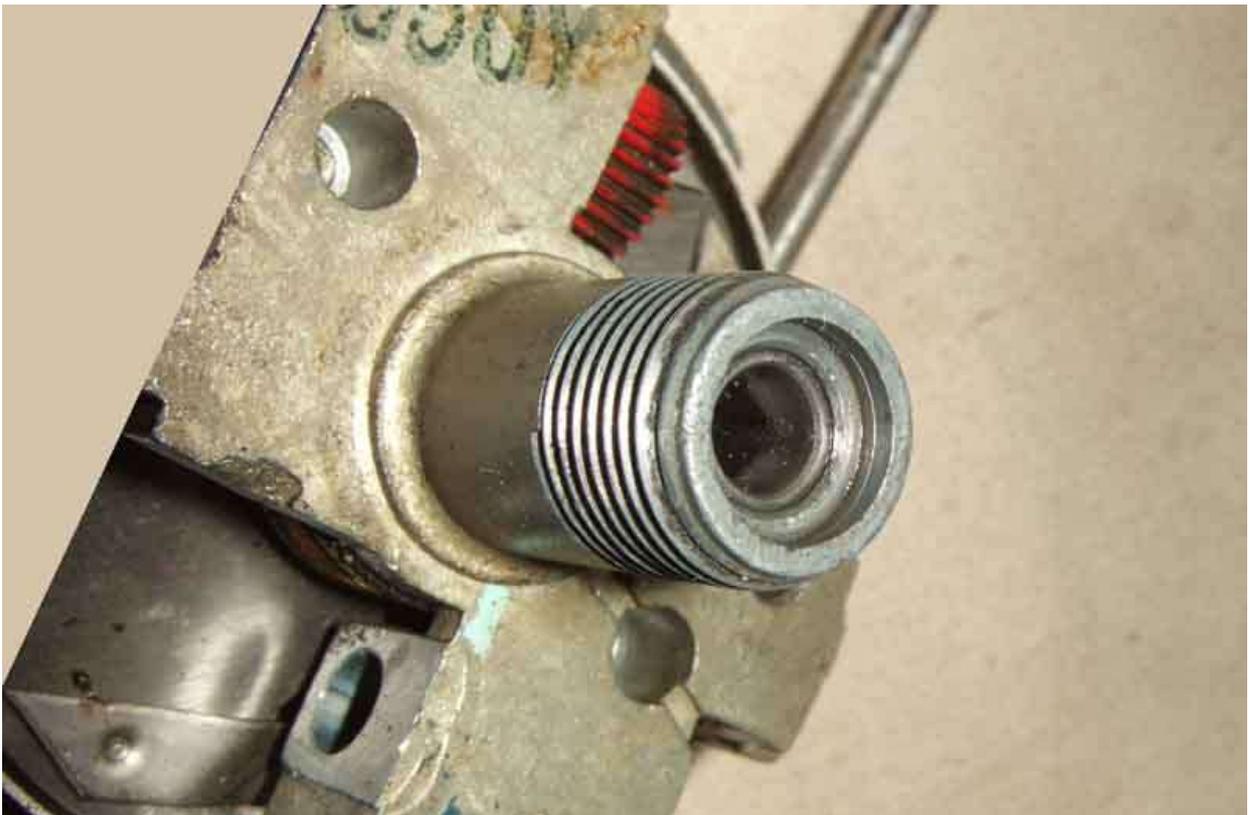
Another potential problem concerns the ferrule in the end of the inner. In the pre-77 cable it projects past the flange on the outer by less than 1mm, and that has to be accommodated inside the speedo fitting or the ferrule will be pushing against the input shaft when the knurled nut is tightened, even though there may be enough clearance for the inner itself. On the corresponding speedo the input shaft is recessed by about 2.5mm, so more than enough:

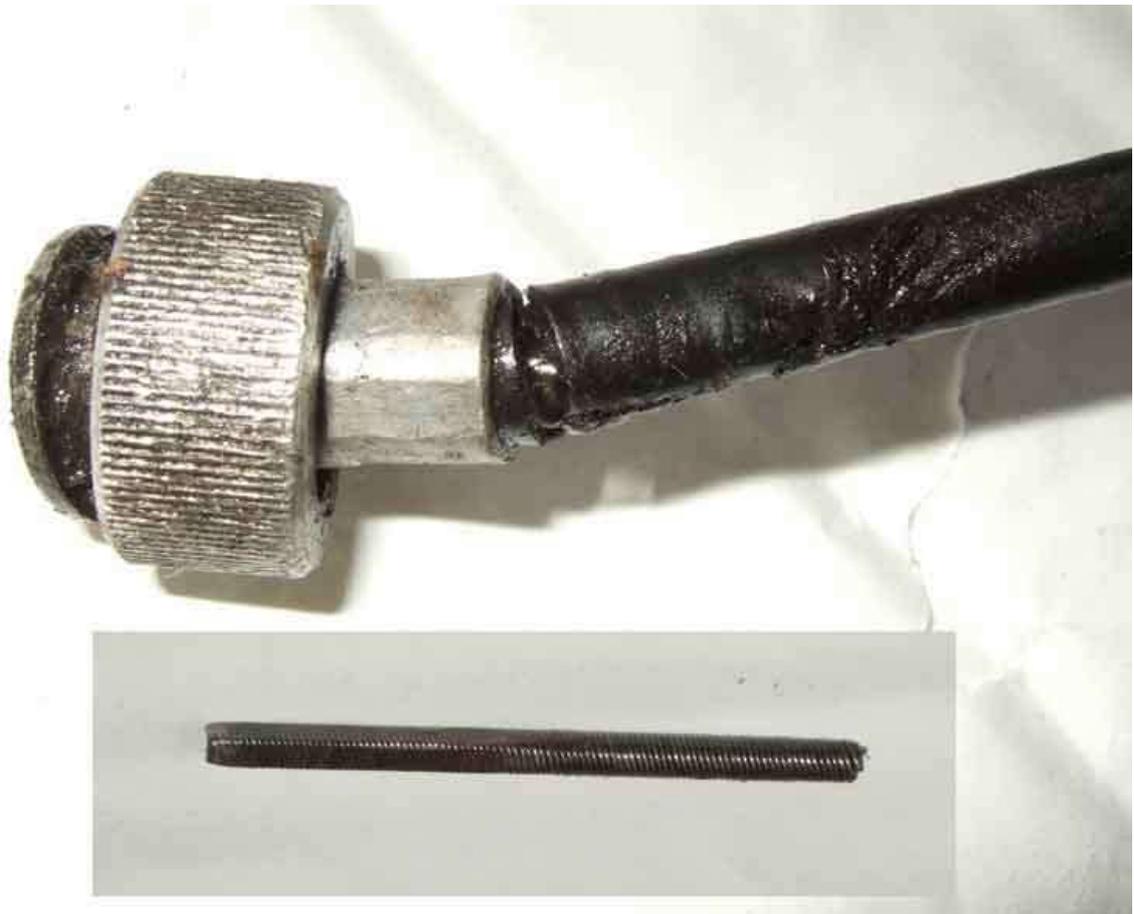
The replacement cable arrives, and one thing I had noticed with the first replacement was that the gearbox end was flattened instead of the square-section I was expecting, and is how all three speedo ends and both broken and 2nd replacement cables are. Left and centre pictures are of the flattened end of the first replacement, the right picture of the 2nd replacement. However I did try the flattened end in the speedo on the bench as a test, the speedo did operate, so probably would have been OK in a gearbox drive:

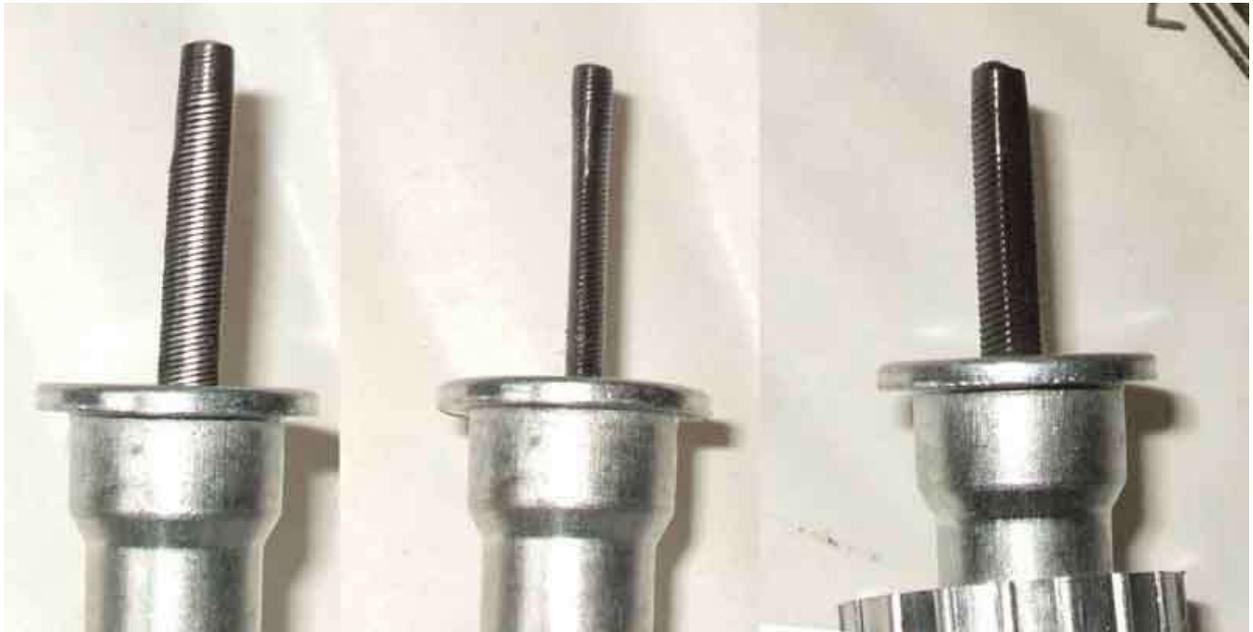
The 'nuts' can vary from cable to cable - finely or coarsely fluted, or knurled, at either or both ends. Someone on the MGO forum posted that on his new GSD117 cable the inner was too long and when fitted to the gearbox the ferrule in the inner at the speedo end protruded and the nut wouldn't reach the speedo, so he chose to cut the excess off the gearbox end, which left it frayed, hardly ideal. His photo also showed the flange at the speedo end as turned over rather than cast, and only just at that looking like it wouldn't take much for it to come out of the nut, unlike the very definite cast stepped flanges on three I have:

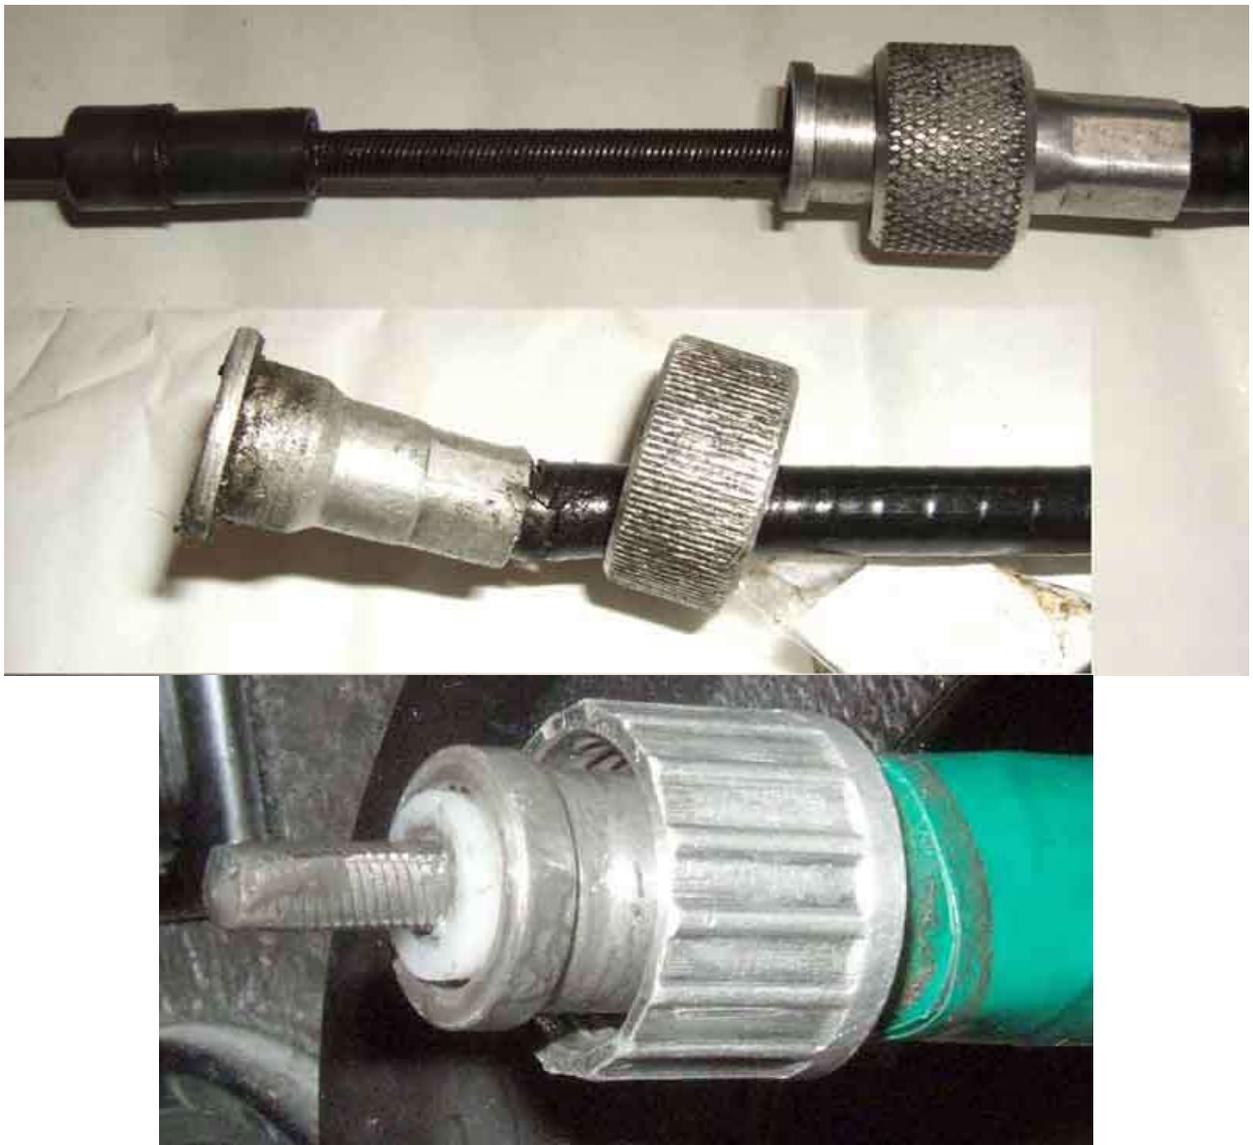
I measured the speedo ferrules of the original and second replacement cables, to find the new one smaller than the original, which was something of a surprise - original on the left, new one on the right. Maybe the 'original', with its 92 date code, was over-size and the hole had been filed out for that to fit. Nevertheless I trial-fitted it from above first and it went in easily:

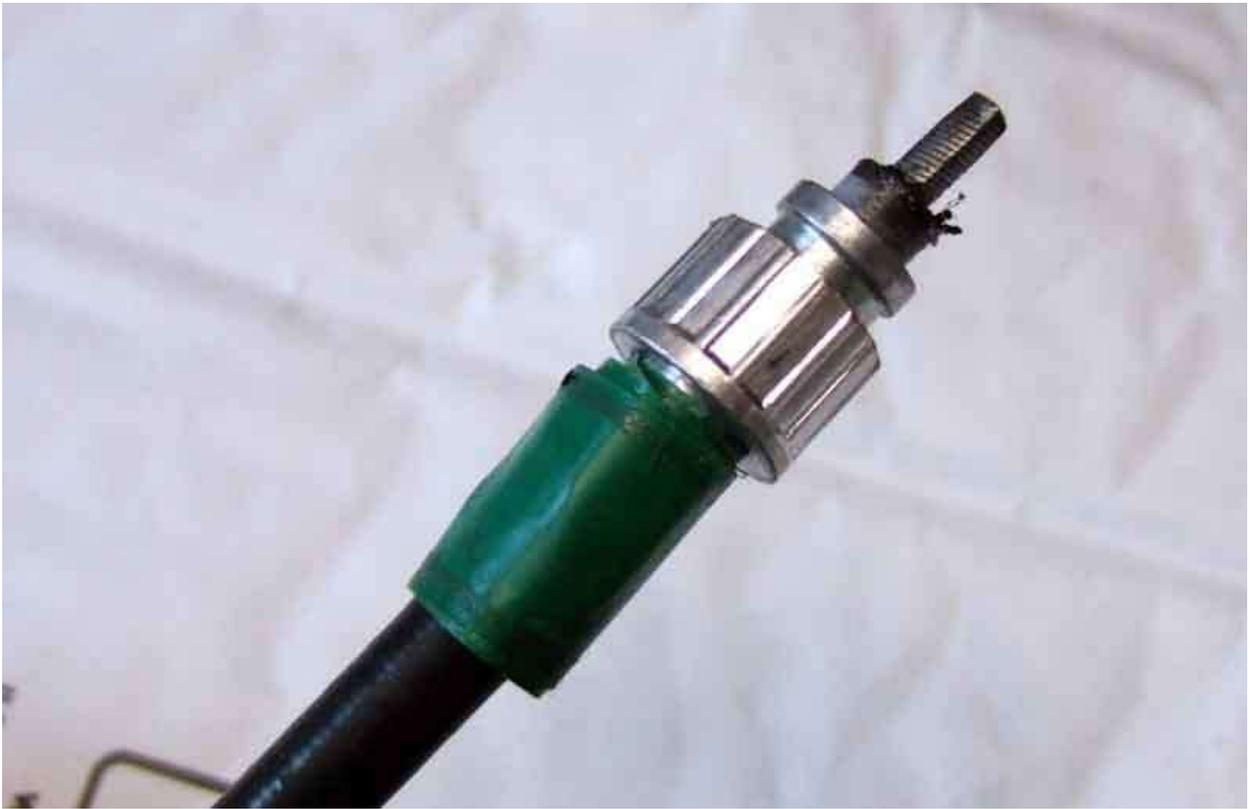
After someone had said it was impossible to get the ferrule up the bulkhead hole while fitting the cable, and he had to push it up with a stick afterwards, I wrapped some tape round the cable to hold the ferrule near the top, and it went through straight away:

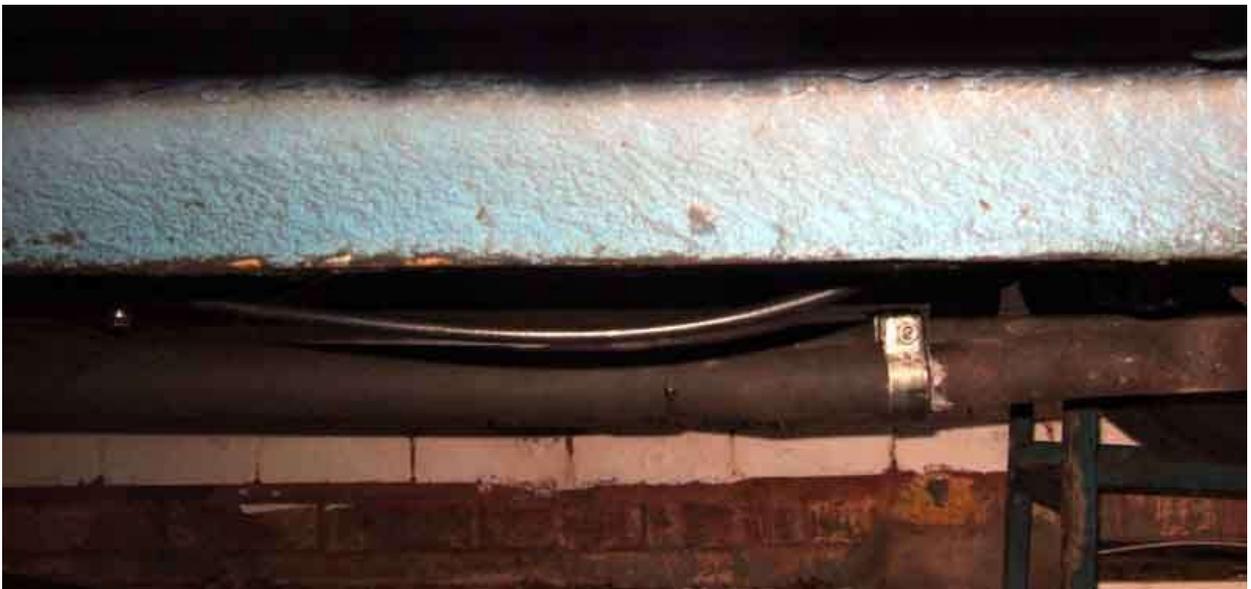
Next job was to clip it to the underside of the removable cross-member, with parts I had to hand. That allowed the forward end of the cable to hang down below the chassis rail:

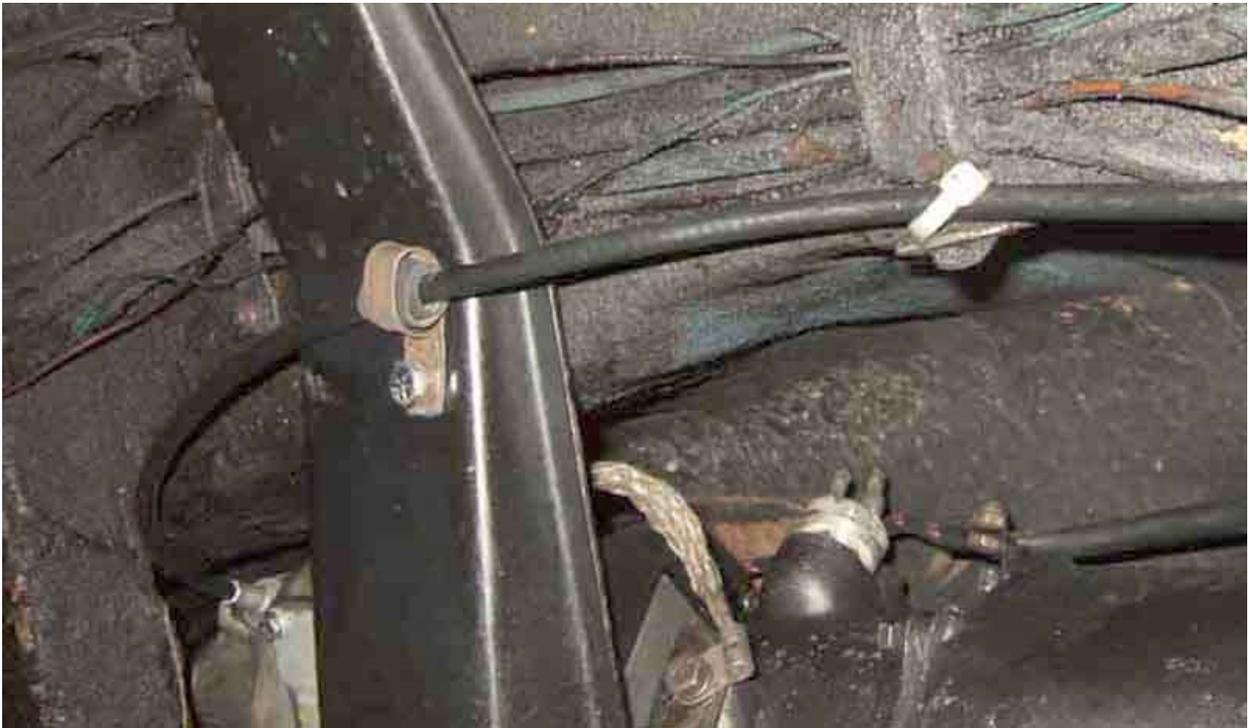
So I used a cable-tie to hold it up out of the way. The cable now makes a smoother exit from the gearbox than previously. Note this shows the gearbox earth strap in the 'correct' position as shown in the manuals - right-hand side front:

I wasn't aware there was a pukka fitting for this originally so hadn't ordered one with the cable, but it is clip PCR809 with split ferrule ACH8529. Even that isn't straightforward as the Parts Catalogue specifies PCR809 for RHD where overdrive is not fitted, and AHH7178 for RHD with overdrive, but not V8. I've not found a picture of this to compare. Later on it says LHD from May 72 and all V8s use PCR809. Clausager says North America got modified speedos and cables from that date, implying V8s had the same and later cable, but the Parts Catalogue shows the V8 cable GSD116 being used for RHD OD cars from the beginning of production. All very confusing.

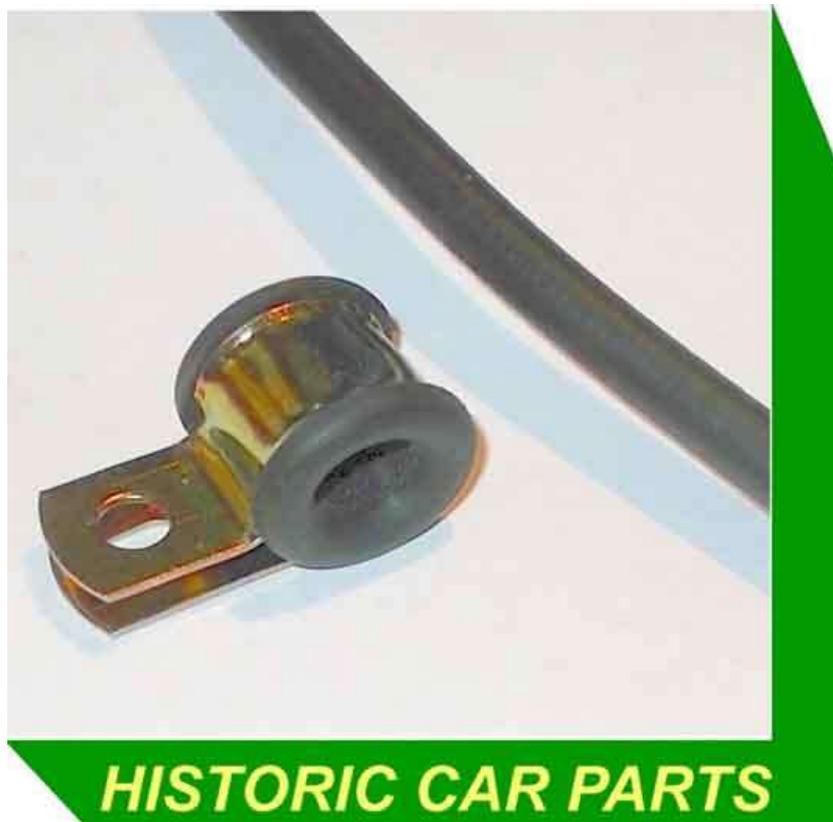
Looks like the same support is used on the side of the tunnel as the cable comes up to enter the cabin:

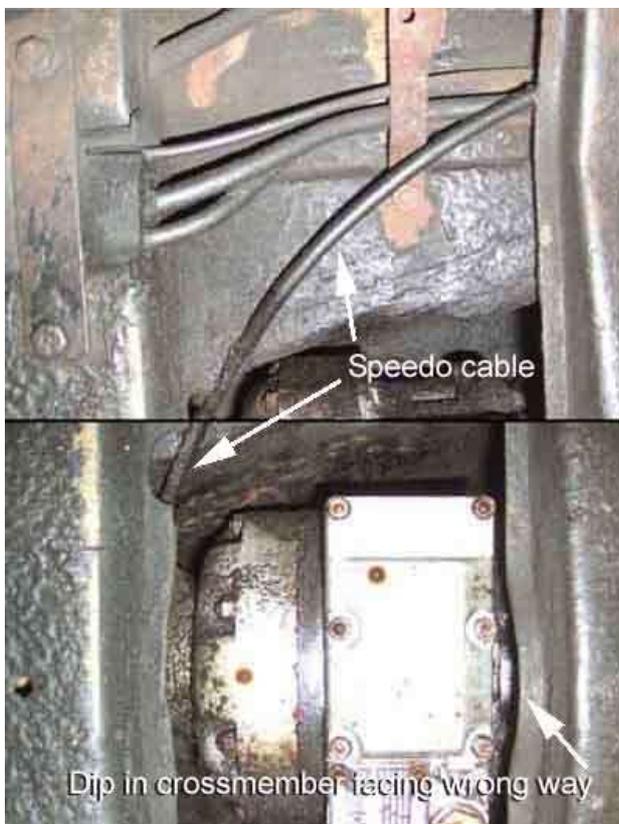
On my 73 roadster the cable (arrowed) comes off the output of the OD conveniently (not!) above the fixed crossmember then turns forwards and under the floor to meet the pipes and cables running the length of the floor, and over the removable crossmember. The notch in the fixed crossmember shows that the cable is designed to exit at right-angles to the gearbox, and then turn forwards. The 1964 3-synch non-OD car pictured in Clausager (p76) does not have this notch.

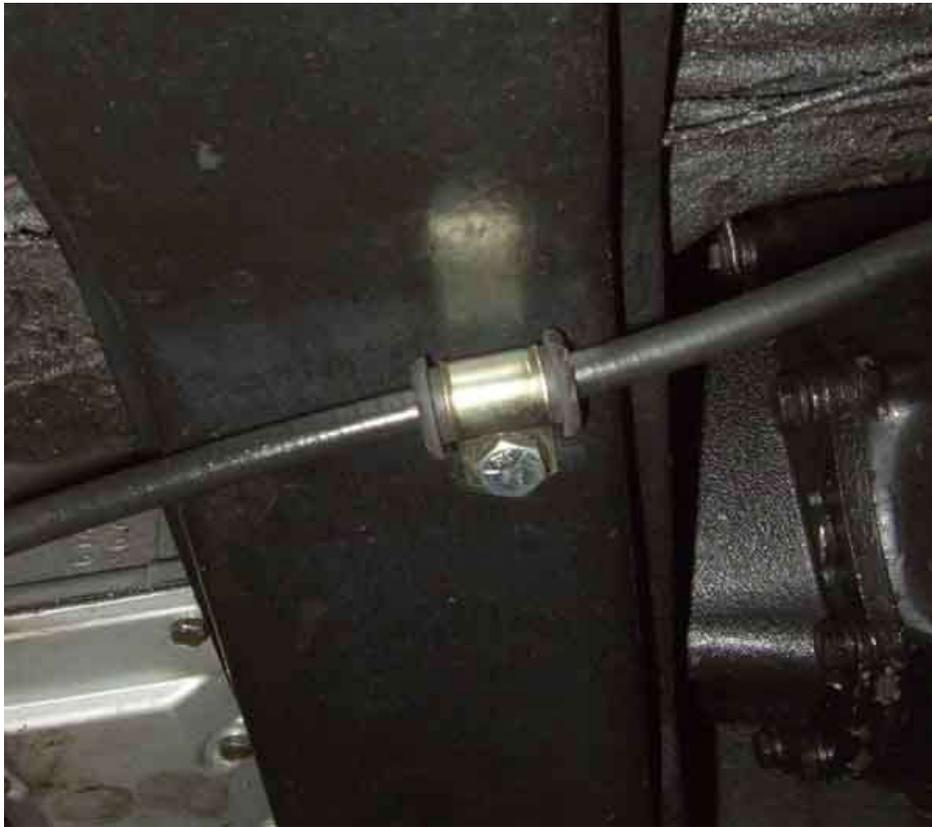
The speedo cable should pass below the crossmember and be supported with a P-clip and split ferrule in a tapped hole:

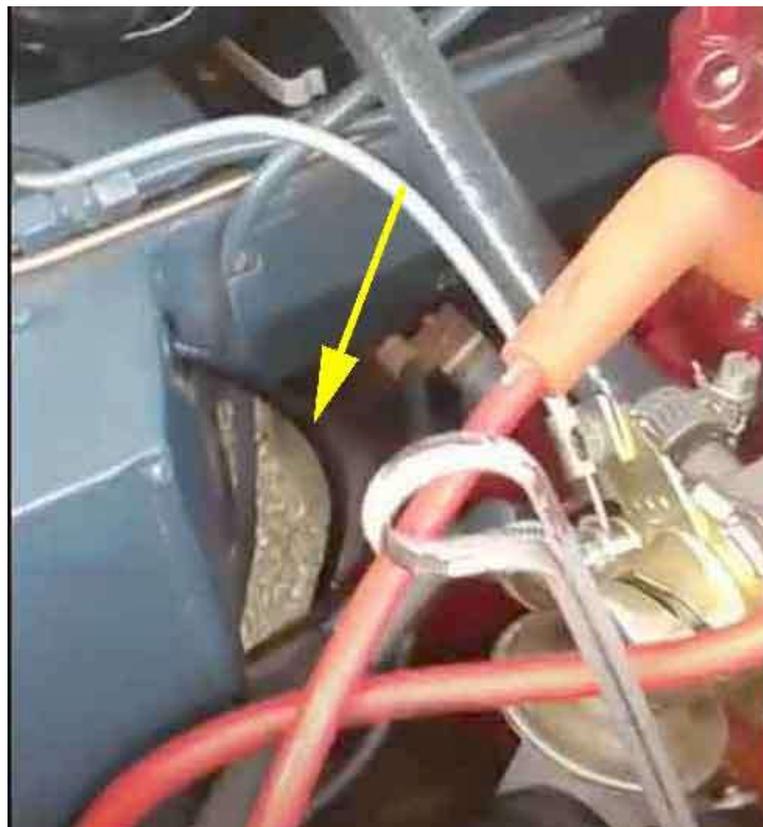
On a 1970 LHD the cable enters the cabin via the hole on the side of the tunnel ... (Bill Etter)

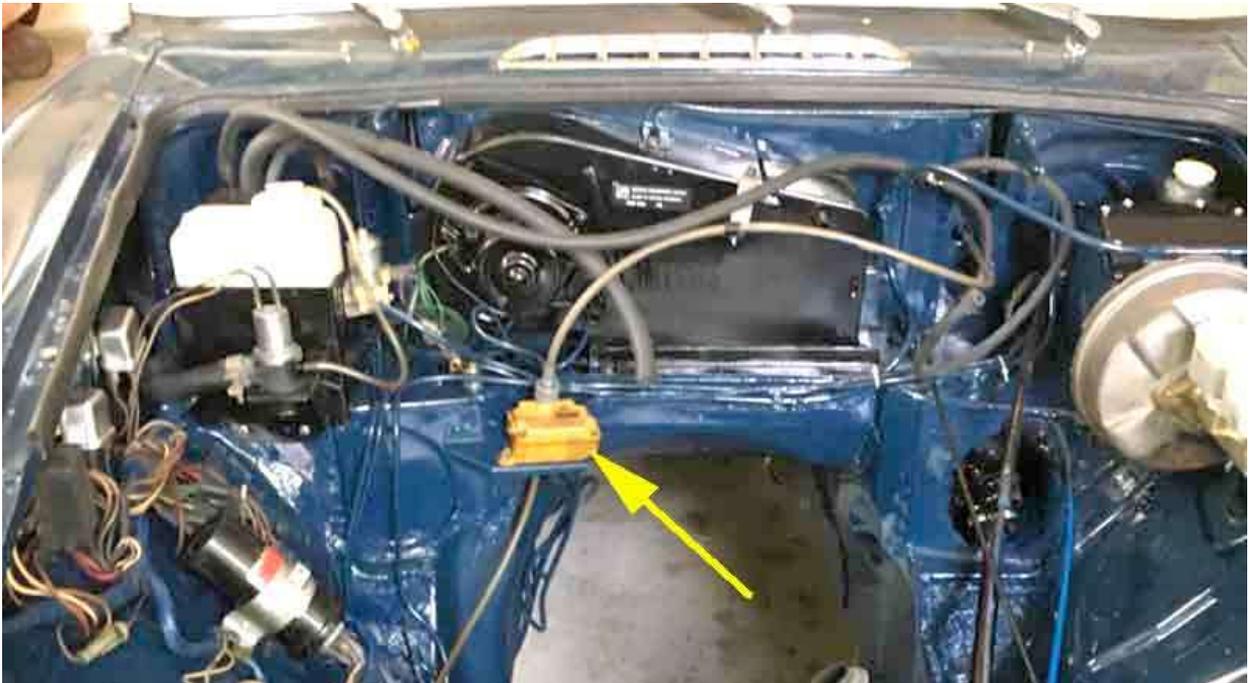
1976 with EGR service counter (arrowed). Note the bracket attaching the cable to the top of the heater casing, my 75 V8 has that stud and I always wondered what it was for: *(Bill Etter)*

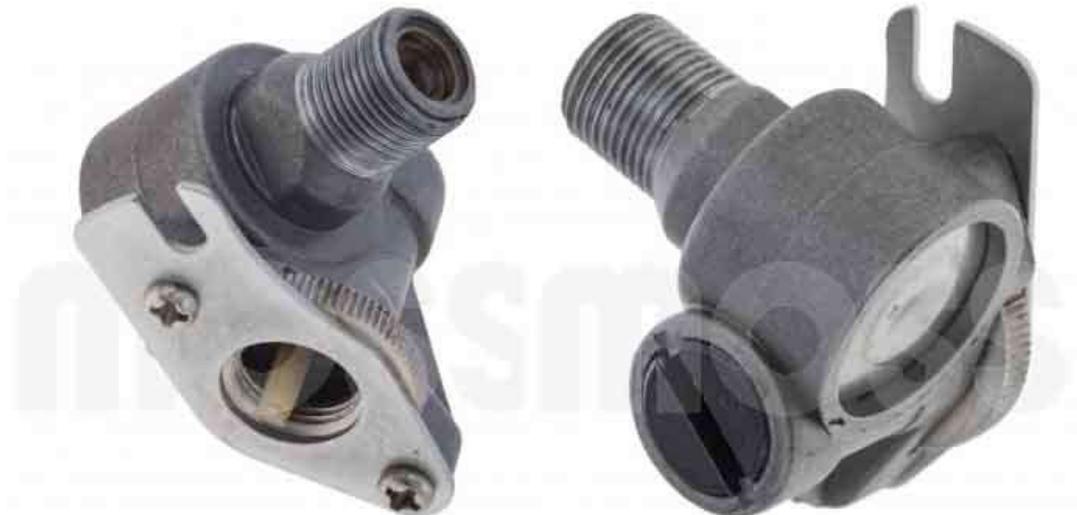
Speedo end - this has a bracket for mounting to the back of the speedo, and a knurled wheel to screw it on. Clausager says this was deleted in May 72, when the cable was run across the bulkhead behind the engine ([Moss Europe](#))

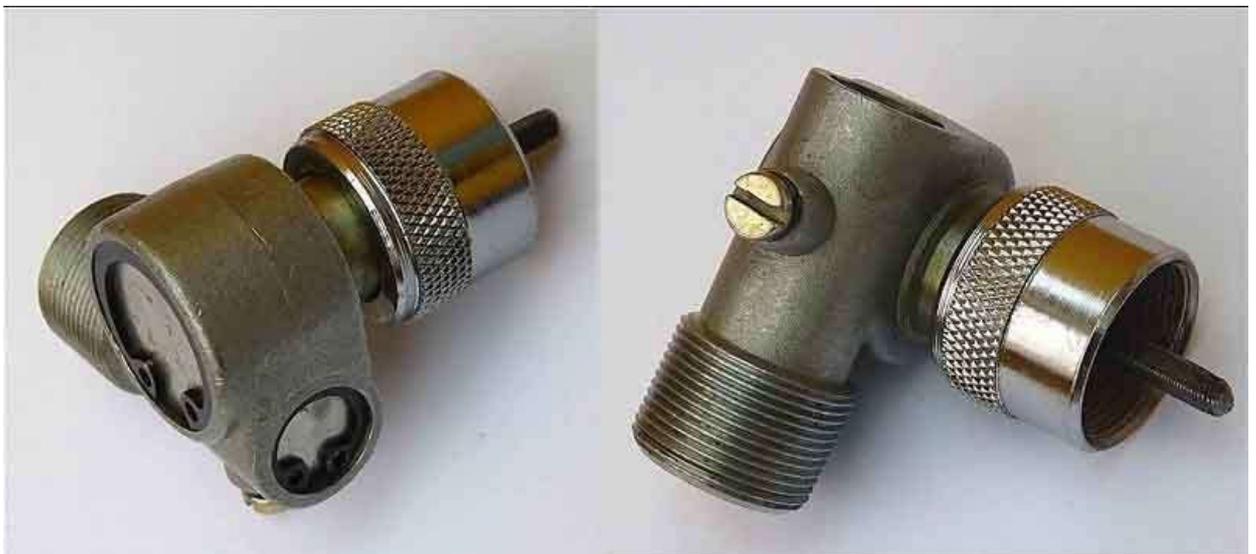
Gearbox end: ([eBay](#))

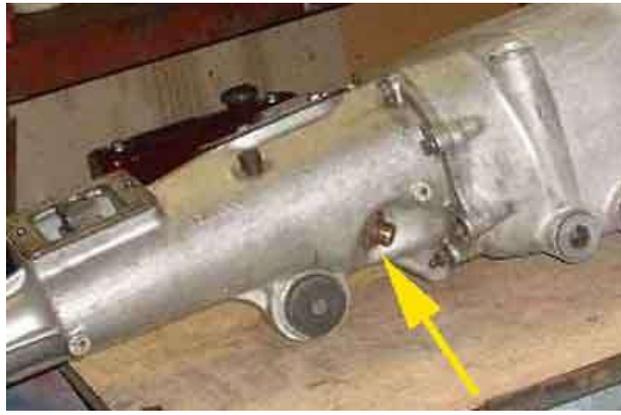
Four-synch non-OD: Close to the wider part of the main gearbox casing and bellhousing, also angled forwards, which means a right-angle drive can only be fitted if the cable leaves it virtually straight up or straight down. Without the right-angle drive the cable will already be pointing forwards by a significant amount, the remainder of the curve forwards can be accomplished under the floor ahead of the removable crossmember to meet the other pipes and cables: (*Chicagoland MG Club*)

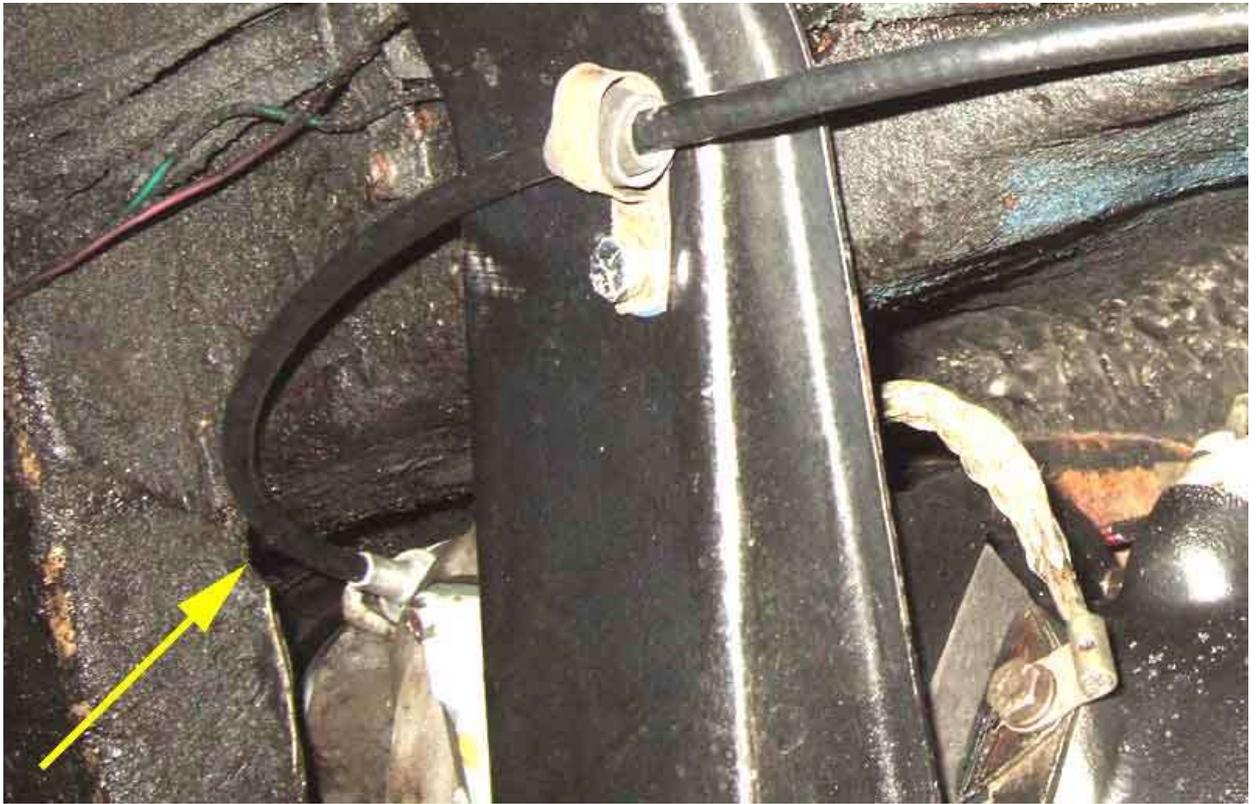
Automatic: Exits at right-angles so would benefit from the right-angle drive as per the 3-synch boxes:

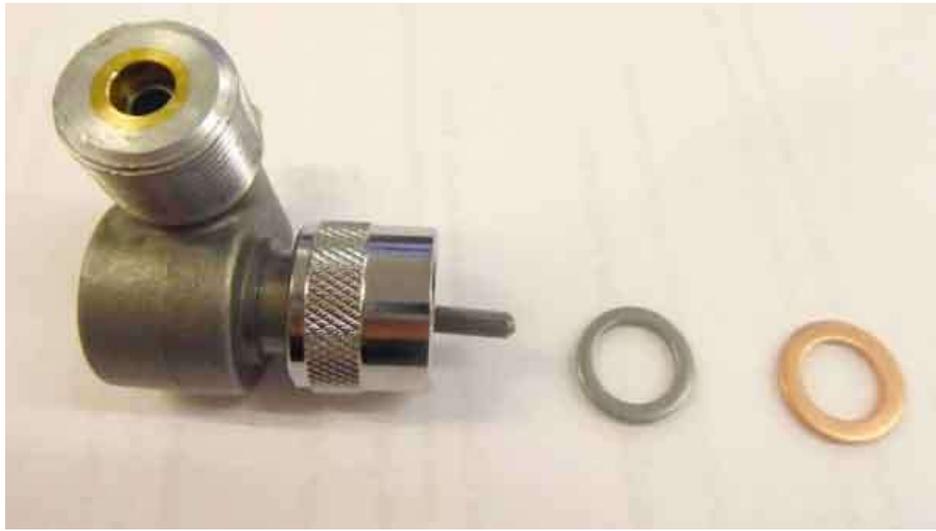
The copper washer 3H550 is shown in this image from [Brown & Gammons](#). It also shows a 'silver' washer but doesn't discuss it, although mentioned elsewhere are one or two O-ring oil seals that also fit into the angle-drive:

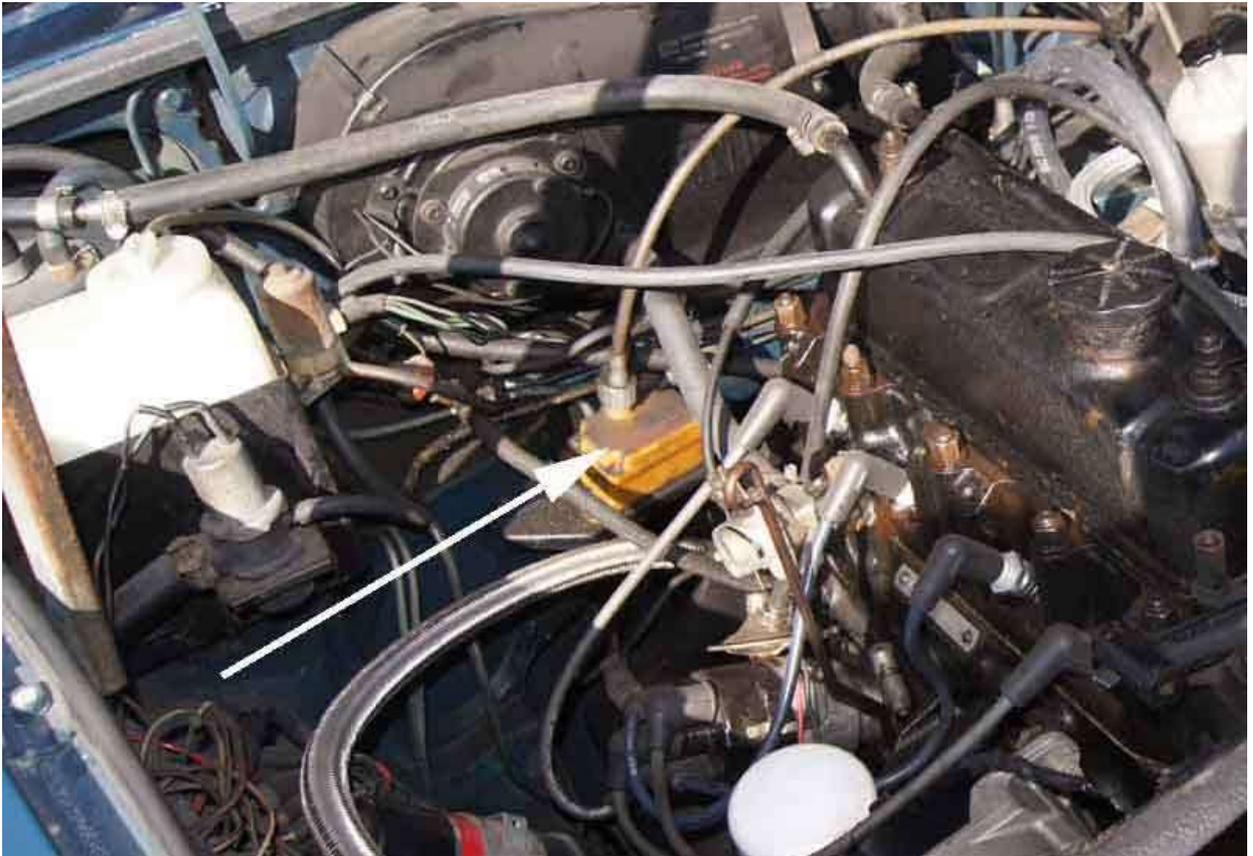
The EGR valve service indicator counter: *(Bill Etter)*

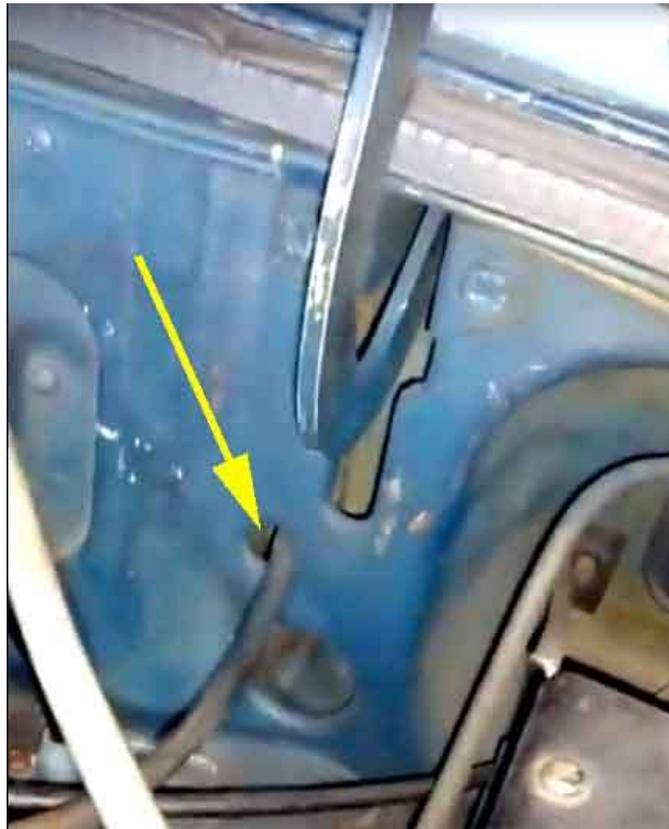
From the EGR counter the cable goes across the bulkhead and through in front of the speedo, so a right-angle drive is not required: *(Bill Etter)*

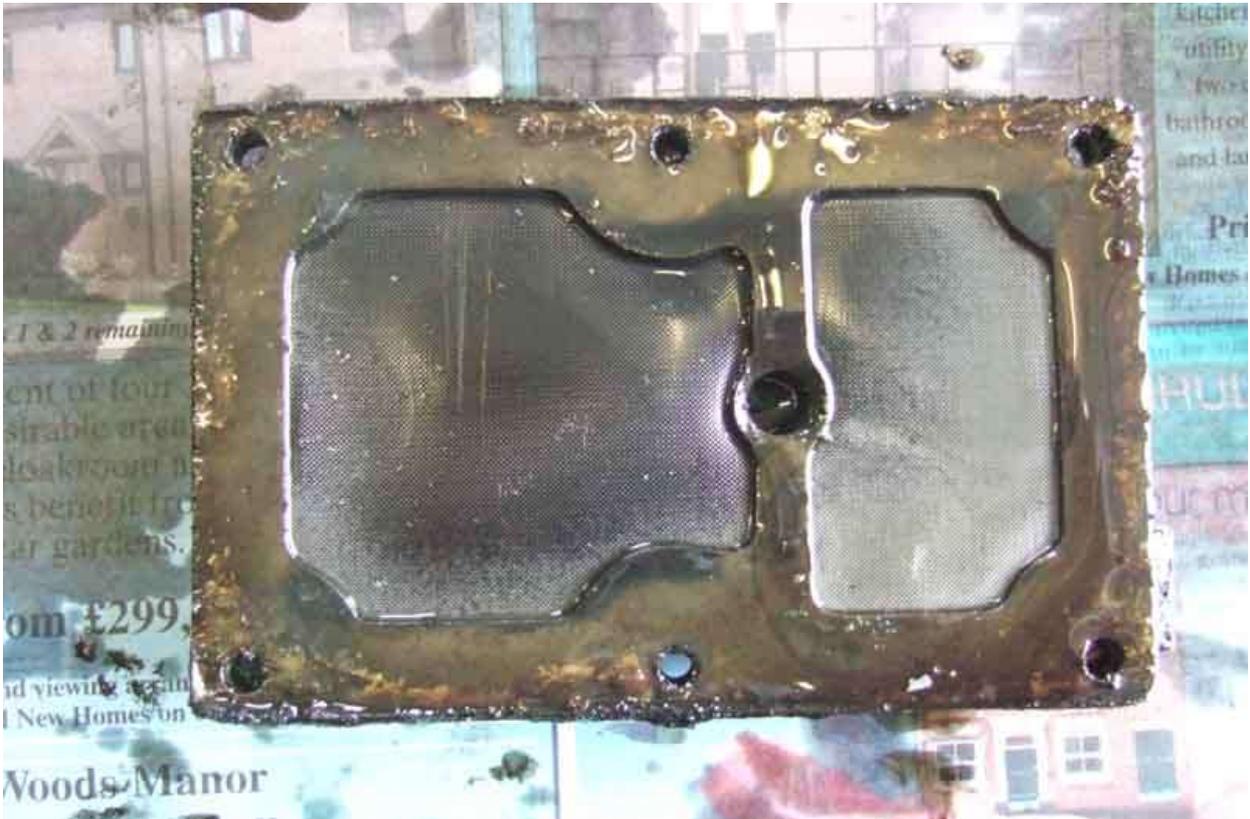
Sump and all the relief valve and filter components from the roadster. The V8 didn't have the coarse screen shown here, may have been left inside. I found all the shims between the valve plunger and the spring, increasing overall thickness

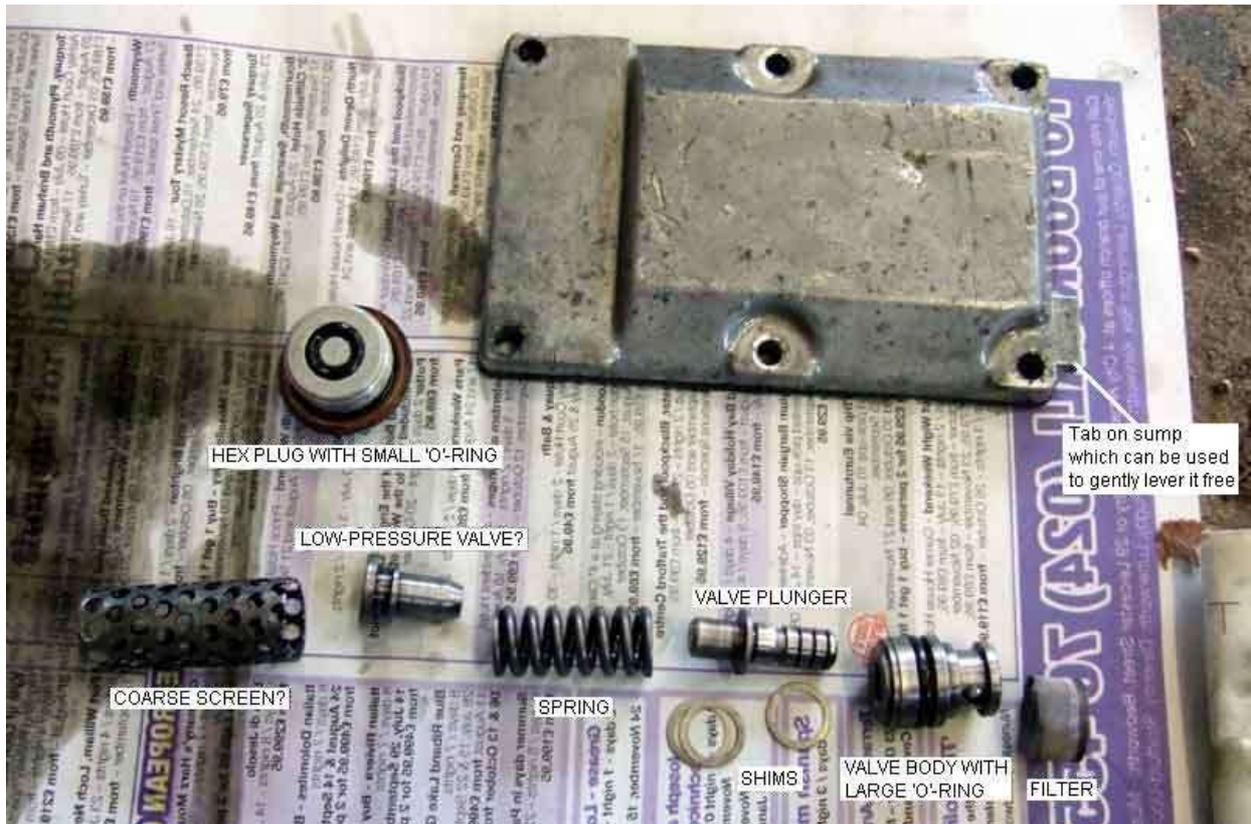
From the original Leyland and Laycock Workshop Manuals. However whilst the 'low-pressure valve plug', 'valve spring' and 'valve ball' at the upper left are shown in both those and the Parts Catalogue and Haynes I didn't find them in either of my cars. Note that the selective shims are shown at the upper end of the spring, not the lower end as I found in both mine, but it makes no difference:

Subsequently information from Overdrive Repair Services in Sheffield is that the plug, spring and ball are pressed into the low-pressure valve body so would not normally be separately visible in routine servicing.
