Mk1 or Mk2?

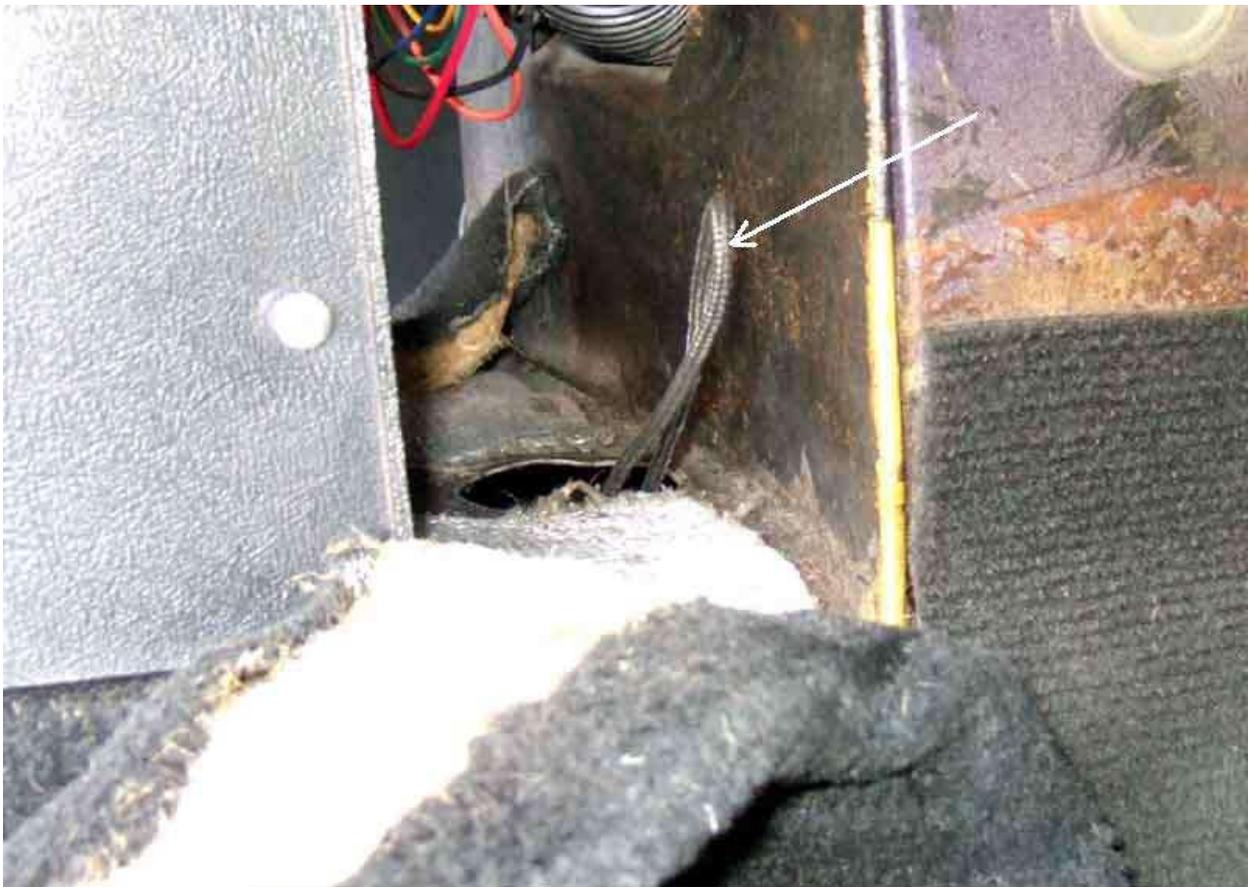
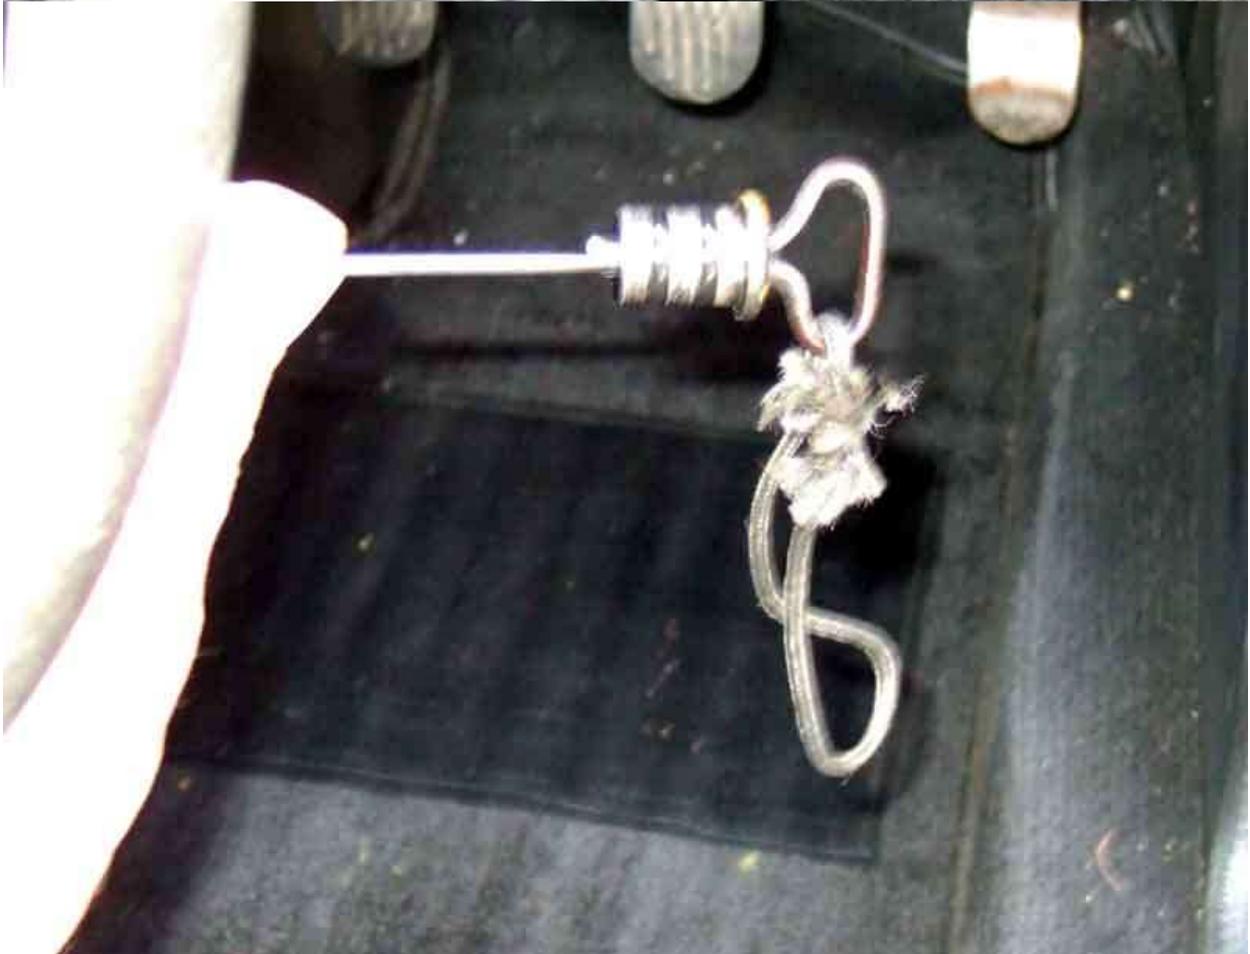
Loop of cord on the dipstick to aid removal:

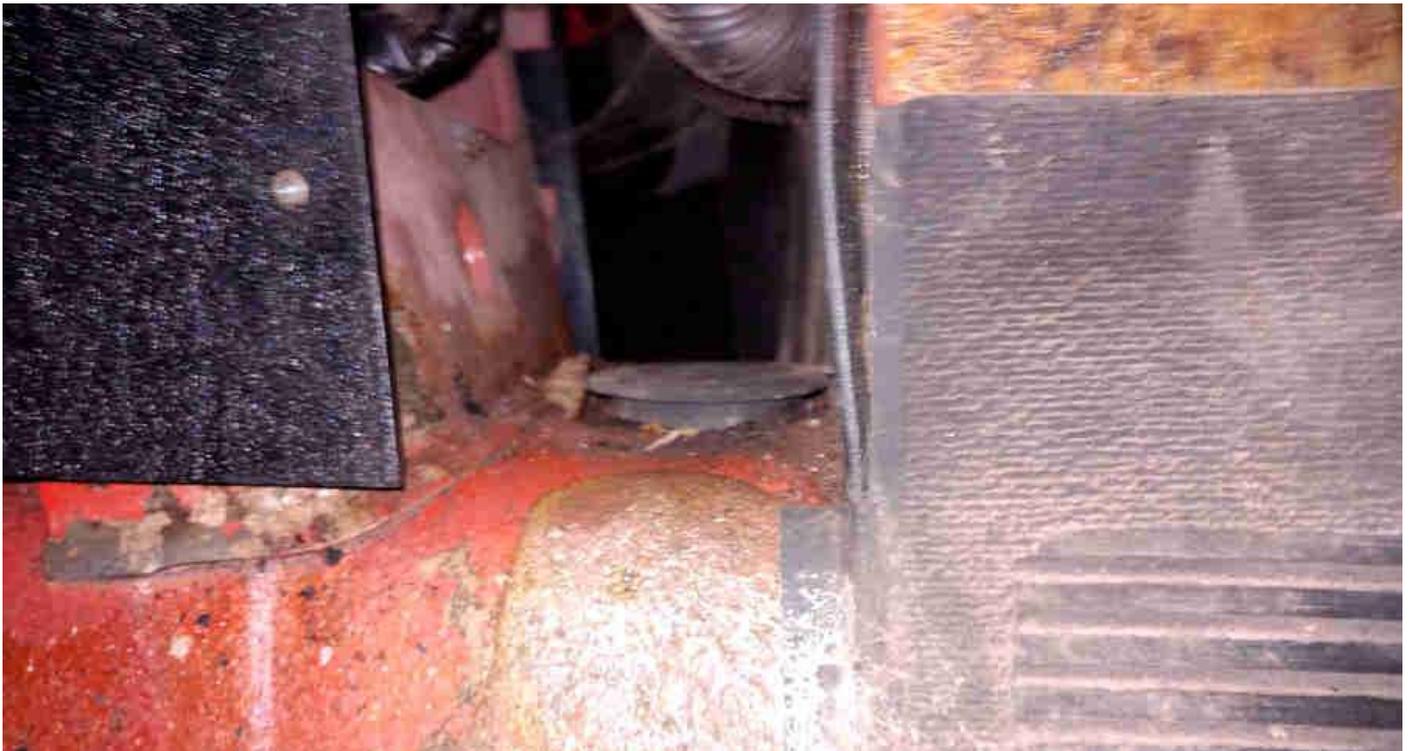
Note that the bung is still present on rubber bumper cars with the side-fill gearbox and some have said they use that hole to feed a tube through to the side fill for filling/topping-up. Others have said either that theirs doesn't have it, or the console is different and you can't access it, but not going by this 78:

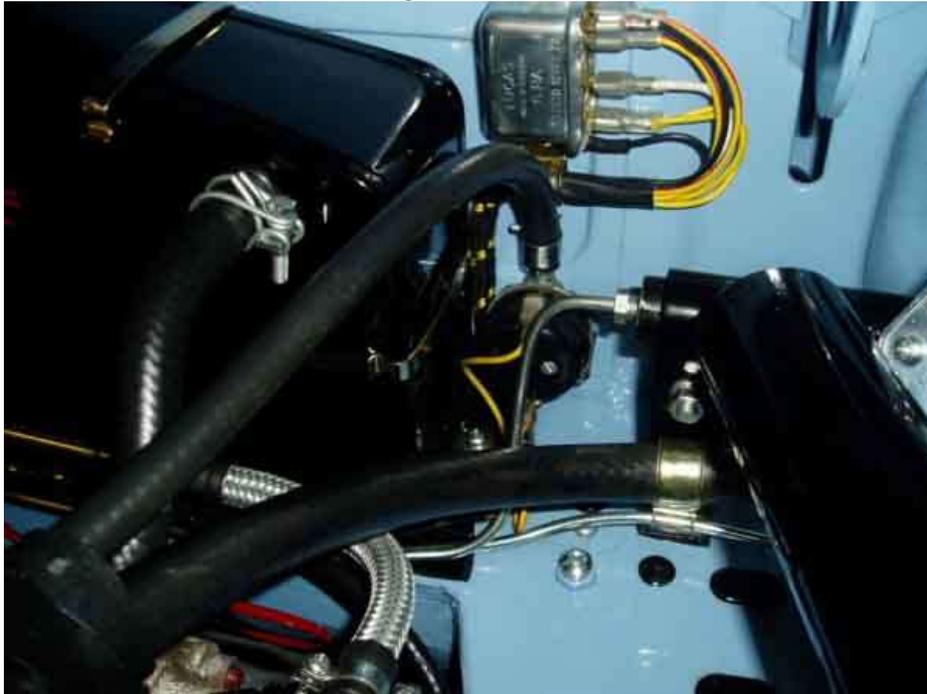
Overdrive relay location, with vacuum switch below, image from Ste Brown, West Yorkshire, UK:

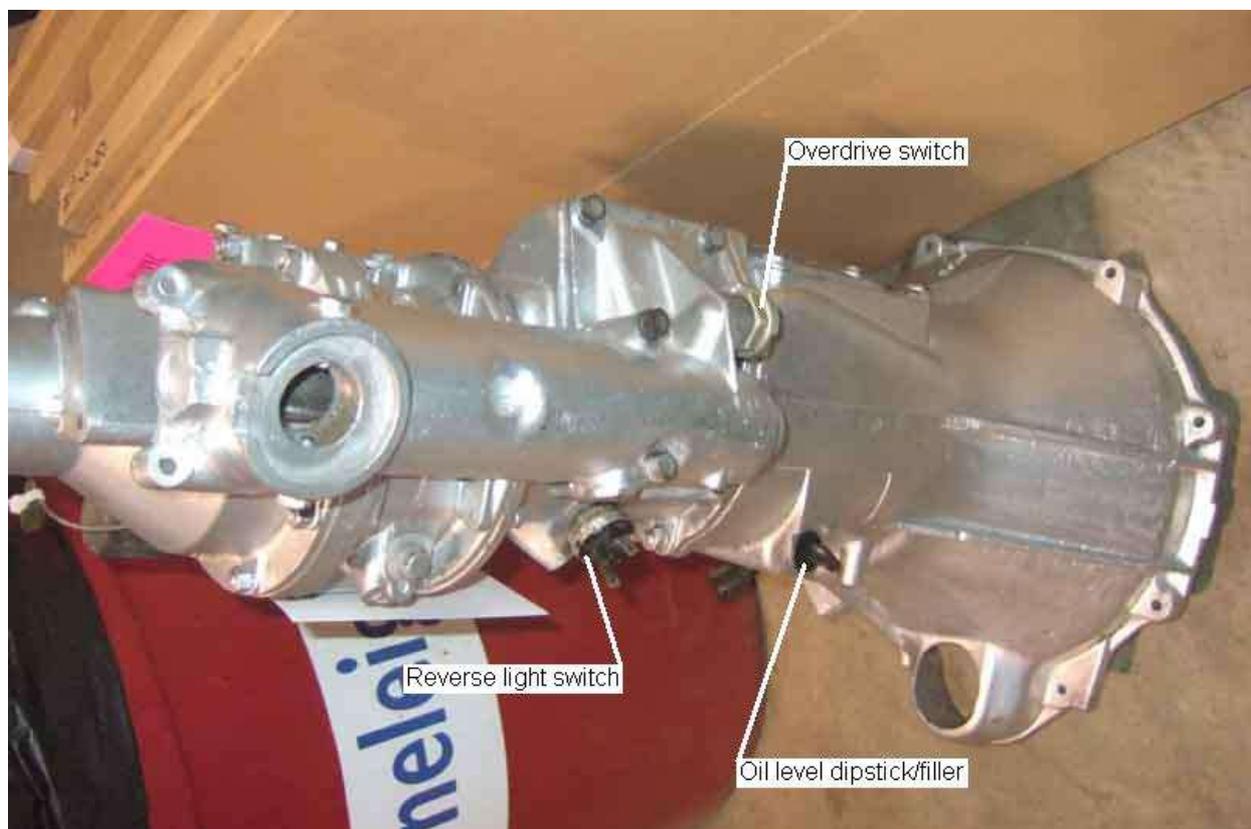
Showing the large access panel on top of the 3-synch tunnel (left), as opposed to the small one on the 4-synch. This should be enough to get at both the OD and reverse light switches on the 3-synch, whereas on the 4-synch the rear crossmember and back of the gearbox has to be dropped as well. *Image from [Moss Europe](#)* Incidentally the 4-synch removable panel is shown the wrong way round by Moss with the hole for the gear lever at the front, it is towards the rear as shown here.

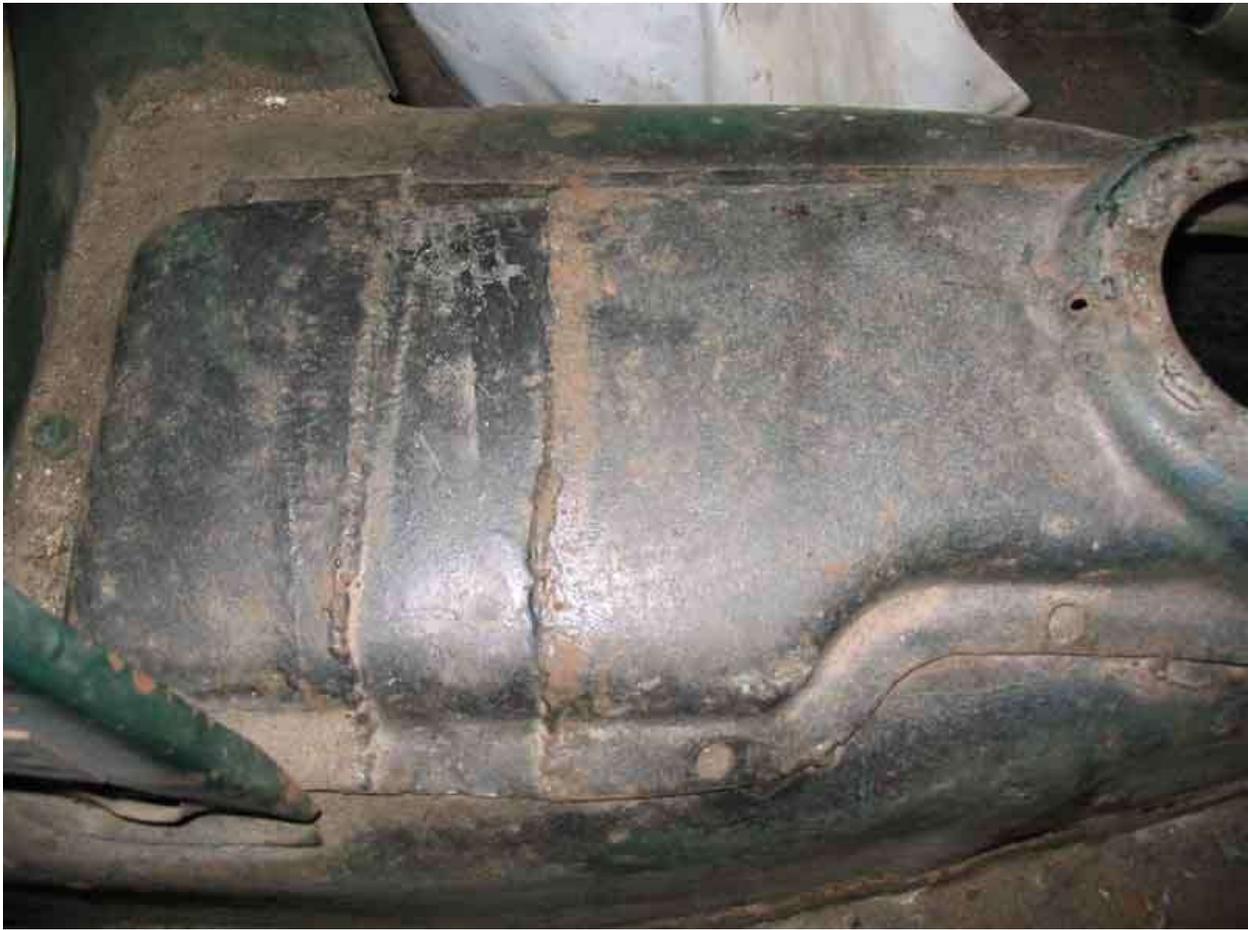
3-synch: The main reason for this picture was to show how the cover is moved backwards when a 4-synch gearbox is fitted to the earlier car. You can see the screws in the forward section, and the holes in the rear section which were for the remainder of the screws originally, but has been tack-welded in place.

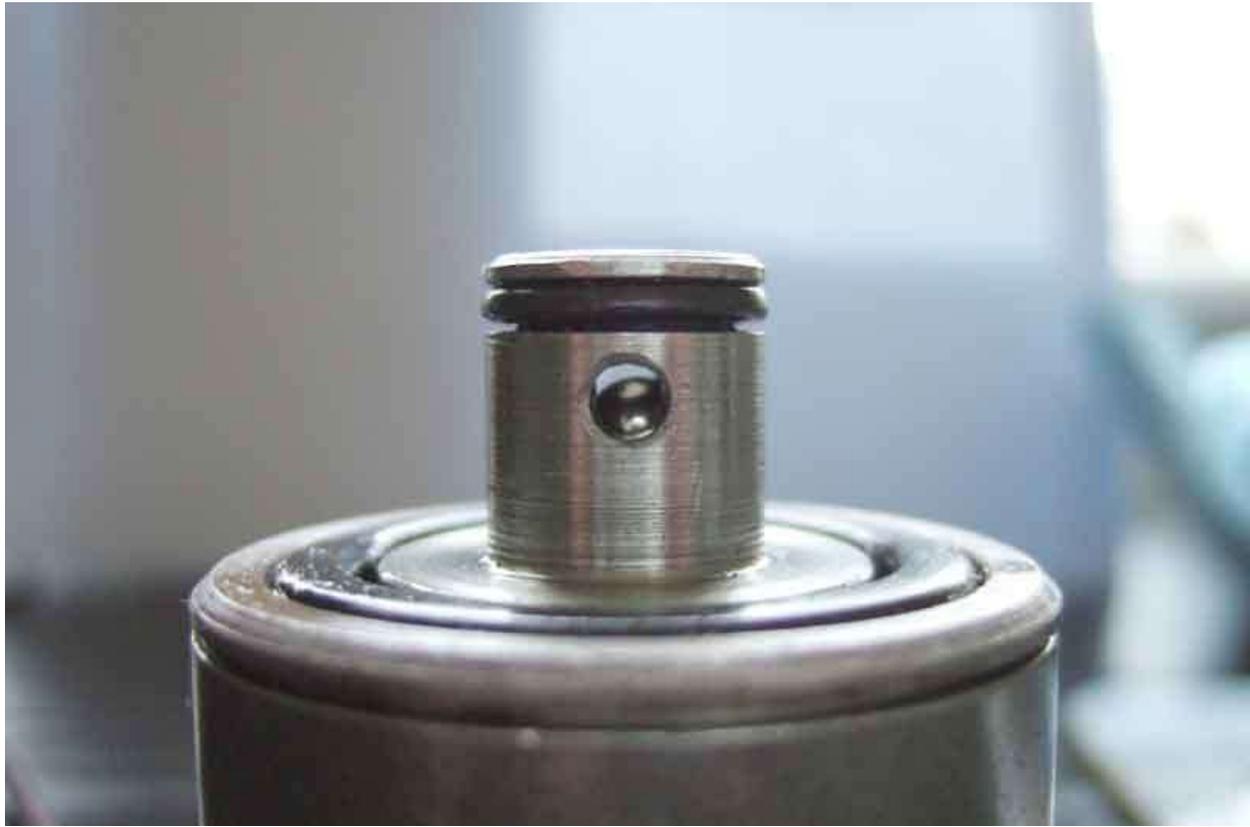
In the released position the ball and plunger should be pushed back so releasing oil pressure. If it doesn't move back far enough there may be enough residual pressure to prevent the operating pistons and clutch sliding member moving fully back from the annulus to the outer casing so it can't fully engage direct drive. While the clutch sliding member is between the two there is no engine braking (you still have drive as until OD is fully engaged the one-way clutch is bypassing the slipping clutch). However the plunger comes back at least 2mm when the solenoid is released, giving a clear path through the valve, as can be seen here.

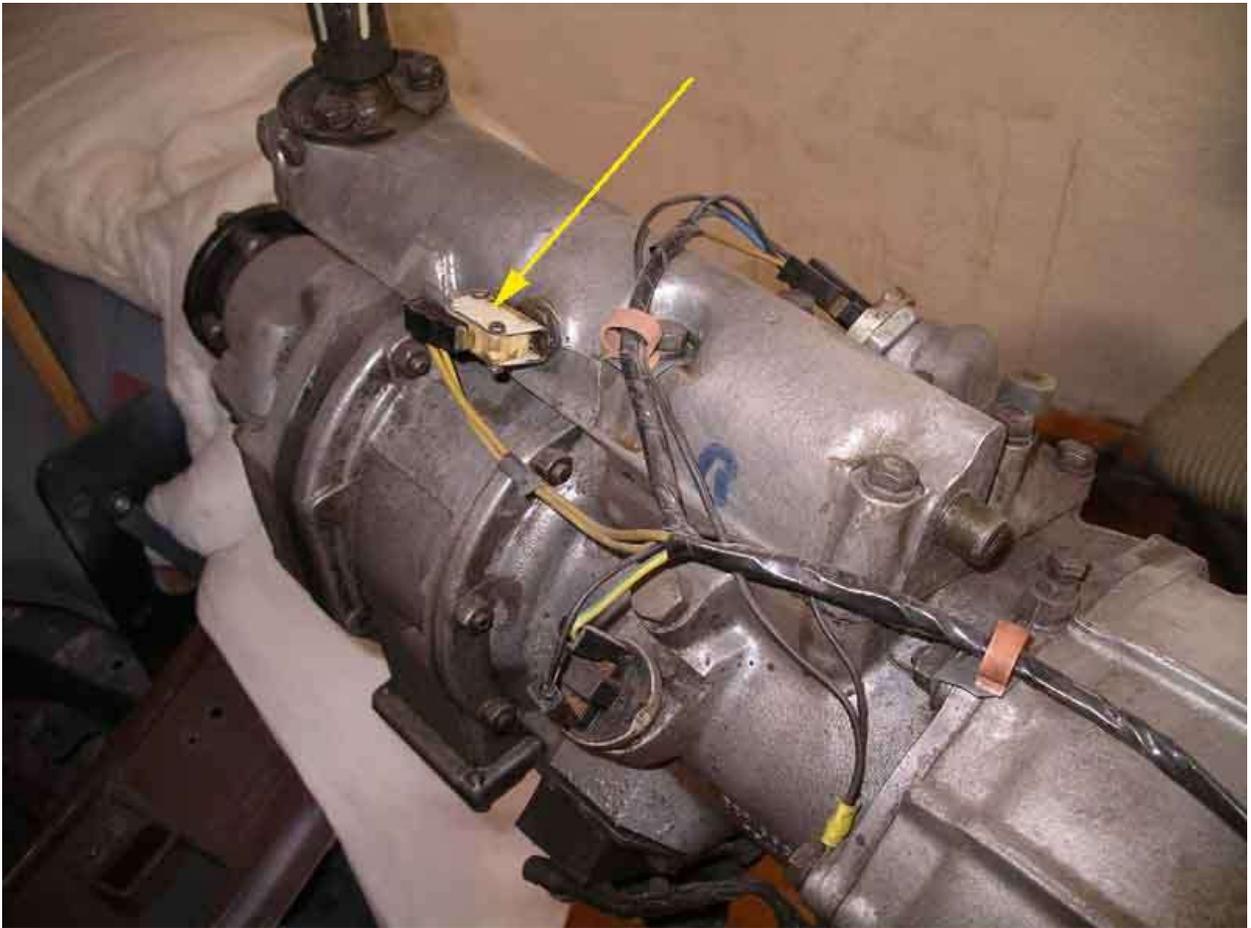
In your picture of the gear box switch positions the anti rattle plunger holder can be seen mid way along the gear lever extension casting (arrowed below). The plunger, now with a ball bearing in the end & pressing on the selector shaft, trips a micro switch (mounted on the plunger holder) when passing a very small depression cut in the shaft.

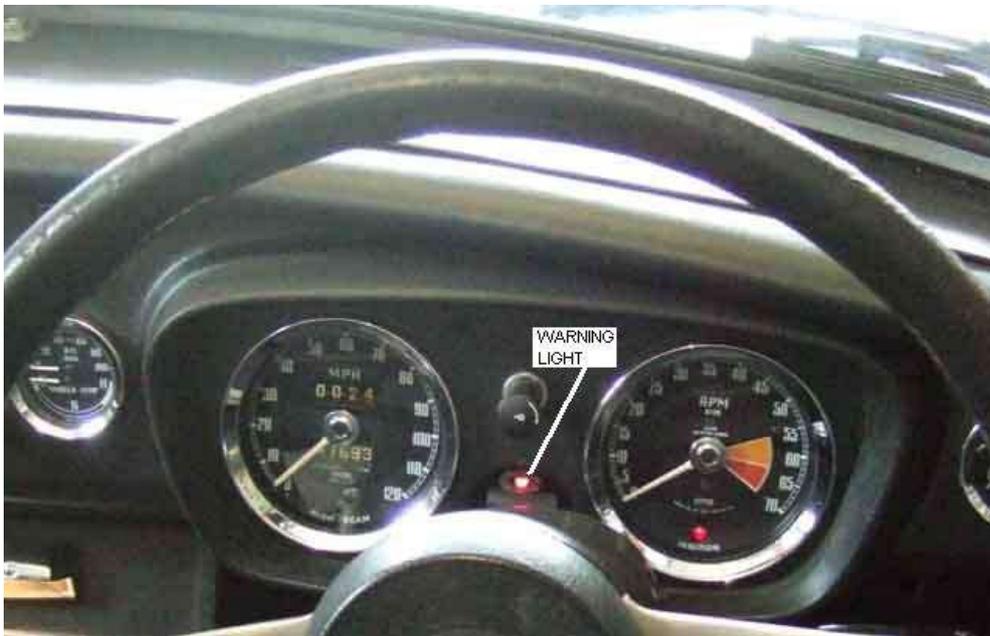
Warning light fitted in a convenient space between steering column and dash

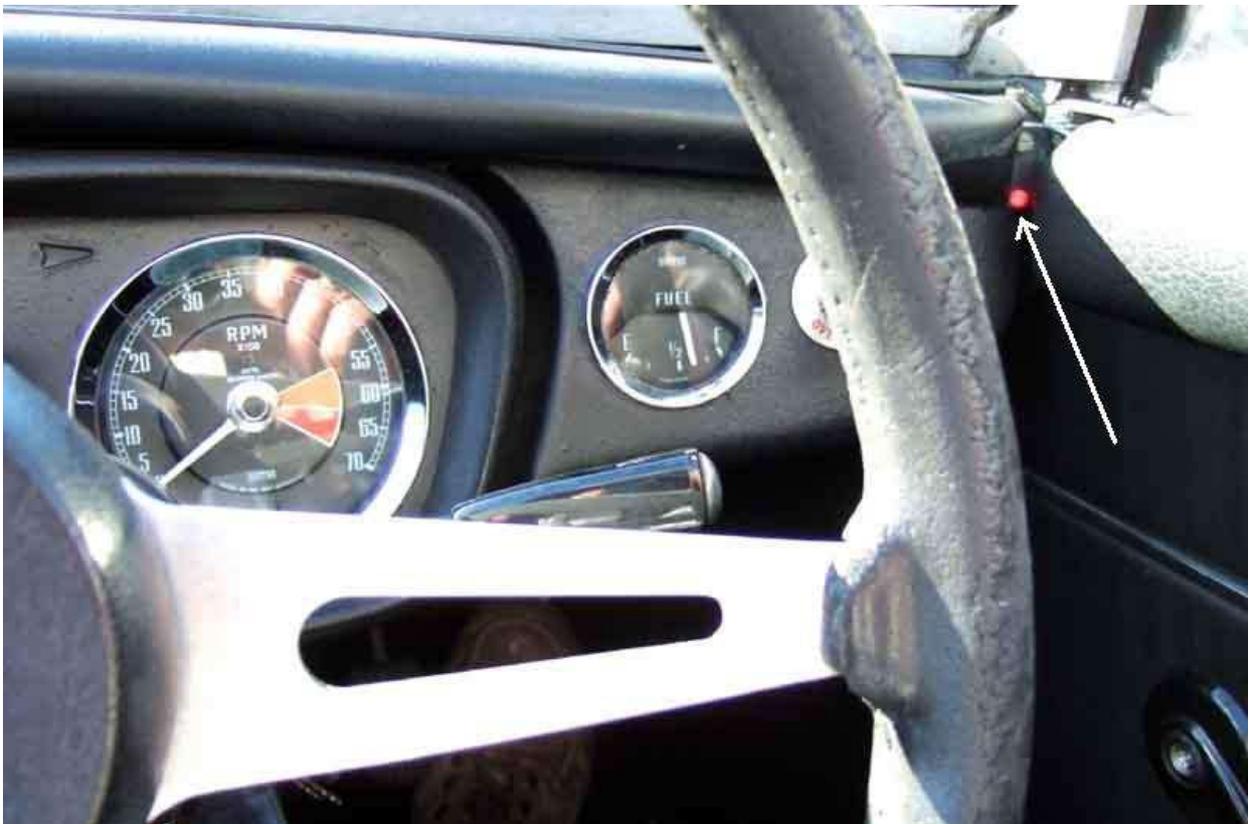
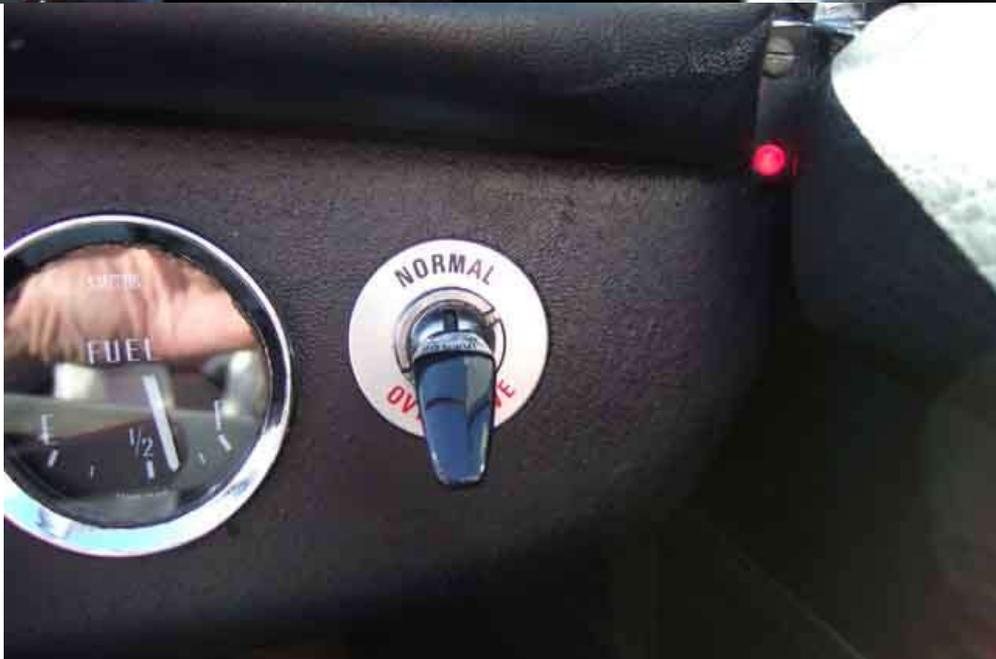
The revised position, a small bracket with a hole for the LED below a smaller hole for the fixing screw for the door seal end-cap sees it neatly positioned at the end of the dashboard crash-pad, and pleasingly close to the manual switch.
