## Body and Fittings

Last updated 02-Jan-2012

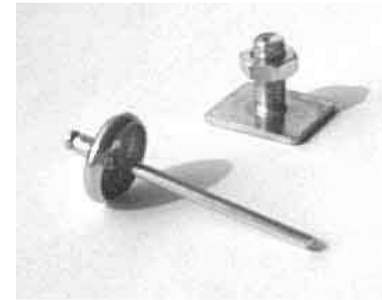
Fitting kits are available containing the full complement of pop-rivets with cup-shaped washers attached and six studs and nuts, sometimes washers too sometimes not, as shown in this picture.

Drill out the old fasteners, which are held on with aluminium pop-rivets of about 2mm in diameter. You may have to hold the cup-shaped washer in a pair of pliers to stop it spinning round with the drill.
