## Clutch Slave

## Clutch Linkage Wear

## Clutch Change

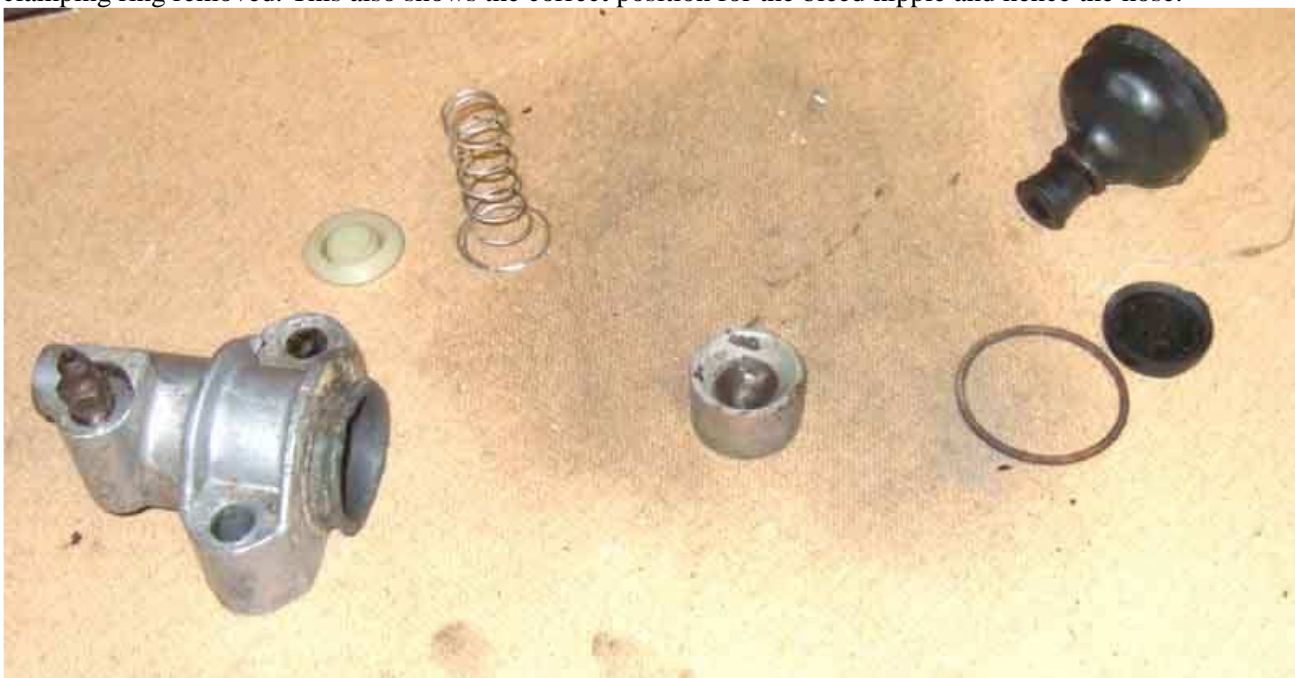
Cleaned, seal positioning disc separated from the spring, and the external boot turned inside-out and its clamping ring removed. This also shows the correct position for the bleed nipple and hence the hose.

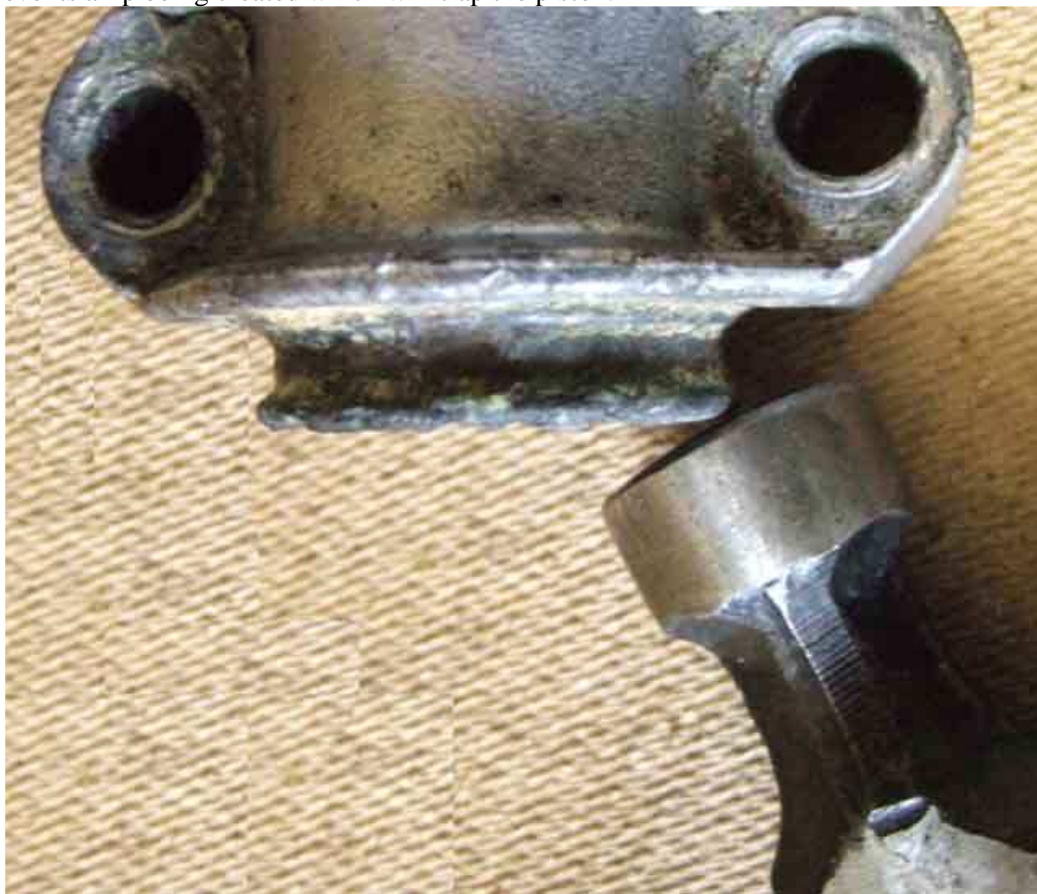
Tap the edge of the cylinder at an angle to dislodge the piston. This and the chamfer on the inside of the

cylinder prevents a lip being created which will trap the piston.

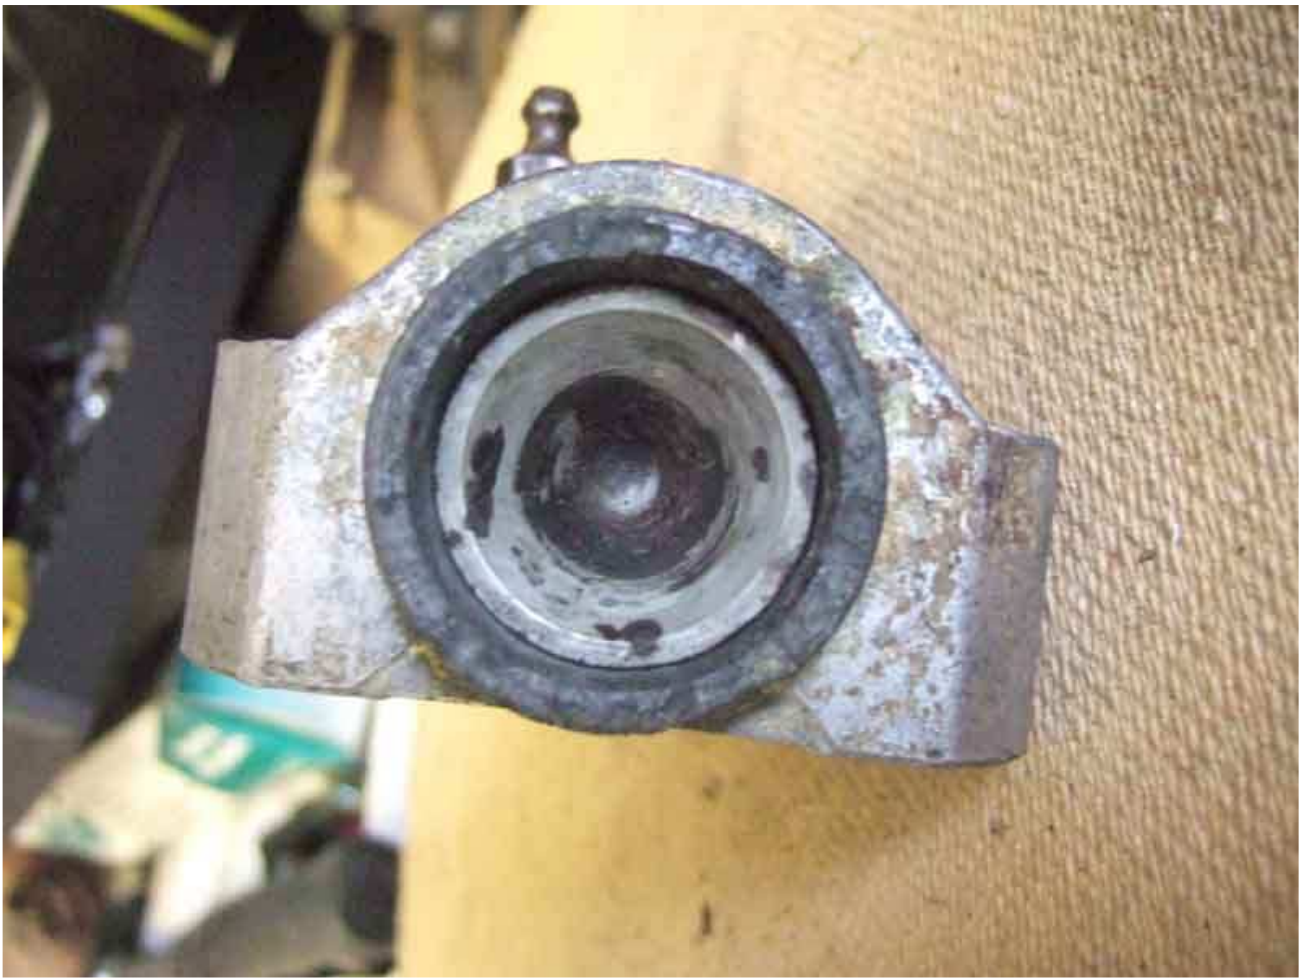
Showing the very close fit between piston and cylinder wall. I have read one claim where so much wear had taken place that the piston got 'cocked' in the bore and jammed. I can't really see this, the seal would have become so loose it wouldn't seal at all long before that, more likely an under-sized piston had been used.

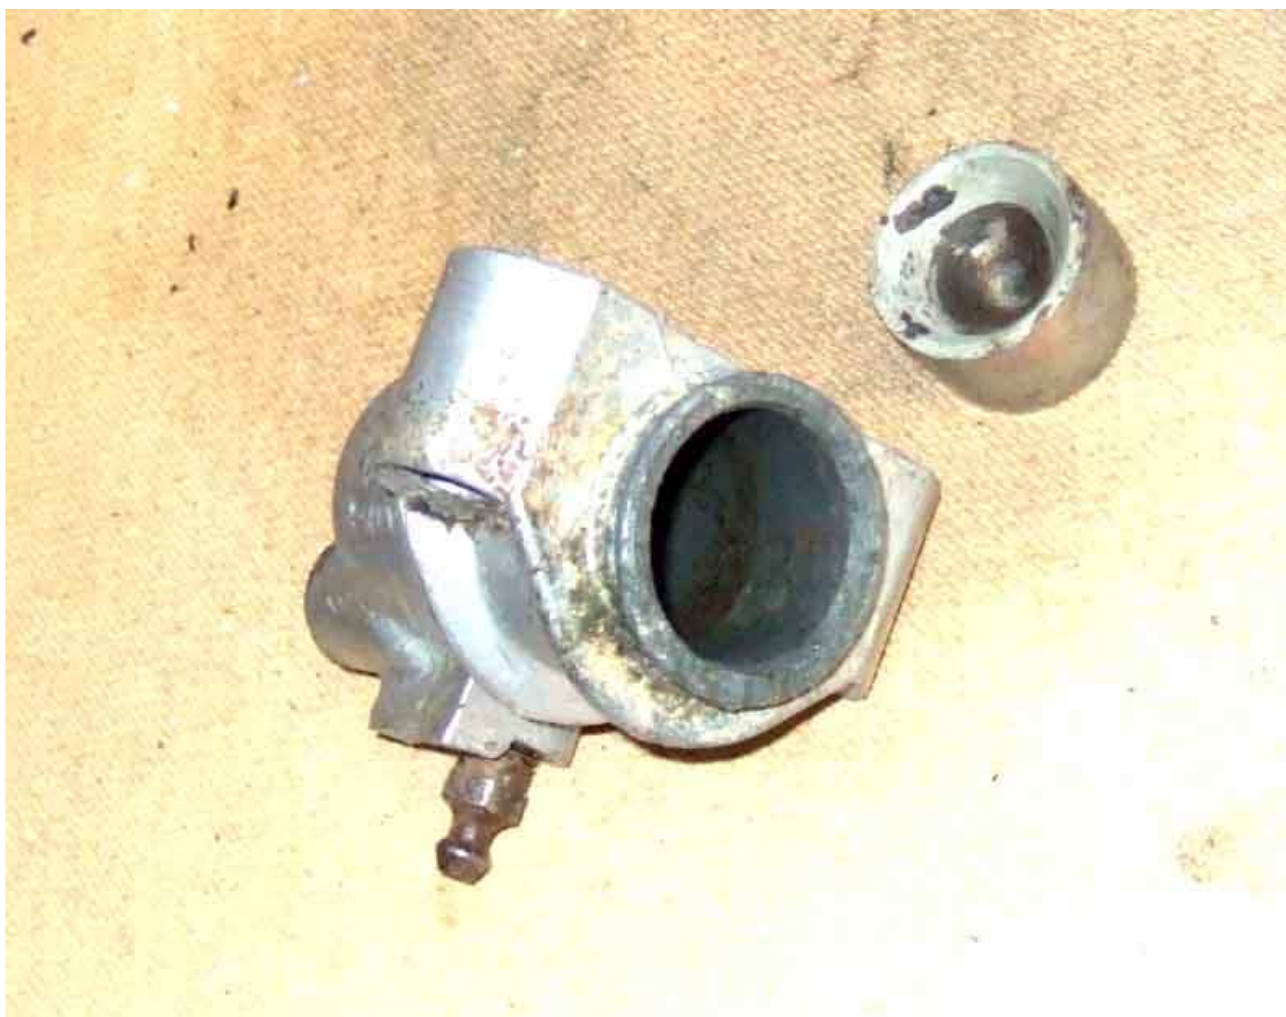
Not terribly clear, but the pale patch is significant erosion of the cylinder wall, the reddish area lighter corrosion.

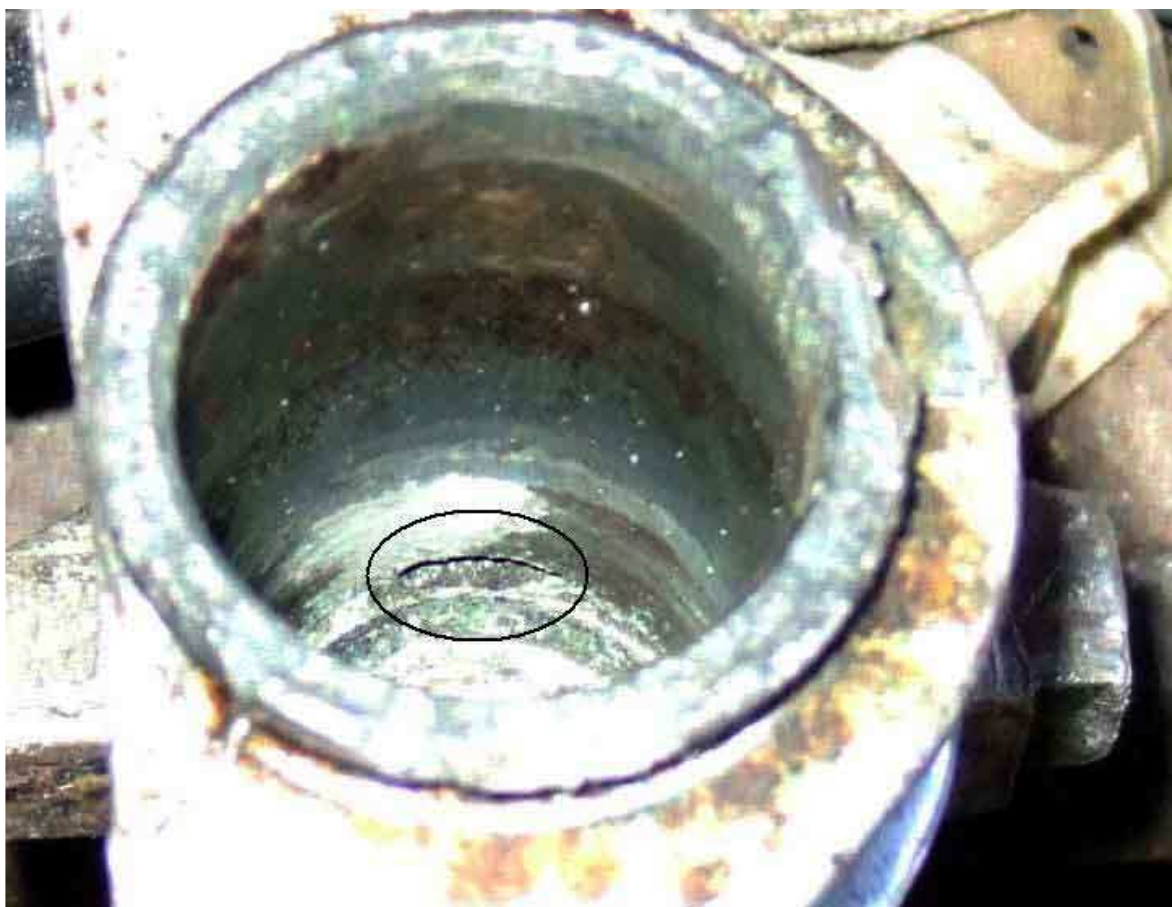
Showing the bleed hole (circled) drilled along the line of the join of the cylinder wall to the back wall, in an arc at the top of the cylinder, normally at the highest point of the cylinder when the car is on its wheels or has the front raised.

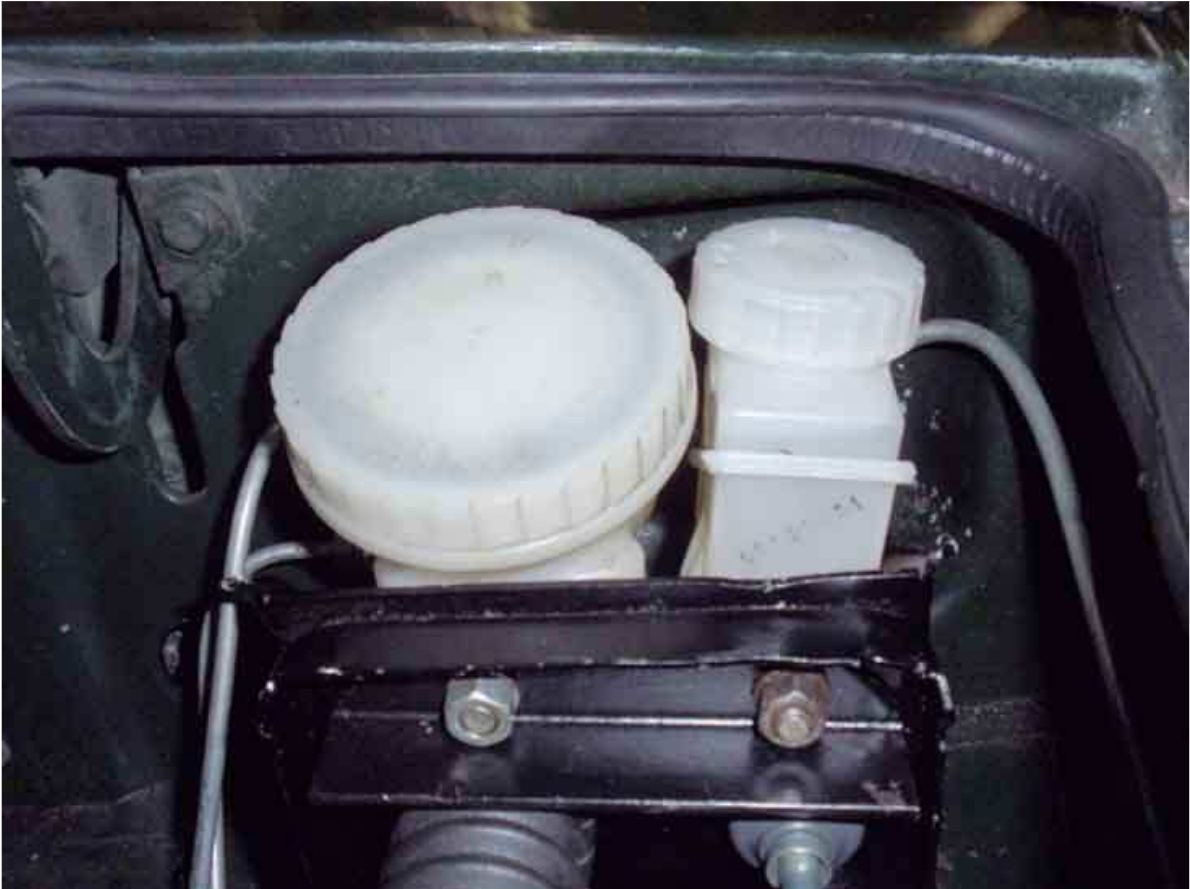
GMC1011 installed on Hans Duinhoven's MGB. Enough room to access the cap even though it is an LHD so the clutch master is more tucked into a corner of the engine compartment that it would be on an RHD. Hans's car is a 4-cylinder, so strictly speaking should have the GMC1007. Originally the V8 master was 1.2mm smaller bore than the 4-cylinder, which with a 4-cylinder slave would give a slightly lighter pedal but less throw, i.e. the biting point would be a bit nearer the floor if the remainder of the mechanical linkage at the master remains the same.

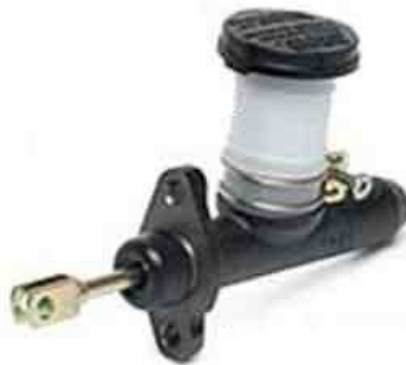
Is this the one that causes problems with the unboosted dual circuit master? Whilst the main casting and the diameter of the reservoir seem to be much the same as for GMC1007, the cap is obviously much bigger. (Image from [Victoria British](#))

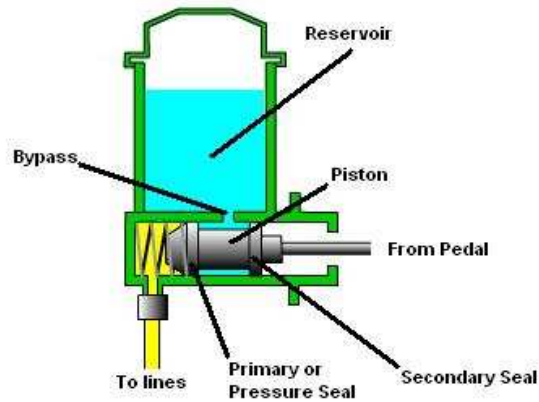
Showing how fluid fills the space between the two seals when the pedal is operated. If the secondary seal (nearest the pedal fulcrum) leaks you will get fluid running down the pedal, but the clutch otherwise operates normally (until all the fluid is lost!).

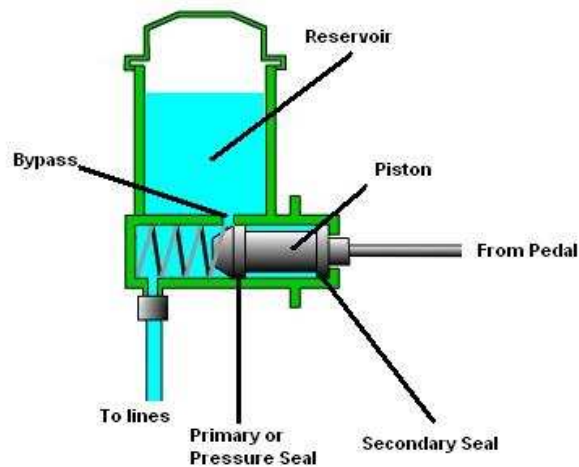
Showing how the primary seal must clear the bypass hole to allow fluid expansion and contraction to pass in and out of the reservoir. If this doesn't happen and the fluid expands, pressure will be applied to the release bearing which could cause the clutch to slip and will definitely accelerate wear, as well as rendering it impossible to bleed.
