## Ron Hopkinson Rear Anti-roll Bar

## Front Anti-roll Bar

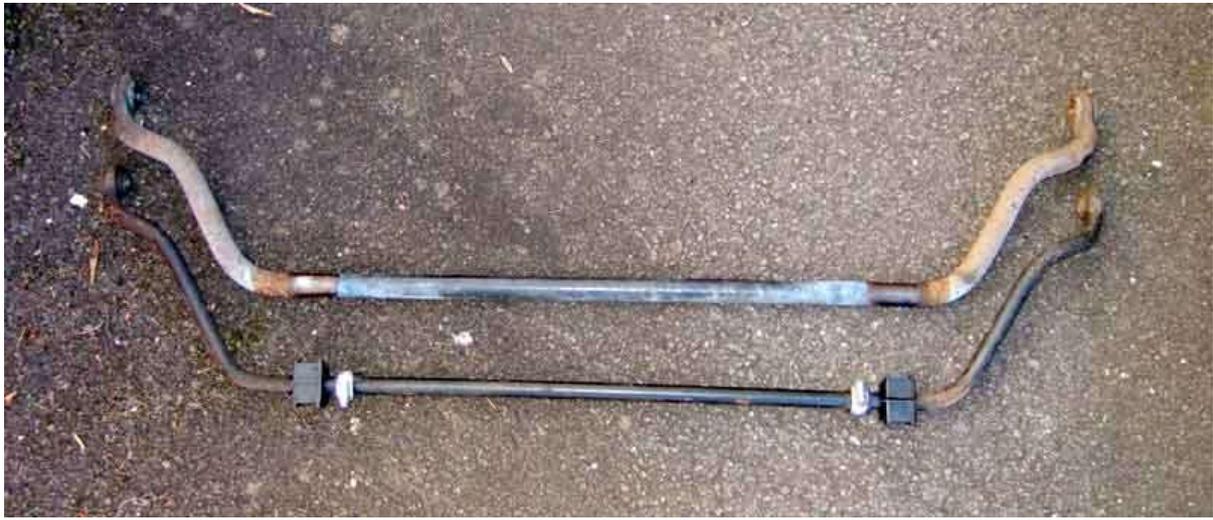
Finding a 5/8" bar on eBay (the original RB V8 bar was 9/16" but the CB was 5/8" so should be fine) I decide to swap that and then see how the drop-links go. It came without pivots or end-stops, but the bushes were good. New pivot rubbers (1B 4526) are cheap enough at under £2, but annoyingly I forget that the Ron Hopkinson pivots and straps are rounded, but the originals ('straps' BHH 2000) are angular. Never mind, the RH ones do for the time being, at less than £2 the P&P on the correct ones is more so they can wait for a supplier visit. Being thinner this time I have some suitable hose so use that with Jubilee clips for end-stops to prevent sideways movement.

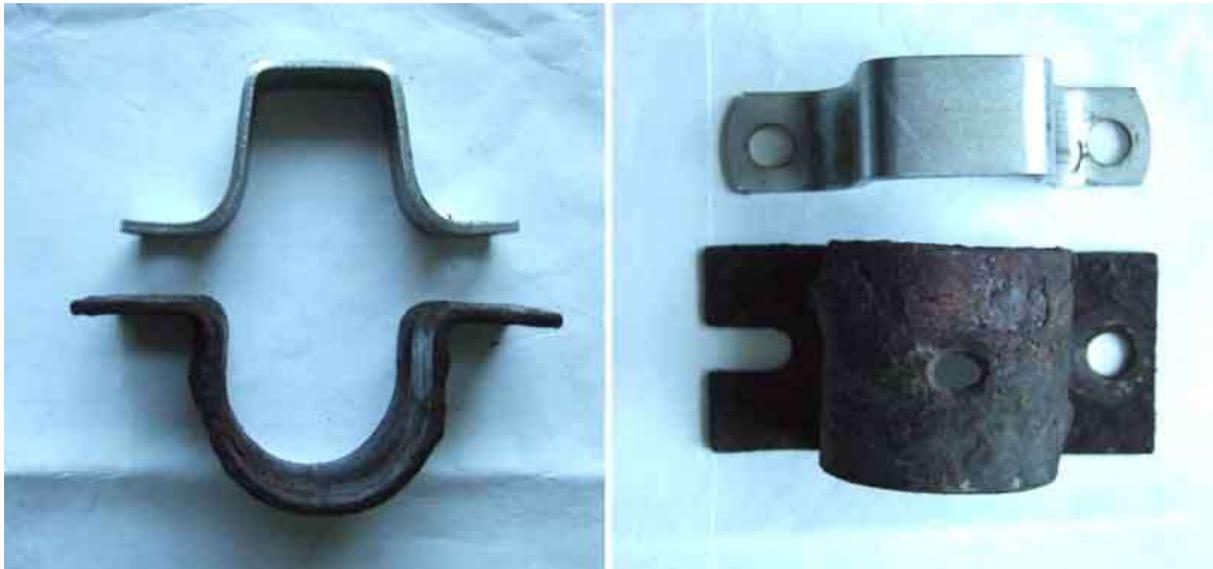
Factory pivot straps top, RH lower - one hole on the latter slotted to aid fitting the second bolt. The factory straps have to be checked against the chassis rail holes and 'adjusted' to suit before attempting to fit the bolts.

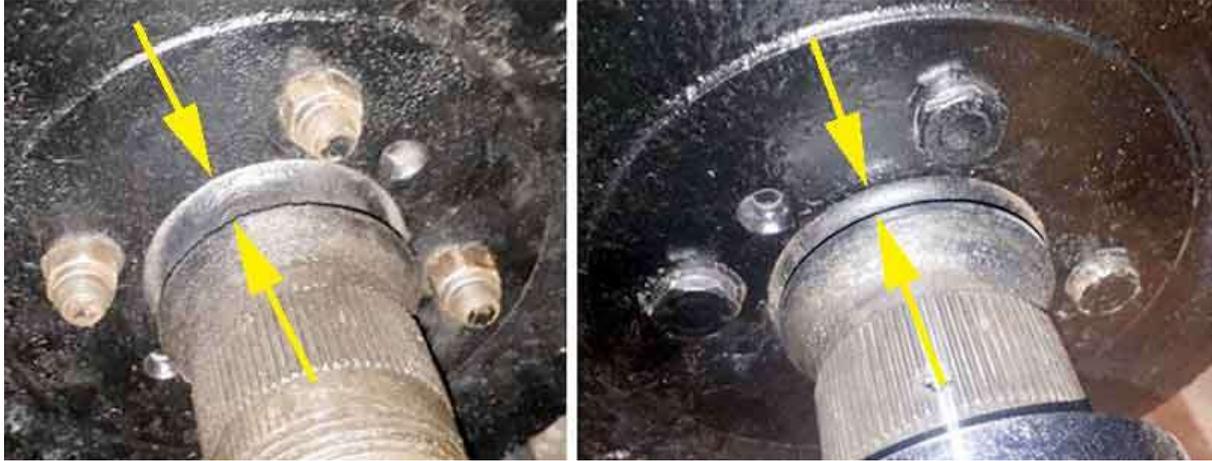
Someone (name withheld to save him from embarrassment) posted pictures of his wire wheel hubs asking why one side had nuts on studs and the other had low-profile bolts. That immediately said to me that he had a standard hub one side but a conversion hub the other, axle type unknown. Conversion hubs are machined to allow the wheel to sit as close as possible to the drum, in an attempt to reduce how much further wire-wheel tyres on a stud wheel axle stick out compared to stud wheel tyres. However only about 10mm is available, whereas the difference in the wheels is about an inch. In this picture you can see the nuts on studs on the left, and low profile bolts on the right. Also the distance between the angled wheel seat and the drum on the left is clearly more than that on the right. It's for this reason that low-profile bolts have to be used on conversions hubs, there simply isn't enough room between drum and hub for the much taller Nylocs and studs:

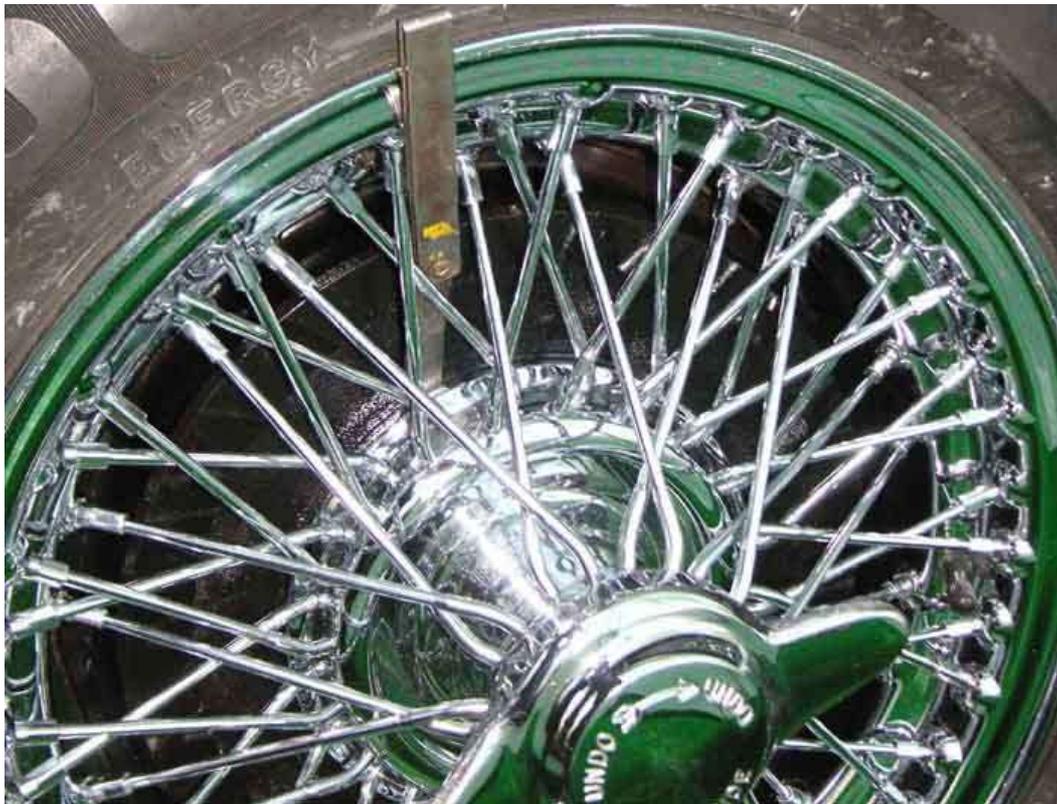
And this is the effect with the wheel fitted. Richard Tower shows his wire wheel with only 15 thou clearance to the drum when it was on conversion hubs on a stud-wheel axle, whereas mine on standard hubs have 11mm.

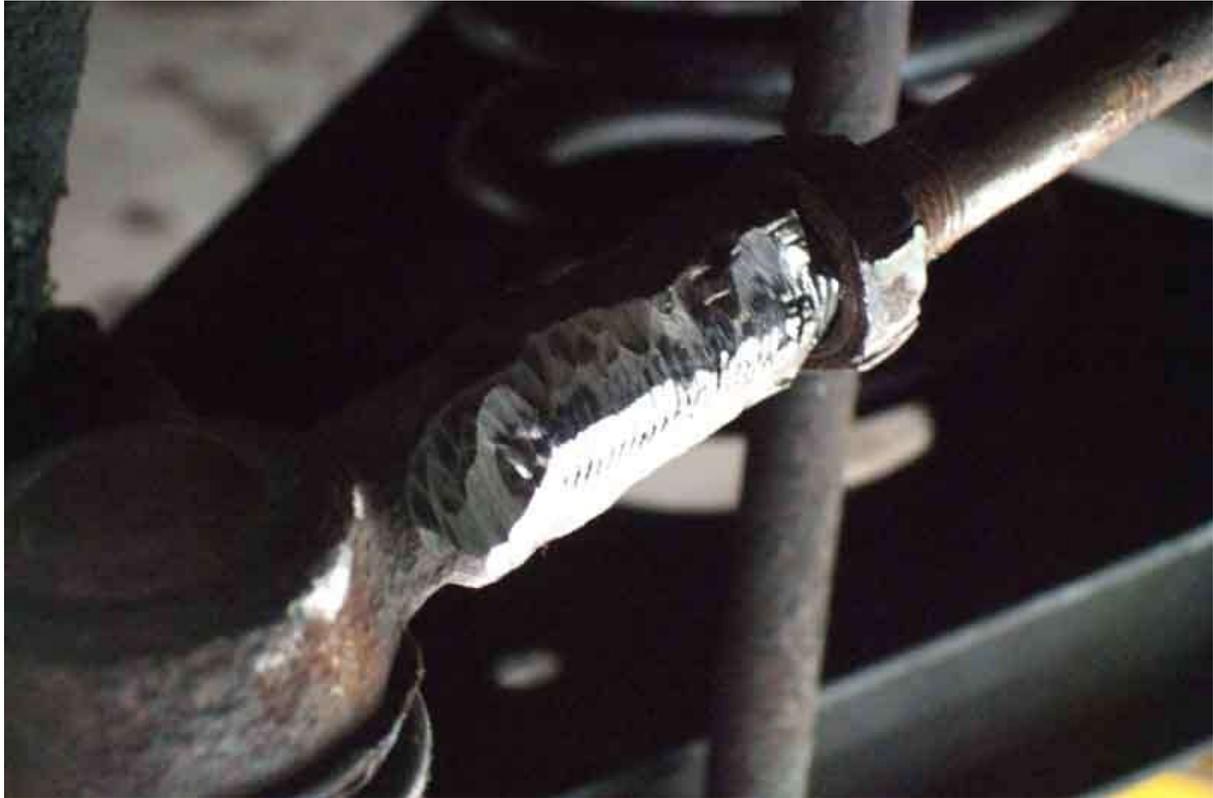
Vee's track-rod ends: Angle-ground along the body of the track-rod to just expose the threads. A bit of a 'do or die' treatment, you wouldn't want to drive it having done this. If this hadn't worked I would have had to remove the rack with track-rod end attached and take it somewhere to get some heat on it:

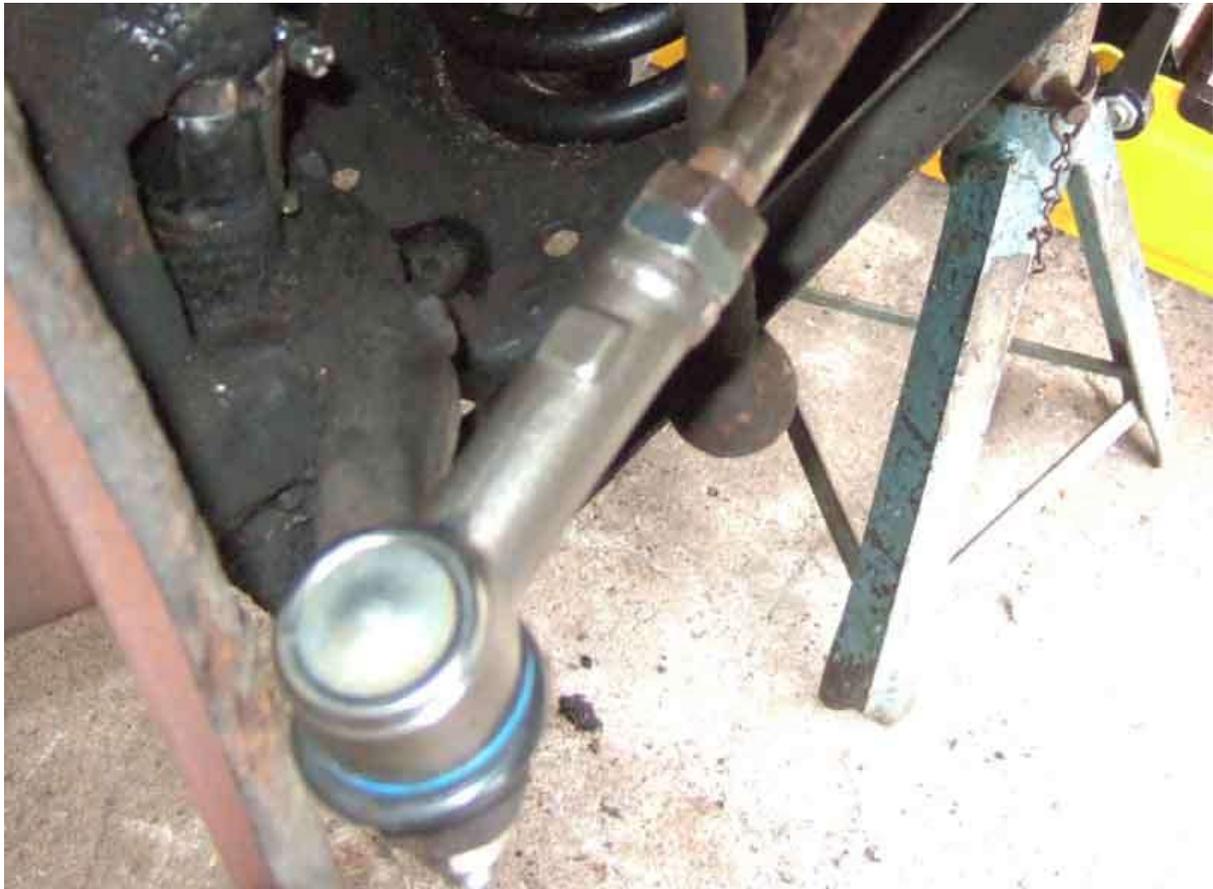
Double lock-nuts which I can lock together to make turning the track-rod easier, although judging by the other side I'll not have a problem with it again. If doing this **make sure** you fully tighten the first lock-nut against the end of the track-rod end, then just lightly nip the second nut up to that. If you just lock the two nuts together the track-rod end could be loose on the track-rod (although highly unlikely to come unscrewed from it):

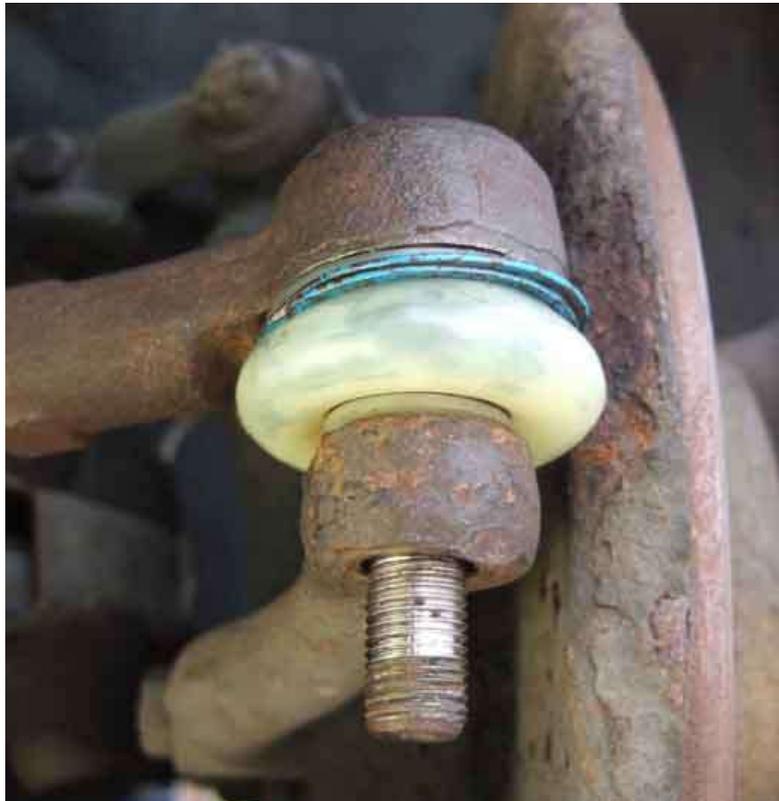
Fitted (yes I know the nut isn't on yet ...), straightened retaining spring looks to be holding OK, I'll have to check after driving a while:

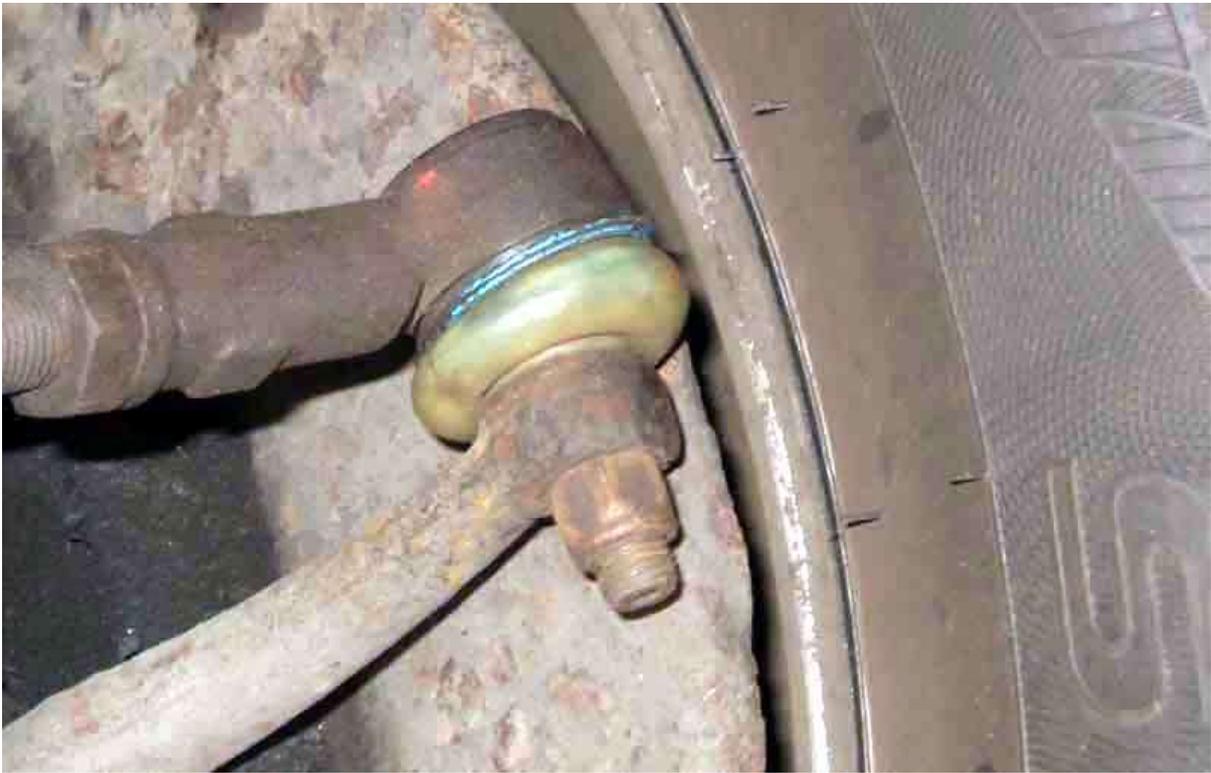
12 months later looks OK:

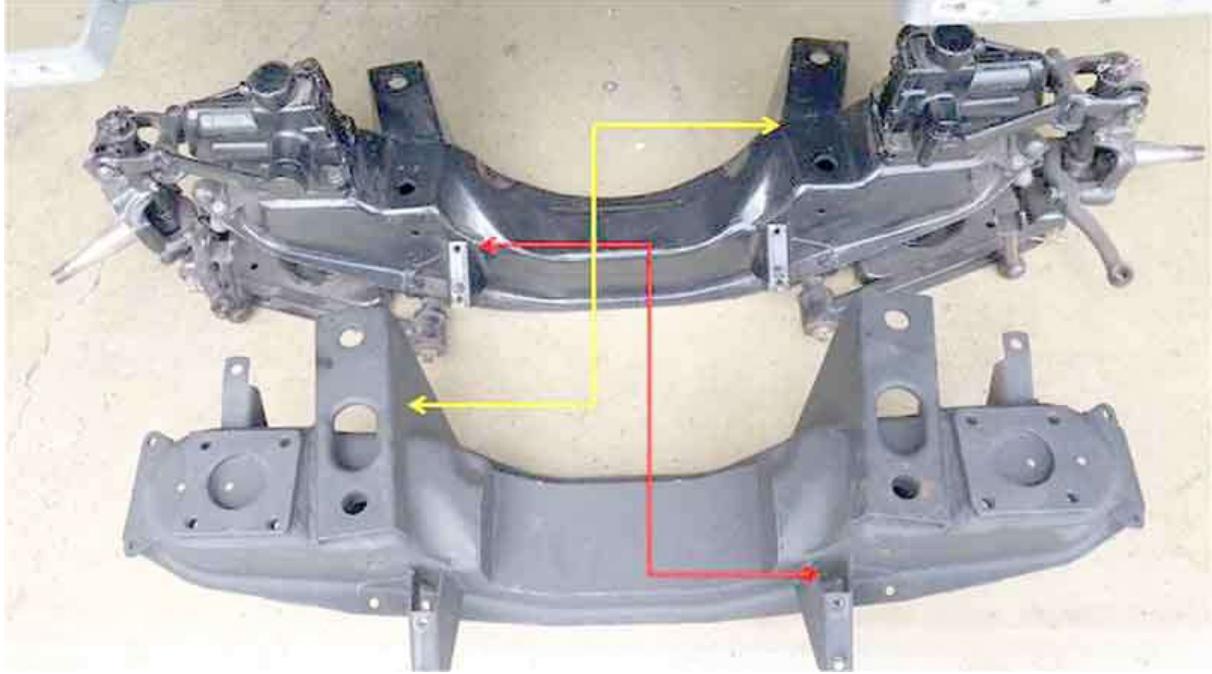
Comparison of chrome and rubber crossmembers. A stout channel (yellow arrows) lifts the chassis rails on the RB (lower) to give the higher ride height. The red arrows show the difference in the rack mounting brackets: ([MG Experience](#)):

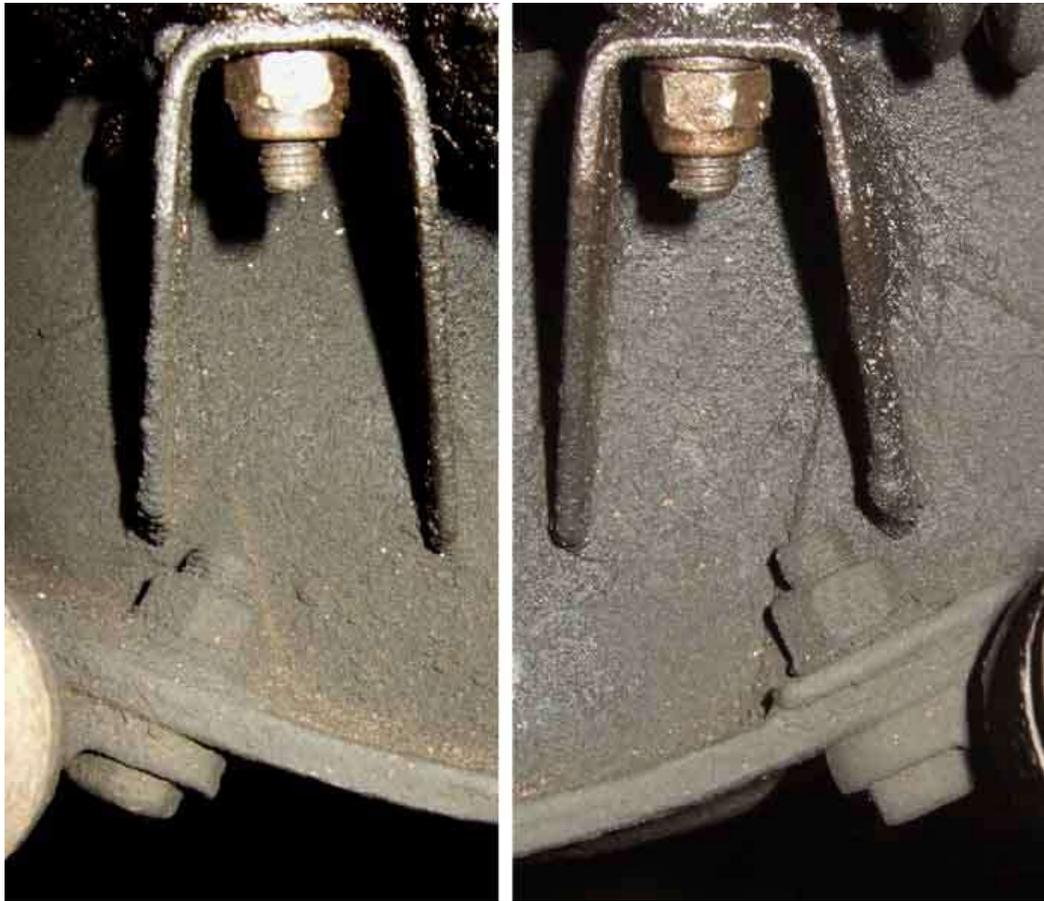
According to [Jim Gibson also on MGExp](#) whereas the CB rack mounts were the same for both LHD and RHD, on RB they are apparently moved to one side for RHD and the other side for LHD. This makes sense as the shaft has to pass through holes in the chassis brackets for the engine mounts on RB making lateral position of the rack important, whereas it passes under them on CB so lateral position was unimportant. Mark Vaughan in USA posted the above comparison so presumably is showing a LHD RB crossmember, but any offset in the brackets to one side or the other isn't obvious from the picture. However comparing CB to RHD RB there IS a difference - on the RB the brackets seem to have moved about 1/4" towards the passenger side. CB equidistant from the A-arm bracket bolt:

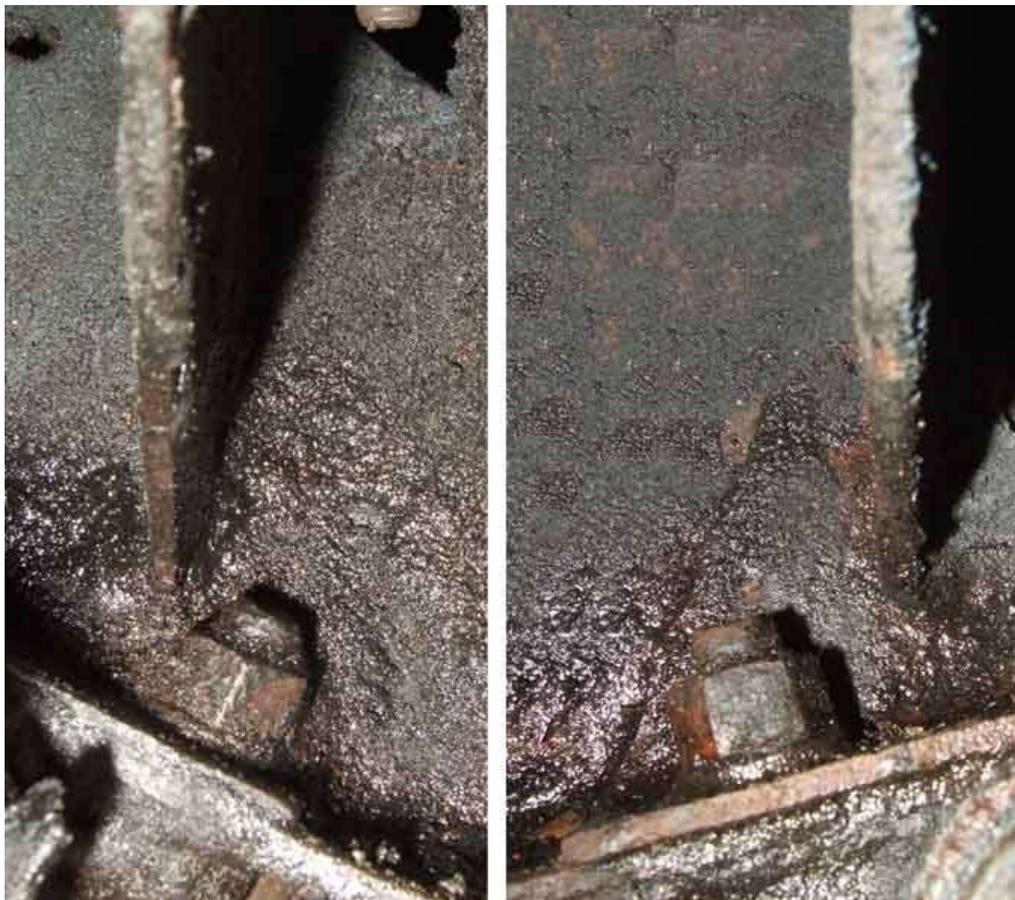
RB offset to the right, although it would be the rack mounting face that would have been positioned by a jig for welding, the bottom of the 'legs' would be welded where they ended up:

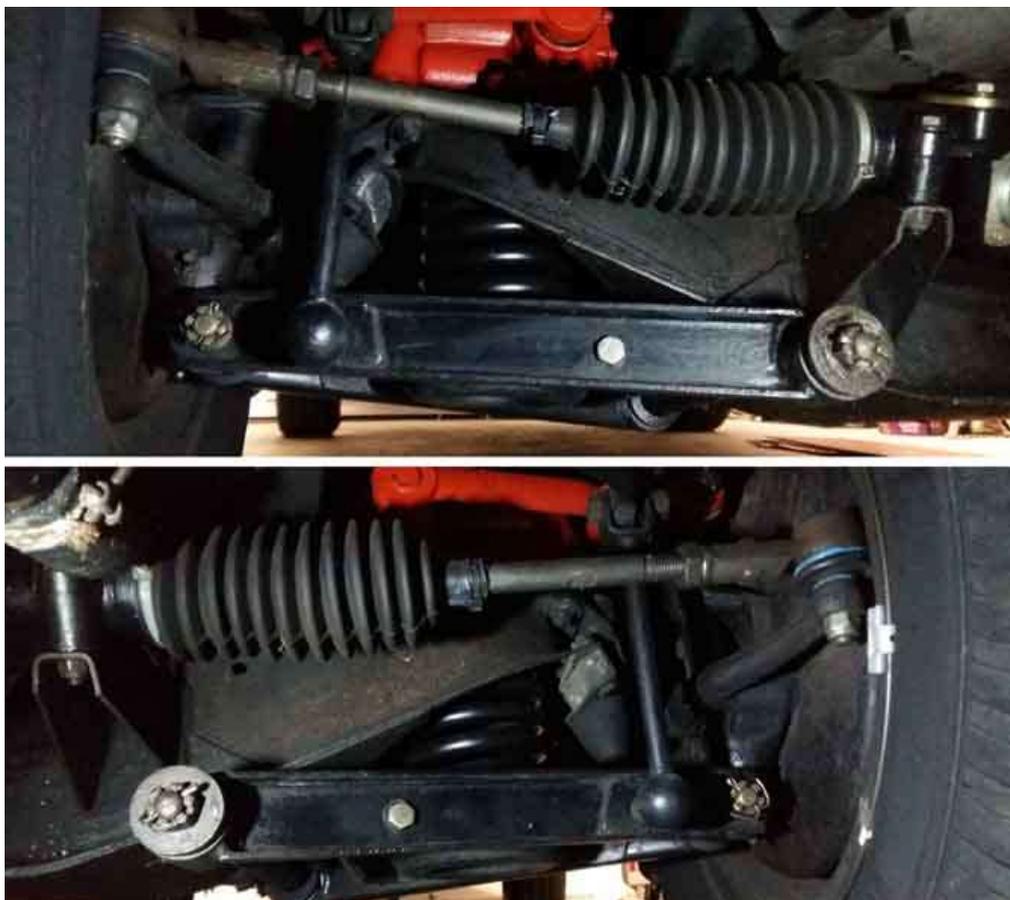
This investigation of rack mounts stems from someone on the MGOC forum saying his driver's side track-rod was angled up towards the wheel whereas his passenger side was level as here:

I suggested he take drop measurements from rack, brackets, crossmember and so on to try and see where the discrepancy lay, and he said one bracket was 10mm higher than the other. His rack shaft passes through the hole in the engine mount chassis bracket correctly, so if the crossmember itself is the same distance from the ground both sides it can only be the passenger side rack bracket being higher than the drivers. And that 'IF' is crucial. Despite saying to take the measurements on flat and level ground, and to take multiple measurements, further investigation revealed that it is his garage floor that is out! In other words rack, brackets, crossmember and chassis rails would all have measured the same both sides.

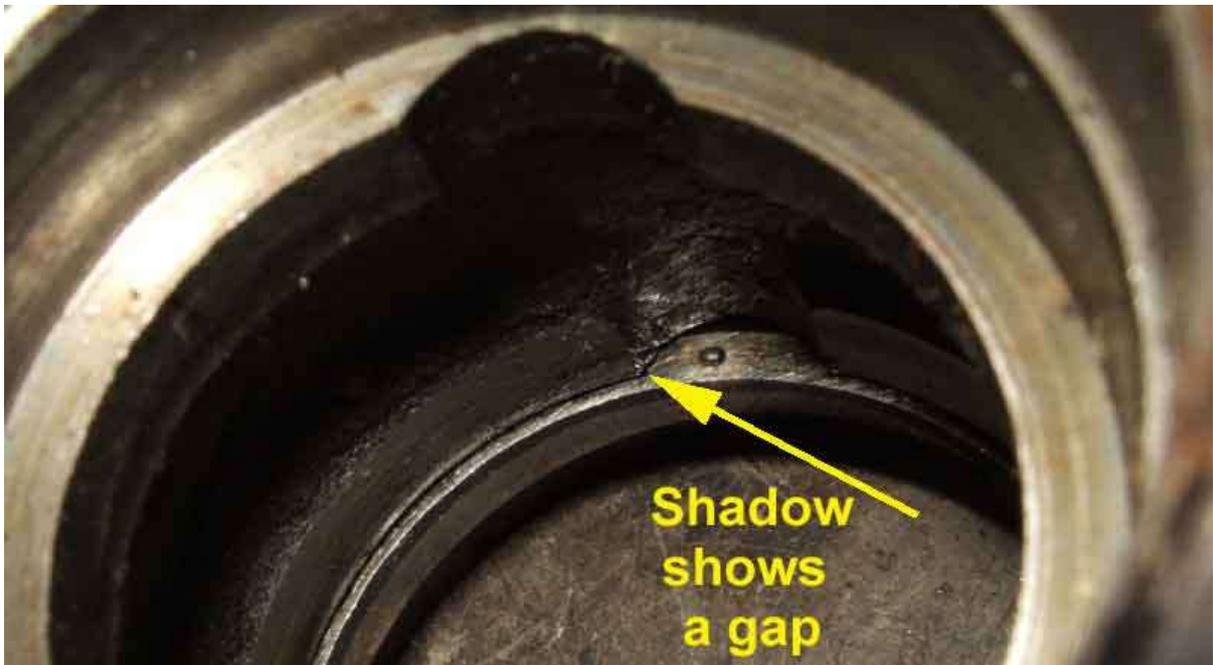
It's important to get the races fully seated. When drifting them in there is a definite change in the sound when they 'bottom', but peering in from the opposite end at the cut-outs used for drifting the old races out you can also inspect them. This is not quite seated and shining a light in shows a shadow on the seating face of the race:

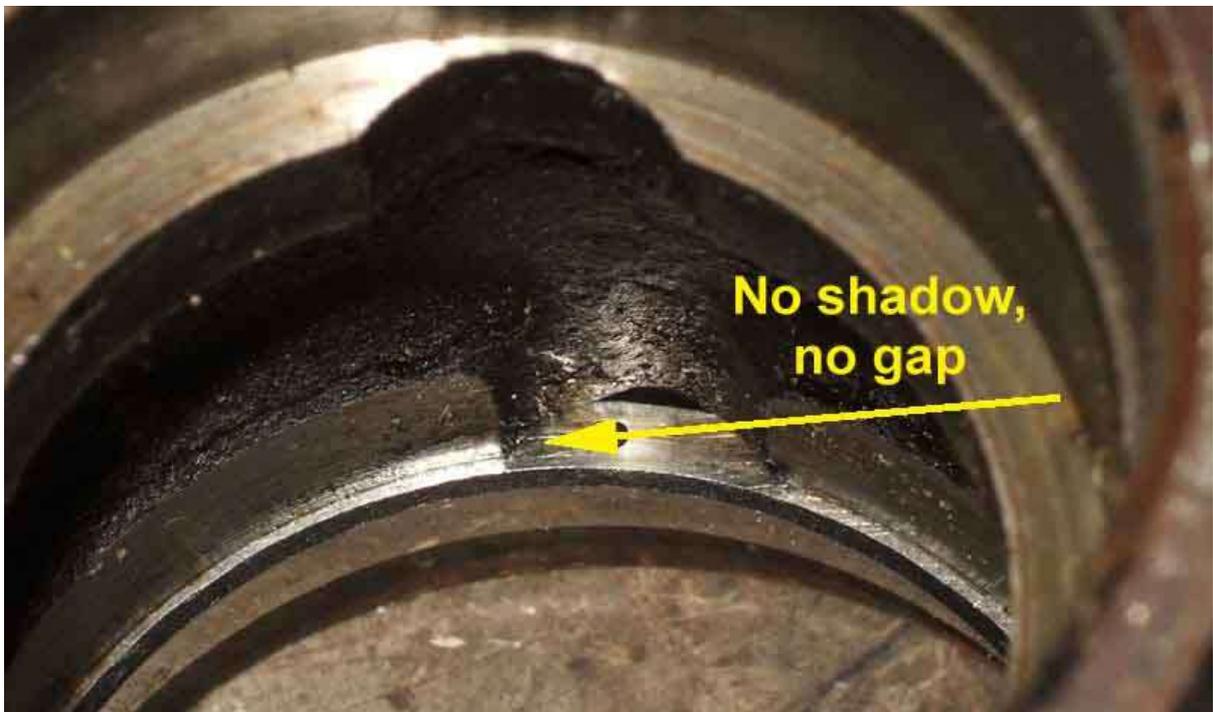
Fully seated and no shadow:

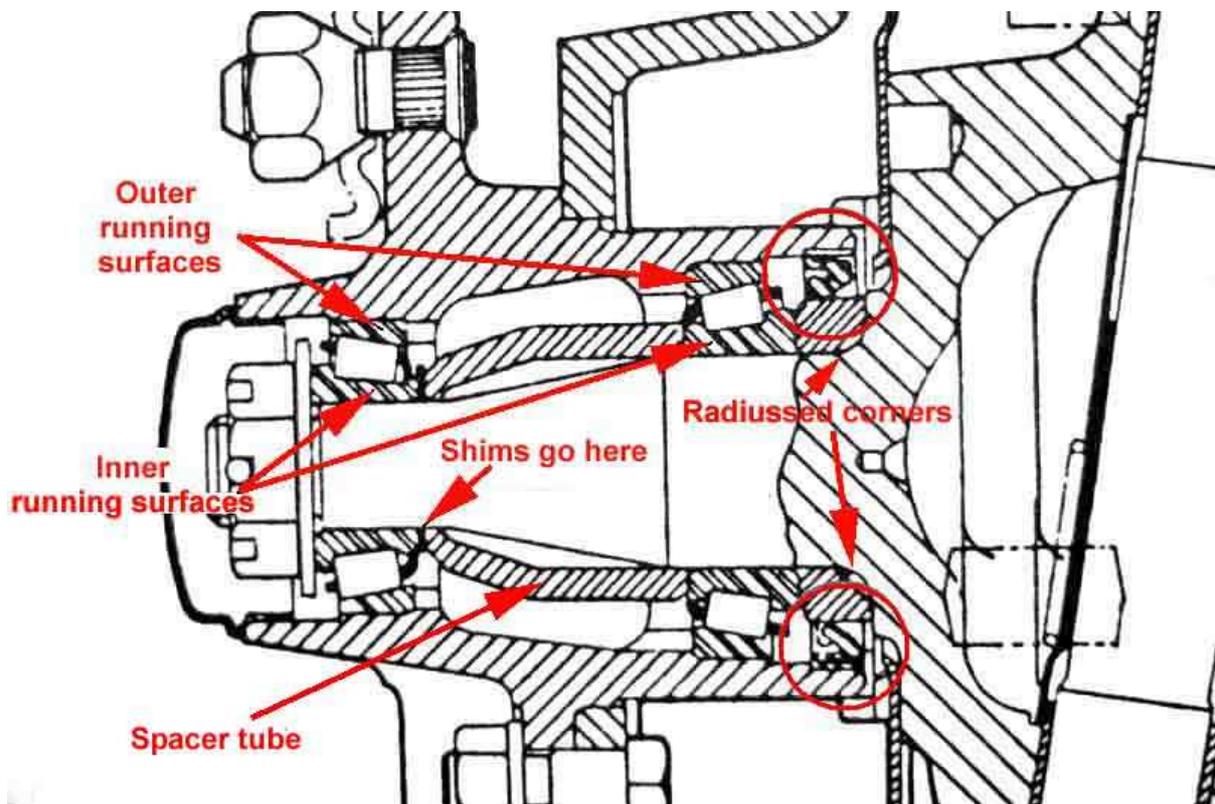
Oil seal (circled) correctly fitted with the flat side facing outwards (to the right) and the lip and groove facing inwards. Also note that the collar it rides on has the inner radiused corner facing the hub, if it's fitted the other way round you won't be able to set the end-float correctly:

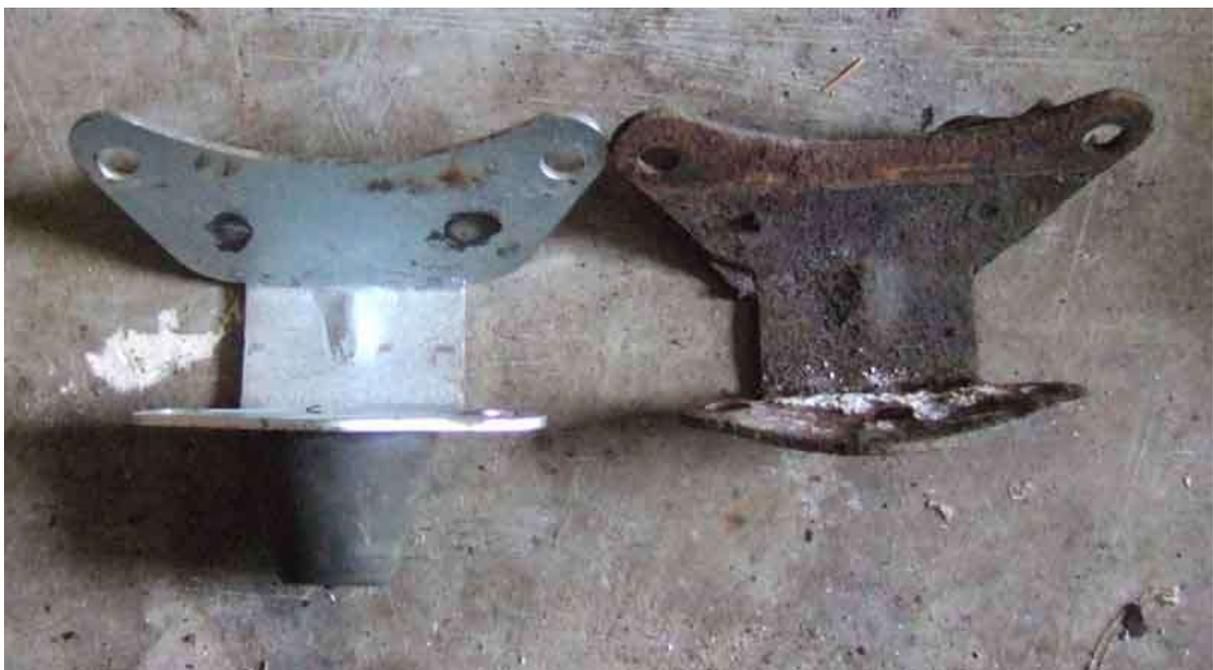
Old and new bump/rebound brackets, notice how the bottom part of the old one is bowed downwards from the swelling of the alloy spacer.

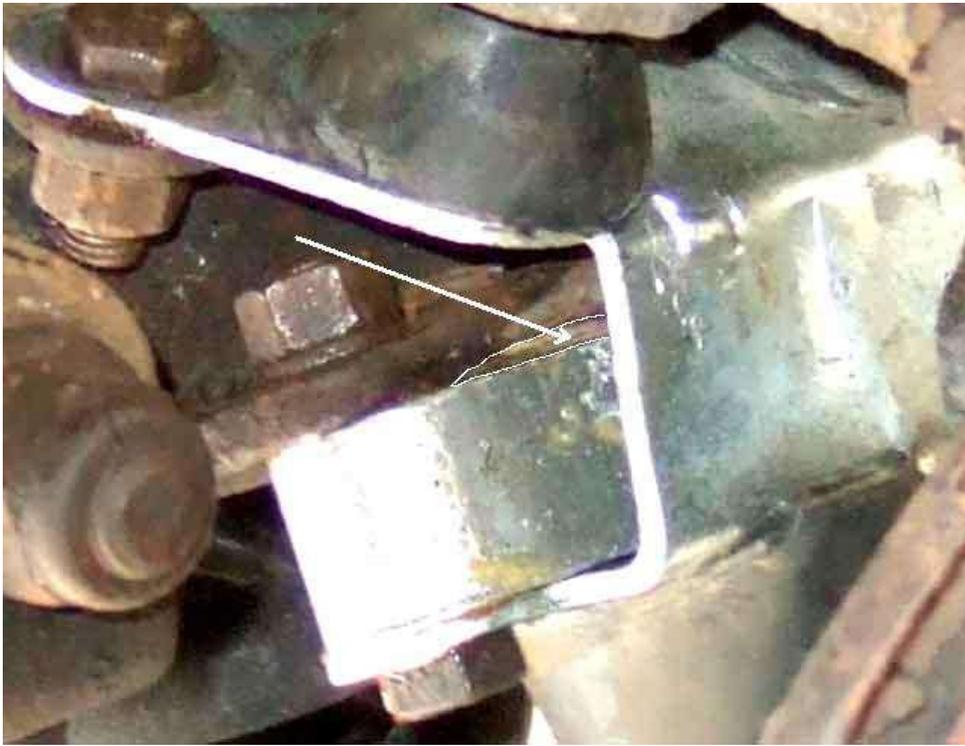
Showing how the cross-member mounting point has been bowed by the swelling of the old spacer

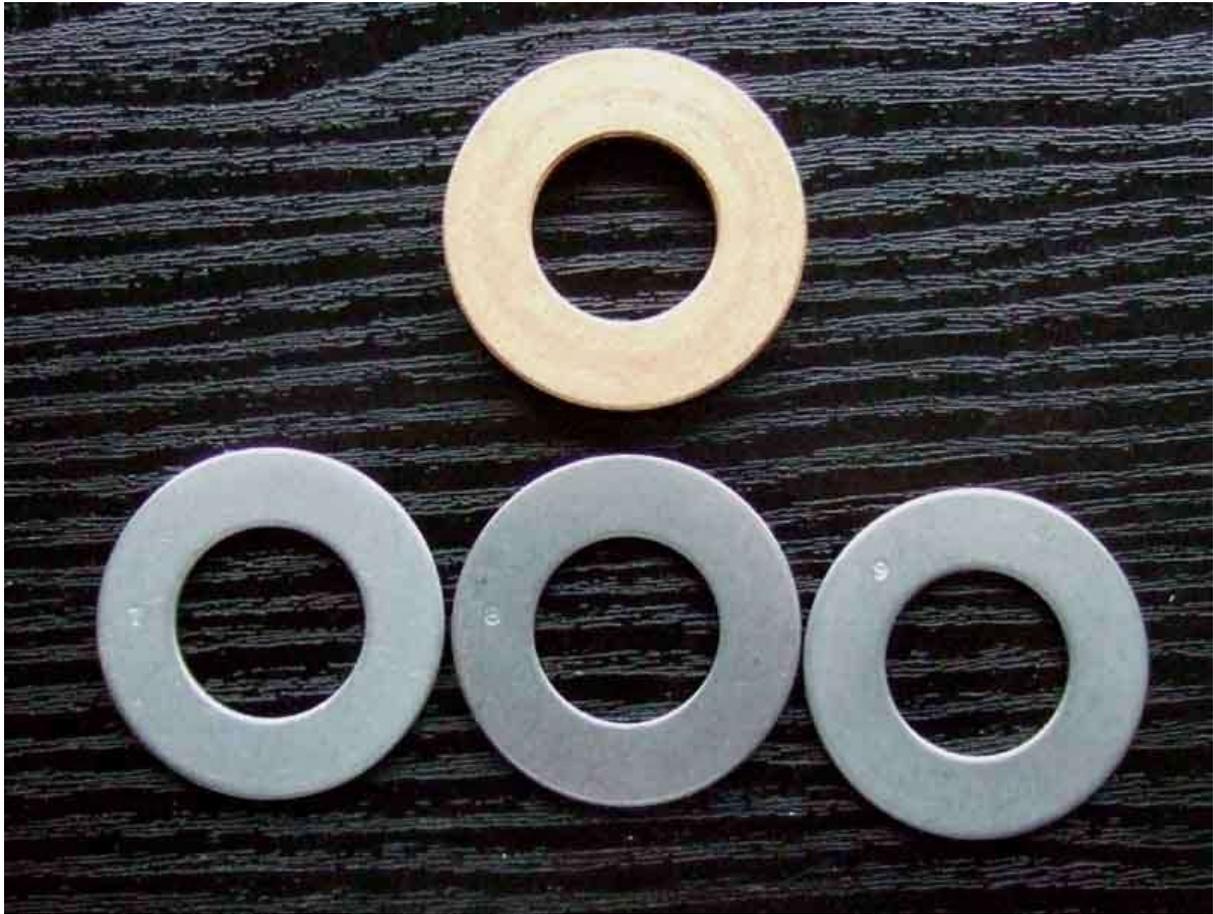
New phosphor bronze thrust washer and three selective sizes of shim. At least that is what the numbers stamped into the shims purport to be, five of the six I got from Moss were all the smallest size!

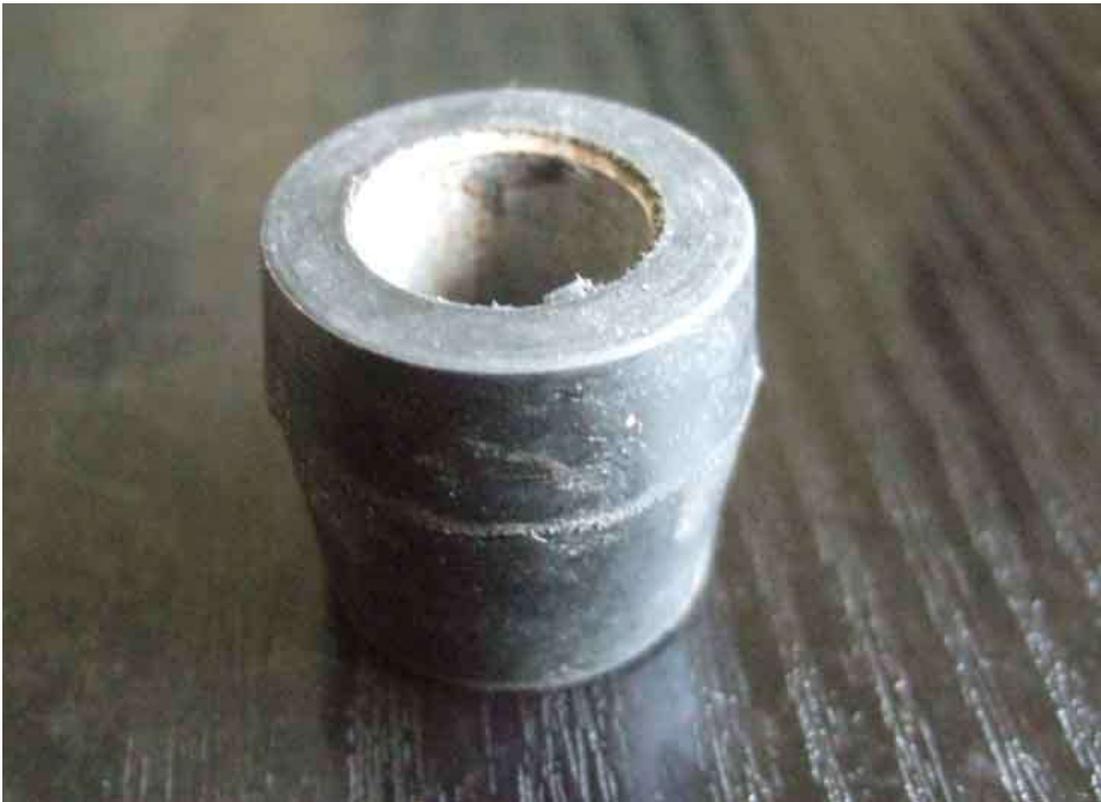
Contrary to rumour, these bushes (described as 'barrel' type, and you can see why) have a steel sleeve in them, which acts as a distance tube to leave the correct clearance between damper arms and upper trunnion. This sleeve rusts to the pin meaning you have to hacksaw through the pin either side of the trunnion, then drill/chisel the remains out of the trunnion. There is talk of a poly 'top-hat' type which also have a sleeve, but the rear shackles use a top-hat type and neither rubber nor red (at least) poly have sleeves, which may be where the confusion comes from:

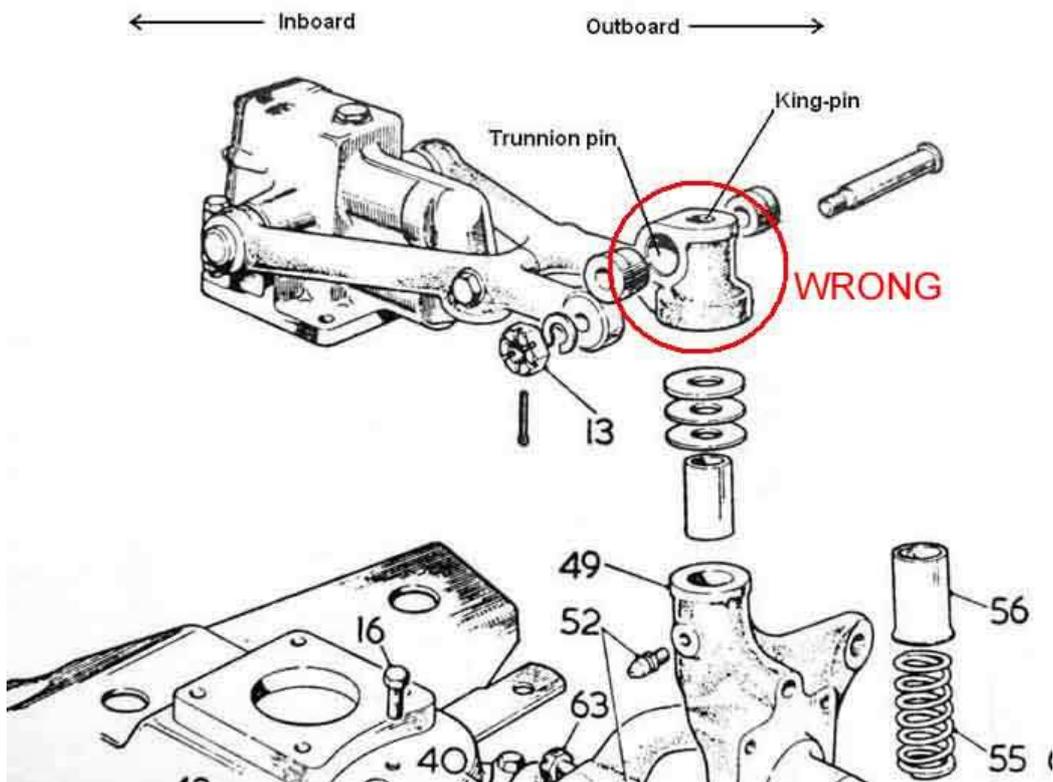
... the Leyland Parts Catalogue and Workshop Manual exploded drawings are incorrect (note this shows a top-fill damper but MGBs are side-fill) ...

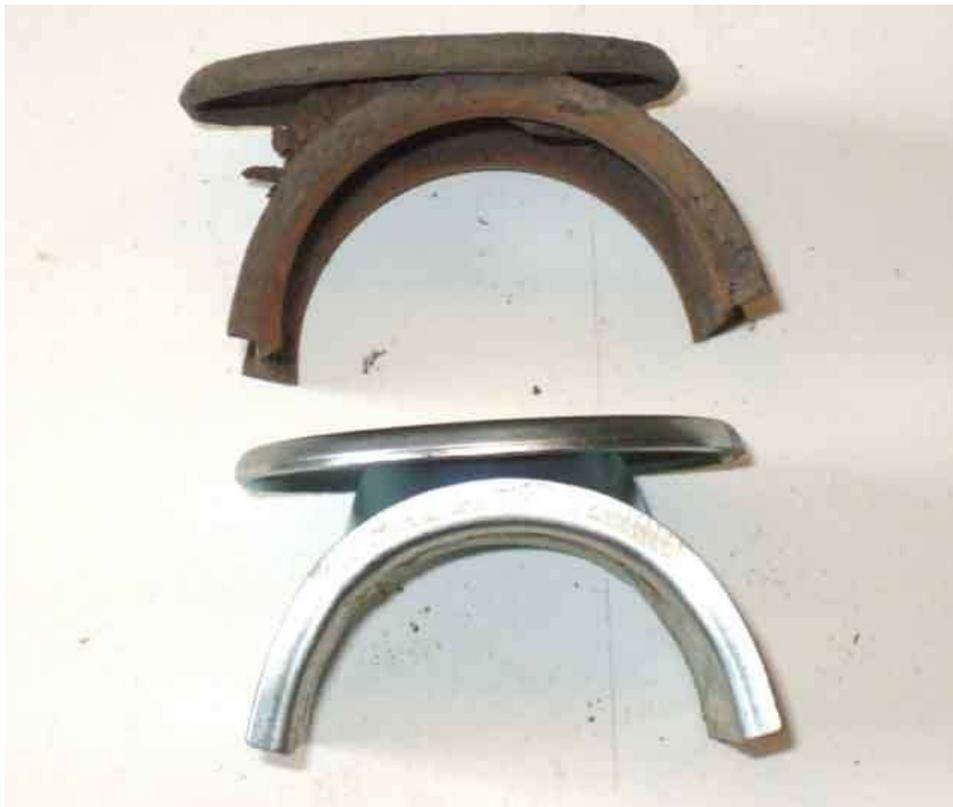
... and collapsed. If it gets worse than this it could be the damper that limits axle travel:

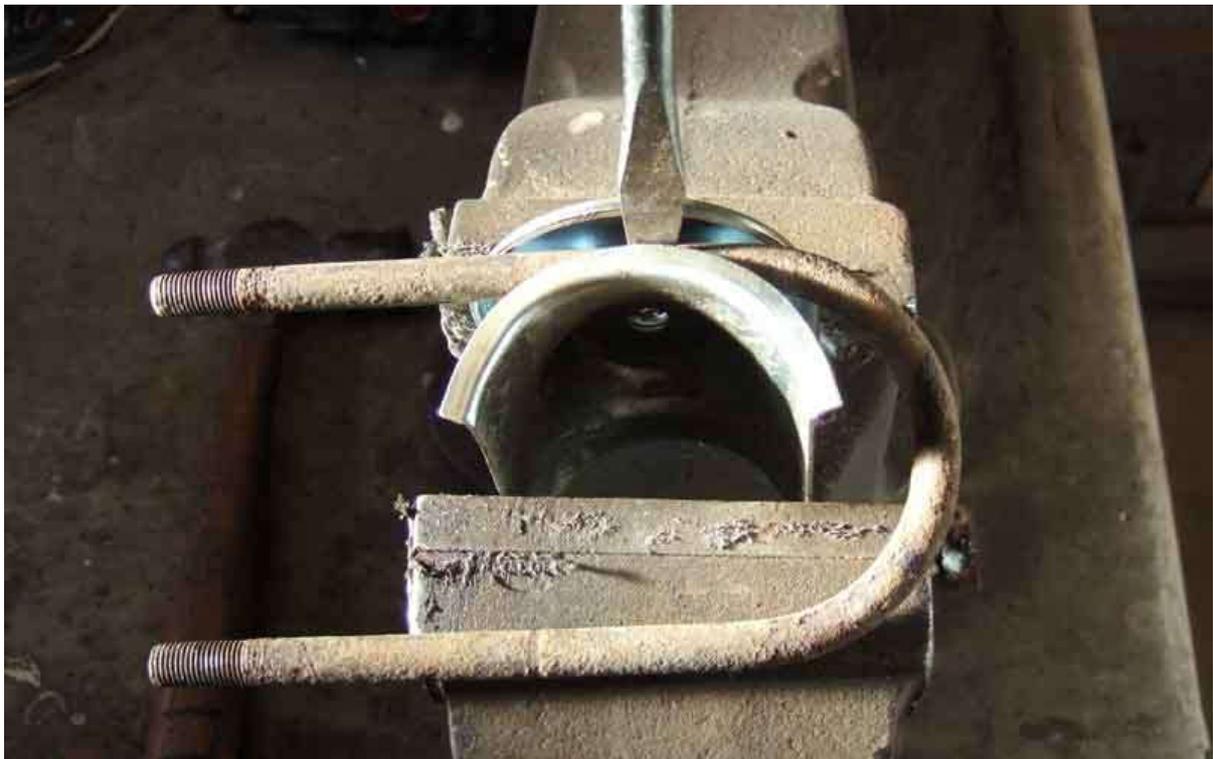
I had to lever the flat part of the new pedestal away from the curved part before I could get the U-bolts in:

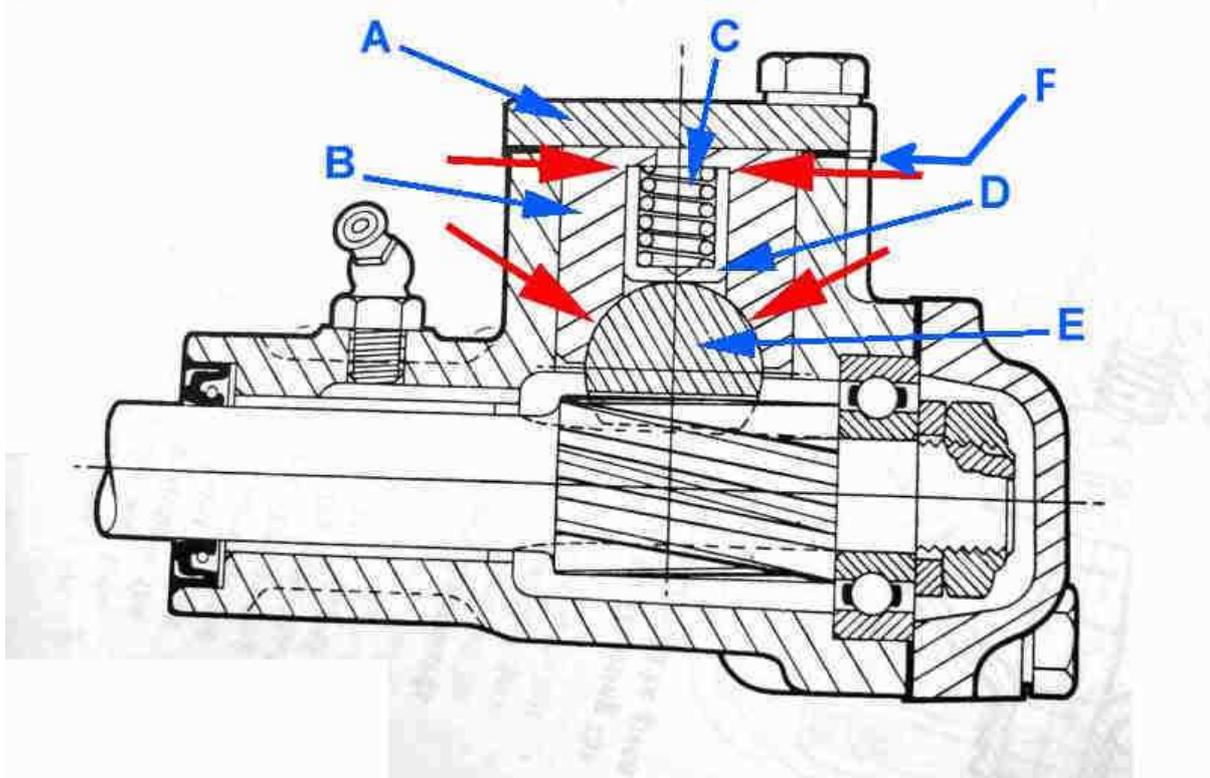
Drawing from Workshop Manual (the 'grease' nipple - actually for oil, was deleted). However the correct damping function requires small clearances at the red arrows. As shown is what happens when the cover is fitted without shims, and the rack starts to bind in the housing. The gap between cover and body F is then measured and shims of that measurement plus 0.5 to 3 thou fitted. The cover A presses on the yoke B, which is pressing on the spring C, which is pressing the damper D onto the rack E, leaving a total of 0.5 to 3 thou clearances at the indicated points. The shims and cover gasket fit round the yoke so that the greater the thickness the lesser the pressure of the yoke on the spring and damper and hence the rack:

*September 2023:* However only the 5 thou shim seems to be available at the moment, the smaller 2.5 and 10 thou not, although multiples of 5 thou can be made up of course. Another possibility is that the damper pad can be worn, they are available (ACA5244, stocks vary) but the spring (17H6583) is NLA. I have seen a damper pad rotated by 90 degrees in the yoke to remove the wear and increase the pressure - and worn half-way again! It's also possible to shim the socket in the pad to increase the pressure.

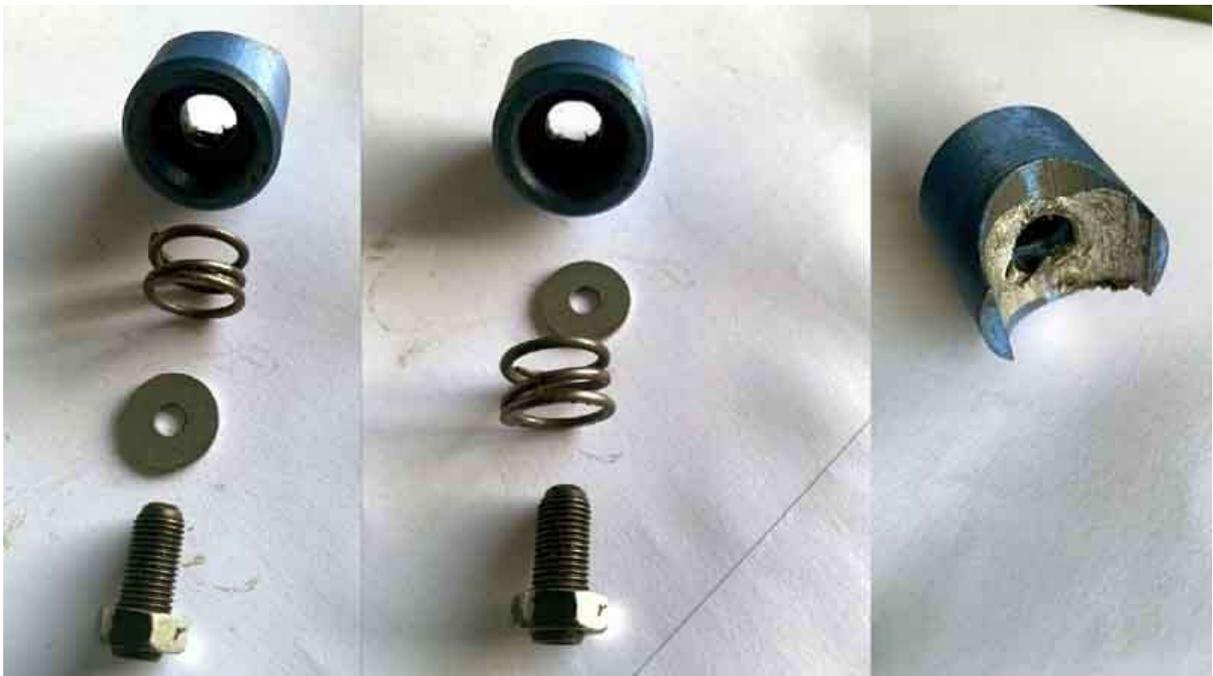
On the left how they should be assembled i.e. with the spring in the yoke and the washer on top of the spring under the screw. In the centre the washer was under the spring and the screw had nothing to press against, resulting in a huge amount of play between rack pinion. On the right the underside of this yoke: (*Linton Husbands*)
