## Ron Hopkinson Rear Anti-roll Bar

## Front Anti-roll Bar

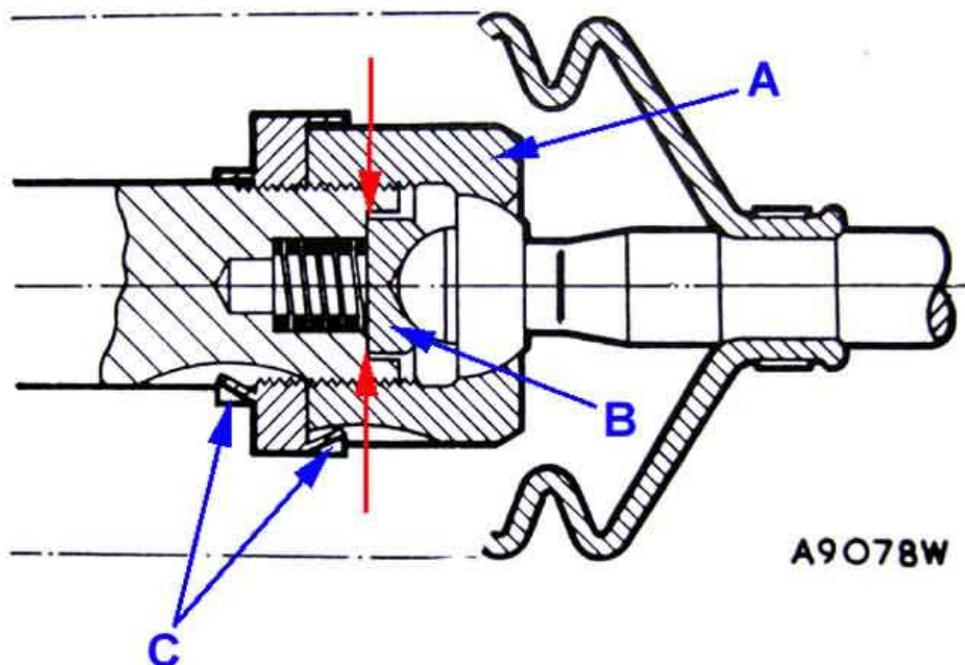
Fig. J.2  
The assembly of a tie-rod ball joint

Ball housing A presses the inner ball on the tie-rod against a sprung seat B. Lock-nut C is staked to both the ball housing and the rack at the indicated points to lock it in position. This drawing from the Workshop Manual should really show clearances at the red arrows, as drawn the joint is fully locked down i.e. the spring is fully compressed and the tie-rod wouldn't articulate: (*Workshop Manual*)

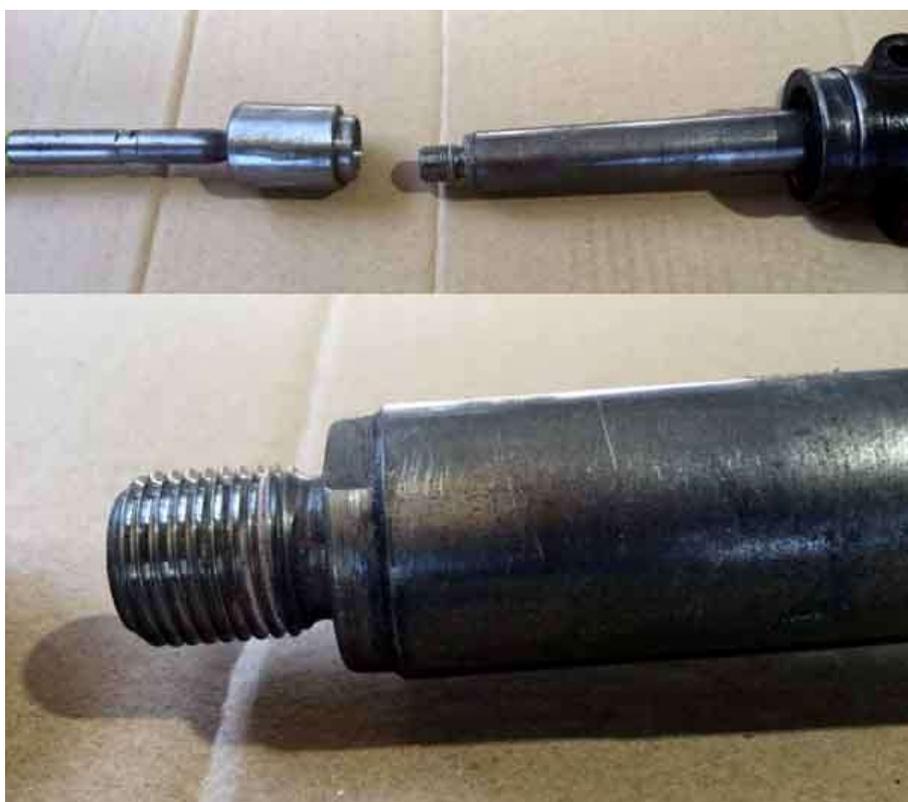
However with perseverance JP discovered that the joint can be separated if you use big enough Stilson's! There is still the question of locking the joint against coming unscrewed, as well as adjustment to give the correct level or articulation of the track-rod:

The reason for dismantling the joint was that there was no bush at the passenger side of the rack tube to support the rack shaft, and it flapped about all over the place! Starting inside the rack tube and working outwards there was a washer that wedged against a narrowing taper in the tube, then a gap, then a step in the tube against which a larger washer sat, then a groove against that with a circlip. So it looks like there should have been a bush of some kind between the two washers to support the rack shaft, but there wasn't. This was a replacement rack with the adjuster screw and locknut for the damper, [as above](#): (JPHall)

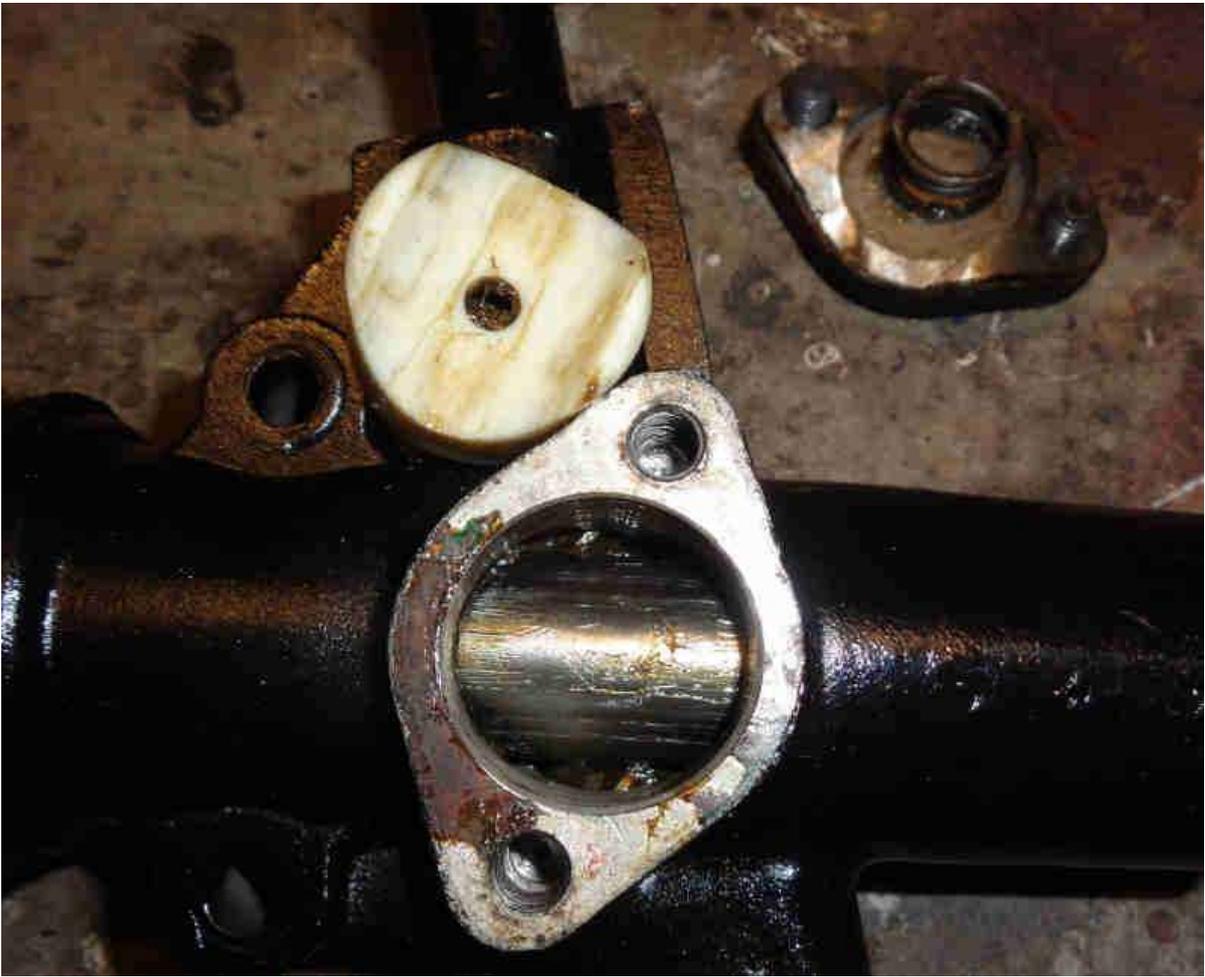
Nylon yoke instead of steel and copper-coloured damper so probably won't last as long, but clearance set by shims which is better than the adjuster that others have had problems with. Grease-lubricated so no more leaks. Bee's rack shaft was very easy to turn by hand and wheels up could be spun from lock to lock with a little finger-tip, probably a factor of the play in the passenger-side bush. This is stiffer even with the pinion cover slack so that is coming from the bush, I hope it's not stiff enough to prevent self-centring on the road. Speaking of 'lasting' I wonder how long the gaiters will last:

Never mind the gaiters, seven months and 1500 miles later this new rack gets an advisory 'both inner joints worn' i.e. exactly the same as before!

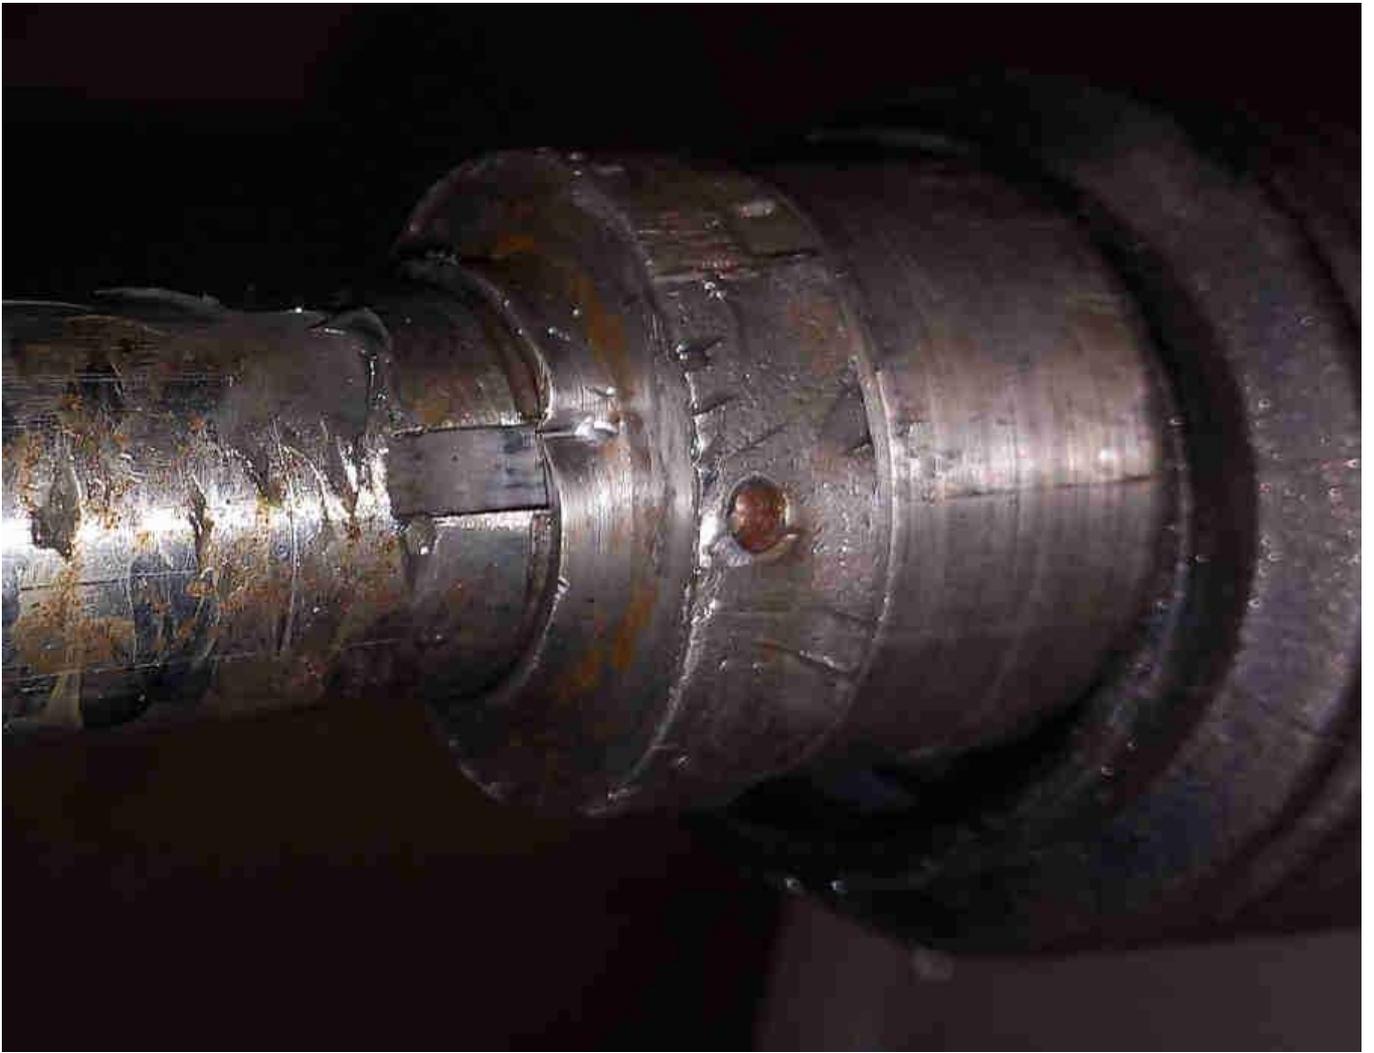
Nevertheless as both inner joints have only about 1/3rd the articulation force I dive in to find them as per the WSM so can be adjusted. The original staking of the locking-ring to the rack ...

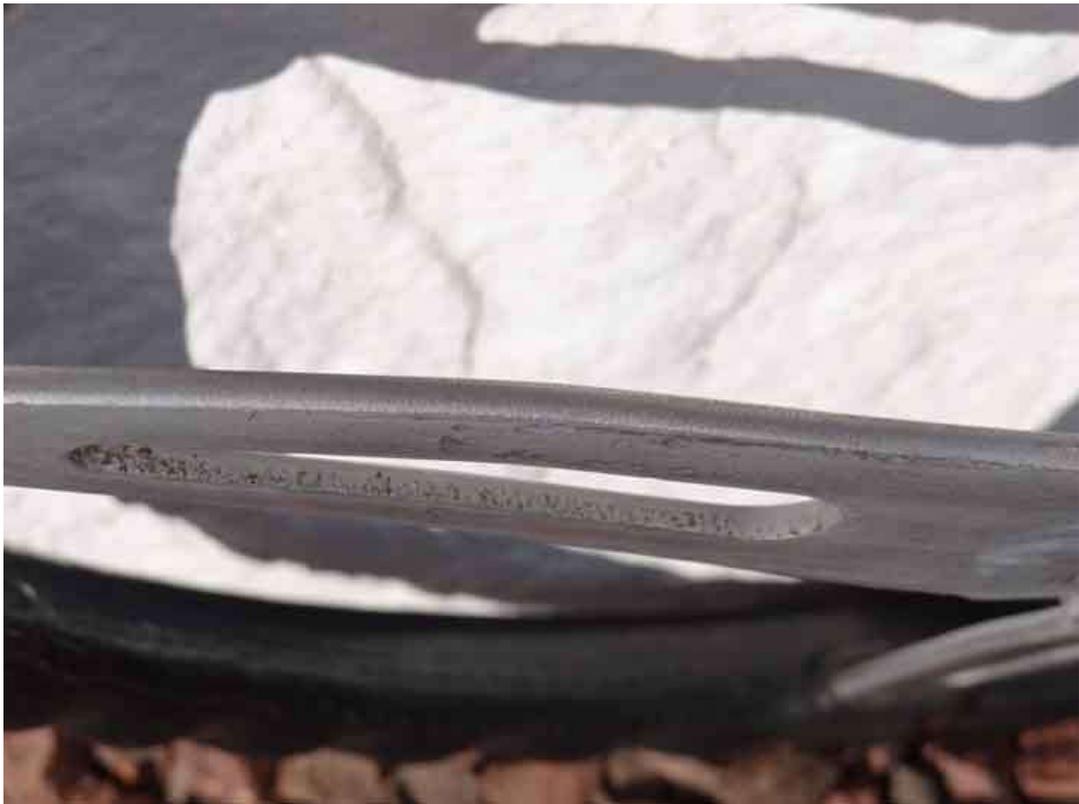
Some buckling, possibly due to the push-pull method of removal in the past ([Ray Longsheds](#))

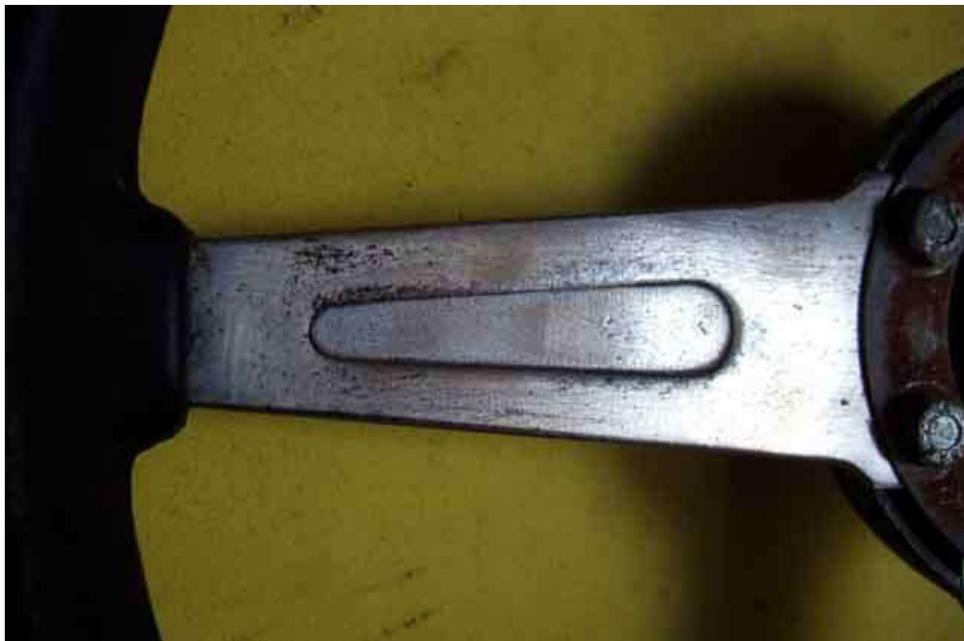
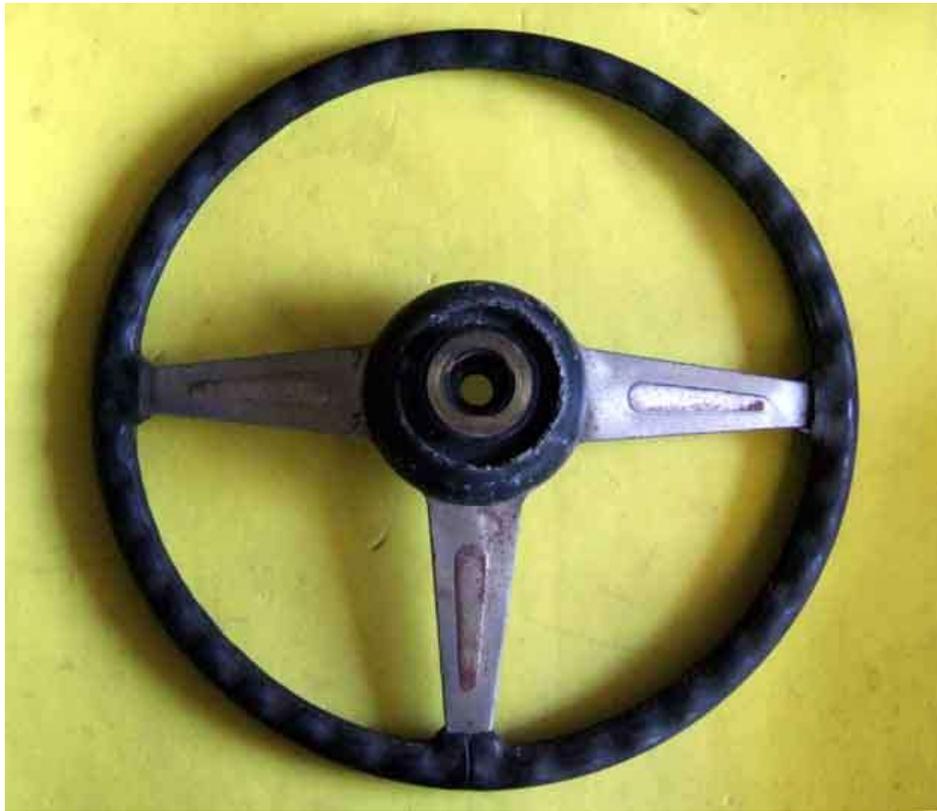
... although wire-brushing marks on the spokes ...

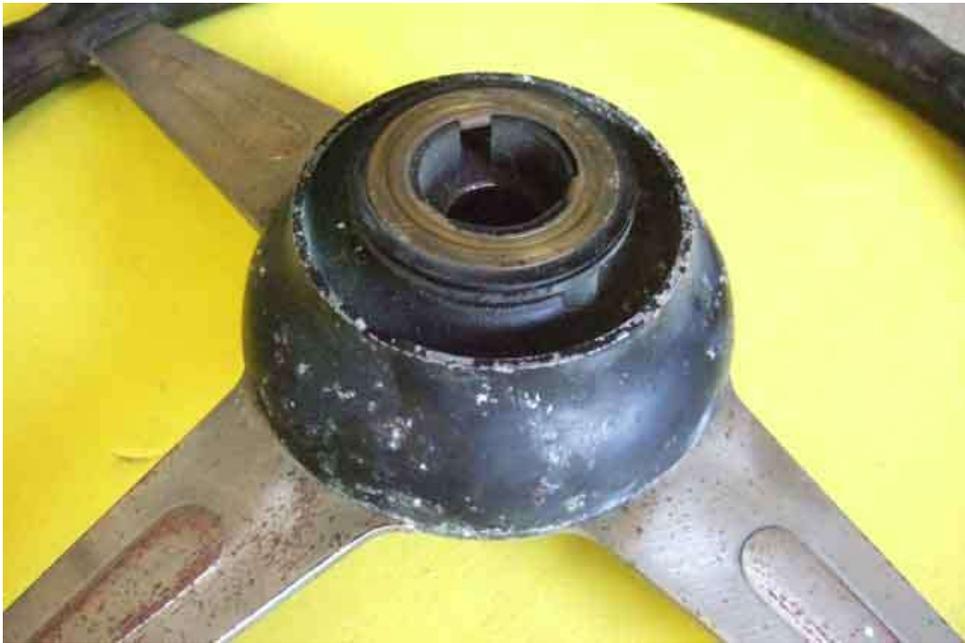
Hub needs repainting. Rubbing with wire wool dipped in cellulose thinners got all the old paint off and left a smooth surface. Hammerite special metals primer as the first coat, then two coats of Hammerite smoothrite satin black.

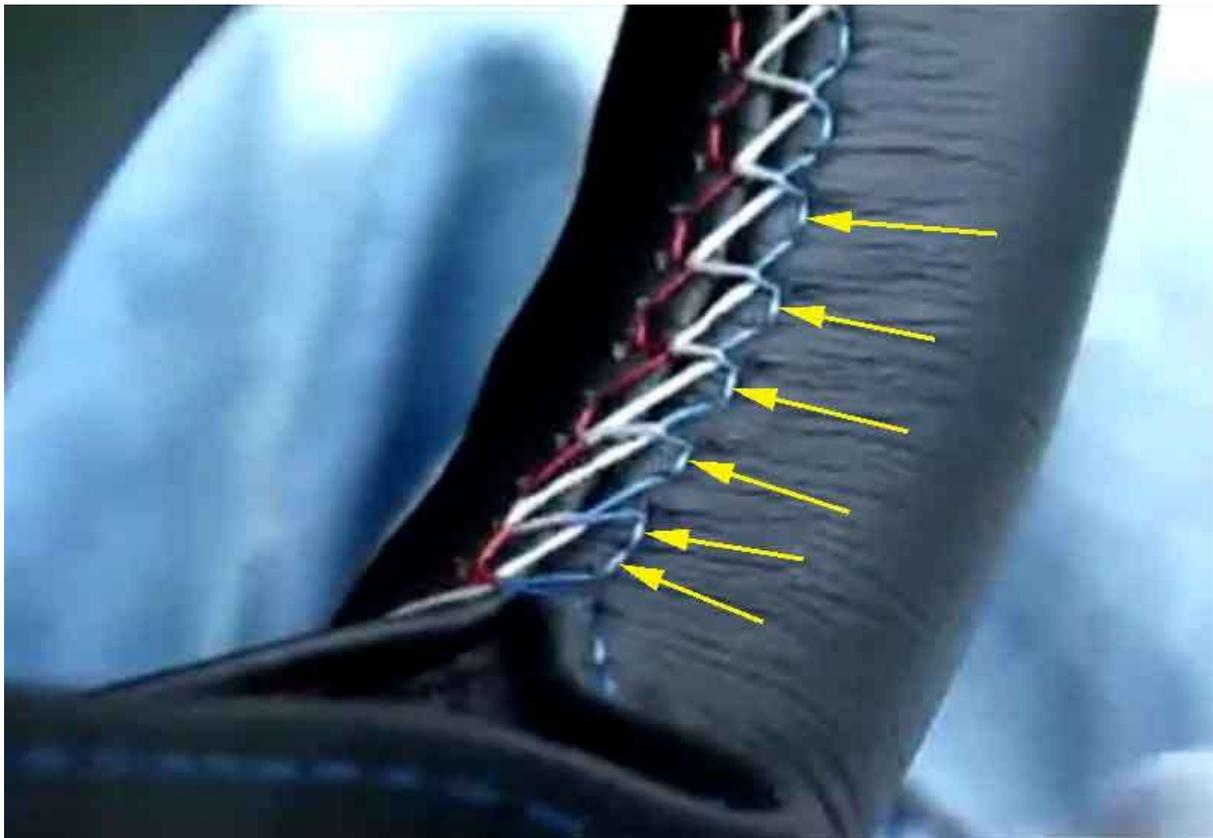
A still from the [Mr Steering instructional video](#) showing how the stitching was getting more and more out of line, until he skipped two stitches on the right-hand edge instead of one:

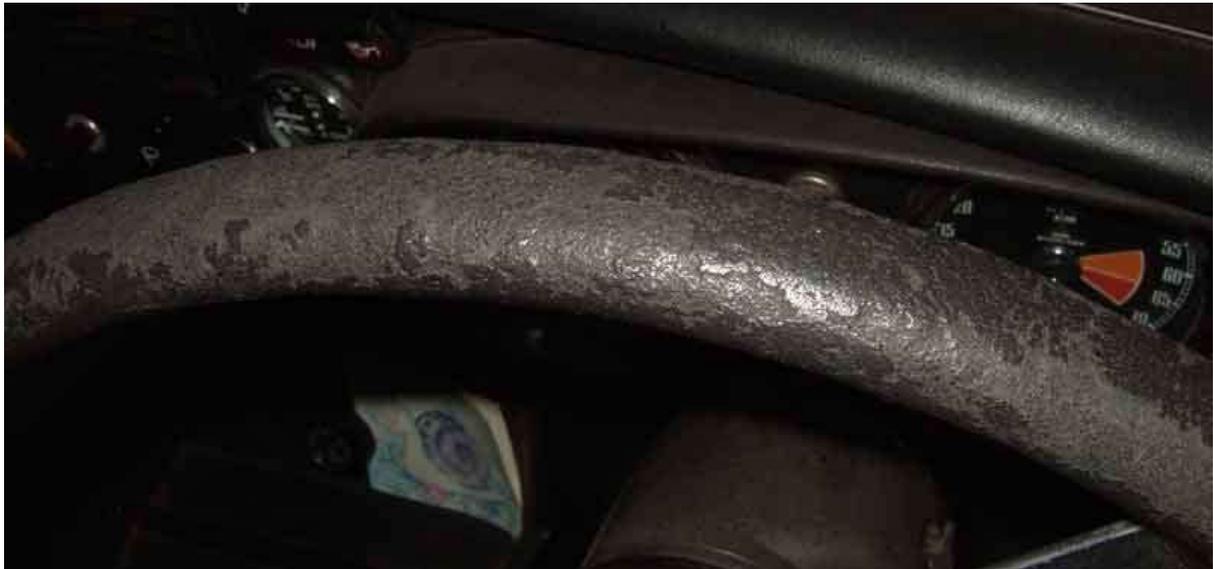
The top of Bee's wheel that gets all the sun is quite ratty, although given the manufacturer would never have intended it to have been used for 50 years it's pretty remarkable:

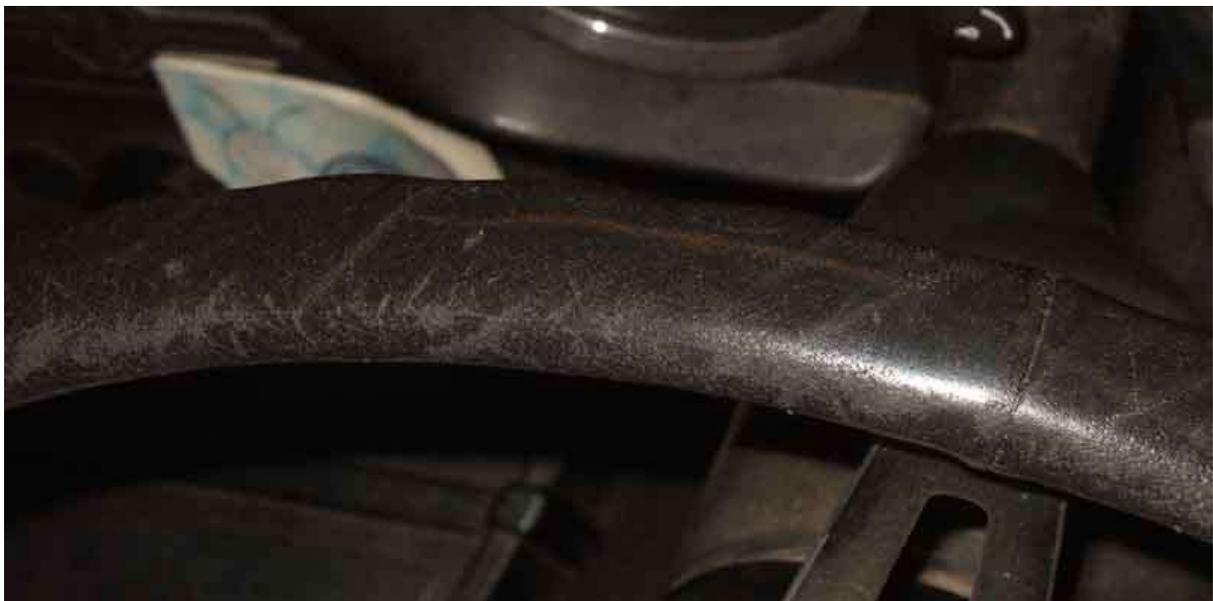
The underside - just light scuffing:

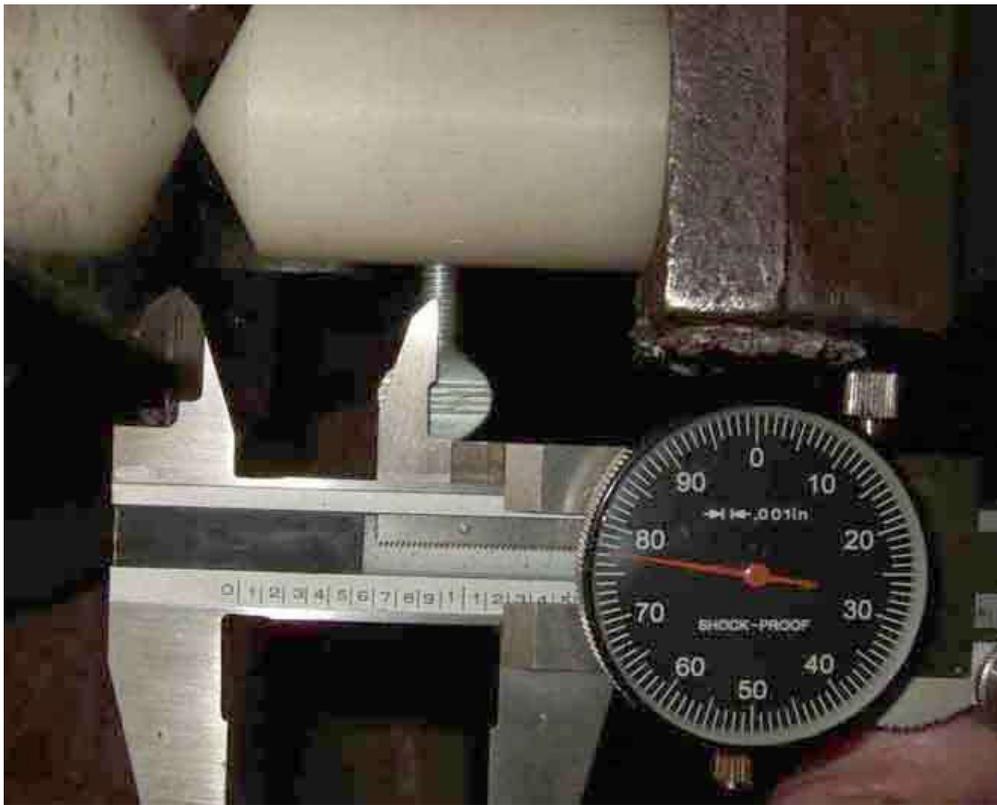
... and 1.177" or 30mm, so 1.5mm out for the RB UJ:

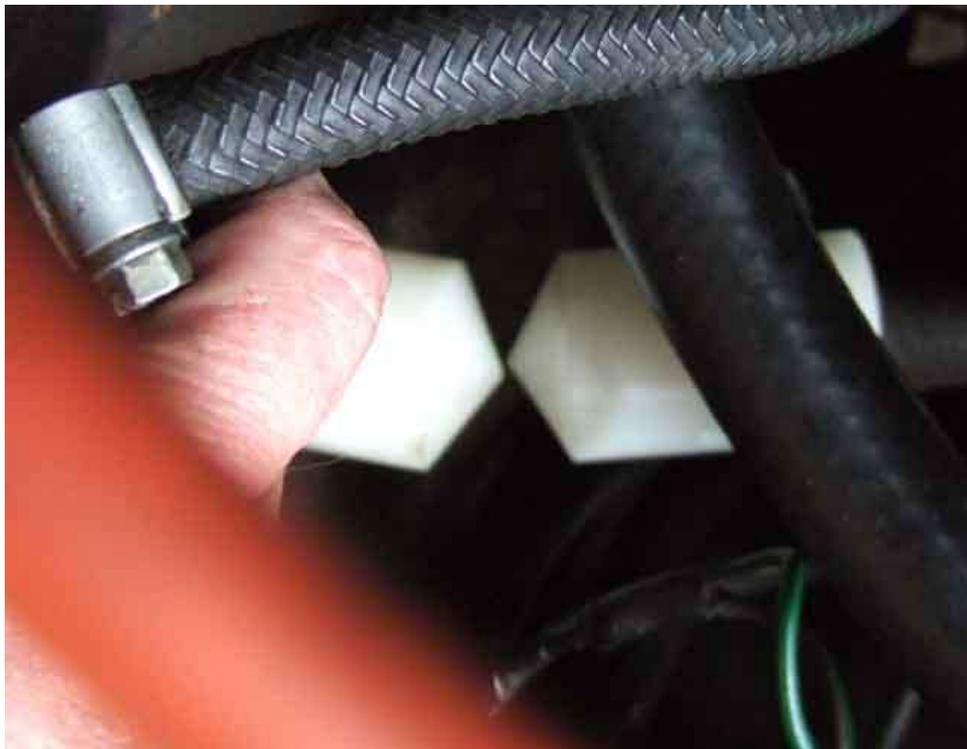
About 1/8" misalignment on the roadster:

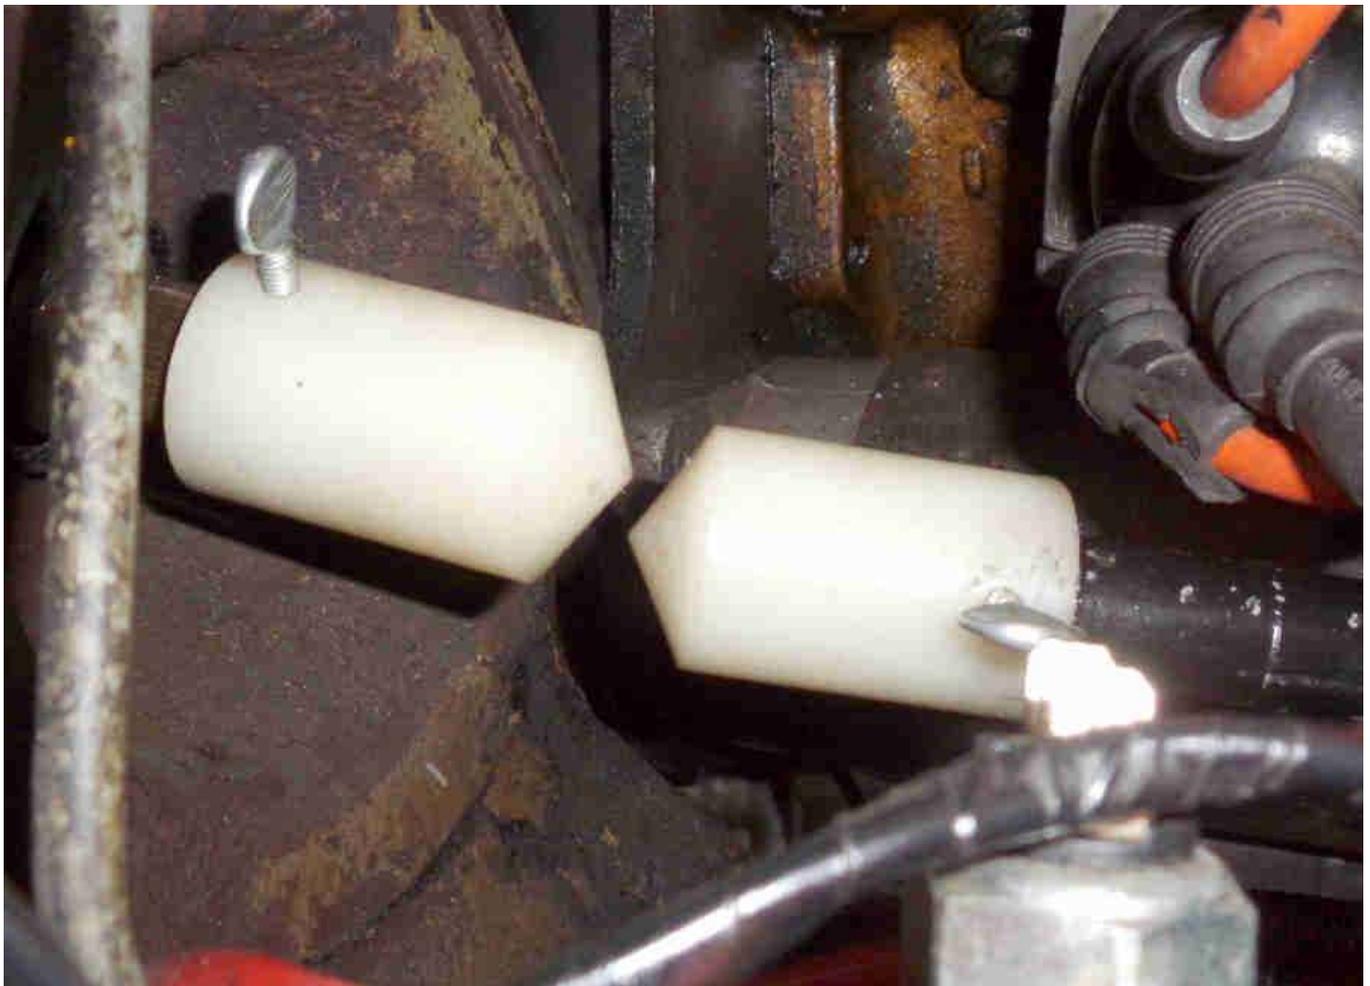
With the Bee's new rack the initial misalignment is a lot more in both vertical and horizontal directions:

There is enough movement in the lower column bracket to correct the horizontal but not enough in either of the column brackets to correct the vertical so the upper mounting points on the new rack will have to be shimmed. As well as all that the four rack mounting points need to sit square to the cross-member brackets and with the new rack (at least, I didn't have cause to check the old rack) the upper end of the near-side has a 12 thou gap to the bracket with the other three bolts nipped up:
