[5-Speed Conversion](#) [Overdrive](#)

Vitesse/Mazda 5-speed gearbox

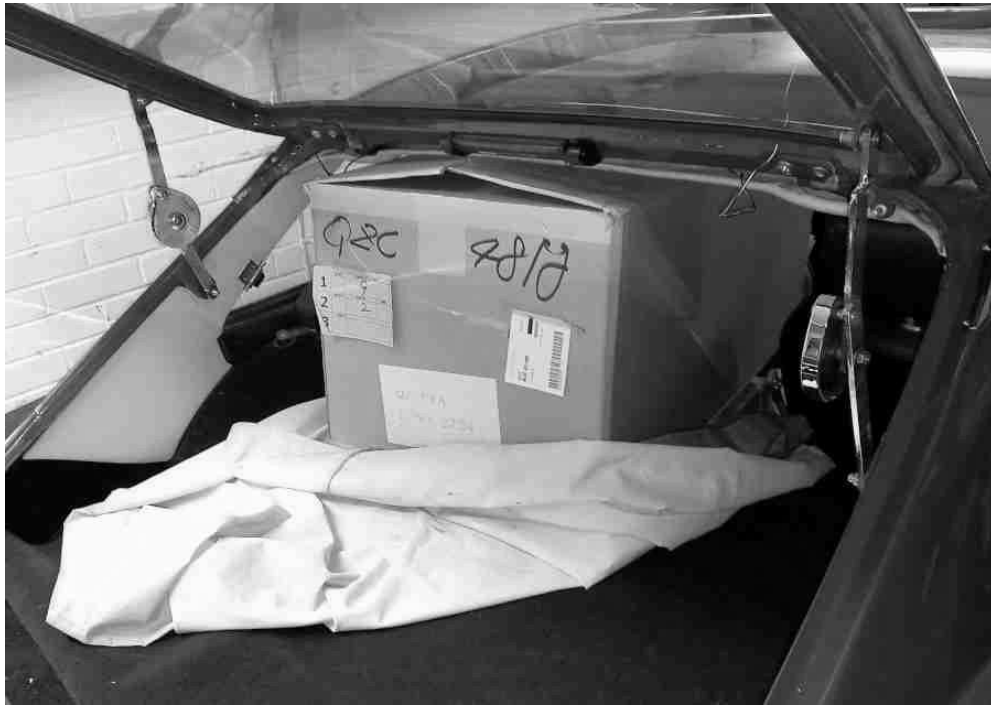
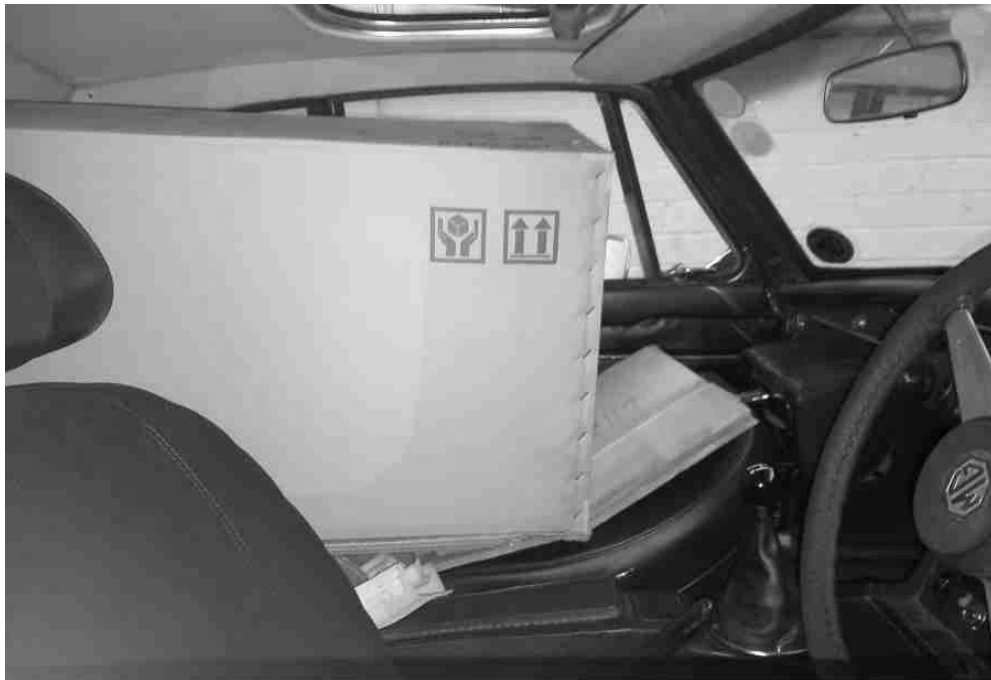
Then to get the old box into the back of Vee! Discussing it on my test-drive visit Wendy said they could put it in the box the Mazda gearbox comes in so that gives me a size and we measure one up minus it's feet which are several inches high - 100cm long x 44 high and 47 wide. Back home I make a 44 x 47 template and that will just go through the open hatch, and most of the way to the front with the seat tilted forward, and 100 long fits easily with several inches clearance to the roof at the front. In hindsight I should have taken the wheel cover carpet and rear seat back out, as with those in and cloths on them to protect against any oil but they had drained it at my request and put it in a poly bag so with that and being in a very stout cardboard box there would be little chance. As it was it only just went in with me pushing the rear cant rail up out of the way while two of them (not Wendy!) pushed and pulled, and it was in!

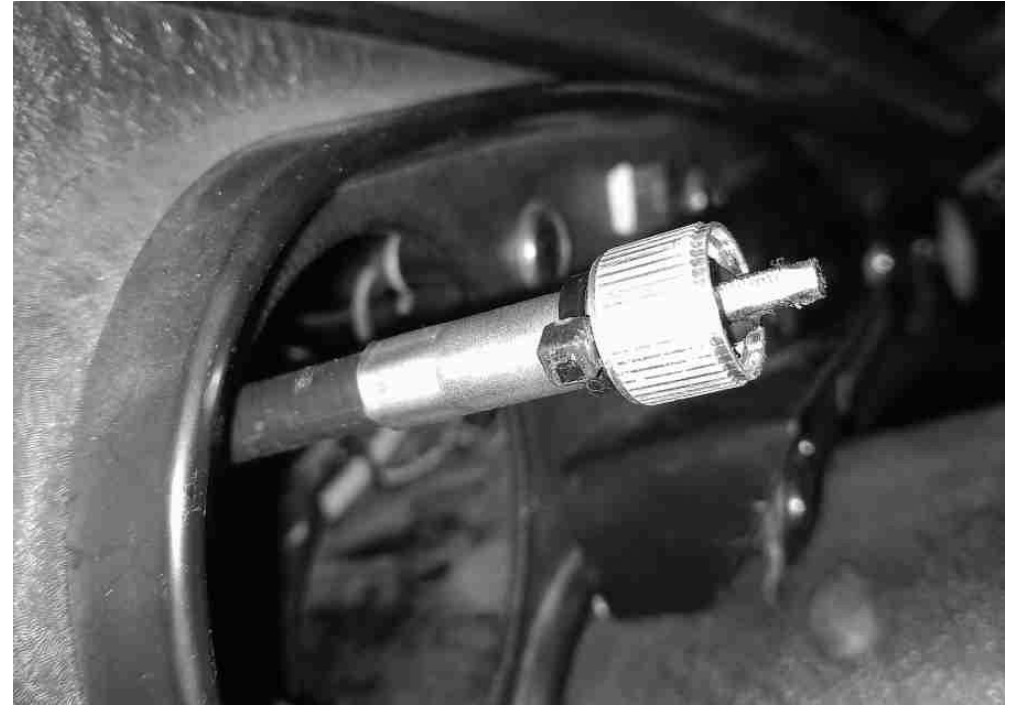
mentioned reaching behind the dash to attach, but in fact it projects forwards about as far as the 60" so it can be attached from the front. They had also put a cable-tie round the cable to stop the knurled wheel sliding down into the spaghetti behind the dash - more attention to detail:

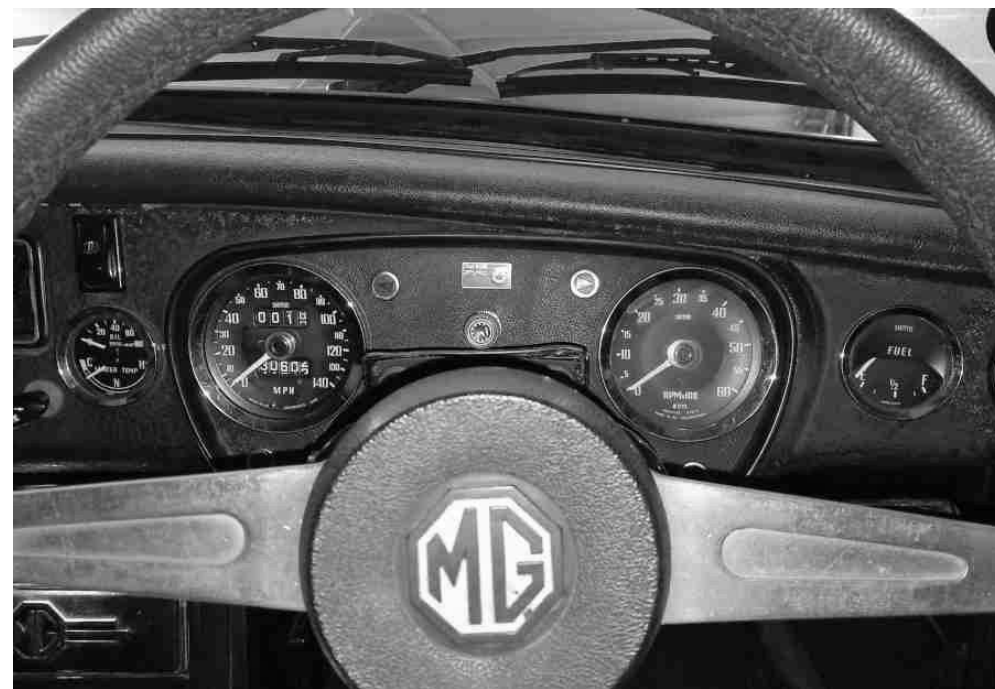
And wonder of wonders it arrives with nice clean wheels. Another £54 to pay which I wasn't surprised at as the formal quote was less than the estimate at initial enquiry. After only a brief trip out at no more than 35mph it seems to be over-reading by the legal maximum of 10% compared with my smart phone speedo app. Irritating, previously (and Bee) it was only 1% or 2% over at most speeds. Needs a longer/faster run to be sure, and see what the mileage is doing. Over several runs the mileage is pretty-well spot on, but the speed is consistently 10% if not 11% over. This is governed by the hair-spring in the pointer, which I'm not going to be able to do much about, but at the lower speeds I might be able to 'correct' it by [resetting the pointer on the spindle](#), which does the trick.

Still, it's nice to get Vee back together again ([mileage tweaked to add on what we had done without a speedo](#)):

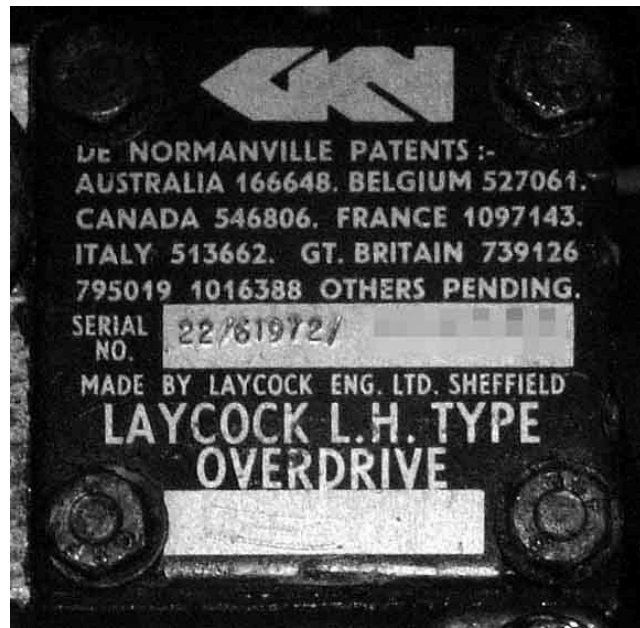
Bee's plate - '1972' seems quite common for 4-cylinder cars and is in line with the A-type sequence above. 'GKN' indicating that the badging changed by September 72 (Bee's build date) as well as the dates above:

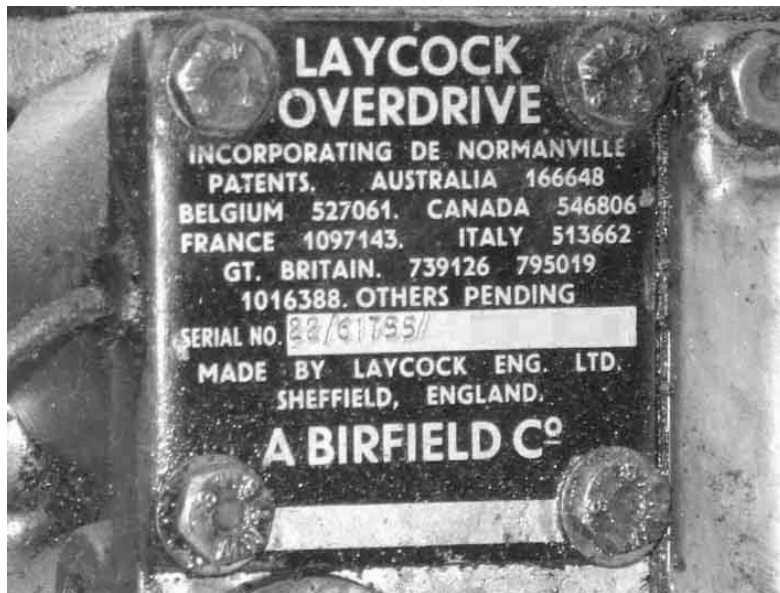
V8s always used a 960tpm speedo drive i.e. for both CB and RB, this is Vee's plate. A number lower than one might expect for a 1975-built car and earlier than Bee's, although V8s probably had their own number series to represent the different operating pressure. Also the earlier 'Laycock/Birfield' plate, so maybe Vee has had a replacement OD ... which may have come from a 4-cylinder!:
