Vitesse/Mazda 5-speed gearbox

After the [trials and tribulations of a rebuild then more problems just three years](#) later I investigate a Mazda 5-speed conversion by Vitesse Global Ltd.

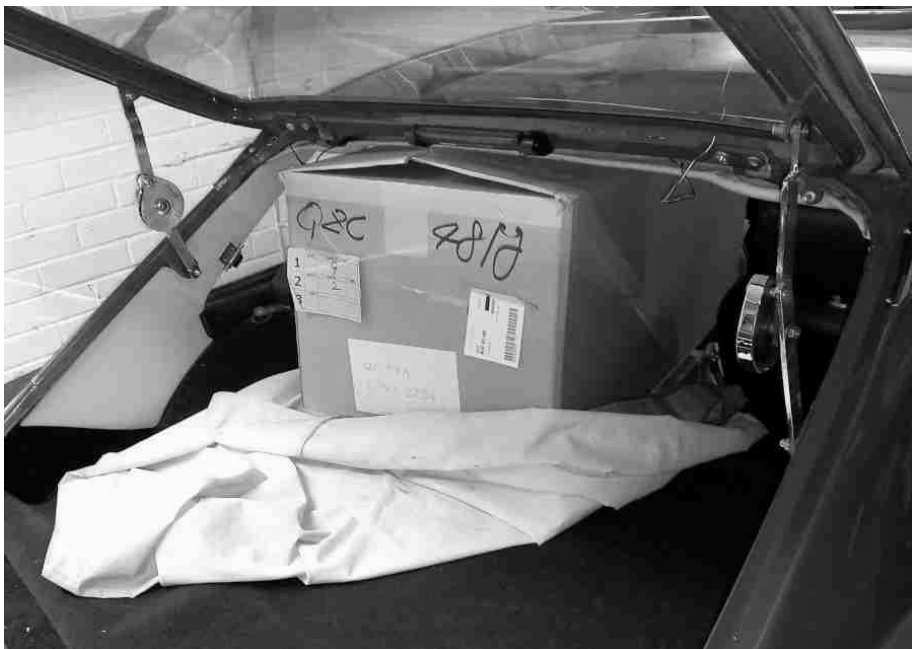
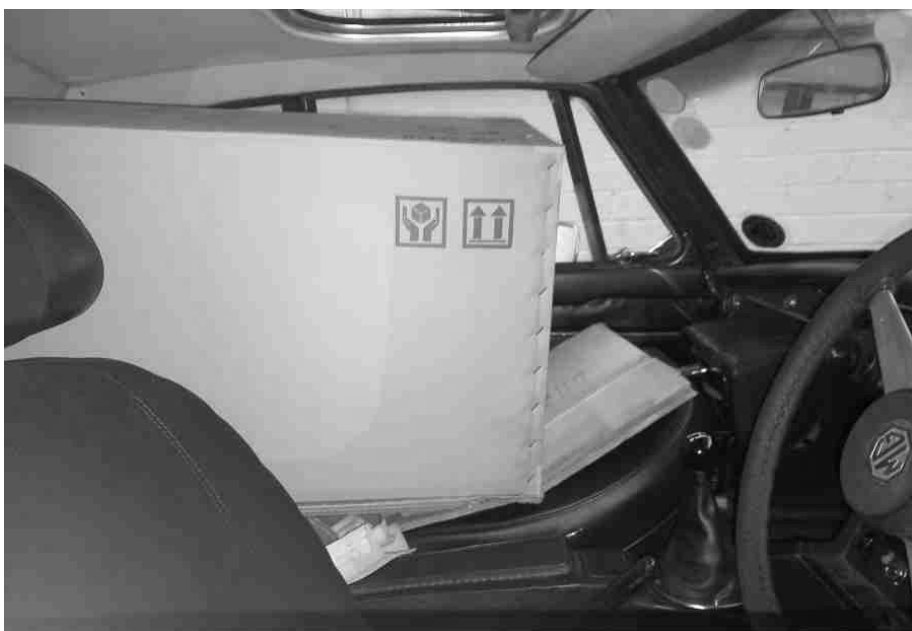
Then to get the old box into the back of Vee! Discussing it on my test-drive visit Wendy said they could put it in the box the Mazda gearbox comes in so that gives me a size and we measure one up minus it's feet which are several inches high - 100cm long x 44 high and 47 wide. Back home I make a 44 x 47 template and that will just go through the open hatch, and most of the way to the front with the seat tilted forward, and 100 long fits easily with several inches clearance to the roof at the front. In hindsight I should have taken the wheel cover carpet and rear seat back out, as with those in and cloths on them to protect against any oil but they had drained it at my request and put it in a poly bag so with that and being in a very stout cardboard box there would be little chance. As it was it only went in with me pushing the rear cant rail up out of the way while two of them (not Wendy!) pushed and pulled, and it was in!

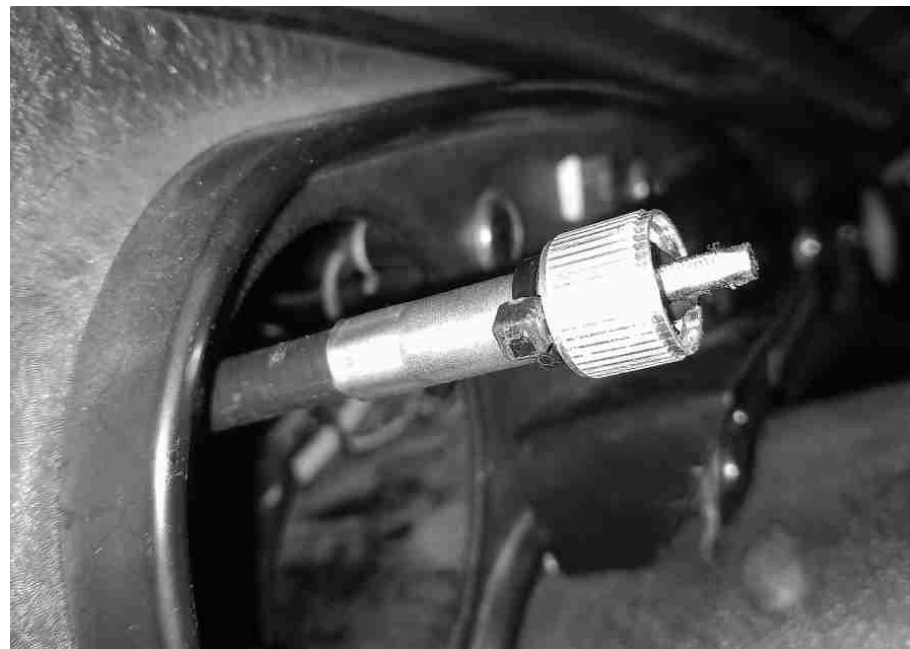
A bit of good news concerns the speedo cable. I'd previously asked about the length as the original 57" had to be removed and attached groping behind the dash, but the later 60" allows it to be pulled forwards. Asking about that earlier they just mentioned reaching behind the dash to attach, but in fact it projects forwards about as far as the 60" so it can be attached from the front. They had also put a cable-tie round the cable to stop the knurled wheel sliding down into the spaghetti behind the dash - more attention to detail:

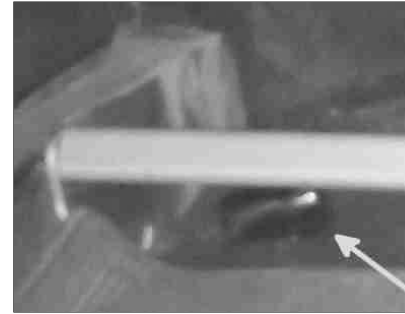
used to it. Or both. Changing gear the lever still seems to have a closer physical relationship to the mechanicals - the original lever seemed 'damped' by comparison, but the lightness and (so far) no baulking is good. One thing I'm noticing is that with the original boxes I rarely put the clutch to the floor to change gear but now I find myself doing so as otherwise there is more of a sensation though the knob.

I enquired about the original gear knob and they said it had been put in the footwell - where I found it, ironically appearing in the above photos but not noticed!

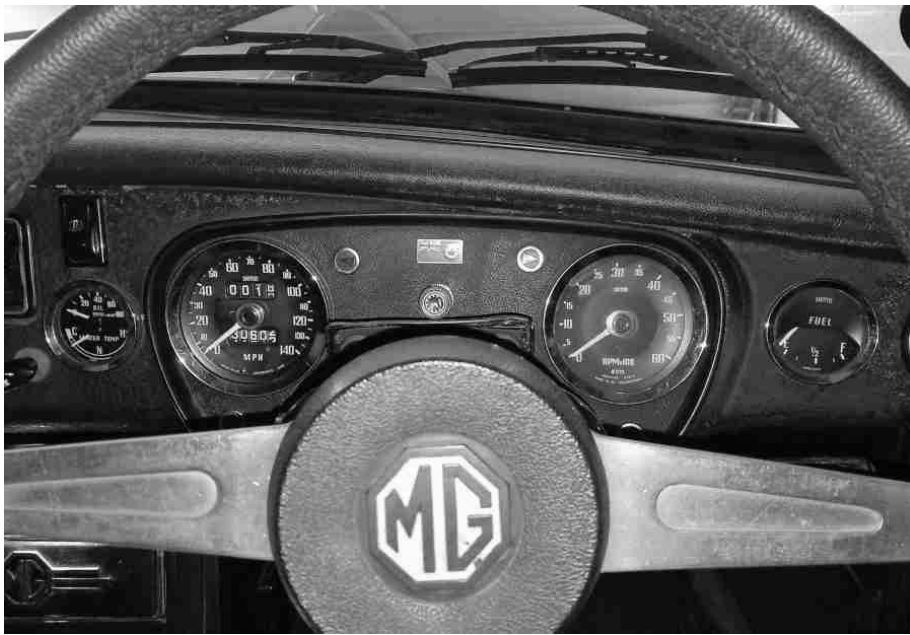
And wonder of wonders it arrives with nice clean wheels. Another £54 to pay which I wasn't surprised at as the formal quote was less than the estimate at initial enquiry. After only a brief trip out at no more than 35mph it seems to be over-reading by the legal maximum of 10% compared with my smart phone speedo app. Irritating, previously (and Bee) it was only 1% or 2% over at most speeds. Needs a longer/faster run to be sure, and see what the mileage is doing. Over several runs the mileage is pretty-well spot on, but the speed is consistently 10% if not 11% over. This is governed by the hair-spring in the pointer, which I'm not going to be able to do much about, but at the lower speeds I might be able to 'correct' it by resetting the pointer on the spindle, and that does the trick across the speed range.

Still, it's nice to get Vee back together again (mileage tweaked to add on what we had done without a speedo):

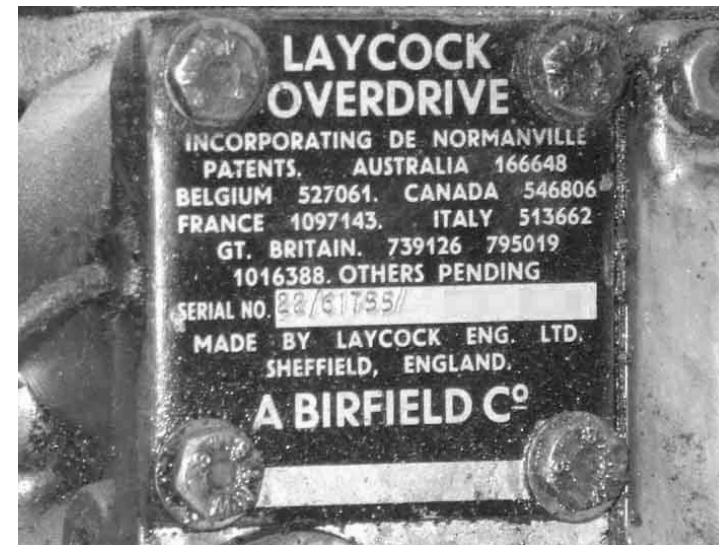
V8s always used a 960tpm speedo drive i.e. for both CB and RB, this is Vee's plate. A number lower than one might expect for a 1975-built car and earlier than Bee's, although V8s probably had their own number series to represent the different operating pressure. Also the earlier 'Laycock/Birfield' plate, so maybe Vee has had a replacement OD ... which may have come from a 4-cylinder!:
