Clutch

The hydraulic clutch system in the MGB is 'self-adjusting', in that it compensates for any mechanical free-play or physical wear between the slave cylinder and the clutch cover-plate. There is normally masses of free play in the release arm when not attached to the slave cylinder which has to be taken out, as well as wear occurring over time primarily at the graphite release bearing, but also the friction plate and the linkage between the slave push-rod, release arm and clevis pin. All of this free-play and wear is taken out by the hydraulic system. The linkage at the pedal/master cylinder end falls outside that and so wear in the pedal, master push-rod and clevis pin contributes to a low biting-point and grinding when selecting reverse as full pedal travel doesn't move the master piston, slave push-rod and hence the release arm as much as it should. If you have a low biting point or grinding in reverse replacing worn components at the slave end i.e. release arm, push-rod or clevis pin will not make any difference, although it is good practice of course. If you have those problems it is something else i.e. air in the hydraulics, wear at the master cylinder end, or poor late

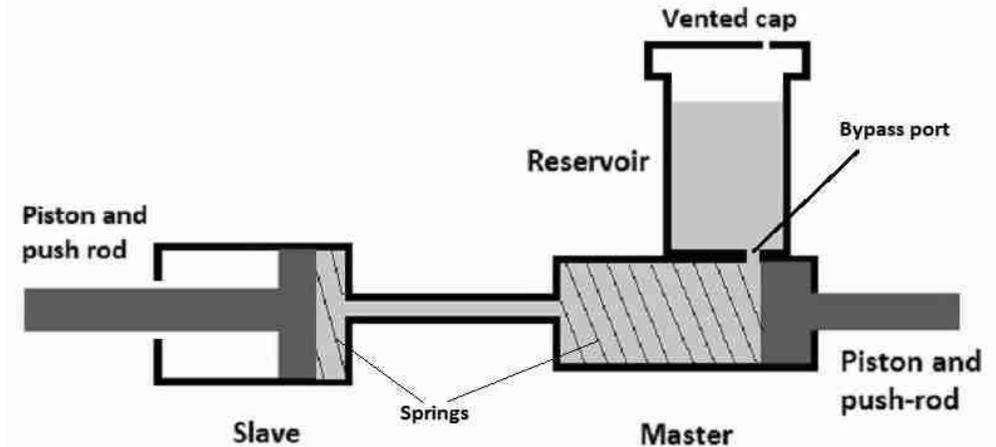
The spring in the master is also pushing its piston towards the open end of the cylinder, but for a different reason. The reservoir has to be able to get fluid into the cylinder and it does that via a bypass port between the two. But that port is only 'open' when the piston is fully retracted i.e. pedal released and piston pushed fully back by the spring. In this position fluid can flow under the effect of gravity from the reservoir right through

to the slave, to be replaced by air passing through the vented reservoir cap, as this greatly simplified drawing shows:

It is only because that bypass port is open when the pedal is released that constant pressure bleeding systems such as EeziBleed are able to push fluid through the system and push air out of the slave. As soon as the pedal starts to move the piston that port is blocked off, and it's only then that the piston can start to apply a force to the fluid, and via the pipework to the slave piston and release arm etc. Until that port is covered movement of the piston displaces fluid up into the reservoir.
