## Body and Fittings

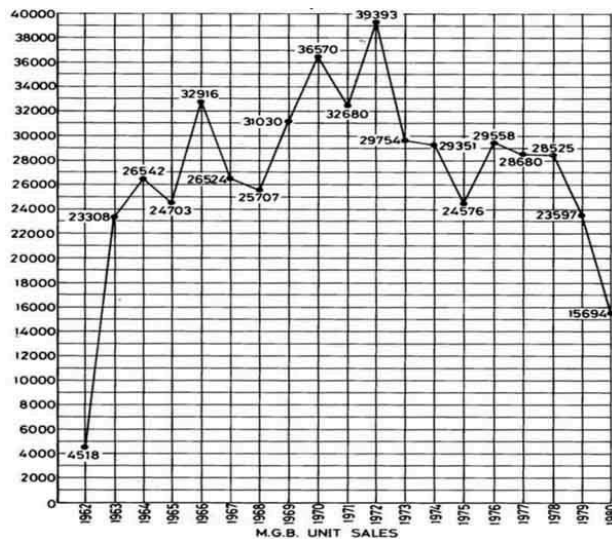
Annual production from Lyndsay Porter's 'Guide to Purchase & D.I.Y Restoration of the MGB', sensibly renamed 'The MGB Restoration Manual':

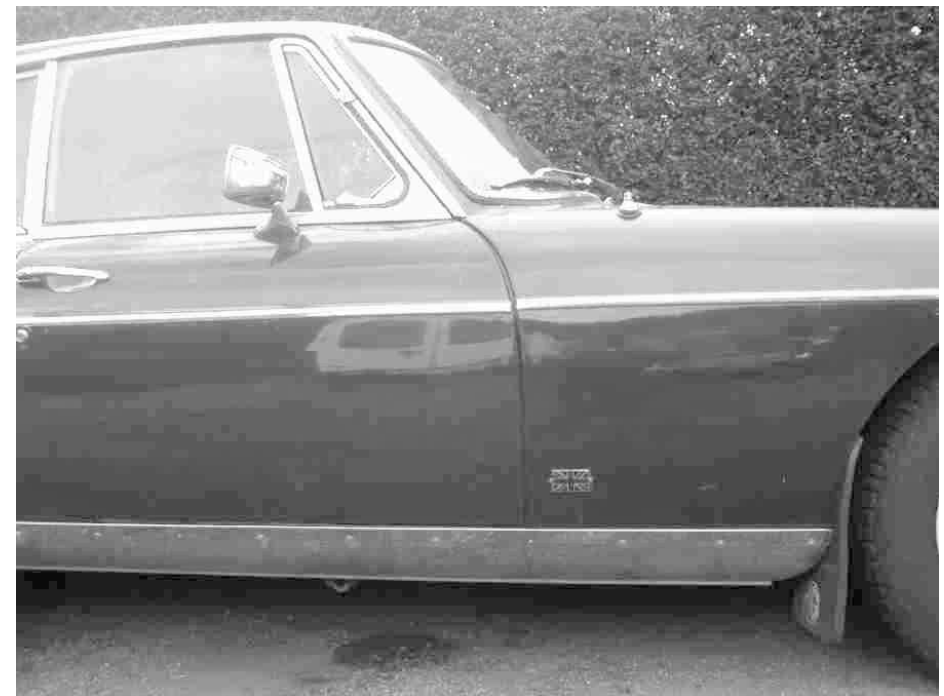
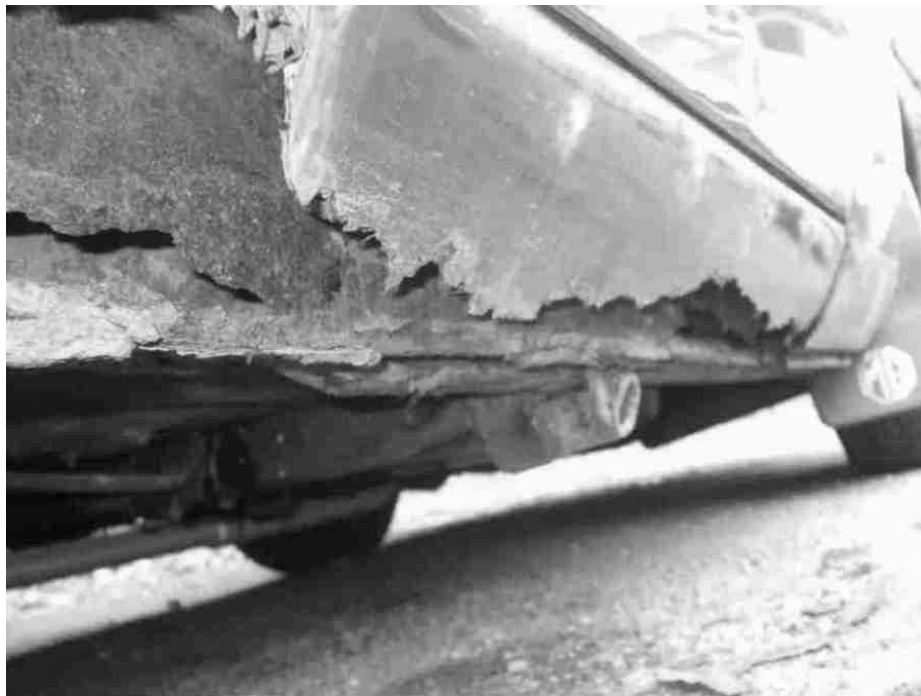
**Never. Ever. Consider buying an MGB that has shiny sill covers ... (this and next image from [Morris Minor Owners Club](#))**

... unless the seller is willing to take them off so you can see the condition of the sills underneath.

Yes that is the same car despite the very different colour rendering, you can tell by the line of pop-rivets holding them on (very crude, usually they have concealed fixings) and corresponding holes in the underlying panel.

There could be anything from rust bubbles to huge holes (as here), and in the latter case you may be able to see the central membrane is also rotten (also as here). Even if you look underneath at the castle rail and floor and they appear to be sound the inner box section - usually covered by glued-down carpet or rubber mats - could also be rotten. These sills have double box-section construction and extend between the two wheel arches, they supply the main structural strength of the body and if heavily corroded the passenger compartment could be crushed in a severe frontal or rear impact.
